Hurricane lan

Released: November 16, 2022 NHERI DesignSafe Project ID: PRJ-

PRELIMINARY VIRTUAL RECONNAISSANCE REPORT (PVRR)

Virtual Assessment Structural Team (VAST) Lead: Maria D. Cortes Delgado, University of Puerto Rico-Mayagüez

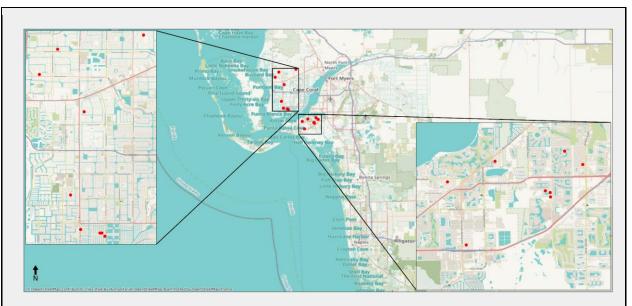
Beyond Babcock Ranch, however, aerial imagery from NOAA revealed damage to roof solar panels in areas that observed higher peak wind gusts. A preliminary assessment conducted in multiple neighborhoods in Cape Coral and Fort Myers identified 30 rooftop panel installations with severe damage (Fig. CS.5.1). An example of typical damage is shown in Fig. CS.5.2. Field inspections can reveal less visible damage to the panels (Burgess & Goodman, 2018; Ceferino et al., 2022), identify specific failure mechanisms (e.g., cracks and local failures in the rack, panel connection, or roof attachment), and evaluate the impacts on continuous power access and building functionality.

Figure CS5.1. Locations with damaged solar panels in Cape Coral and Fort Myers shown with red dots. Damage was visually inspected from NOAA's aerial imagery after Hurricane lan.

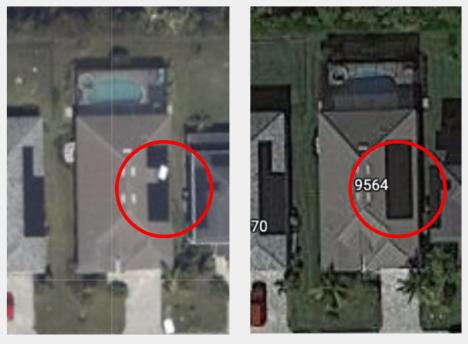
Figure CS5.2. Evidence of roof solar panel damage by comparing (left) a damaged panel visible in the post-storm NOAA imagery, and (right) pre-event imagery showing the undamaged panel.

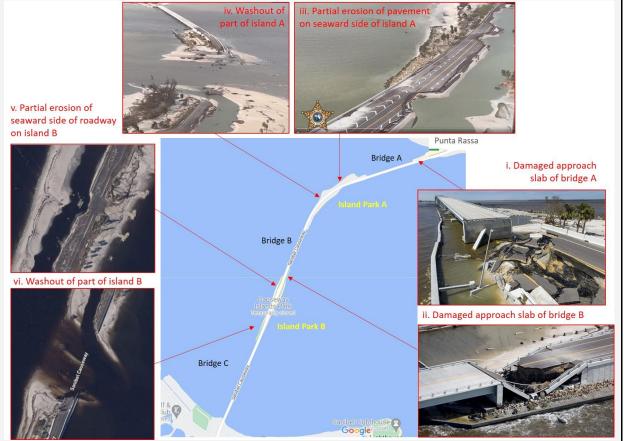
A notable case is the failure of the Sanibel Causeway, experiencing three different types of damage at different locations (see Fig. CS.5.3). The Sanibel Causeway consists of three bridges (A, B, C) and two islands (Causeway Island Park A, B) as shown in Fig. CS.5.3. Interestingly, in contrast to past hurricanes (e.g. Hurricane Katrina) that had uplifted bridge superstructures in multiple locations of the Gulf Coast Region, in this case the superstructures and their connections to the substructure (piers) were intact and the damage occurred at the approach slab of both Bridge A (on the mainland side) and Bridge B (on the south side). In both cases the approach slab was elevated (same elevation with the bridge span) and was supported on backfill material that was protected by wing-walls consisting of modular panels restrained by soil anchors embedded in the compacted fill. These panels were exposed to lateral loads from the surge and the waves. Since there is no observed erosion of the area in the vicinity of the wing-walls, it could be hypothesized that the lateral hydrodynamic loads made some of the panels unstable, which exposed the backfill material to hydrodynamic actions and scour. Once the backfill material started undergoing scour, the vertical pressures that were applied by the backfill on the slab and helped keep the slab in place were reduced, essentially leading to a simply supported slab.

Figure CS.5.3. Observed damage to Sanibel Causeway, including damage to approach slabs of bridge A (Source: Lasey (2022) and B (Source: Brackett and Wesner Childs, 2022), erosion and washout of island A (Source: Lee County Sheriff's Office) and erosion of island B (Source: NOAA Hurricane Ian Imagery).

Two other types of damage were also observed in the Sanibel Causeway, particularly 'at the two islands. The first type was the partial damage of the pavements on the seaward side, which was caused by the erosion of the soil below the roads, and the second type was the total washout of the road with the island below it (see Fig. CS.5.3). Interestingly, for both island A and B, the first type of damage occurred towards the north side of the island and the second type (total washout) occurred towards the south end. As shown in Figure CS.5.4, for island A at the location where a total washout was observed, the road was very close to the shore, which means that it could be exposed to surge and direct impact from the waves. On the other hand, at the location with partial damage and scour of the pavement, the road was located further from the shore. This would consequently imply that while in the former case the road would be subjected to hydrodynamic effects (e.g., scour) immediately after the instant at which the surge and waves reached the elevation of the road, in the latter case the road would be subjected to the same effects only after the sandy beach (on the seaward side) would have been eroded. Apart from this hypothetical explanation, other potential reasons that could have contributed to the different levels of damage are (i) differences in road elevations, (ii) directionality effects which may be important in the case of skewed bridge superstructures subjected to extreme
