# District Report

## Rasuwa

20 July - 2 August 2018

## Field Visit Reports

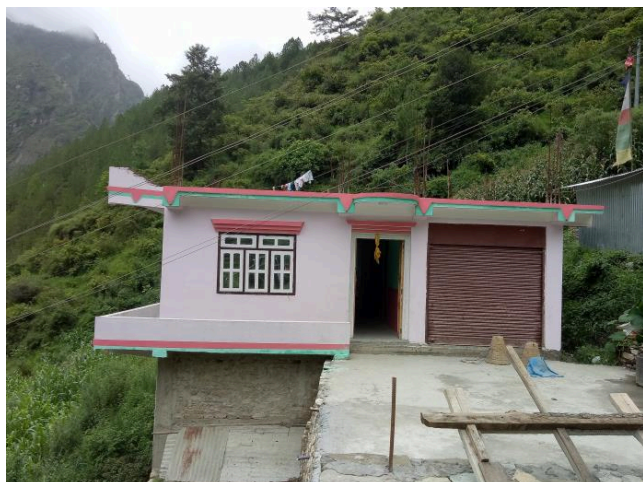
Caption: The house belongs to two beneficiaries; Santu Tamang and Birman Tamang brothers in relation. The two houses have the common slab. The one in the left belongs to Santu Tamang and consist of RCC structures with Stone as infill wall in ground floor and brick in first floor. The house in the right with shutter belongs to Birman Tamang not having the lower portion. The house in the left side (Santu Tamang) consist of 3 rooms in the ground floor and 3 rooms in the top floor and the house in the right (Birman Tamang) consist of 3 rooms. Tranche: Third tranche received. Santu Tamang is also involved in the construction of houses in his area but has not taken any formal trainings. He has helped in construction of 3 houses in his area

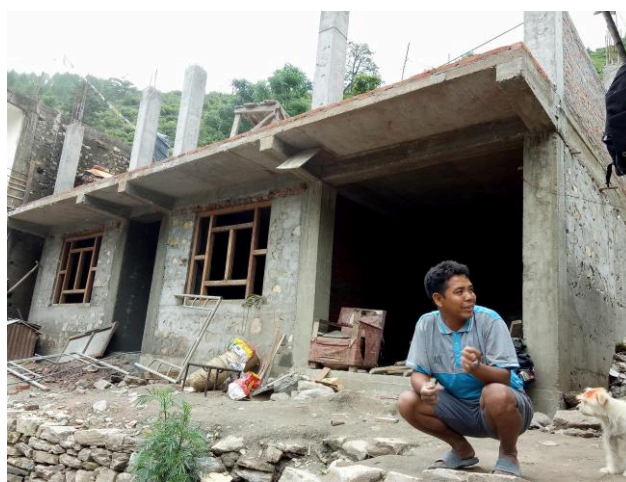
Caption : The house belongs to two beneficiaries; Bunima Tamang. He registered grivences on resurvey and verification but not addressed on grivences as well . he has given for punarabedan.Currently he is staying on tempory shelter . He has taken loan from megha bank to build house.

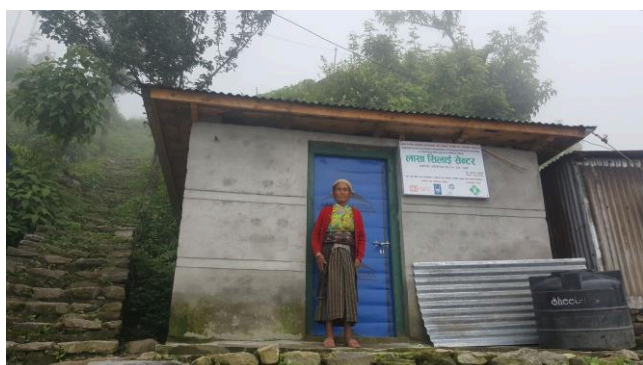
Name of Owner: Mesang Tamang  
Kalikasthan RM ward no-1, Ramche  
Tranche: Third Taken  
Housing Typology: BMC with CGI sheet roof, One room house  
She is a 75 years old single woman living in the one room house constructed under the government housing.

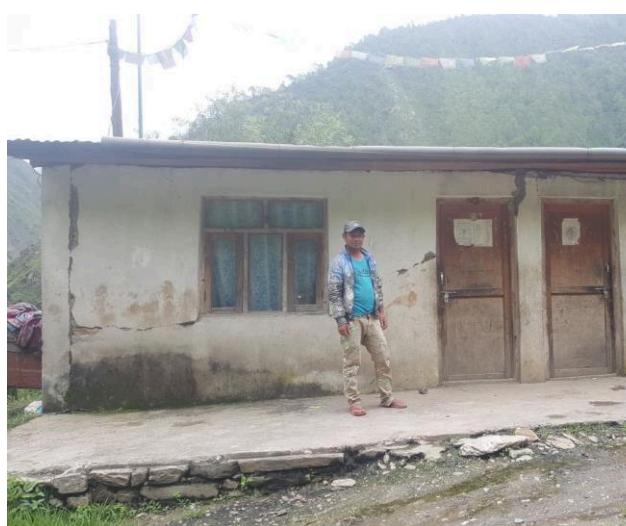
Name of Owner: Birbal Tamang  
Gosikunda RM ward no-5, Syafru  
Retrofitting beneficiary  
Housing Typology: SMC with CGI sheet roof, One room house  
The beneficiary is still staying in the same house as he doesn't have any temporary shelter to stay.

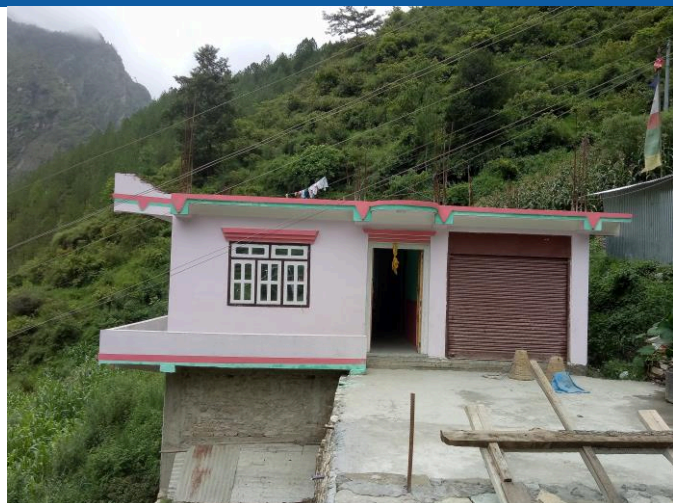
The house belongs to two beneficiaries; Santu Tamang and Birman Tamang brothers in relation. The two houses have the common slab. The one in the left belongs to Santu Tamang and consist of RCC structures with Stone as infill wall in ground floor and brick in first floor. The house in the right with shutter belongs to Birman tamang not having the lower portion. The house in the left side(Santu Tamang) consist of 3 rooms in the ground floor and 3 rooms in the top floor and the house in the right(Birman Tamang)consist of 3 rooms .

Tranche: third taken

Santu Tamang is also involved in the construction of houses in his area but has not taken any formal trainings. He has helped in construction of 3 houses in his area.

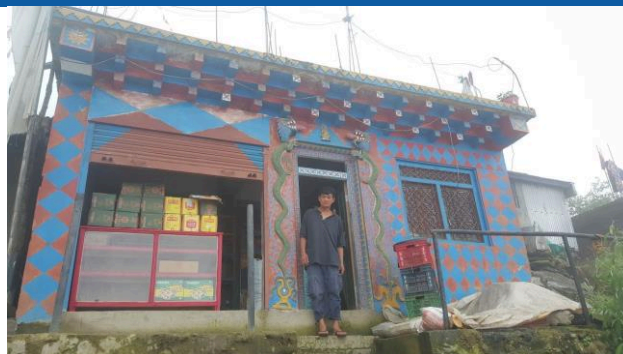
Name of Owner: Pemba Tamang

Kalikasthan RM ward no-1, Ramche

Tranche: Second Taken

Housing Typology: One-storeyed RCC structure

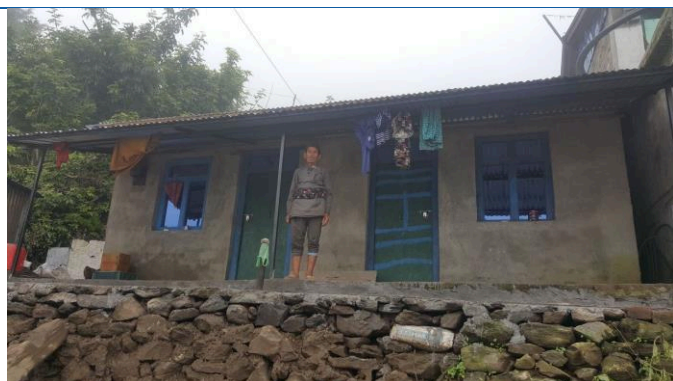
Name of Owner: Lawang Lopchan

Kalikasthan RM ward no-1, Ramche

Tranche: Third Taken

Housing Typology: BMC with CGI sheet roof, Two room house

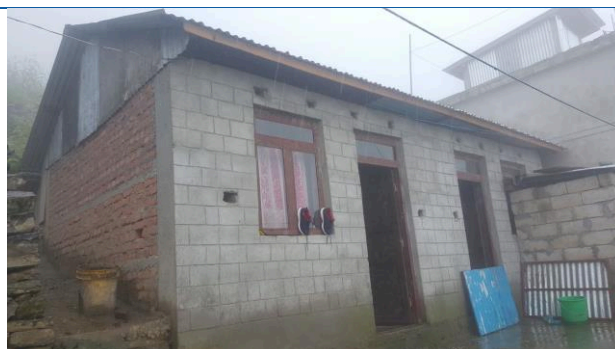
Name of Owner: Sagar Tamang

Kalikasthan RM ward no-1, Ramche

Tranche: Second taken and 3<sup>rd</sup> recommended

Housing Typology: BMC with CGI sheet roof, Two room house.
