# District Report

## Sindhuli

4 – 11 May 2018

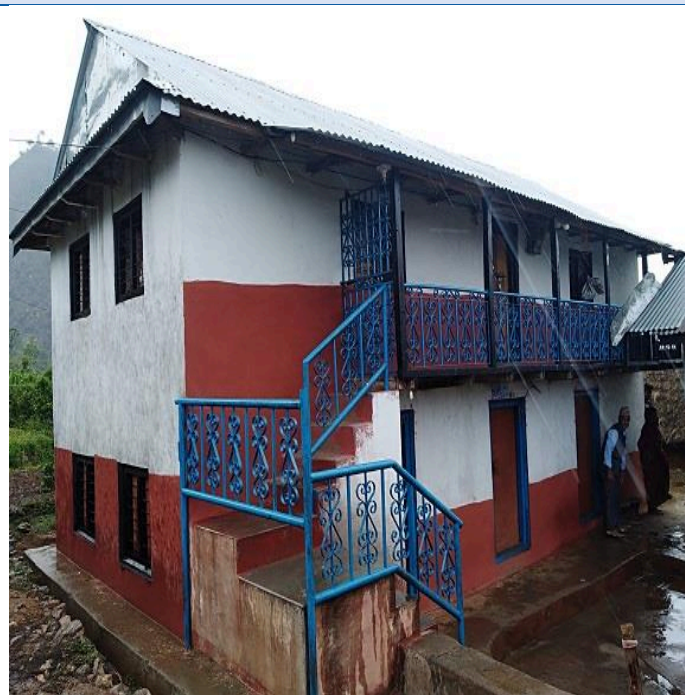
Caption: Stone Masonry building located in Majhuwa ward no – 07 of Sunkoshi Rural Municipality, Sindhuli district. This house was built recently after the Gorkha Earthquake, there is attic height problem. Due to non-compliance issue house owner hasn't received government 2<sup>nd</sup> tranche.

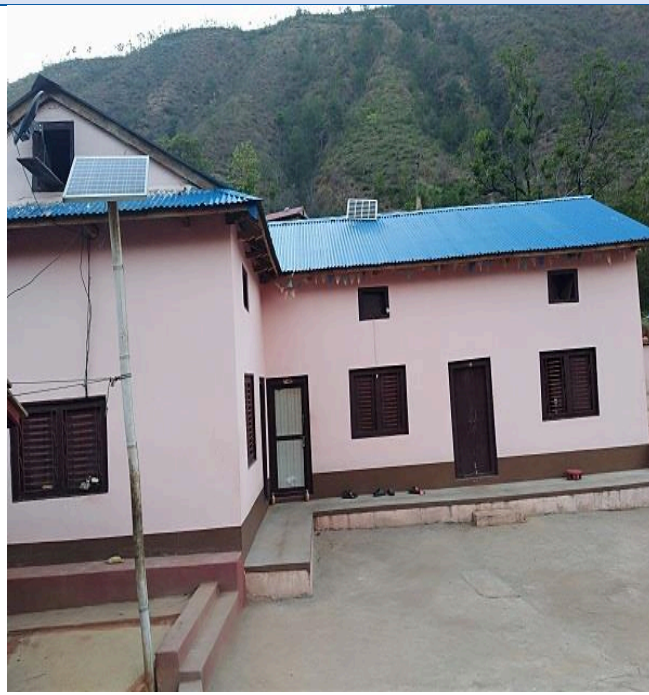
Caption: Stone Masonry building located in Tamling Ward no – 03 of Sunkoshi Rural Municipality, Sindhuli district. This house was built recently after the Gorkha Earthquake, before the deployment of DLPIU Engineers. The house is L-Shape with non-compliance issue, so that house owner hasn't yet received government 2<sup>nd</sup> tranche.

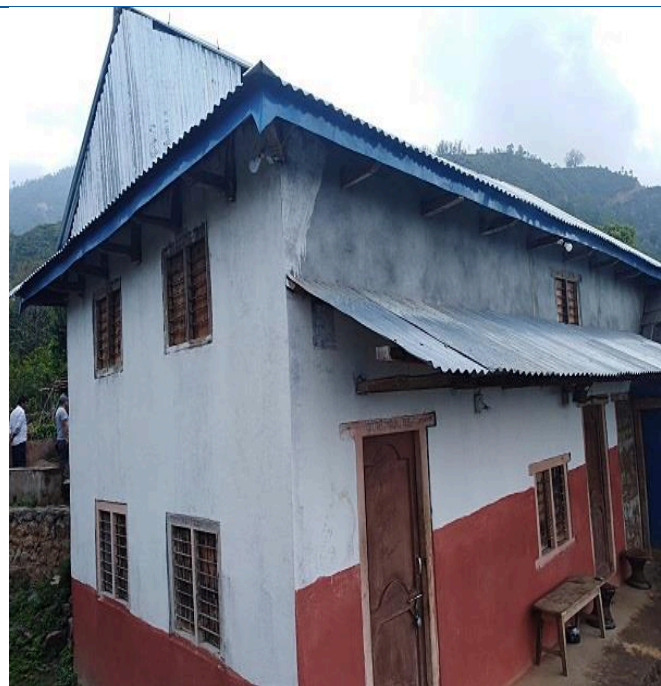
Caption: Stone Masonry building located in Majhuwa ward no – 07 of Sunkoshi Rural Municipality, Sindhuli district. This house was built recently after the Gorkha Earthquake, there is attic height problem. Due to non-compliance issue house owner hasn't received government 2<sup>nd</sup> tranche.

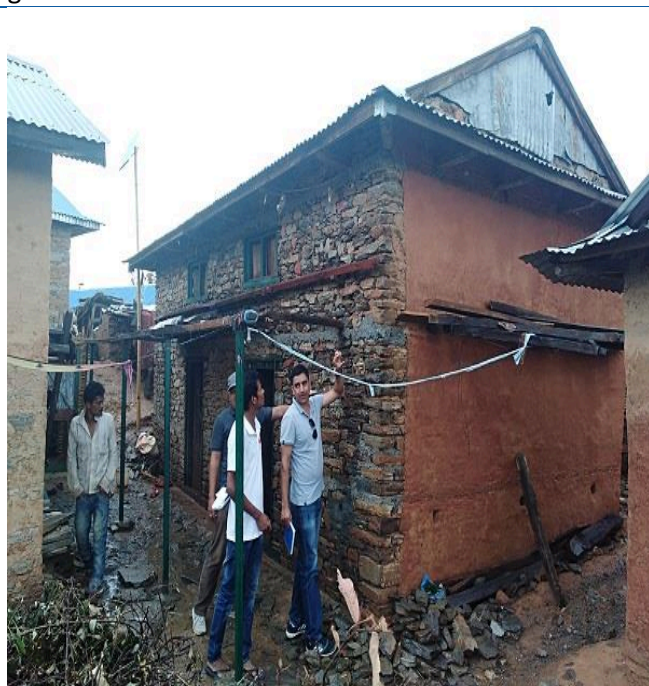
Caption: Stone Masonry building located in Amare Sitalpati ward no – 06 of Sunkoshi Rural Municipality, Sindhuli district. NRCS/ERO Sindhuli provided technical assistance to build houses in this area. The house was non-compliance so we provided some correction tips so

| | that house owner could receive government 2 <sup>nd</sup> tranche. |

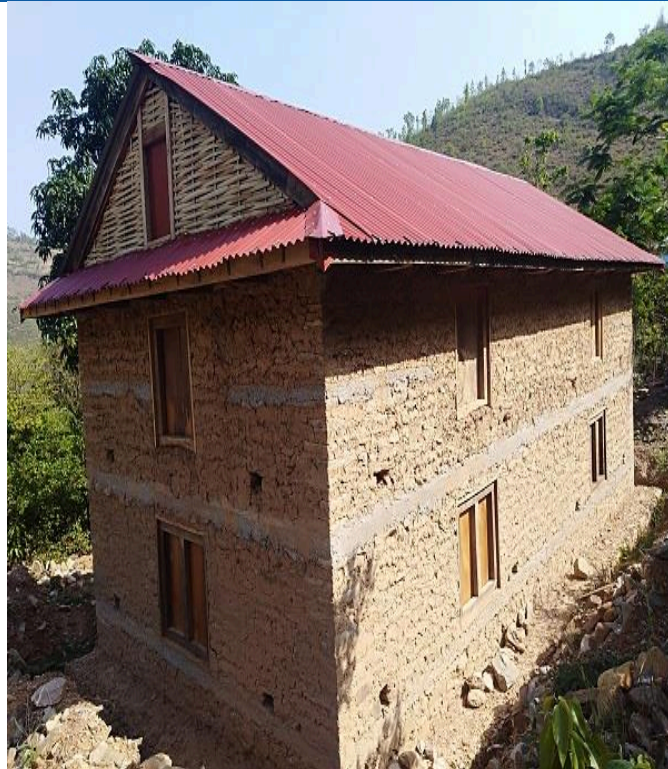
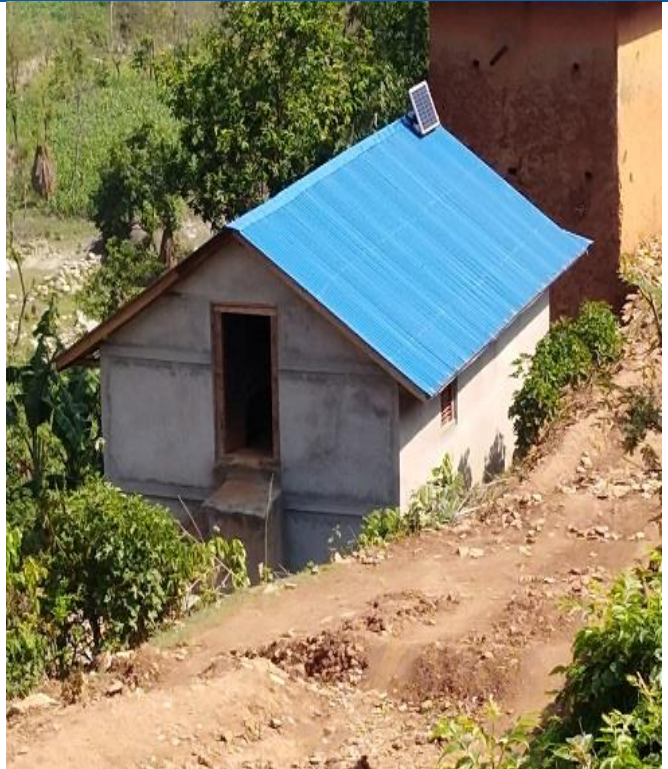
| <p>Caption: Stone masonry building located in Gaikhora ward no – 05 of Sunkoshi Rural Municipality, Sindhuli district. The house was non-compliance due that there was no horizontal band below and top of the window. House owner has received government 2<sup>nd</sup> tranche and waiting for 3<sup>rd</sup> tranche.</p> | <p>Caption: Stone masonry building located in Gaikhora ward no – 05 of Sunkoshi Rural Municipality, Sindhuli district. Construction of this house is completed but there seems problem regarding that no adequate set back distance from the road but house owner has received government 2<sup>nd</sup> tranche.</p> |
