# District Report

## Okhaldhunga

23-29 March 2018

## Housing Typology Report

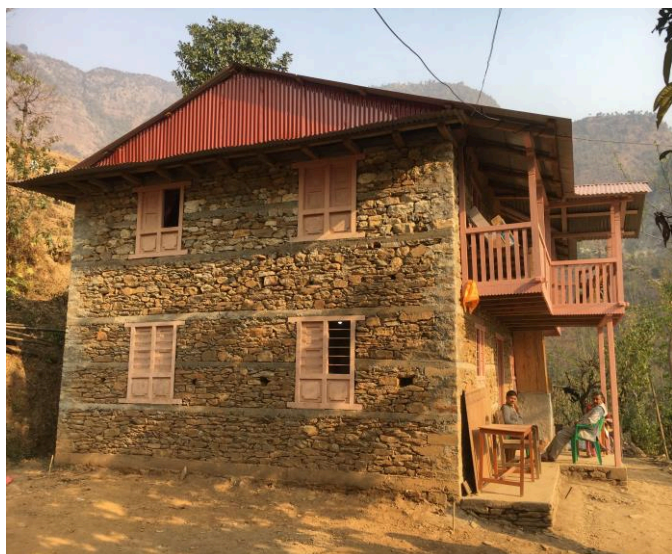
**Ward 4, Molung Rural municipality, Okhaldhunga:** Stone masonry structure in mud mortar and Concrete horizontal bands in lintel, seal and DPC level. The House owner Mr. Gopi Krishna Karki has received second tranche and forwarded the file for third tranche, But the file for third tranche has been rejected. Two story building with mud mortar leads the problem to get the final tranche, the house owner complained about the technical supervisor, he told us "I have constructed this house with collection the advice from the technical person but these day I could not able to get my third tranche by showing this full structure". He asks for recommendation that how he can get the final tranche.

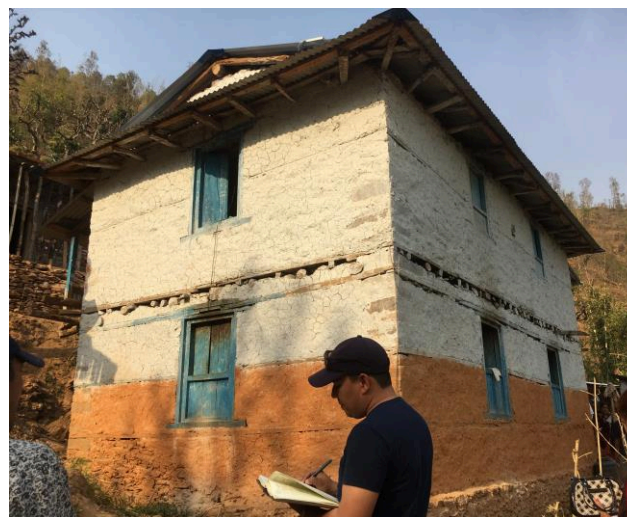
**Ward 3, Molung Rural municipality, Okhaldhunga:** Stone masonry structure in mud mortar and wooden horizontal bands in lintel and seal level. Kamal Parsad Phuyal the house owner constructed this house immediate after the earthquake i: e early January of 2016. Without supervised and technical guidance, he had constructed this house having two stories. The house owner has only received first tranche and rejected for second tranche. We gather the information from the Ward chairperson Ram Karki he told us, in this ward 14 numbers of houses have problem in getting second and third tranche.

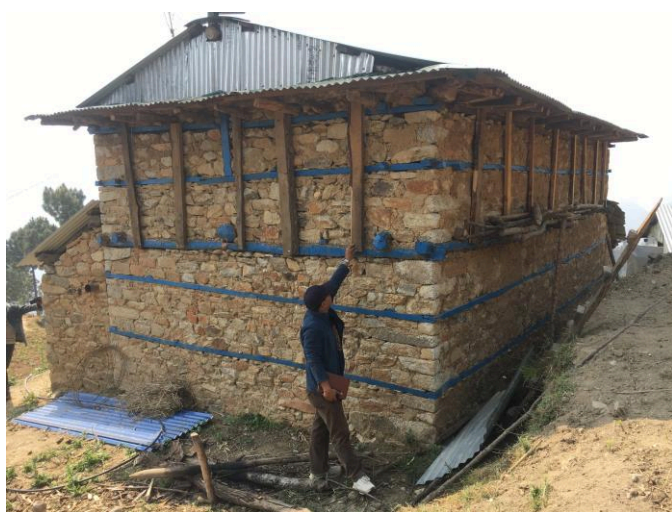
**Ward 5, Molung Rural municipality, Okhaldhunga:** Tika Bahadur Tamang house owner has received second

tranche and transferred the file for third tranche. Stone masonry structure in mud mortar and wooden bands used to construct the house. Technical person recommended Mr. Tamang to correct the height of the house, he has corrected by providing the wooden vertical member to join the upper horizontal and lintel horizontal band.

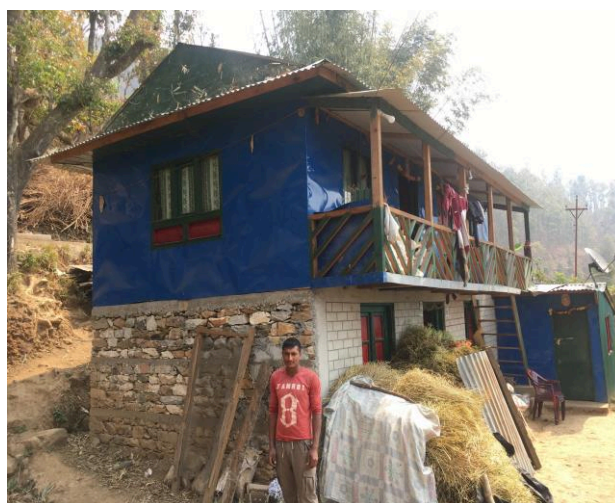
**Ward 2, Molung Rural municipality, Okhaldhunga:**

The owner of composite hybrid structure is Cheena Maya Khatri. The lower part constructed with stone masonry in mud mortar providing concrete horizontal band and upper part constructed with the wooden frame with CGI partition. She has received second tranche. Technical person who has working in this ward do not have inspection form and, they are bit confusing about this type of structure to transfer the file.
