# District Report

## Kathmandu Valley

20 July - 2 August 2018

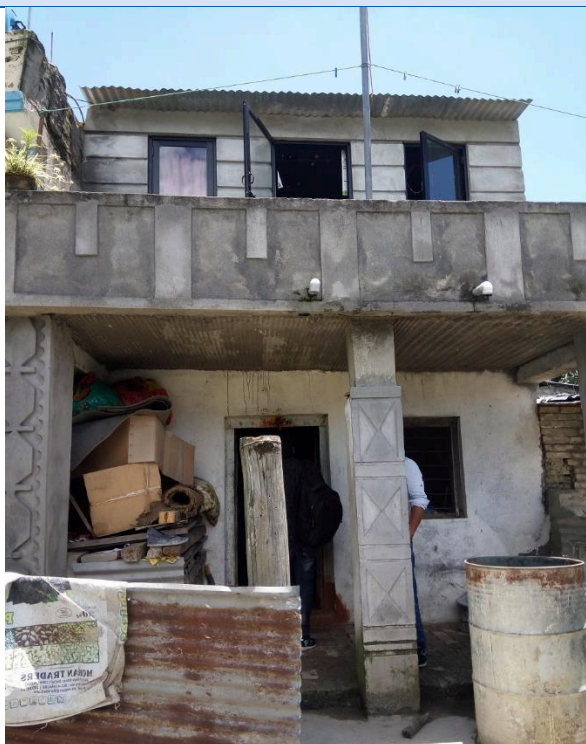
Beneficiary name: Mr. Dhan Bahadur Putuwar, Ward no. 1, Sangla is a well- trained mason. The observed 2 storey, wall system and masonry structure non-compliance house seem to stand on old foundation with walls done after the earthquake. The house owner was suggested to shift the beneficiary status from complete damage to partial damage whereby requesting to achieve a retrofitting status through letter submitted to Tarakeshwor Municipality. The beneficiary has applied for 2<sup>nd</sup> tranche.

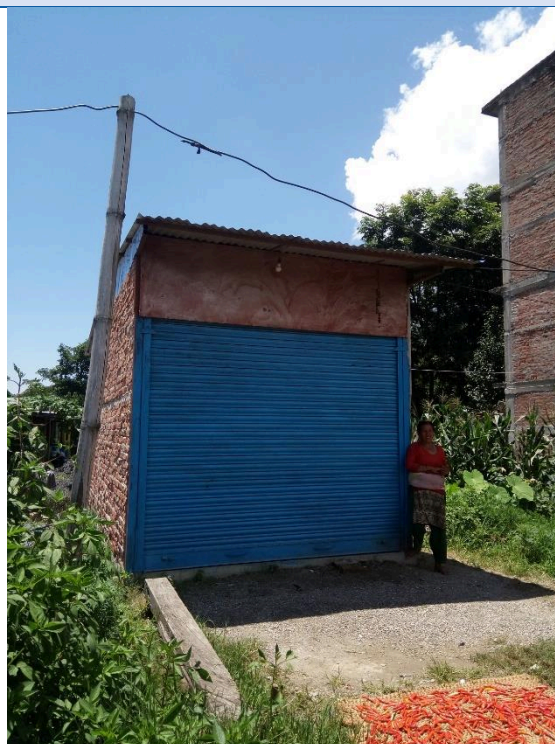
Beneficiary name: Mr Naicha Maharjan, Ward no. 3, Sangla, a single bay and non-compliance house of Mr. Naicha Maharjan located at Ward no. 3, Sangla has missed lintel band and vertical reinforcement with 4-inch wall and shutters. The owner has approved building drawing and has applied for 2<sup>nd</sup> tranche.

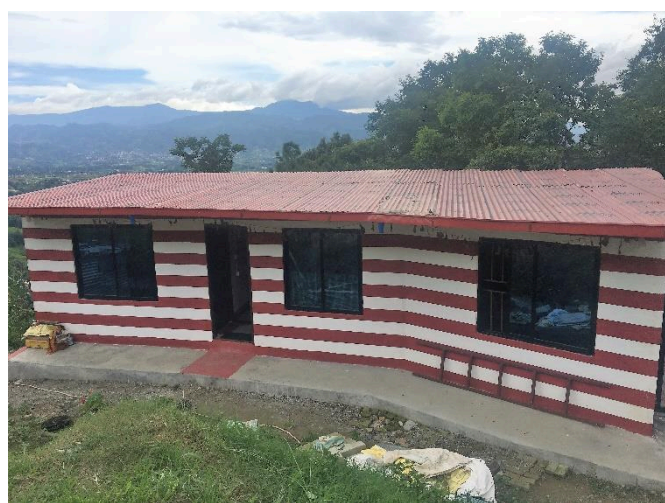
Beneficiary name: Arjun K.C, Nagarkot Ward no 6, Changunarayan Municipality, Bhaktapur district. 1 storey, Load bearing structure using ACC lightweight blocks with CGI roof and steel post as vertical reinforcement. The beneficiary has requested for the 3<sup>rd</sup> tranche and submitted all the documents included the test reports of the blocks. DSE asked to forward the file for the analysis.

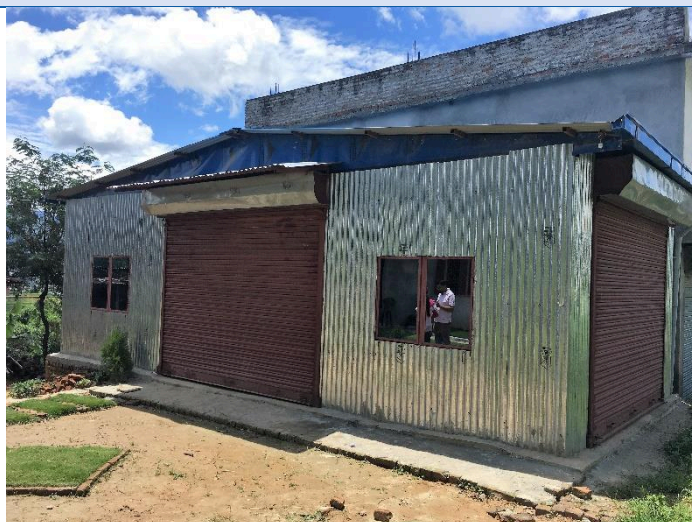
Beneficiary name: Hari Bahadur Karki, Sudal, Ward no 8, Changunarayan Municipality, Bhaktapur district. 1 storey structure using CGI sheets and steel post. The beneficiary has requested for the 2<sup>nd</sup> and 3<sup>rd</sup> tranche but as the structure is non-compliance the tranche process couldn't processed. The beneficiary was suggested to replace the CGI sheets with other construction material such as bricks, stone and keep all the earthquake resistant elements as specified in the reconstruction guideline to be eligible for the grant.

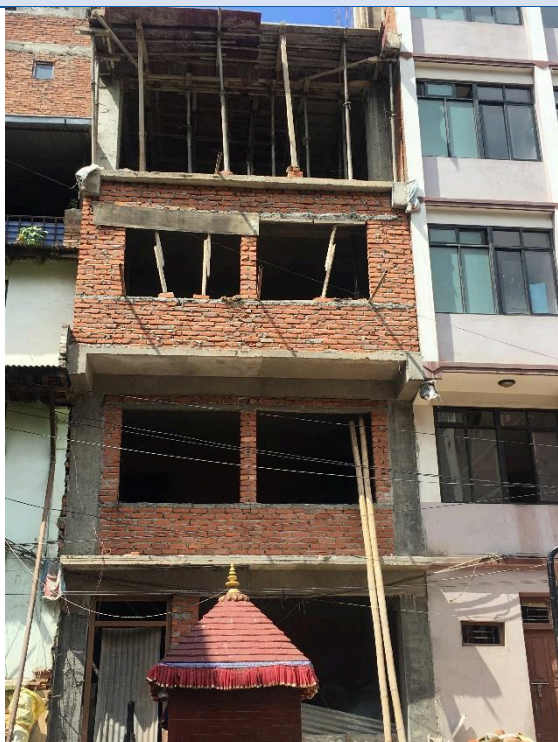
Beneficiary name: Shyam Maharjan, Teku ward no 12, Kathmandu Metropolitan City, Kathmandu district. 4 and half storey RCC frame structure. The inspection for the third tranche was conducted during the visit. The beneficiary has submitted the structural analysis report and the house as per built drawing.

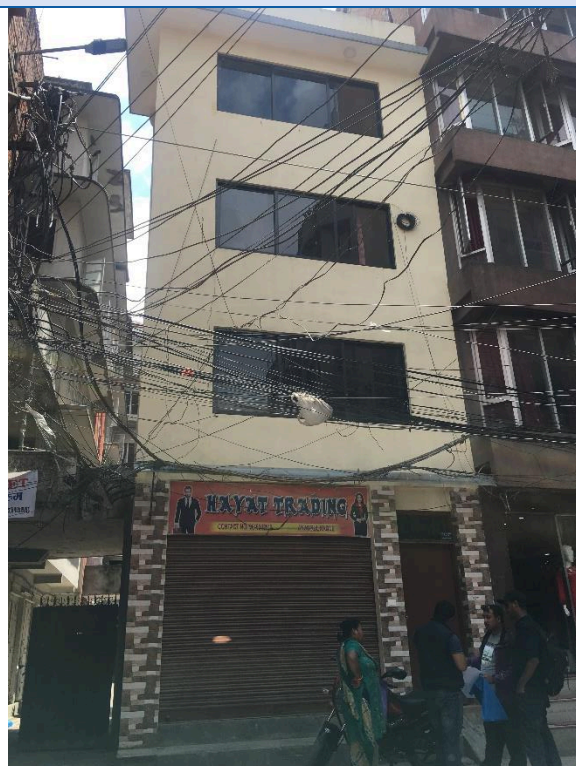
Beneficiary name: Harsha Laxmi Tuladhar, Indrachowk ward no 24, Kathmandu Metropolitan City, Kathmandu district. 4 and half storey RCC frame structure. The inspection for the third tranche was conducted during the visit. The beneficiary has submitted the structural analysis report and the house as per built drawing.

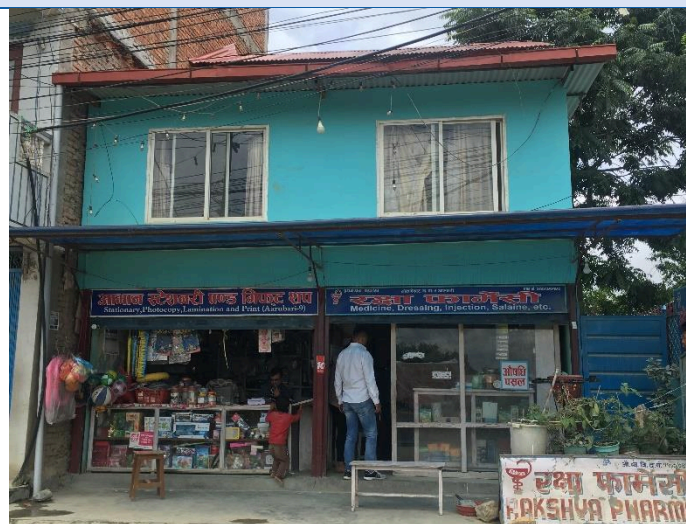
Beneficiary name: Sita Rayamajhi, Aarubari Jorpati, ward no. 9, Gokarneshwor Municipality, Kathmandu district. 2 storey structure constructed using cement board and steel post with CGI roofing. The beneficiary has requested for the 3<sup>rd</sup> tranche. Without any guideline supporting the material, the house was considered non-compliance.

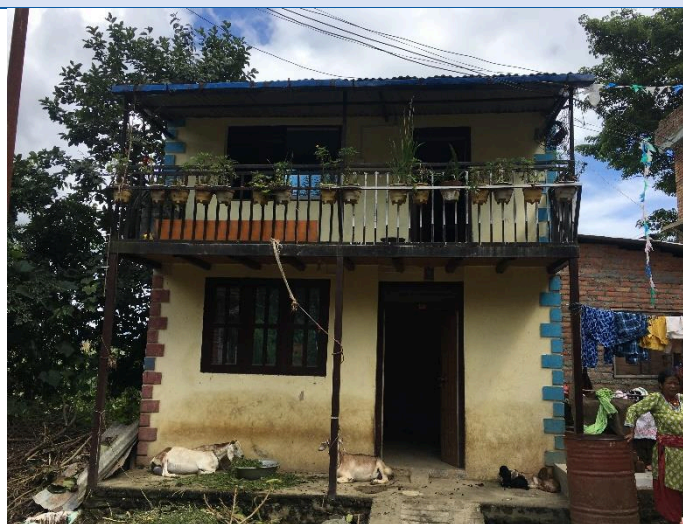
Beneficiary name: Buddhiram Nagarkoti, Baluwa ward no. 3, Gokarneshwor Municipality, Kathmandu district. BMC 2 storey structure with 9" wall. 3" steel post has been used as vertical reinforcement. The beneficiary has requested for the 3<sup>rd</sup> tranche but as the structure is vulnerable the tranche cannot be processed.

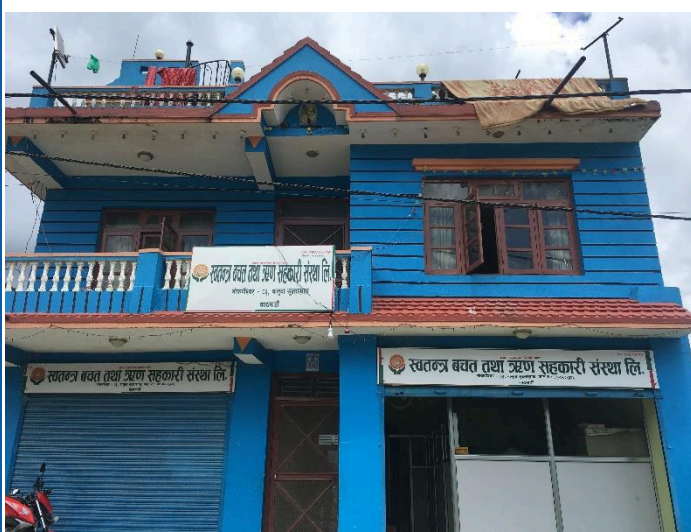
Beneficiary name: Raj Kumar Bista, Aarubari Jorpati, ward no. 9, Gokarneshwor Municipality, Kathmandu district. 2 storey RCC house with rigid roof has retrofitted the damage structural elements and have requested to change from complete to partial damage.

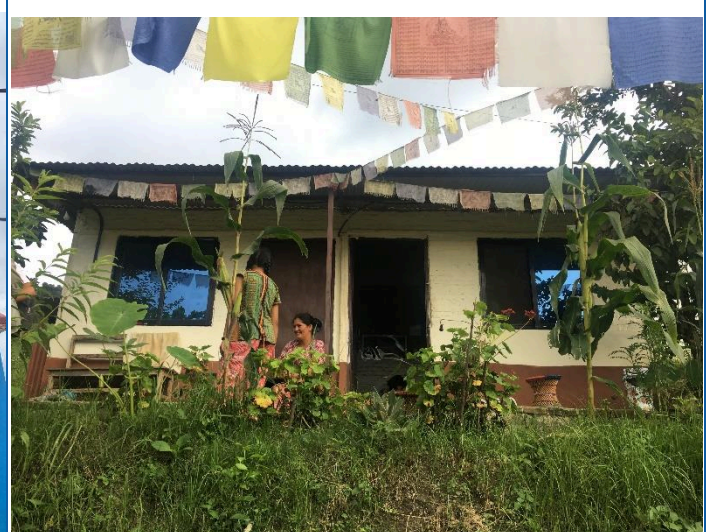
Beneficiary name: Rajan Bastola, Nagarkot, Ward no. 06, Changunarayan Municipality, Bhaktapur. One storey 2 roomed mixed structure. The house has hollow concrete block till sill level whereas the remaining structure has 4" brick wall. The earthquake resistant element such as sill bands, roof bands are missing. The beneficiary has received 1<sup>st</sup> tranche but as the house is non-compliance the further tranche request has not been addressed. DSE suggested the beneficiary to use only one material and follow the government guideline to be eligible for the remaining grant.
