# Experiences on Retrofitting of Low Strength Masonry Buildings by Different Retrofitting Techniques in Nepal

**Hima Shrestha, Suman Pradhan, Ramesh Guragain**  
*National Society for Earthquake Technology-Nepal (NSET)*

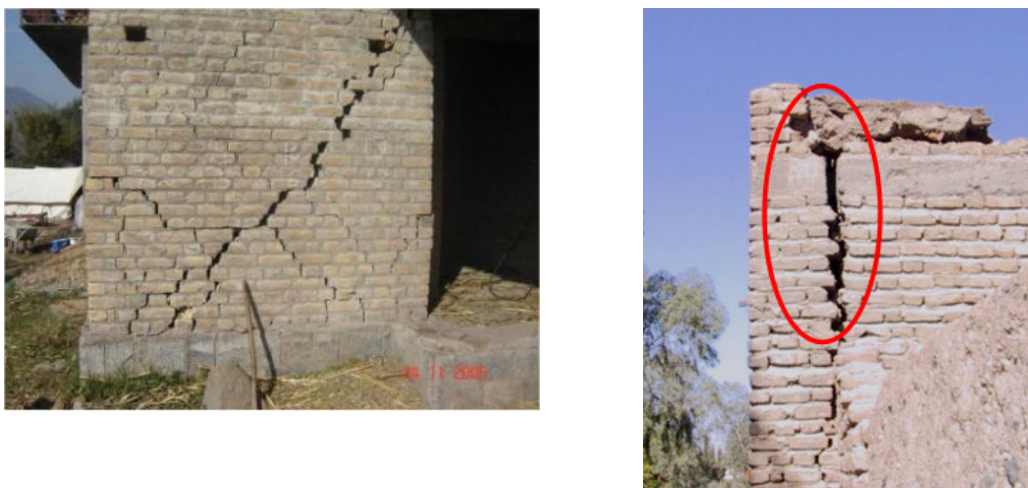
Fig 2.1 Diagonal shear failure, (left); Corner separation due to lack of integrity (right), 2005 Pakistan earthquake, Photo courtesy NSET

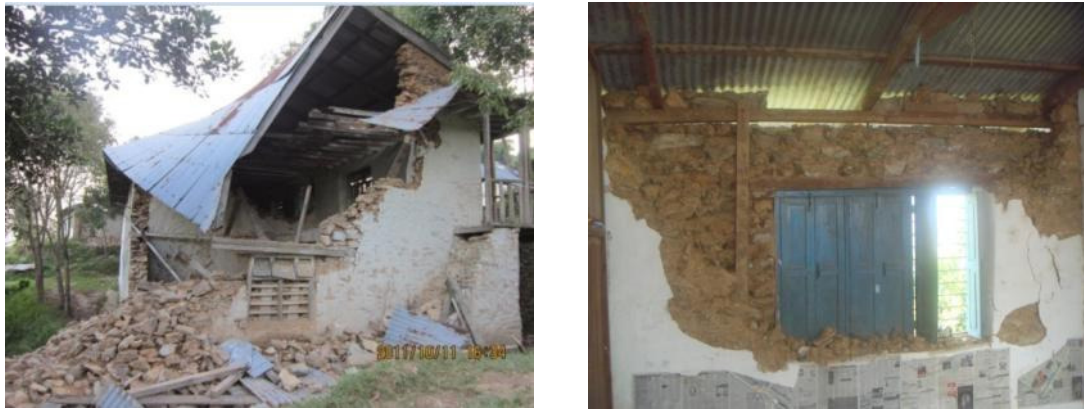
Fig 2.2 Failure of roof connection to wall (left); Collapse of inner wythe of stone wall due to lack of through stone (right), 18th Sept 2011 Taplejung Nepal earthquake, Photo courtesy NSET

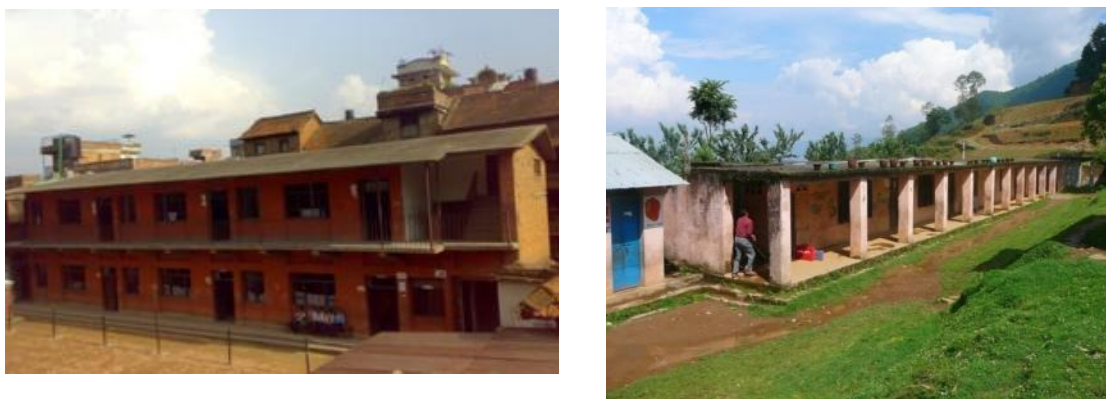
Fig 3.3 Two of the school buildings before retrofitting

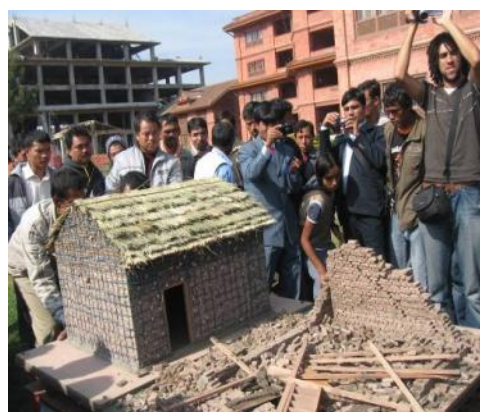
Fig 3.7 Shake table result' Non-retrofitted building collapse while retrofitted building is standing
