## Monthly District Report

Lamjung, Tanahau, Kaski and Syangja

12 July – 22 August 2019

## Field Visit Reports (Lamjung)

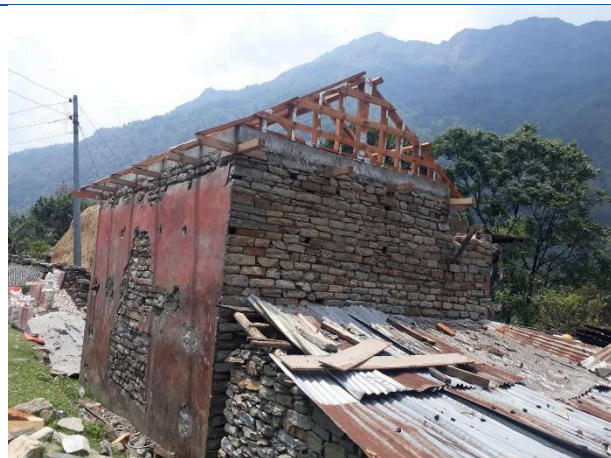
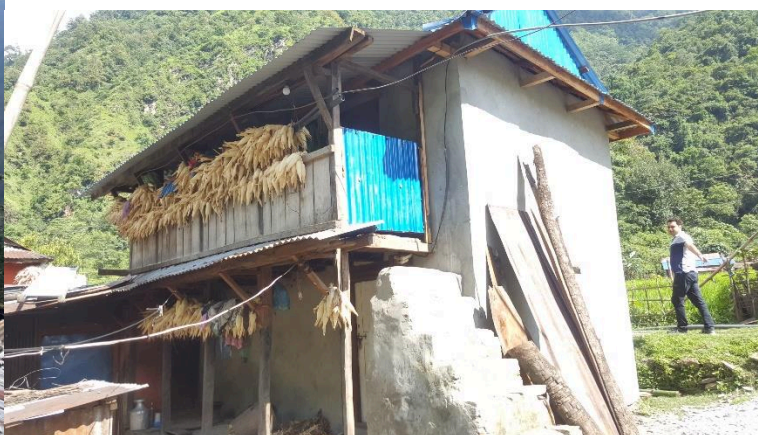
**Ward No. 5, Marsyangdi Rural Municipality, Lamjung:** Demo retrofit house carried out as part of the DFID funded retrofit project implemented by a consortium of UNOPS and Build Change. Five masons and nine Engineers are trained under the Retrofit Program. The retrofitting was started on 19<sup>th</sup> April, 2019 and Finished on 14<sup>th</sup> June, 2019.

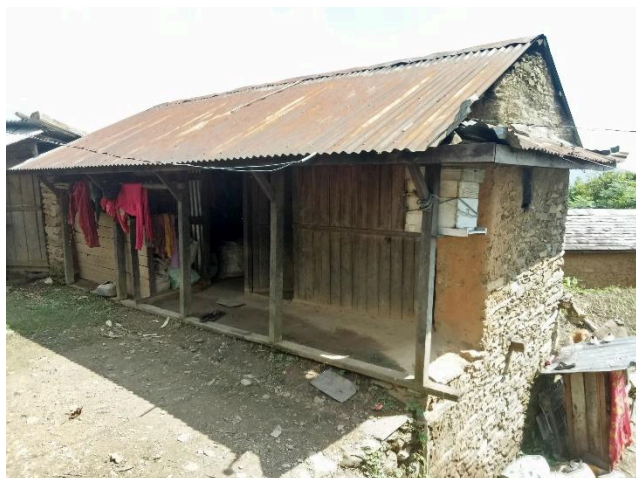
Front view

Talaborang, ward no-1, Rainas Municipality, Lamjung

Name of the beneficiaries: Shakuntala Adhikari

Description of house: Two storey – two rooms Stone Masonary in mud mortar house in which the they have done animal husbandry in lower floor and are living in the upper floor. Small hair line cracks and shear cracks are seen with large openings. Walls on the two eaves only and the remaining two sides are open.

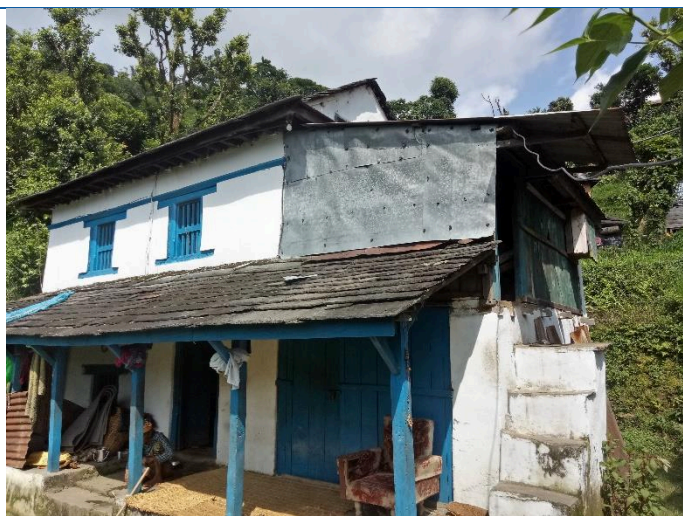
Name of the beneficiary: Daya Ram Neupane

Description of house: Two storey – two rooms with attic Stone Masonary in mud mortar house. Already plastered the house which has already cost them nearly 20-30k. Now they are not financially able to retrofit as it will cost more than the support granted by the GON.

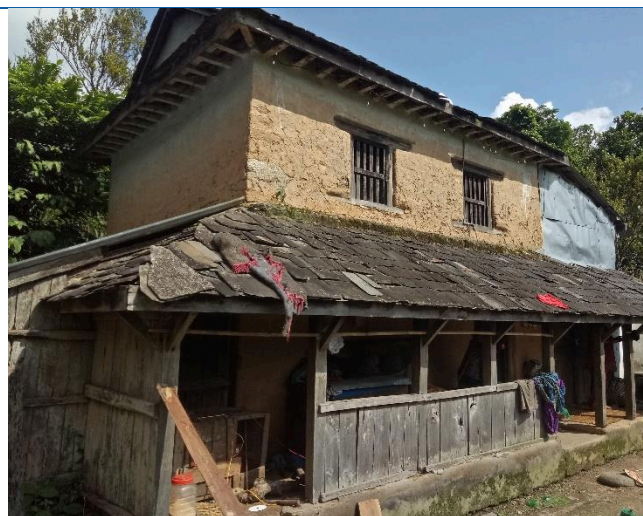
Name of Beneficiary: Laxmi Kanta Dawadi

Description of house: Two storey – three rooms with attic Stone Masonary in mud mortar house. As he wants to get converted to reconstruction beneficiary and reconstruct a new house as per his need he has field to get converted. If he is not converted, then he has planned to refund the first tranche of retro grant to the government and construct a new house by dismantling the old one.

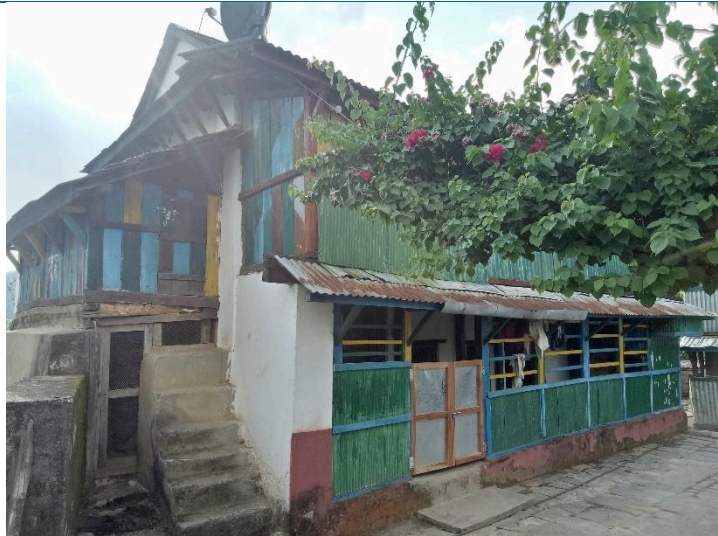
| <p><b>Name of Beneficiary:</b> Aas Maya Gurung</p> <p><b>Description of House:</b> Two storey plus attic house, Stone in mud mortar Masonary. Hair lines and shear cracks in all walls. The beneficiary is interested in retrofitting but due to lack of technical support and trained masons she has not been able to retrofit her house and receive the second tranche.</p> | |

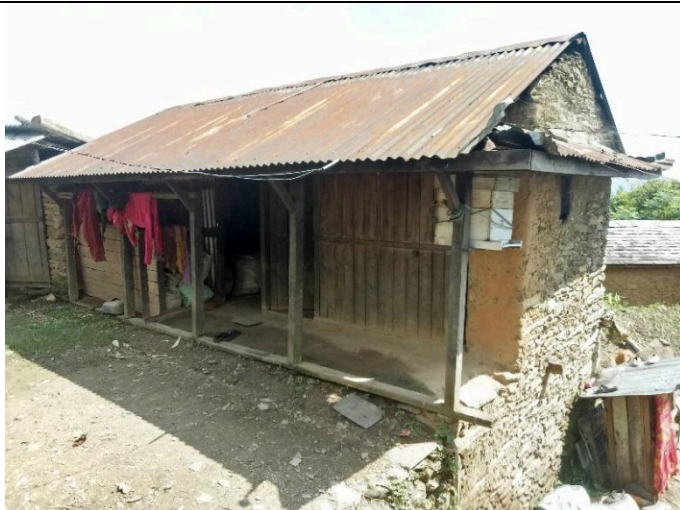
- Description of house: [Two storey – two rooms](#)  
[Stone Masonary in mud mortar house in](#)  
[which the they have done animal husbandry](#)  
[in lower floor and are living in the upper floor.](#)  
[Small hair line cracks and shear cracks are](#)  
[seen with large openings. Walls on the two](#)  
[eaves only and the remaining two sides are](#)  
[open.](#) Front view

- Issues and challenges, they have faced/facing:  
The beneficiary is not satisfied for retrofitting and has also applied for conversion from retro to recon beneficiary. She says that “I am not satisfied with the government evaluation right now and if I could be converted, I will make new house as per my requirement. The process of retrofitting will be costly and, I would not get the house as per my occupancy. Also, there is no masons and technical support yet so this could be tedious and long process for me.
- what types of support they are expecting?
