## Monthly District Report

### Lalitpur, Bhaktapur

27 September - 21 October 2019

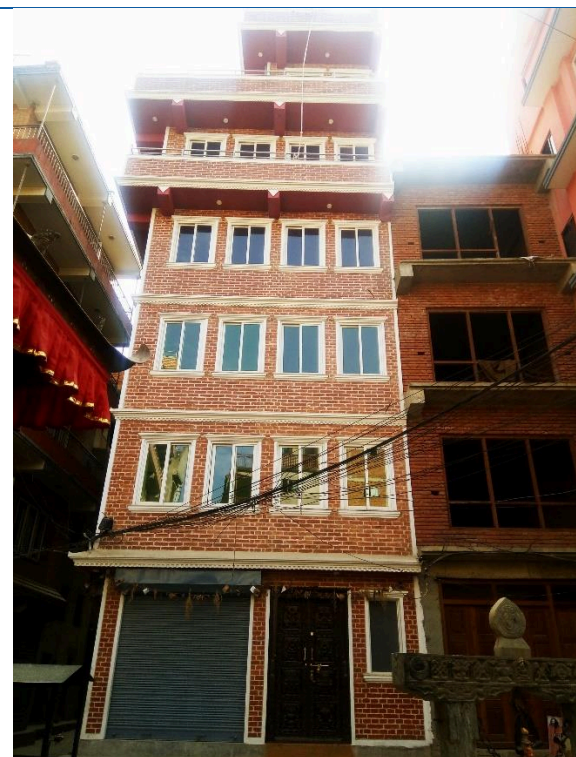
Image: Mr. Bagacha Maharjan, Ward no 17, Lukhusi, Lalitpur Metropolitan City. 5 ½ storey RCC framed structure house has received all three tranches from government. However after accessing 3<sup>rd</sup> tranche, the owner has added extra storeys (1.5 storeys). The engineer advised that the house will not receive construction completion certificate.

| Challenge | Way Forward |
|---|---|
| Addition of extra storeys after accessing 3 <sup>rd</sup> tranche has in fact raised question over resiliency of houses. | Building permit approval and number of needful storeys are provided on the basis of size of land. Any addition in the storeys in fact increases risk of the rebuild houses. Ward offices should be responsible in disseminating key messages of risks and threats of adding extra storeys other than mentioned in the building drawing. Concerned ward office and municipality office should properly disseminate information of abiding by the building bylaws. The key messages of constructing resilient structures should be the highlighted in information sharing sessions by Ward office. |

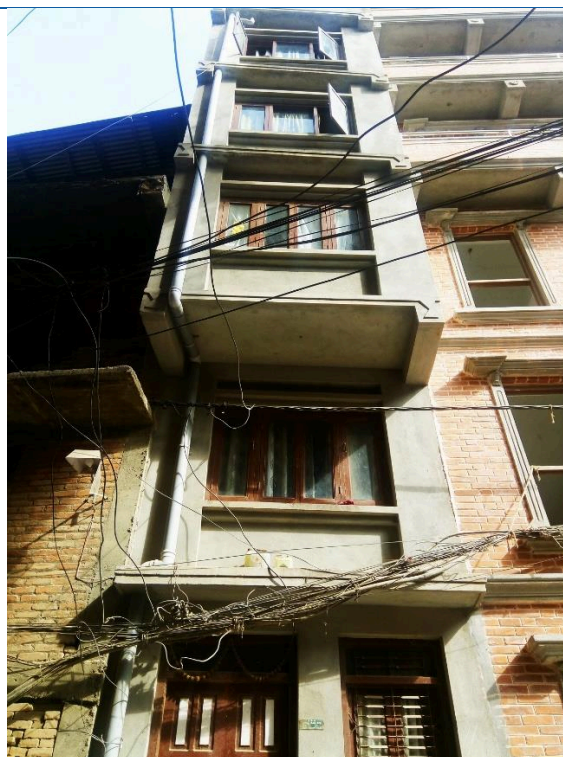
Image: Ward no 17, Lukhusi, Lalitpur Metropolitan City. 5 ½ storey RCC framed structure house has received upto 2<sup>nd</sup> tranche. The owner has added extra storeys which was not mentioned in building permit (not as per drawing), further 1 room has been added in cantilever side.

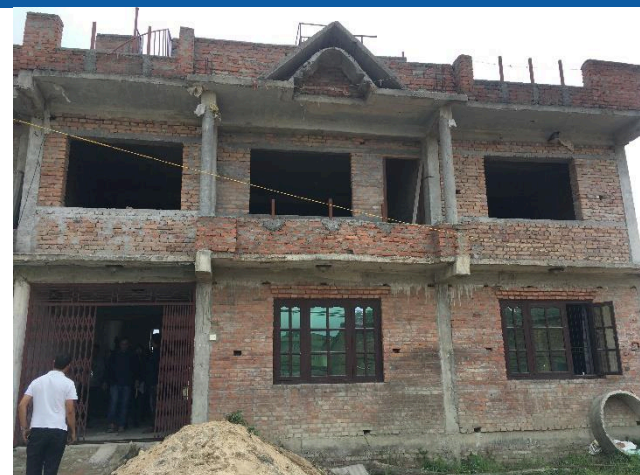
Beneficiary name: Santa Bishunke, Ward no 3, Changunarayan Municipality has non compliance structure of 9"x12" column which came out unsafe during analysis. The structure was completed immediately after earthquake.
