# District Report

## Ramechhap

23 November - 6 December 2018

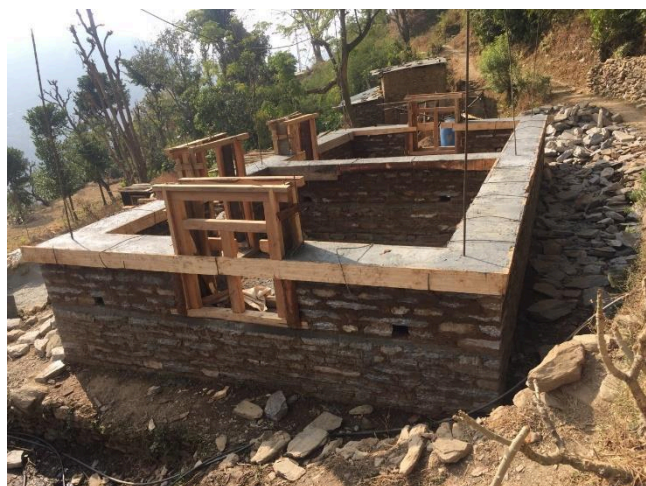
House of Lothan Tamang at Dorumba ward-7, Thapagaun. The house owner has received 2nd tranche of government tranche

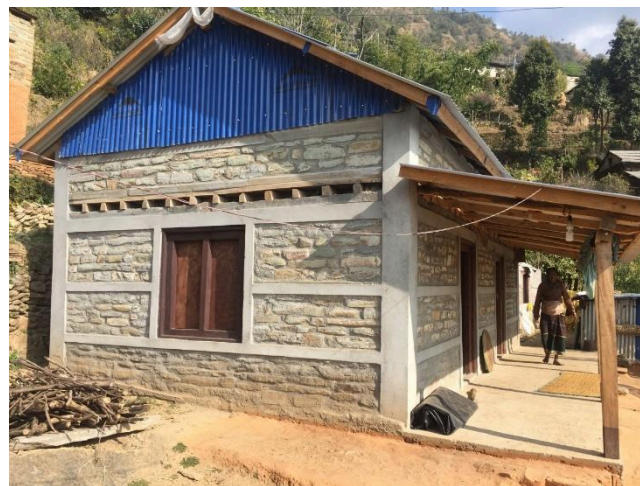
House construction at Thapagaun at Dorumba-7. Mr. Hasta Bahadur Tamang is the owner of the house. Who received 2<sup>nd</sup> tranche and forwarded for 3<sup>rd</sup> tranche.

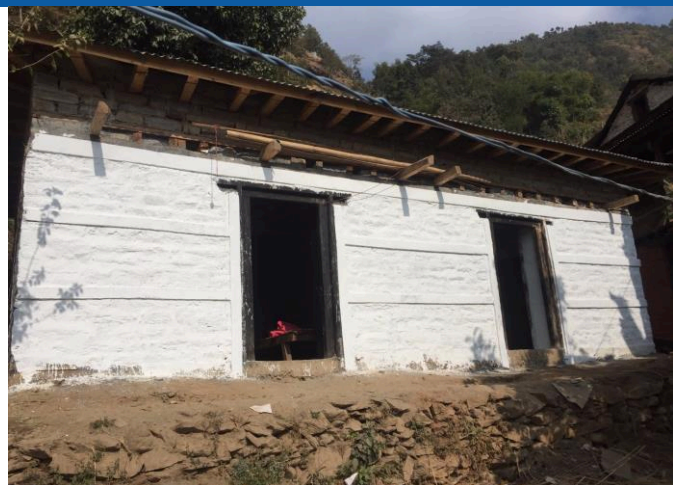
The house of Bir Bahadur Tamang being constructed in formerly Lakhanpur VDC current Doramba Rural Municipality ward no 7. The house has been constructed using stone in mud mortar. RC bands has been provided in the house. It is a load bearing house and its construction has been completed. The house owner has received the second tranche of reconstruction tranche as of date 7<sup>th</sup> Dec 2018.

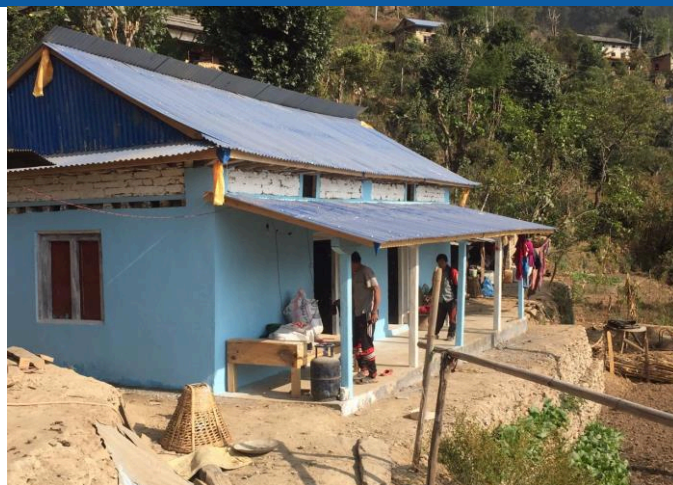
The house of Nima Tamang being constructed in formerly Lakhanpur VDC current Doramba Rural Municipality ward no 7. The house has been constructed using stone in mud mortar. RC bands has been provided in the house. It is a load bearing house and its construction has been completed. The house owner has received the second tranche of reconstruction tranche as of date 7<sup>th</sup> Dec 2018.

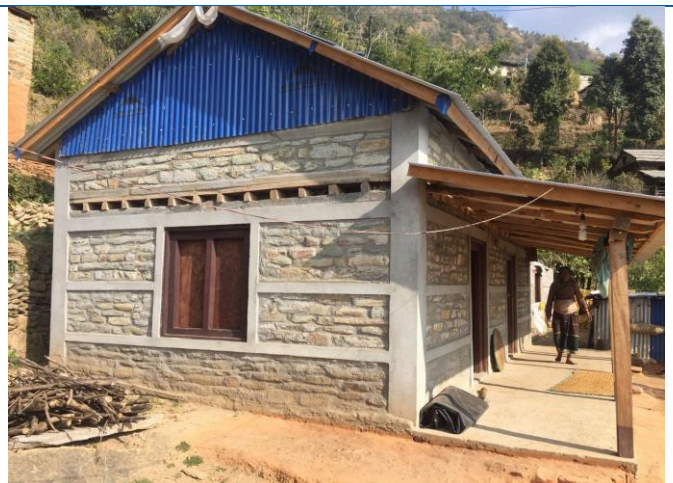
The house of Harta Bahadur Tamang being constructed in formerly Lakhanpur VDC current Doramba Rural Municipality ward no 7. The house has been constructed using stone in mud mortar. RC bands has been provided in the house. It is a load bearing house and its construction has been completed. The house owner has received the second tranche of reconstruction tranche as of date 7<sup>th</sup> Dec 2018.

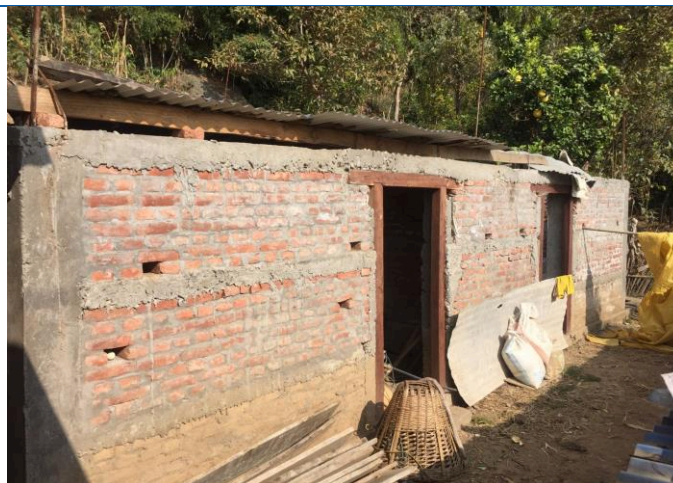
The house of Dhana Dorje Tamang being constructed in formerly Lakhanpur VDC current Doramba Rural Municipality ward no 7. The house has been constructed using brick in cement mortar. RC bands has been provided in the house. The house owner has constructed a single way temporary roof. The house has been completed upto roof band. The house owner has received the second tranche of reconstruction tranche as of date 7<sup>th</sup> Dec 2018.

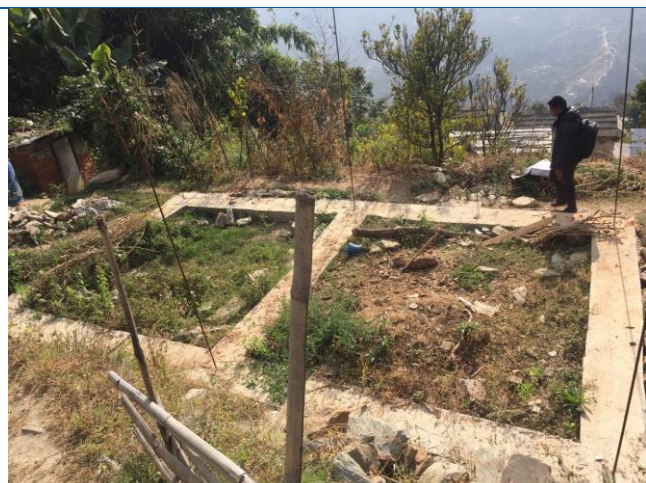
The house of Geet Bahadur Tamang being constructed in formerly Lakhanpur VDC current Doramba Rural Municipality ward no 7. The house has been constructed upto plinth level. The house owner has received the second tranche of reconstruction tranche as of date 7<sup>th</sup> Dec 2018. The house owner will continue the reconstruction after the transportation will be ease in the village.

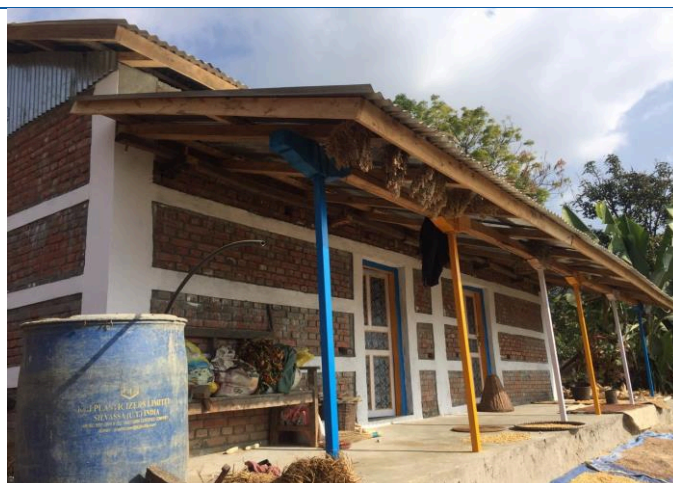
The house of Buddhi Tamang being constructed in formerly Lakhanpur VDC current Doramba Rural Municipality ward no 7. The house has been constructed using brick in cement mortar. Rc bands has been provided in the house. It is a load bearing house and its construction has been completed. The house owner has received the second tranche of reconstruction tranche as of date 7<sup>th</sup> Dec 2018. The house owner is one of the 1263 lying in vulnerable group.

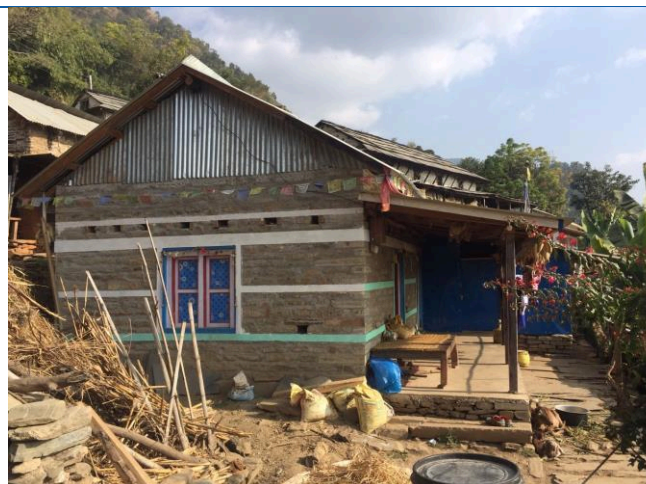
The house of Tulka Tamang being constructed in formerly Lakhanpur VDC current Doramba Rural Municipality ward no 7. The house has been constructed using stone in mud mortar. RC bands has been provided in the house. It is a load bearing house and its construction has been completed. The house owner has received the second tranche of reconstruction tranche as of date 7<sup>th</sup> Dec 2018.

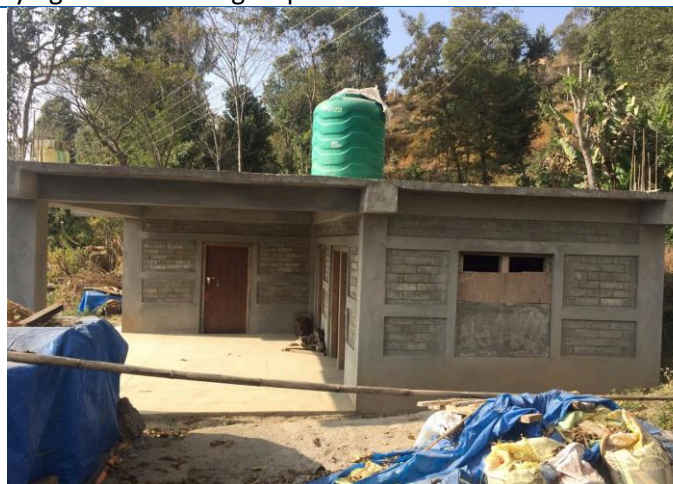
The house of Sonam Kumar Moktan being constructed in formerly Lakhanpur VDC current Doramba Rural Municipality ward no 7. The house has been constructed using stone in cement mortar. RC bands has been provided in the house. It is a RC frame house and its construction has been completed. The rebars of 12mm dia has been provided in the column which do not comply with the building code. The house owner has received the second tranche of reconstruction tranche as of date 7<sup>th</sup> Dec 2018.

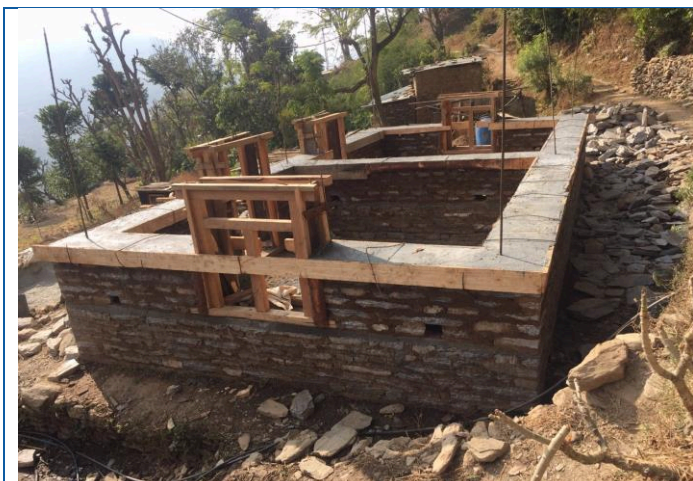
The house of Lothan Tamang being constructed in formerly Lakhanpur VDC current Doramba Rural Municipality ward no 7. The house has been constructed using stone in mud mortar. RC bands has been provided in the house. It is a load bearing house and its construction has been

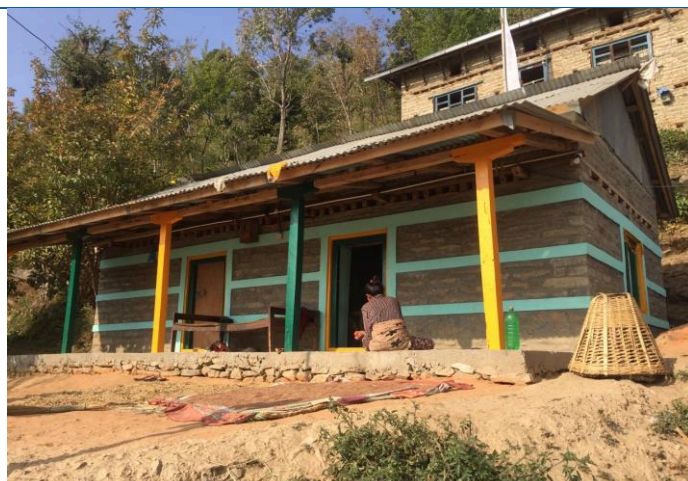
The house of Chandra Bahadur Tamang being constructed in formerly Lakhanpur VDC current Doramba Rural Municipality ward no 7. The house has been constructed using stone in mud mortar. RC bands has been provided in the house. It is a load bearing house and its construction has been completed. The house owner has received the second tranche of reconstruction tranche as of date 7<sup>th</sup> Dec 2018.
