# Retrofitting earth-quake damaged housing in Nepal

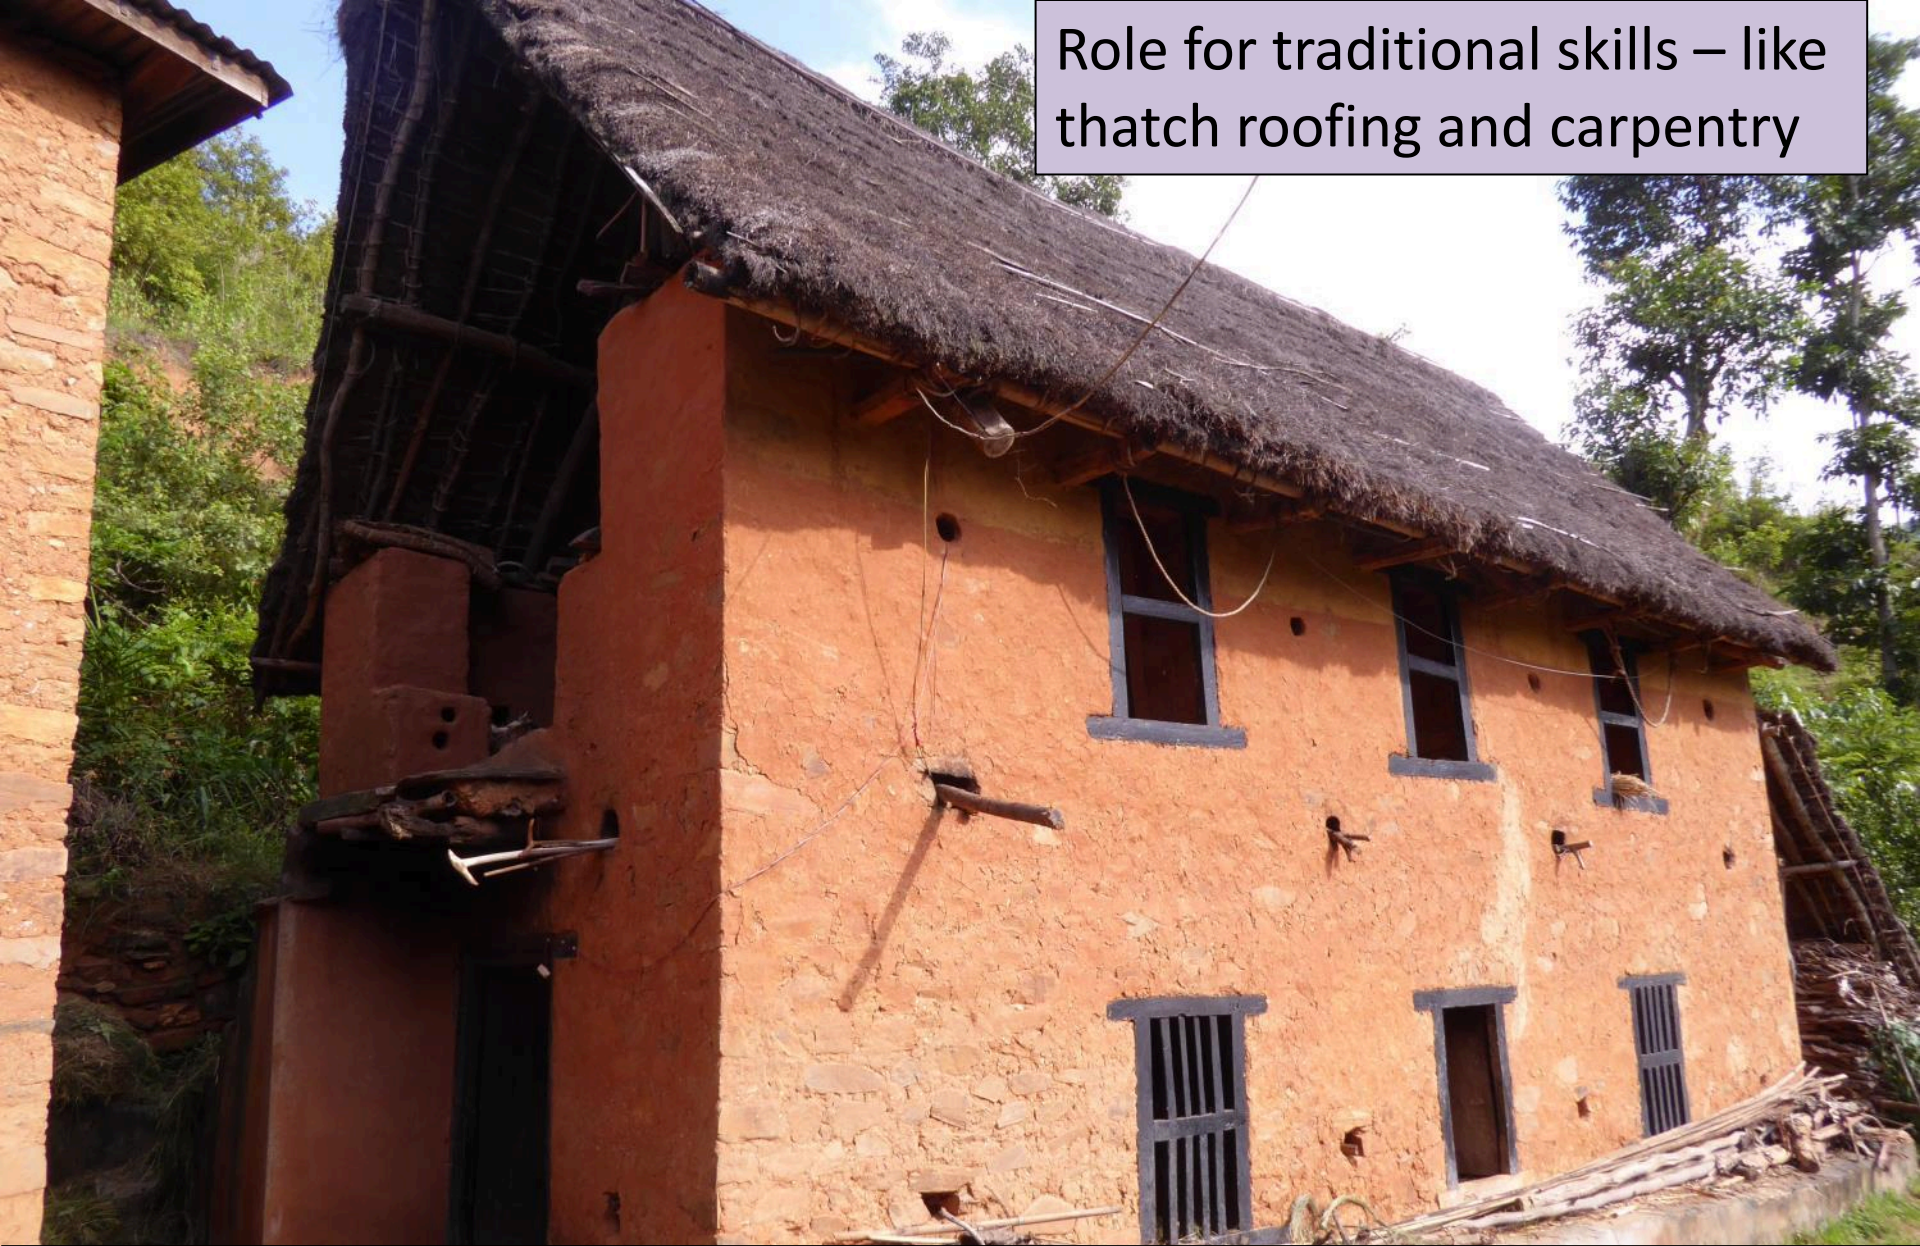
- All these houses assessed as category 3 damage.
- To access the housing grant, these families would have to demolish these homes and start again with new foundations.

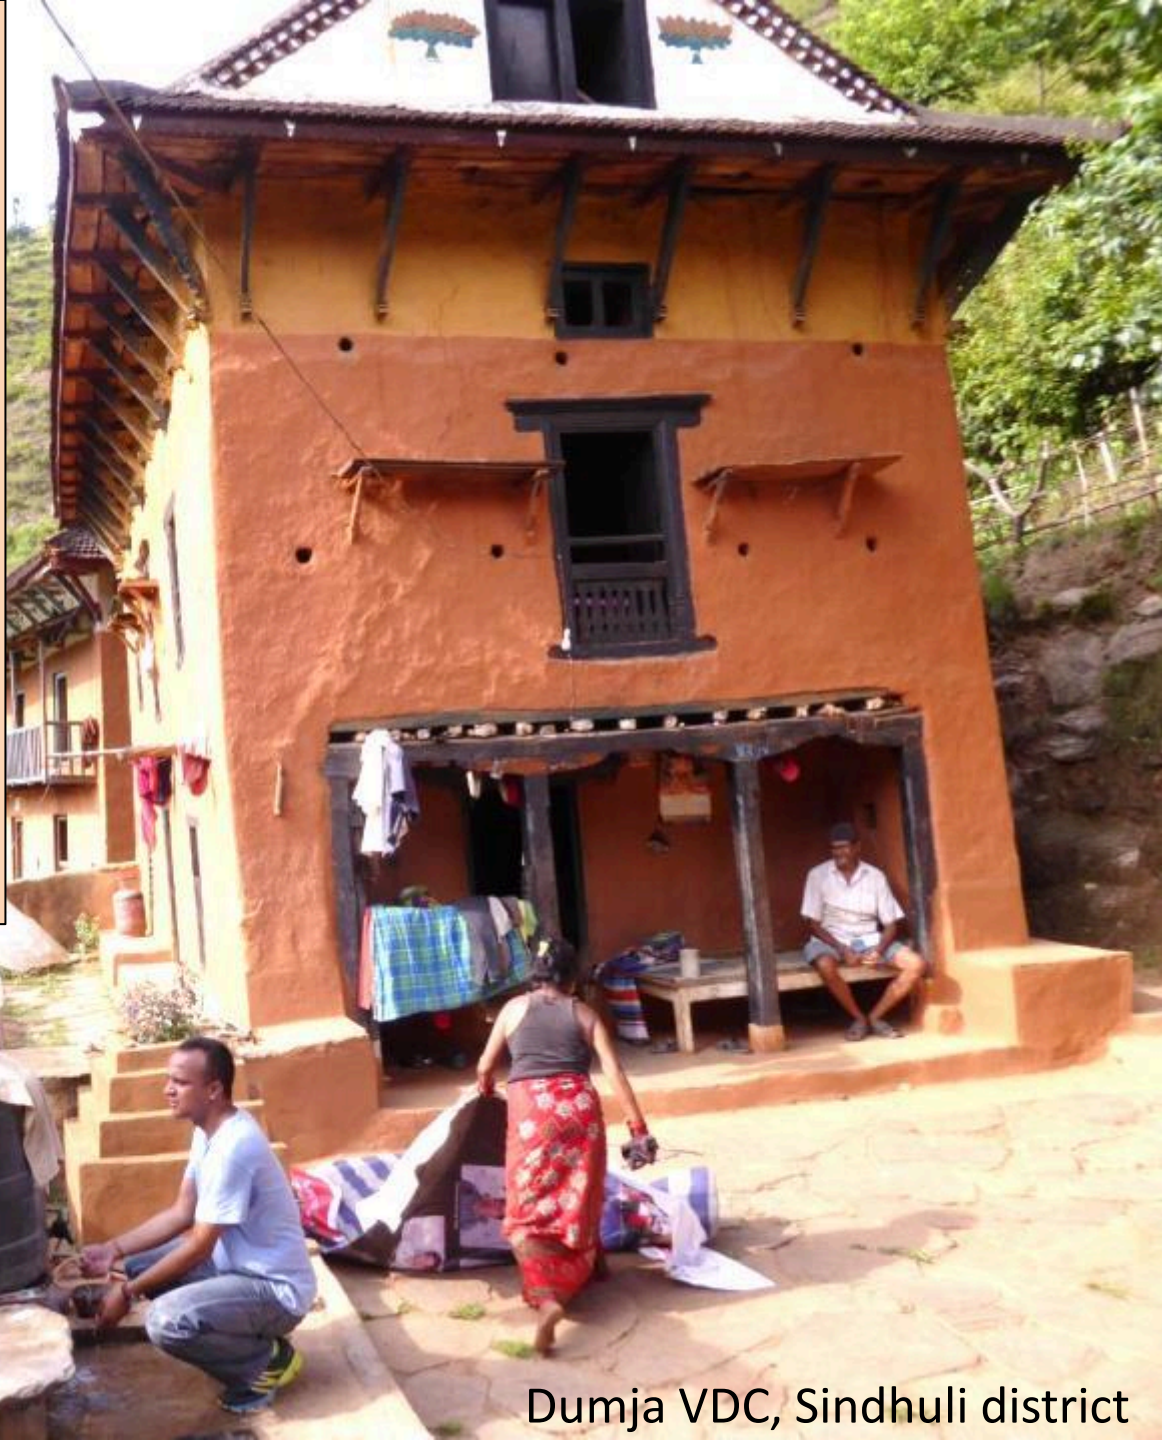
Dumja VDC, Sindhuli district

Vernacular architecture has adapted to local agricultural economy and life-styles. Many parts of these large houses are used for storage, animals, shops, extended families, etc.

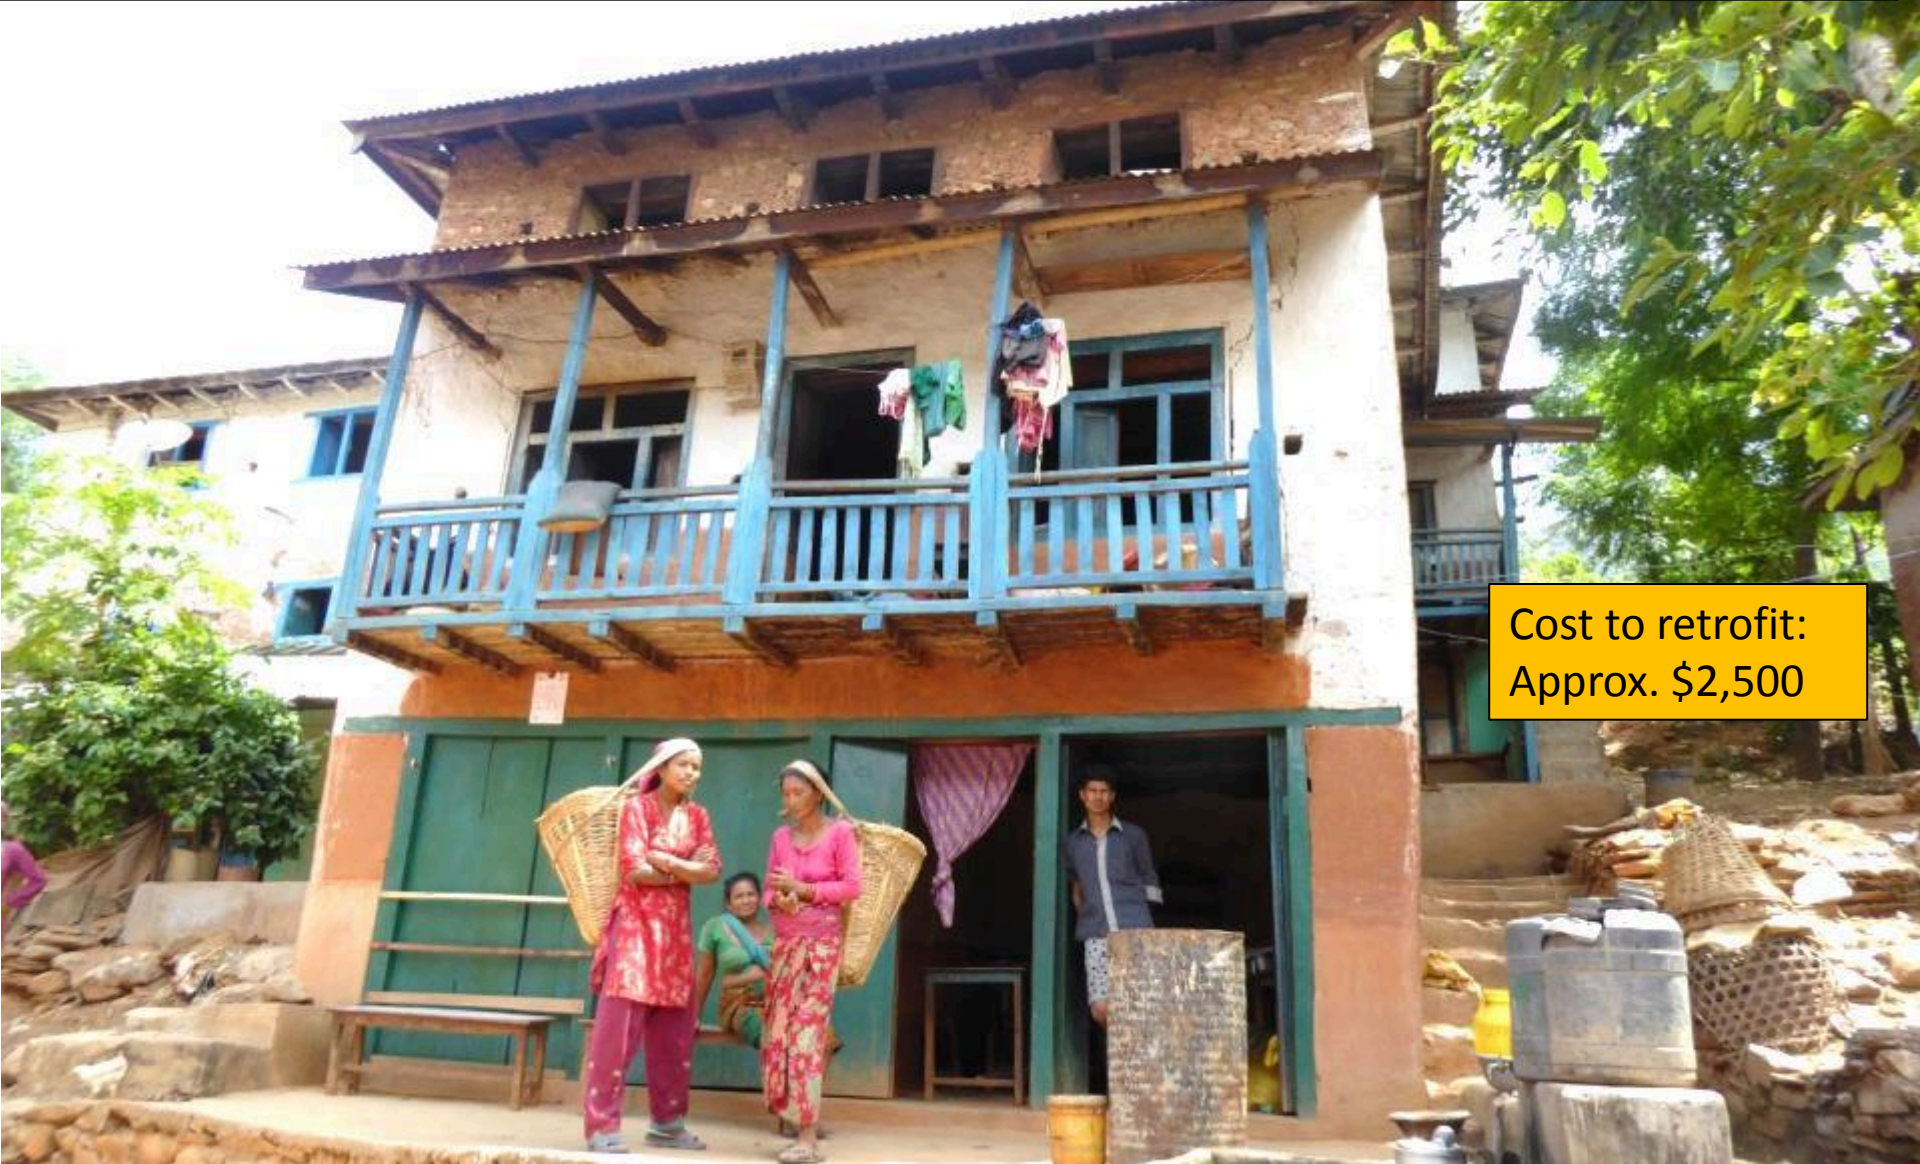
Cost to retrofit:  
Approx. \$2,500

Another example of a category 3 damaged house – which may be suitable for retrofitting.

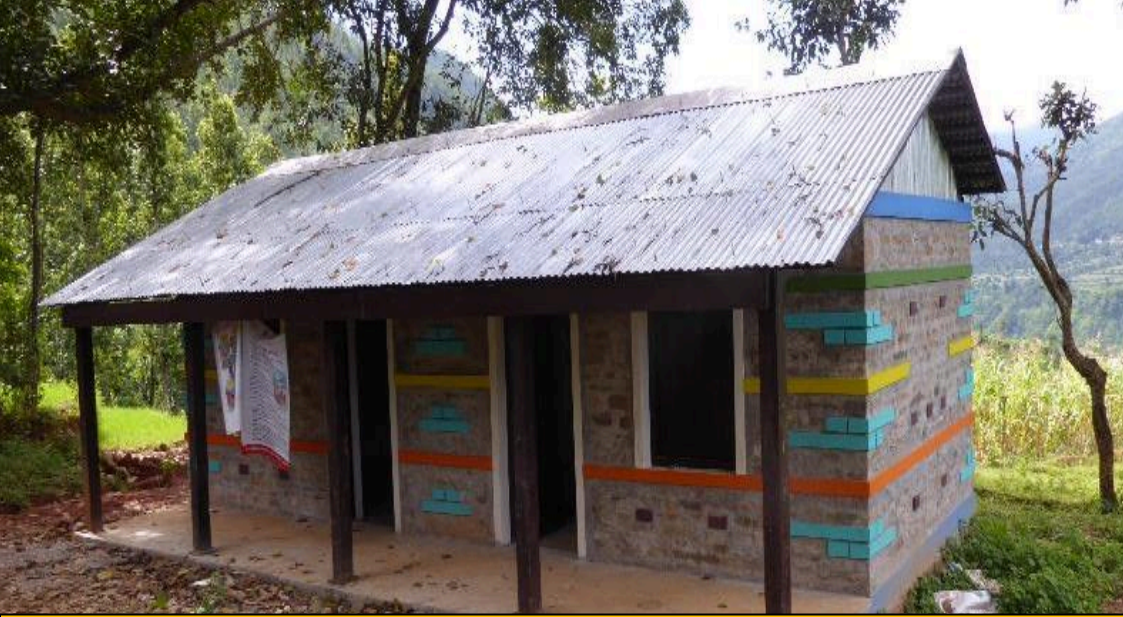
Compare the size and design of these houses with traditional architecture. What impact for rural Nepal?

Cost for new build like this, following approved designs: < \$10,000

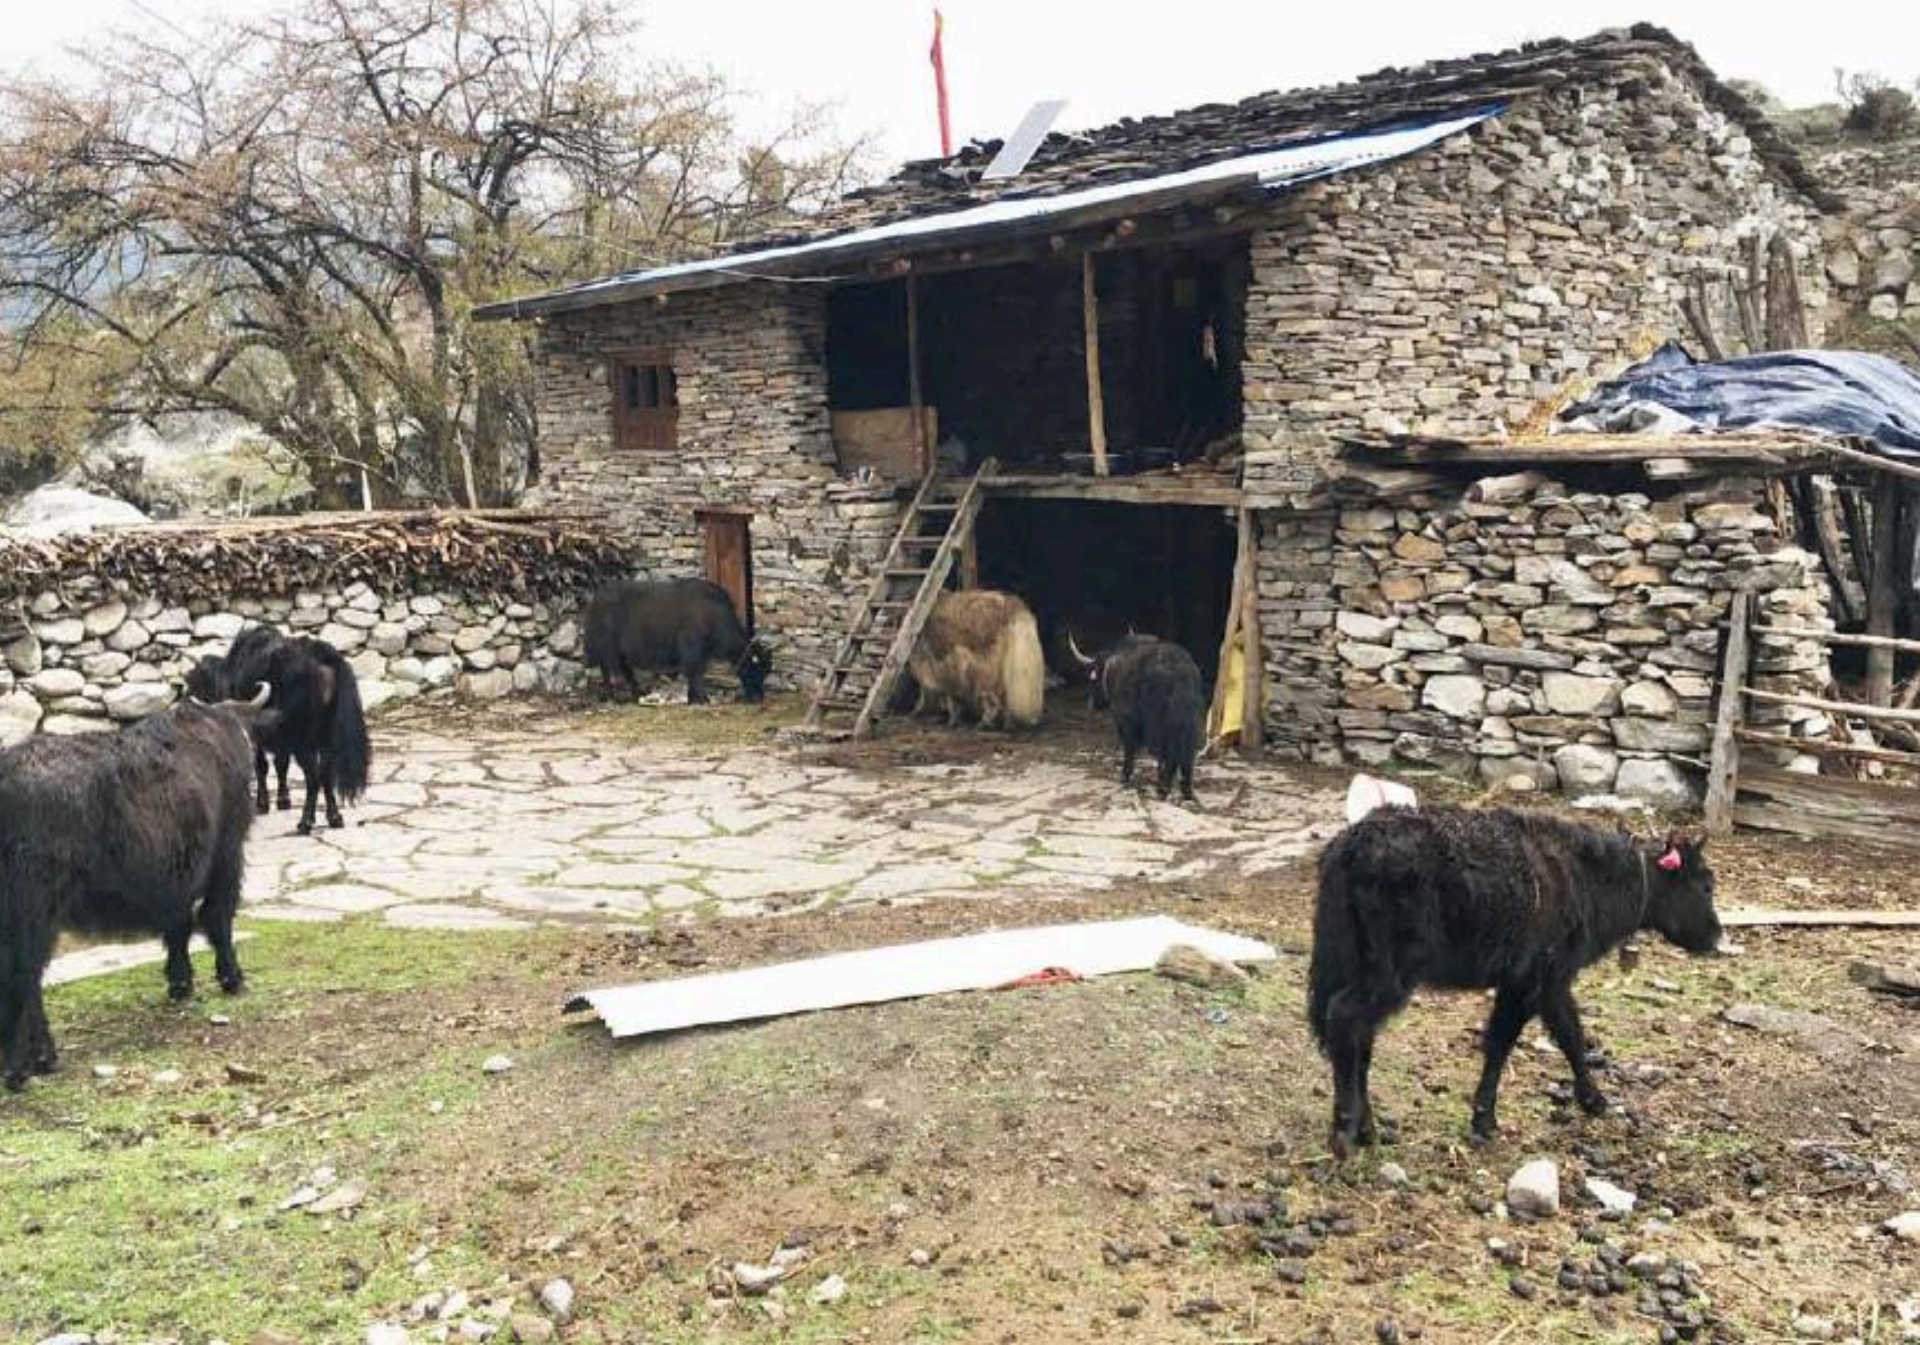
# Northern Gorkha (CRS)

**Reconstructed home in Haku (Rasuwa). Highly vulnerable to future earthquakes or tremors.**
