# Fortnightly District Report

## Sindhuli

18 – 31 January 2019

## Housing Typology Report

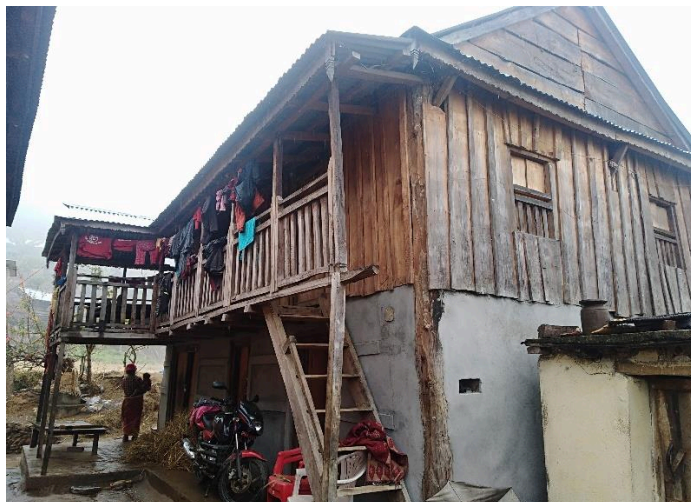
Photo

The house belongs to Mr. Khadka Bahadur Thapa, permanent residence of Bitijor ward no 02, Golanjor Rural Municipality, Sindhuli district. He has received 2<sup>nd</sup> tranche of GON housing grant. The house is timber framed structure constructed using Stone in Cement Mortar (SMC) in ground floor and light structure materials in first floor. According to house owner this house was constructed recently after the Gorkha earthquake before the deployment of DLPIU Engineers, hence is non-compliant. During the visit our team recommended for correction to be eligible for receiving 3<sup>rd</sup> tranche of GON housing grant.

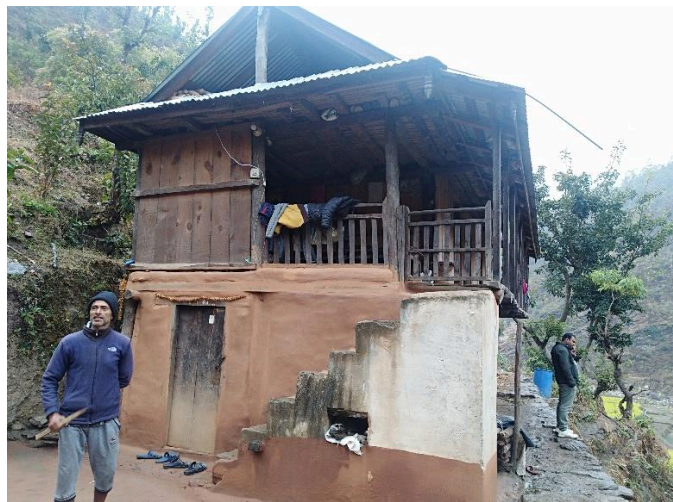
Photo

The house belongs to Mr. Dhurba Kumar Karki, permanent residence of Bitijor ward no 02, Golanjor Rural Municipality, Sindhuli district. He has received 1<sup>st</sup> tranche of GON housing grant. The house is timber framed structure constructed using Stone in Cement Mortar (SMC) in ground floor and light structure material in first floor. The house is non-compliance since opening percentage is larger and no proper bands. According to house owner this house was constructed recently after the Gorkha earthquake before the deployment of DLPIU Engineers. During the visit our team had advised for correction to be eligible for receiving 3<sup>rd</sup> tranche of GON housing grant.

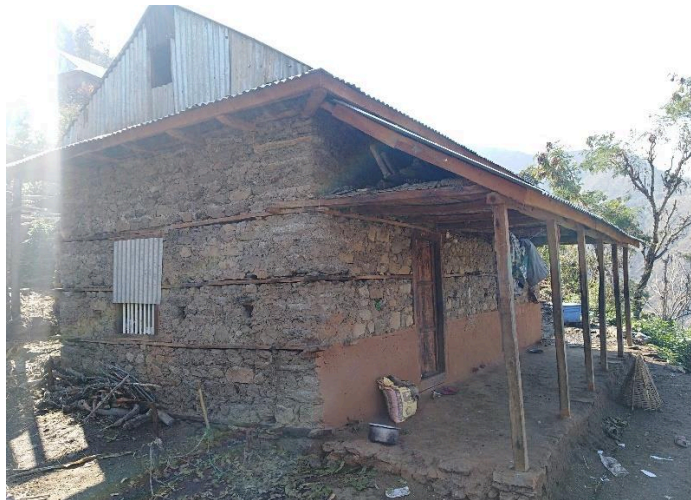
Photo

The house belongs to Mr. Buddhi Raj Bayalkoti, permanent residence of Bhubaneshwori ward no. 03, Golanjor Rural Municipality, Sindhuli district. He has received 3<sup>rd</sup> tranche of GON housing grant. The house is load bearing structure with stone in mud mortar (SMM). The house owner modified the house by constructing 6 feet verandah after receiving 3<sup>rd</sup> tranche.

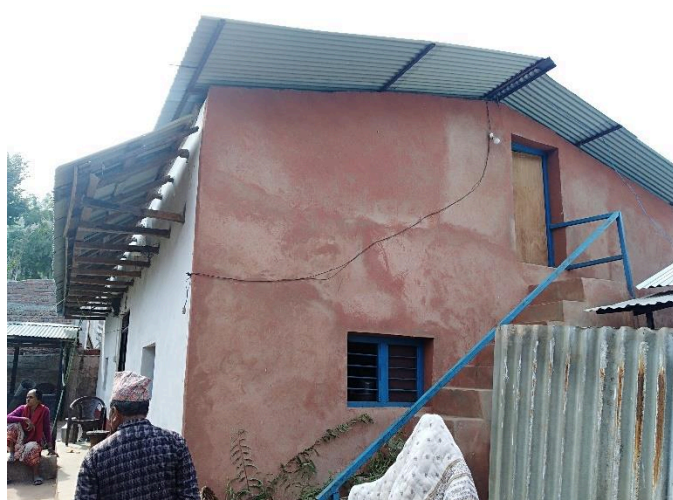
Photo

The house belongs to Mr. Dinesh Kumar Devkota, permanent residence of Bhimeshwor (Khurkot) ward no. 07, Golanjor Rural Municipality, Sindhuli district. He has received 2<sup>nd</sup> tranche of GON housing grant. The house is isload bearing structure constructed using brick in cement mortar. The house is non-compliance due to attic height and larger opening area in first floor. After visiting this house our team recommended for correction to be eligible for receiving 3<sup>rd</sup> tranche of GON housing grant.
