## Monthly District Report

### Lamjung, Tanahun, Kaski, Syangja

9 May - 13 June 2019

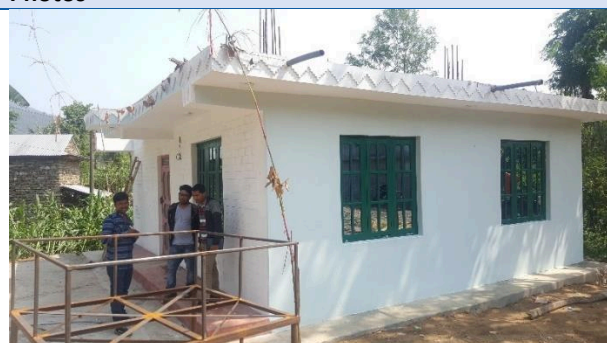
**Beneficiary Name:** Banik Raj Bhatta  
**Location:** ward no- 5, Tinpile , Rainas Nagarpalika , Lamjung  
**Tranche Update:** Second Received  
**Building Typology:** It is a single storey, four rooms RCC structure with brick masonry with RC band as infill material with columns of size 12" x 12". The floor area is less than 1000 sq. feet and building size 27 x 23 feet. The cost of construction is NRPs 1700000.

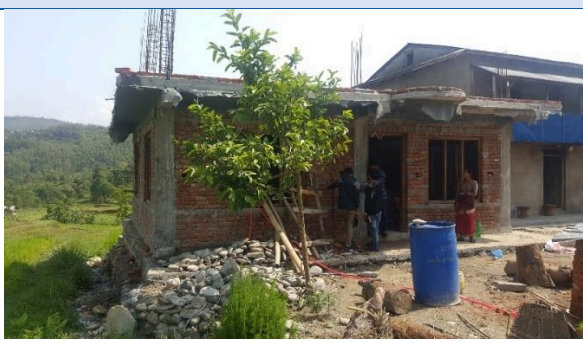
**Beneficiary Name:** Kamal Kanta Bhatta  
**Location:** ward no- 5, Tinpile , Rainas Nagarpalika , Lamjung  
**Tranche Update:** Second Received  
**Building Typology:** It is a single storey, four rooms RCC structure with brick masonry with RC band as infill material with columns of size 12" x 12". The floor area is less than 1000 sq. feet and building size 27 x 23 feet. The cost of construction is NRPs 1400000

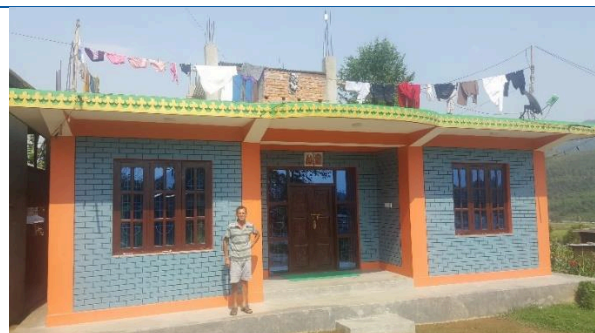
**Beneficiary Name:** Ram Krishna Bogati  
**Location:** ward no- 5, Tinpile , Rainas Nagarpalika , Lamjung  
**Tranche Update:** Third Received  
**Building Typology:** It is a single storey, four rooms RCC structure with brick masonry with RC band as infill material with columns of size 12" x 12". The floor area is less than 1000 sq. feet and building size 27 x 23 feet. The cost of construction is NRPs 2700000.

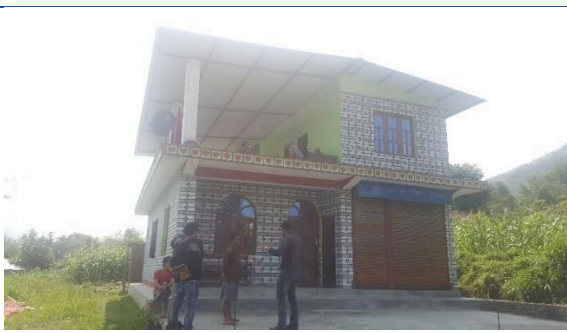
**Beneficiary Name:** Uday Raj Pokhrel  
**Location:** ward no- 5, Tinpile , Rainas Nagarpalika , Lamjung  
**Tranche Update:** Second Received  
**Building Typology:** It is a two storey, six rooms RCC structure with brick masonry with RC band as infill material with floor area less than 1000 sq. feet and building size 30 x 30 feet. The cost of construction is NRPs 3500000.

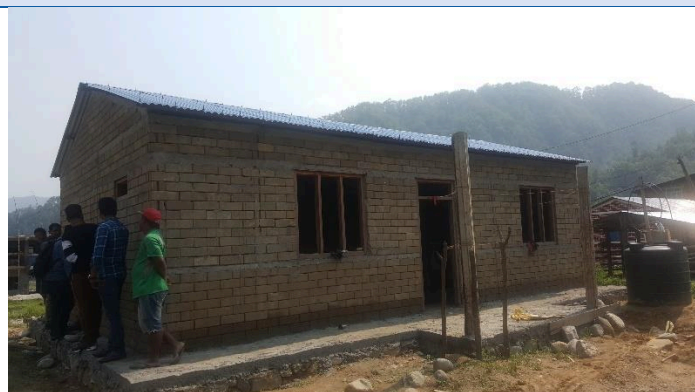
Beneficiary Name: San Bahadur Ale Magar  
Location: ward no- 5, Parajuli Besi , Madhya Nepal Nagarpalika , Lamjung  
Tranche Update: Second Received  
Building Typology: It is a single storey, five rooms house made of interlocking brick masonry with floor area less than 1000 sq. feet and building size 25 x 18 feet. The cost of construction is NRPs 5,50,000.

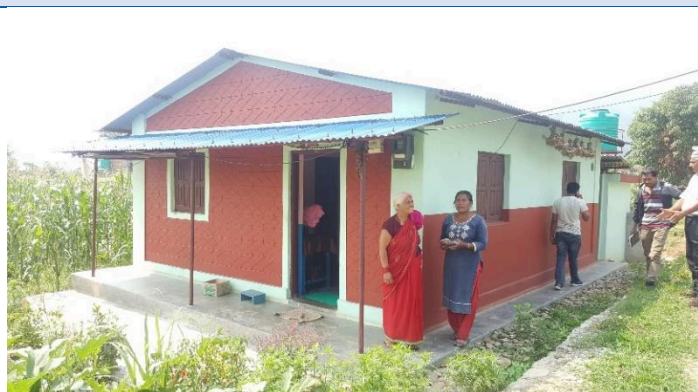
Beneficiary Name: Pabitra Devi Poudel  
Location: ward no- 5, Parajuli Besi , Madhya Nepal Nagarpalika , Lamjung  
Tranche Update: Second Received  
House status: Non- compliant  
Building Typology: It is a single storey, three rooms Brick Masonary in Cement Mortar structure with floor area less than 1000 sq. feet and building size 24 x 15 feet. The cost of construction is NRPs 12,00,000.  
The span and size of one room is more than minimum requirement so the house has been recommended for correction (addition of buttress wall).

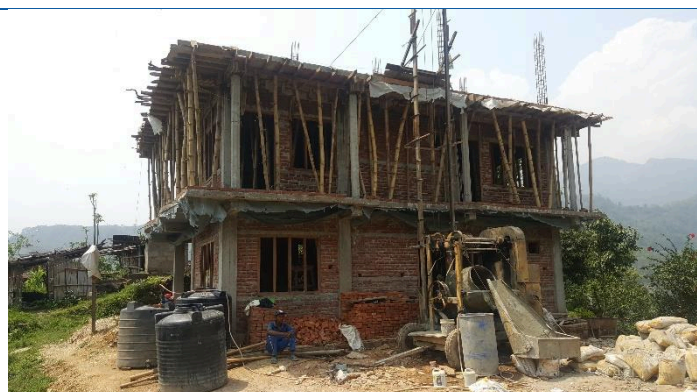
**Beneficiary Name:** Radha Kunwar.  
**Location:** ward no- 6, Rani Pani , Madhya Nepal Nagarpalika , Lamjung.  
**Tranche Update:** First Received.  
**House Status:** Compliant.  
**Building Typology:** It is a two storey, seven rooms RCC structure with brick Masonary with RC band as infill material and columns of size 12" x 12". The floor area less than 1000 sq. feet and building size 30 x 26 feet. The cost of construction is NRPs 35,00,000.

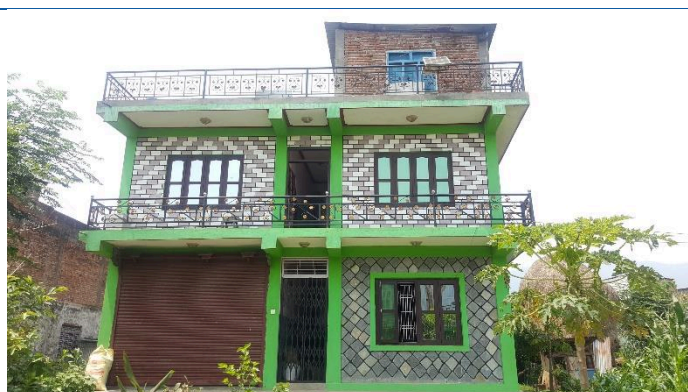
**Beneficiary Name:** Mani Ram Ghimire  
**Location:** ward no- 5, Borletar , Madhya Nepal Nagarpalika , Lamjung  
**Tranche Update:** Second Received  
**House status:** Non-compliant  
**Building Typology:** It is a two storey, eight rooms RCC structure with brick masonry with RC band as infill material with floor area less than 1000 sq. feet and building size 28 x 24 feet. The cost of construction is NRPs 40,00,000. The size of columns is 9" x 9" resulting the structure to be non-compliant.

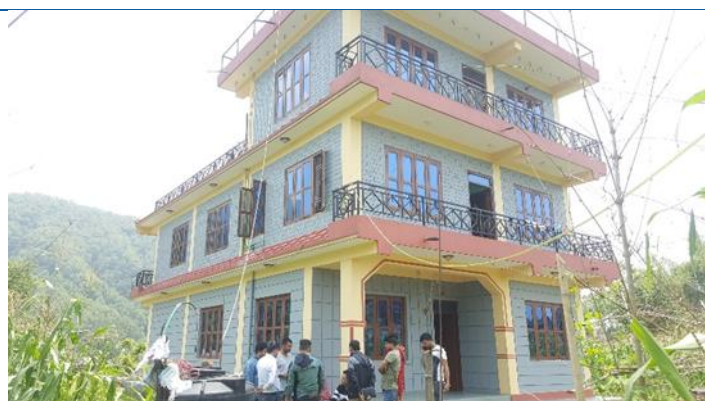
**Beneficiary Name:** Shree Prasad Regmi  
**Location:** ward no- 6, Borletar , Madhya Nepal Nagarpalika , Lamjung  
**Tranche Update:** First Received  
**Building Typology:** It is a three storey, sixteen rooms RCC structure with brick masonry with RC band as infill material with floor area more than 1000 sq. feet and building size 40 x 32 feet. The cost of construction is NRPs 1,00,00,000.  
**House Status:** Non-Compliant  
Columns are missing in grids due to which after structural analysis the structural failed to be earthquake resilient.

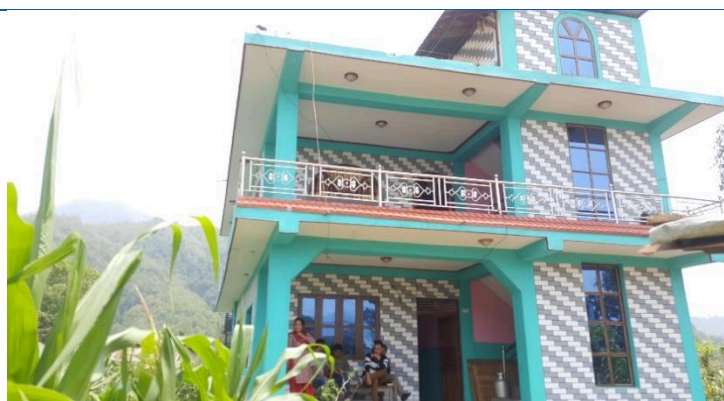
**Beneficiary Name:** Ram Krishna Ghimire  
**Location:** ward no- 6, Borletar , Madhya Nepal Nagarpalika , Lamjung  
**Tranche Update:** Third Received  
**Building Typology:** It is a two storey plus staircase cover, nine rooms RCC structure with brick masonry and RC band as infill material with floor area less than 1000 sq. feet and building size 30 x 30 feet. The cost of construction is NRPs 45,00,000.

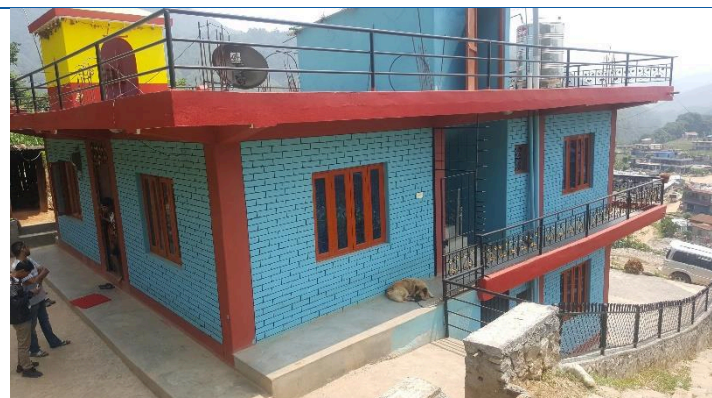
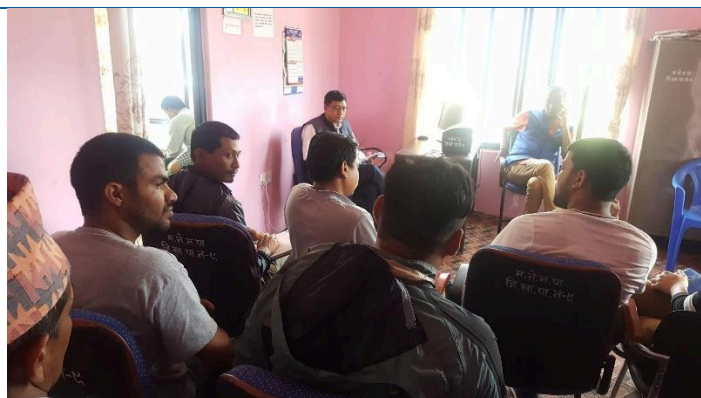
**Beneficiary Name:** Arjun Parajuli Thapa  
**Location:** ward no- 6, Rani Pani , Madhya Nepal Nagarpalika , Lamjung  
**Tranche Update:** Second Received  
**House Status:** Non - compliant  
**Building Typology:** It is a two storey, ten rooms RCC structure with brick masonry with RC band as infill material with floor area less than 1000 sq. feet and building size 30 x 26 feet. The cost of construction is NRPs 65,00,000.  
The structure has stepped footing with addition of first floor after receiving the second tranche.

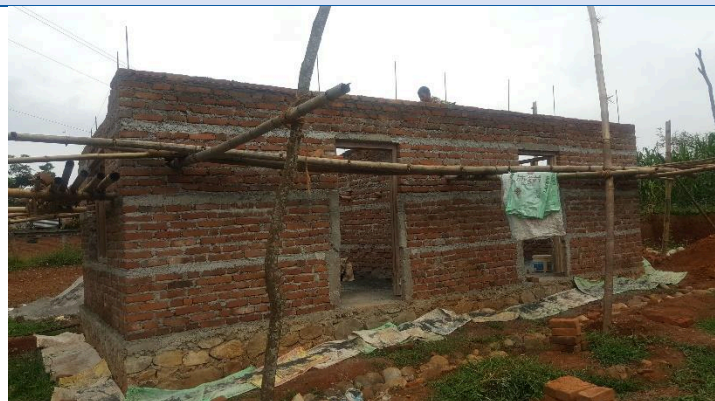
Beneficiary Name: Meena Kumal  
Location: ward no- 2, Ananda Tole, Bhanu Nagarpalika , Tanahun  
Tranche Update: First Received  
Building Typology: It is a single storey, two rooms Brick Masonary in Cement Mortar with RC band and floor area less than 1000 sq. feet and building size 26 x 12 feet. The cost of construction is NRPs 5,00,000.  
House Status: Non-compliant  
During the construction of vertical bands at the openings brick was laid instead of concrete casting therefore the structure is under correction and will be forwarded after the correction.

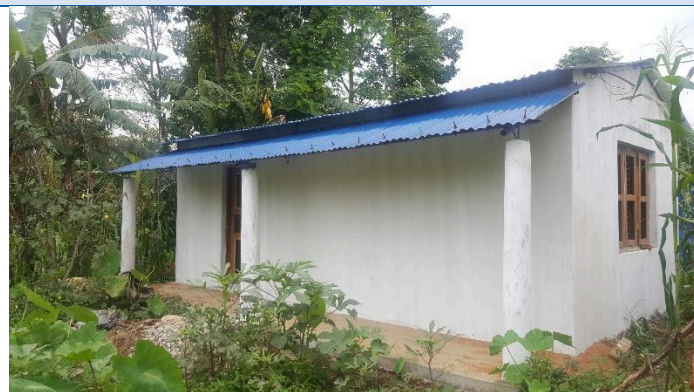
Beneficiary Name: Rishi Bahadur Baral Chhetri  
Location: ward no- 2, Bhanu Chowk, Bhanu Nagarpalika , Tanahun  
Tranche Update: Third Received  
Building Typology: It is a single storey, two rooms Brick Masonary in Cement Mortar with RC band and floor area less than 1000 sq. feet and building size 24 x 12 feet. The cost of construction is NRPs 5,50,000.

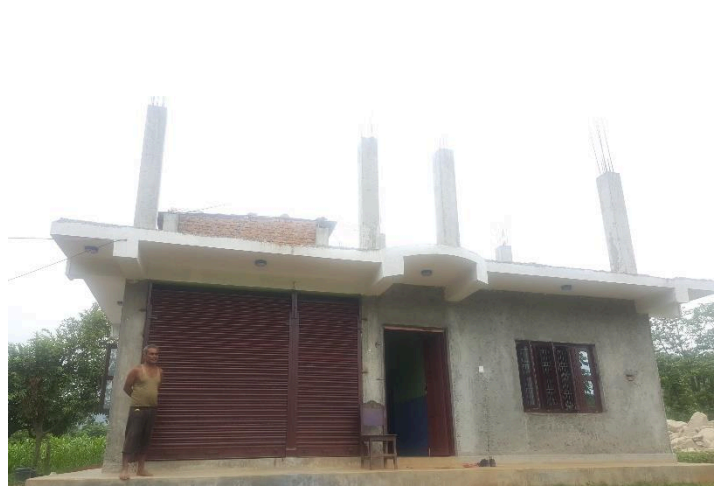
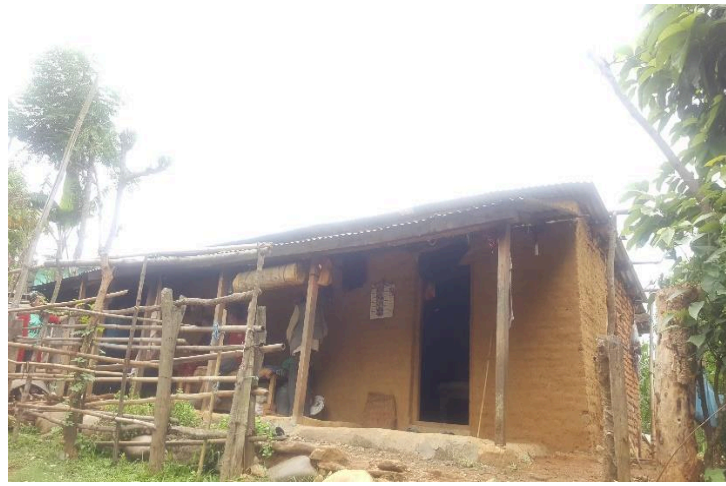
**Beneficiary Name:** Babu Ram B.K.  
**Location:** ward no- 2, Ananda Tole, Bhanu Nagarpalika , Tanahun  
**Tranche Update:** Third Received  
**Building Typology:** It is a single storey, three rooms RCC structure with brick masonry with RC band as infill material with columns of size 12" x 12". The floor area is less than 1000 sq. feet and building size 28 x 24 feet. The cost of construction is NRPs 45,00,000.

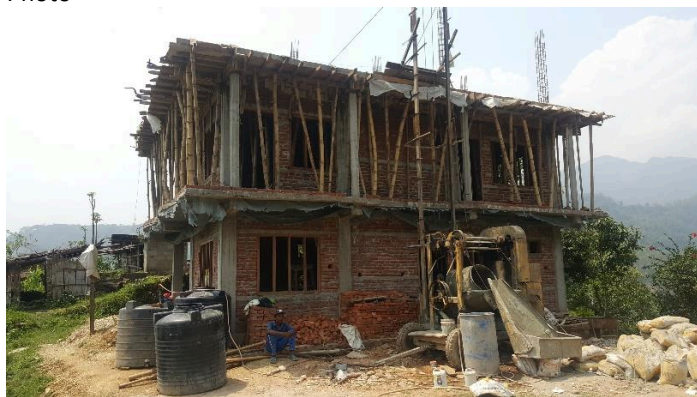
**Beneficiary Name:** Tek Nath Poudel  
**Location:** ward no- 2, Syano Bagaicha, Bhanu Nagarpalika , Tanahun  
**Tranche Update:** Second Received  
**Building Typology:** It is a single storey, two rooms Brick Masonry in Mud Mortar with timber band and floor area less than 1000 sq. feet and building size 28 x 12 feet. The cost of construction is nearly 1,00,000.  
**House Status:** Non-Compliant  
The house owner has used bricks of the Earthquake damaged house and local unskilled masons due to which there is no proper and continuous bands at different levels .There is no DPC as well in the house.

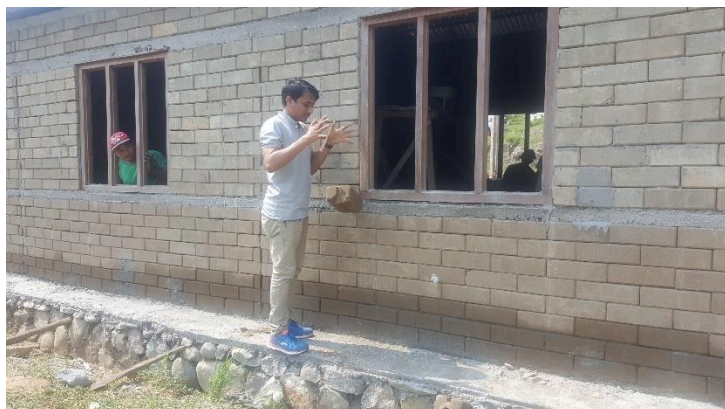
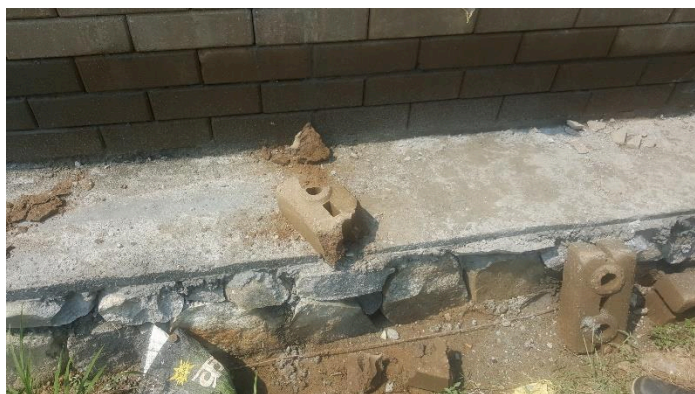
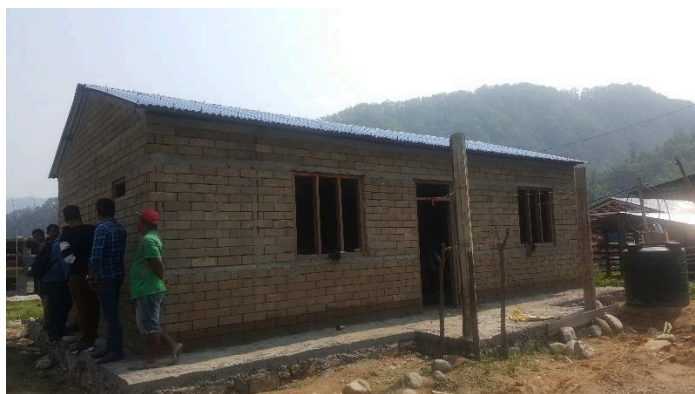
- Interlocking Brick Masonry Quality Test:
- Beneficiary Name: San Bahadur Ale Magar
- Location: ward no- 5, Parajuli Besi , Madhya Nepal Nagarpalika , Lamjung
- Tranche Update: Second Received
- Building Typology: It is a single storey, five rooms house made of interlocking brick masonry with floor area less than 1000 sq. feet and building size 25 x 18 feet. The cost of construction is NRPs 5,50,000.

During our field visit at households level we found some of houses are using very less quality interlocking brick at Madhanepal municipality, Lamjung. We saw their walls are getting crack in newly constructed houses also physical quality test of interlocking block was conducted with 5 blocks and the test specimen were of poor quality. The compressive strength of interlocking brick masonry was found to be less than 3.5 MPA since while the specimen were thrown from the chest height it broke down into several pieces as shown in the picture.
