# District Report

## Makwanpur

20 July - 2 August 2018

### Visit 1

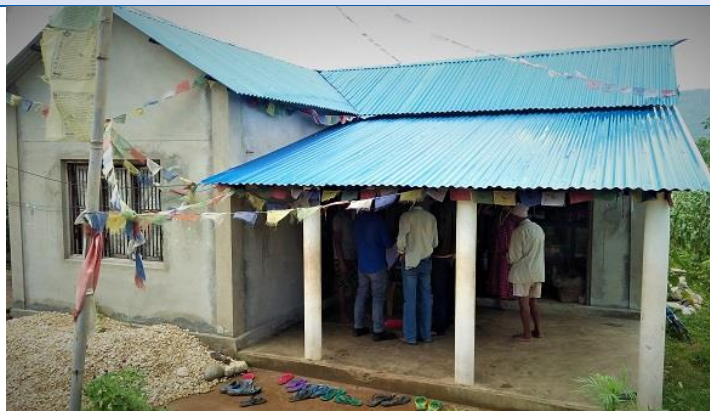
*Figure 2: Hetauda-12, Bhimsen Thing, one of the example of block masonry constructed before deployed government engineers. This house is L-shaped, not provided any band. DSE recommended for correction exception and he has given necessary methodology of correction.*

| Challenges / Issues Identified | Action Required | Responsible | Timeframe |
|---|---|---|---|
| Non- compliance issues in block masonry. Before deployed engineers, it had been constructed. | Regularly site visit and give suggestion and methodology of correction exception & retrofitting. Also solve by SAP analysis that type of structures. | DSE, ward engineer | Regular |

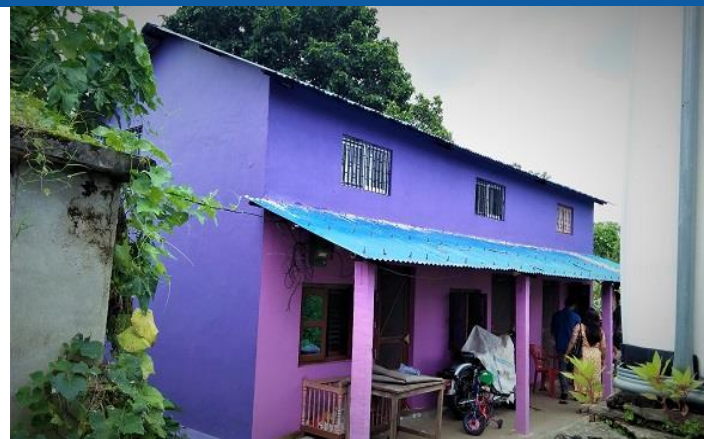
*Figure 3: Hetauda- 09, house owner Sita Lamichane, she has constructed her house with ground Floor brick in cement mortar & an attic constructed with block masonry. She has not provided any vertical post for seismic resistant so DSE suggested for correction.*

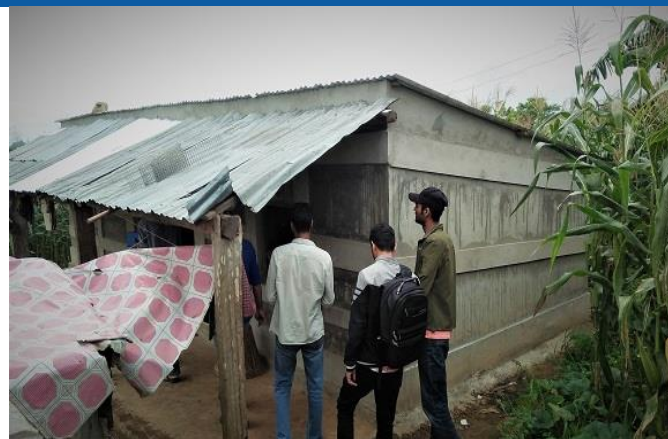
*Figure 4: Hetauda- 12, house owner Nanda Bahadur Roka, his house eligible for tranches after some correction. Now his house has verified for second & third tranche.*

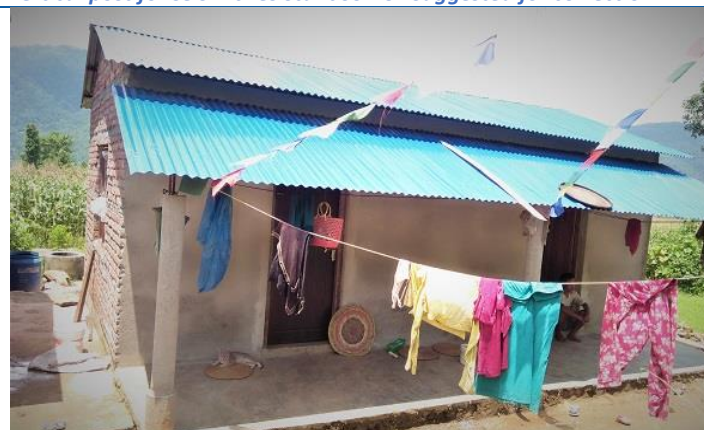
*Figure 5: House owner Ram Bahdur Tholar, Hetauda-12, he received all tranche of government grant. Brick in cement mortar with flexible roof. The total construction cost is around 6.5lakh.*

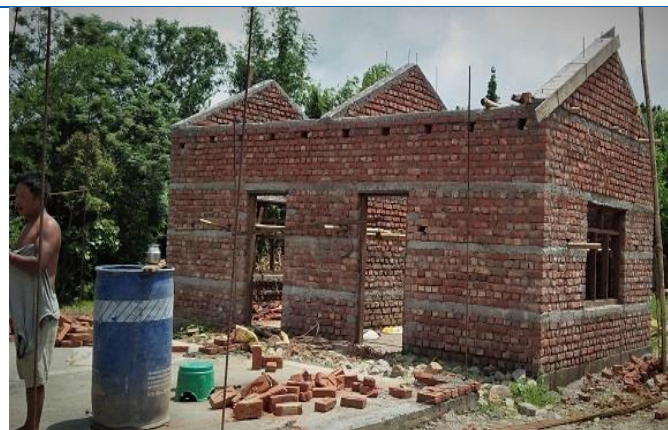
*Figure 6: Hetauda-12, house owner Dil Kumari Karki, brick in cement mortar with two room, one story an attic. She received second tranche and verified for third tranche.*

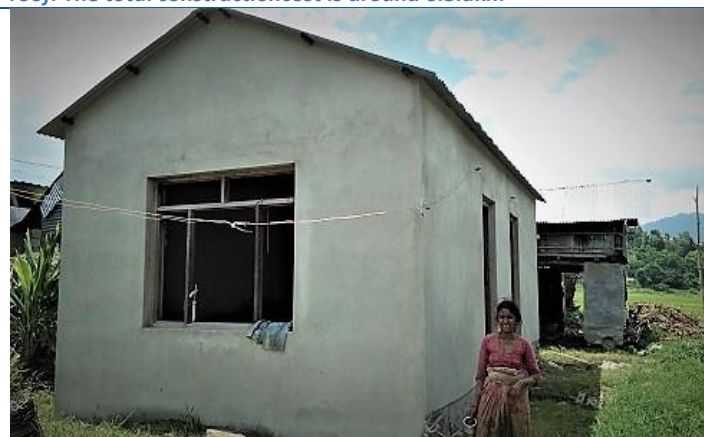
*Figure 7: House owner Govind Lamichanne, Hetauda-12, brick in cement mortar with two rooms, one story an attic with flexible roof. Herecived all tranches of government grant.*

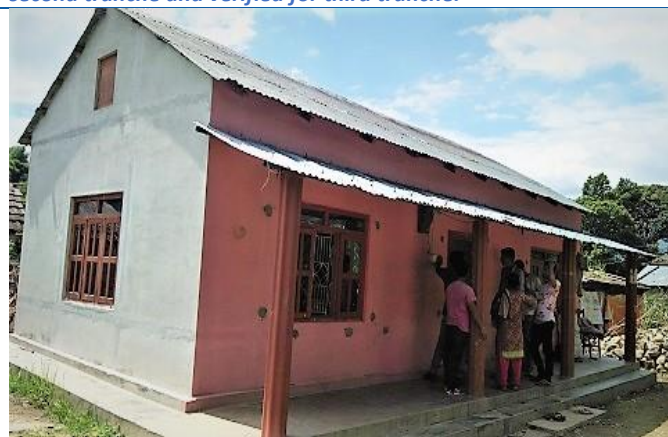
*Figure 8: House owner Aarati Balami, Hetauda-12, her house constructed block masonry. She has not provided gable band & stretch band but after correction suggestion she has provided horizontal band also her house recommended for second tranche. after provide gable & stretch band her house eligible for third tranche. The DSE was suggested for exception.*
