## District Report

### Sindhuli

15 February - 14 March 2019

## Housing Typology Report

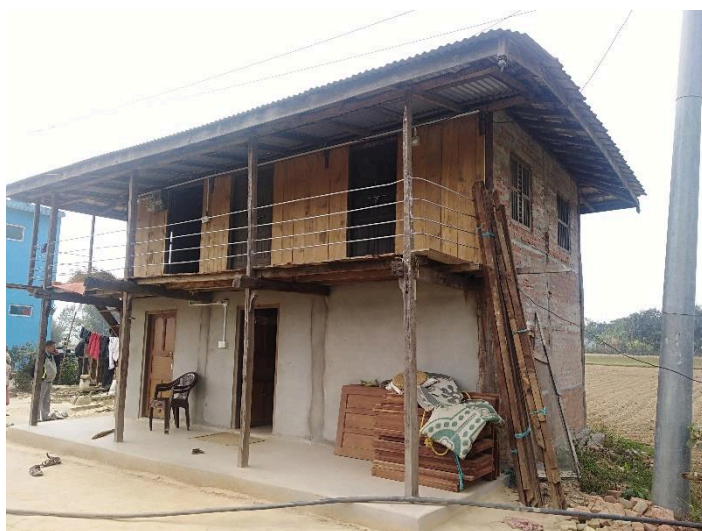
The house belongs to Mrs. Laxmi Maya Pahadi, permanent residence of Hatpate, ward no. 02, Dudhouli Municipality, Sindhuli. She has received 2<sup>nd</sup> tranche of GON housing grant. The house is constructed using timber frame structure with 5-inch Brick in Cement Masonry (BMC) wall and light timber planks in first floor. The house is non-compliance, since there seems no adequate bracing between timber post and joists. Recommended for correction.

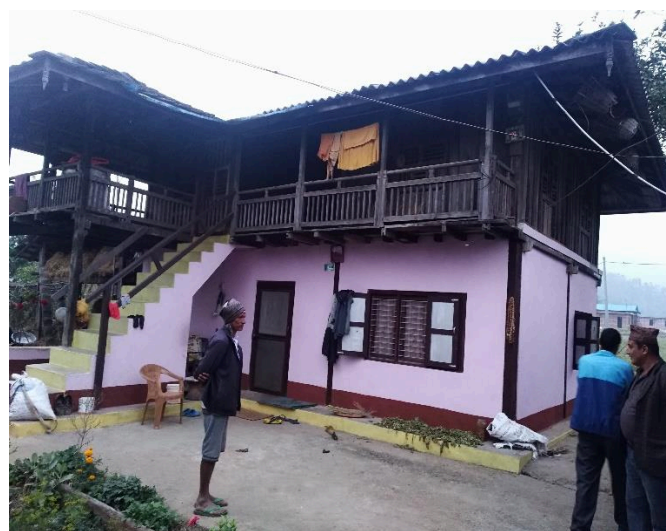
The house belongs to Mr. Netra Hari Bhandari, permanent residence of Nipane, ward no. 01, Dudhouli Municipality, Sindhuli. He has received 1<sup>st</sup> tranche of GON housing grant. The house is constructed using timber frame structure with 5-inch Brick in Cement Masonry (BMC) wall and light timber planks in first floor. The house was constructed before the deployment of DLPIU Engineers and is non-compliance due to L-shape.

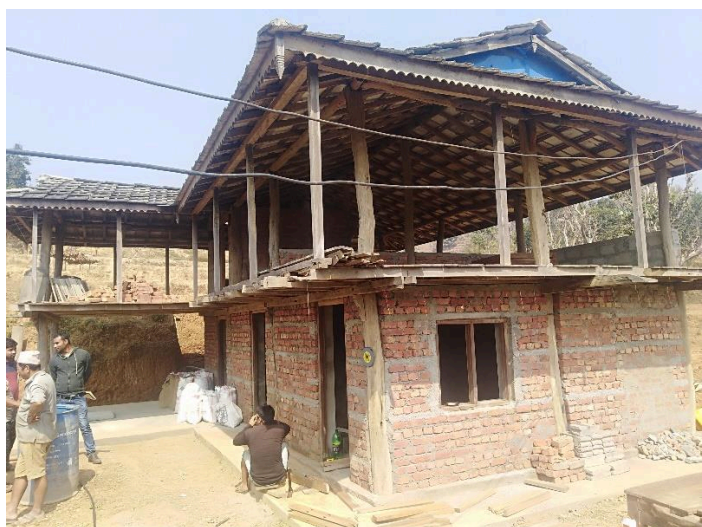
The house belongs to Mrs. Hari Maya Sijali, permanent residence of Lampantar, ward no. 11, Tinpatan Rural Municipality, Sindhuli. She has received 2<sup>nd</sup> tranche of GON housing grant. The house is constructed using timber frame structure with 9-inch Brick in

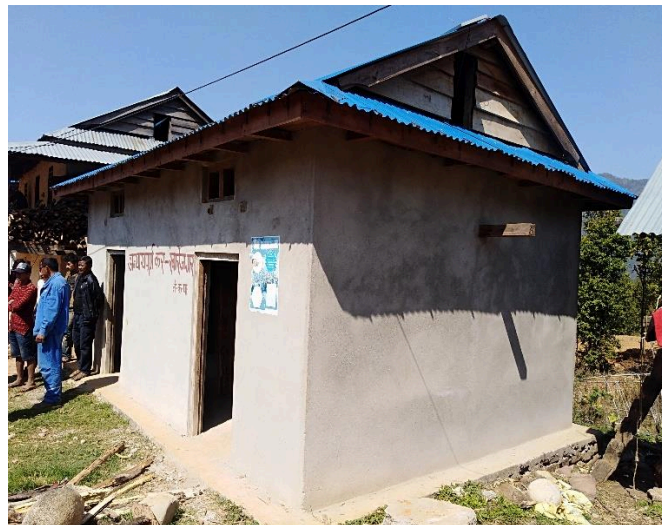
The house belongs to Mr. Prem Bahadur Ghising, permanent residence of Chisapani, ward no. 01, Hariharpurgadhi Rural Municipality, Sindhuli. He has received 2<sup>nd</sup> tranche of GON housing grant. Construction of the house is completed using timber frame structure with Hollow Concrete Block (HCB) Masonry structure in ground floor. The house is non-compliance due to improper lacing and bracing of vertical post and horizontal joists.

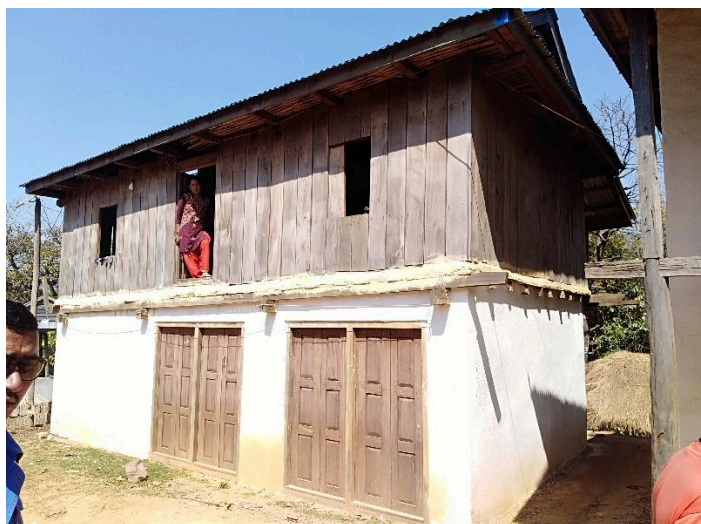
The house belongs to Mr. Dip Kumar Ghising, permanent residence of Chisapani, ward no. 01, Hariharpurgadhi Rural Municipality, Sindhuli. He has received 2<sup>nd</sup> tranche of GON housing grant. Construction of the house is completed using timber frame structure with Stone in Cement Mortar (SMC) in ground floor and light timber planks in first floor. The house owner was advised to add cross bracing to make eligible for receiving 3<sup>rd</sup> tranche.

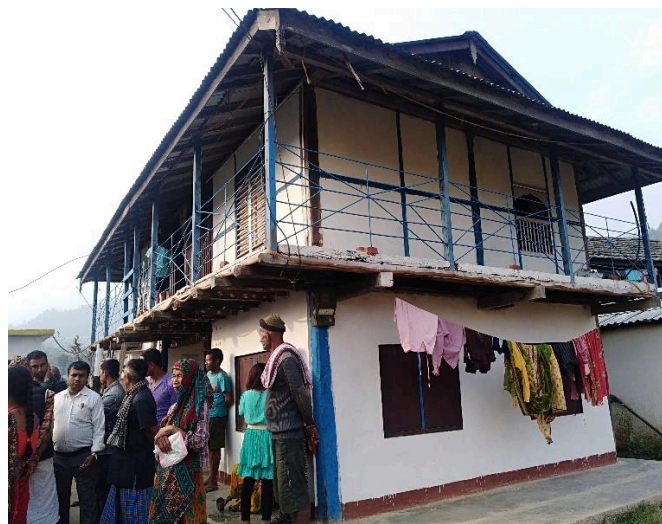
The house belongs to Mr. Chandra Prasad Pahadi, permanent residence of Hatpate, ward no. 02, Dudhouli Municipality, Sindhuli. He has received 2<sup>nd</sup> tranche of GON housing grant. Construction of the house is completed using timber frame structure with 5-inch Brick in Cement Mortar (BMC) wall in ground floor and first floor. The house is non-compliant due to heavy wall in first floor and was recommended for correction.

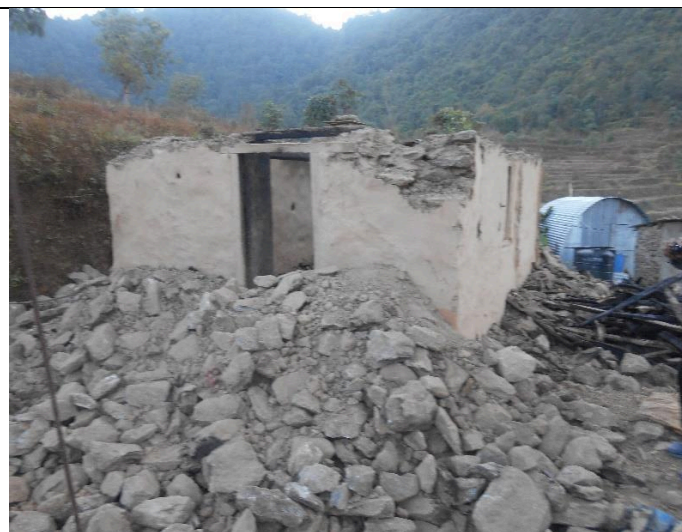
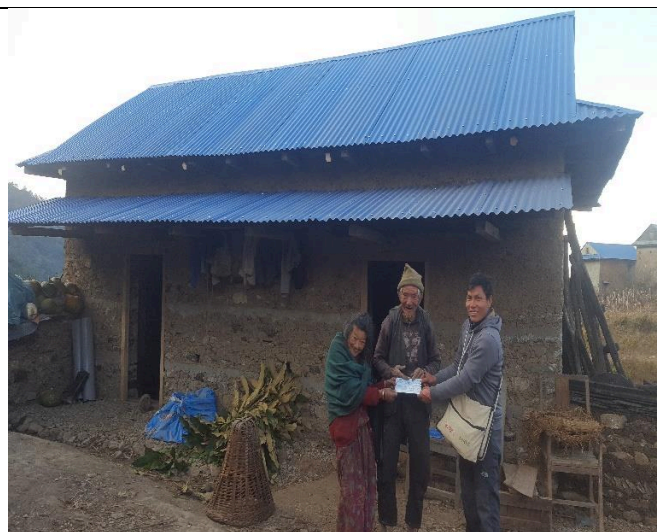
Dhansingh Syangba (*grant agreement #20-36-8-0-12*) is very happy nowadays because his new house construction has been completed. Till the construction time, he was living in goat shed with his wife. He is permanent residence of Sunkoshi Rural Municipality Ward No. 7 locally known as Chalise Pokhari. The house was badly damaged by 2072 earthquake and demolished before constructing new house. He had constructed up to plinth level before SERVE project intervention.

When the technical team of SERVE visited his house, he was living in his old damaged house. He was not able to complete the newly constructed house due to elder. He was then informed about SERVE Project and top up support from Mercy Corps, then he agreed to complete the construction of new house. Also, he was informed about the governments housing grant and its timeframe.

He started constructing his house by technical support from Mercy corps. Dhansing also demolished the old house and used the stone and other materials to construct his new house. After completion, they have shifted into new house and had planned to use one room as kitchen and another as bed room. Mercy Corps (SERVE project) provided NPR 50,000/- top up support to Dhansingh to complete the construction.
