# District Report

## Kathmandu Valley

8-21 June 2018

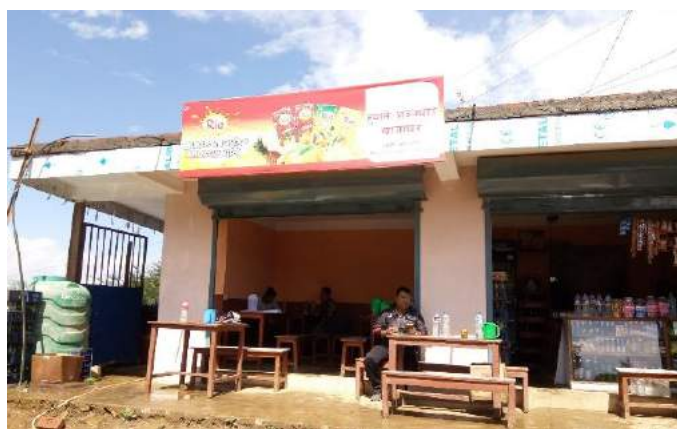
Beneficiary name: Parshuram Khatri, Ward no.9, Humane Bhyanjyang, Dakshinkali Municipality, Kathmandu district, 1 storey, Load bearing structure with rigid roof using steel post as vertical reinforcement. The file has been forwarded to the DSE for analysis after which the process for the 2nd tranche will be processed.

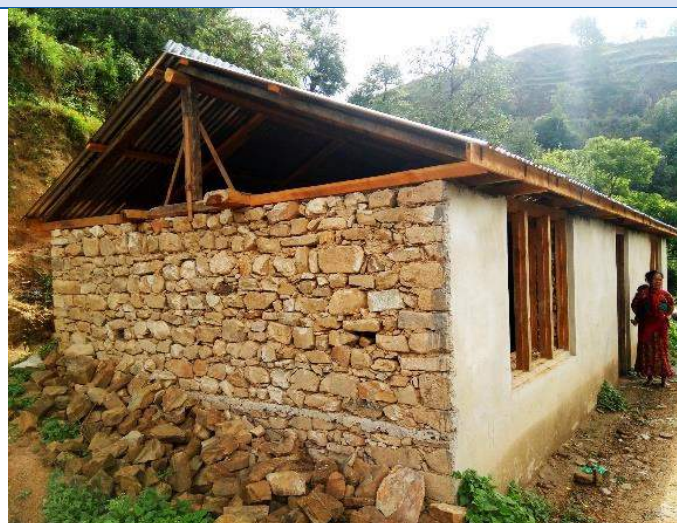
Beneficiary name: Sukmaya Bhaju Tamang, Ward no. 9, Humane Bhyanjyang, Dakshinkali Municipality, Kathmandu district, single storey, SMM structure with flexible roof. The vertical reinforcement, roof band and corner stitch were missing. The house has double frame on door and windows. The house owner was to imply correction measures such as adding band and reinforcement in order to become eligible for 2<sup>nd</sup> tranche.

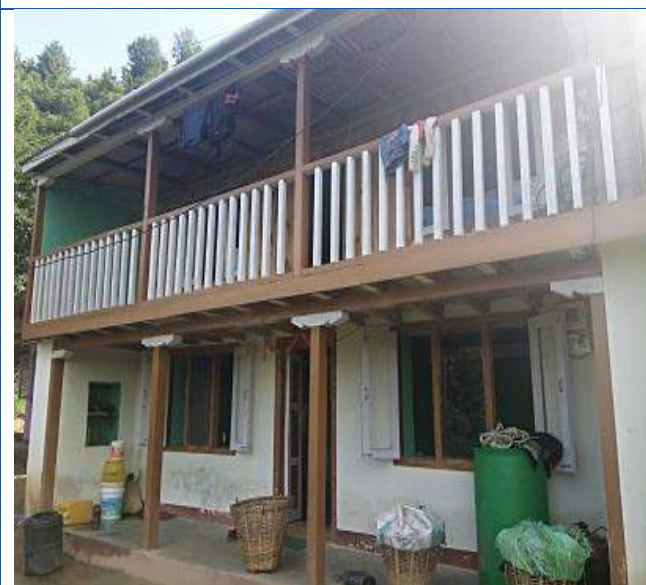
Beneficiary name: Buddha Bhaju Tamang, Ward no. 9, Humane Bhyanjyang, Dakshinkali Municipality. 2 storey, hybrid structure. The ground floor is SMM and the upper structure is of CGI sheets with partition using wooden planks. Double frames have been used in windows and door. The wall is 18 inches with use of timber bands and flexible roof with bracings done. The owner has successfully received 2<sup>nd</sup> tranche and 3<sup>rd</sup> tranche application has been applied.

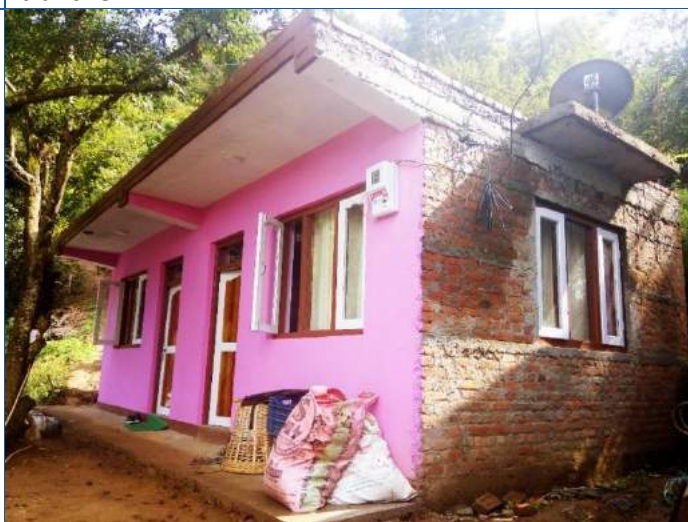
Beneficiary name: Sun Bahadur Bhaju Tamang, Ward no. 9, Humane Bhyanjyang, Dakshinkali Municipality. 1 storey load bearing structure with rigid roof. The house was found to be technically sound and compliance. The owner has been a local mason and has reconstructed this house by himself. The owner has successfully received 3<sup>rd</sup> tranche.

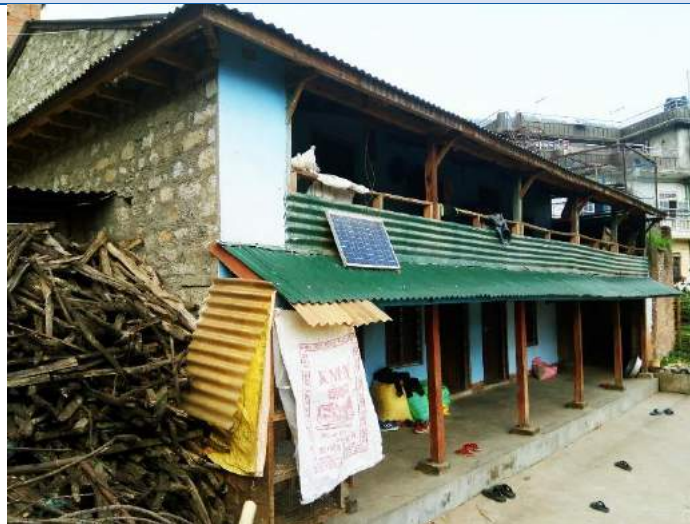
Beneficiary name: Binod Adhikari, Ward no. 1, Jhor Mahankal, Tokha Municipality. 2 storey SMC structure with flexible roof. 18 inch wall has been raised. The owner has received 2<sup>nd</sup> tranche and applied for 3<sup>rd</sup> tranche as well.

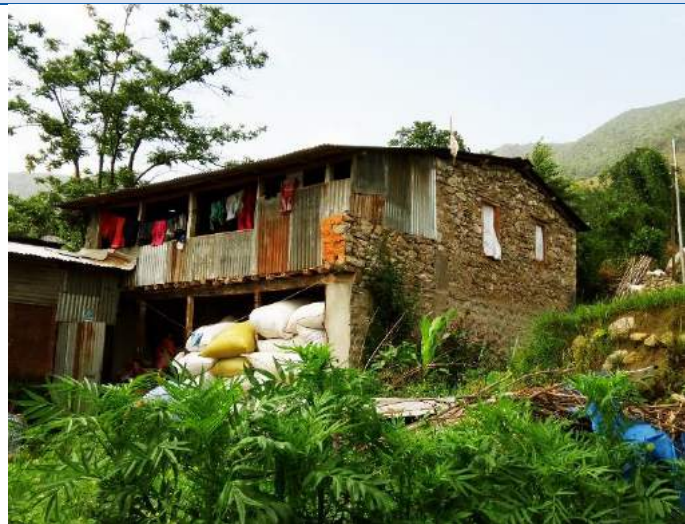
Beneficiary name: Hari Prasad Dulal, Ward no. 1 Jhor Mahankal, Tokha Municipality. 2 storey SMC structure house. The lintel band was missing in the house. The building drawing was made after the house was construction. Technically the house was found to be non-compliance and M & E Consultant suggested the owner to apply corrective measures by removing the top storey.

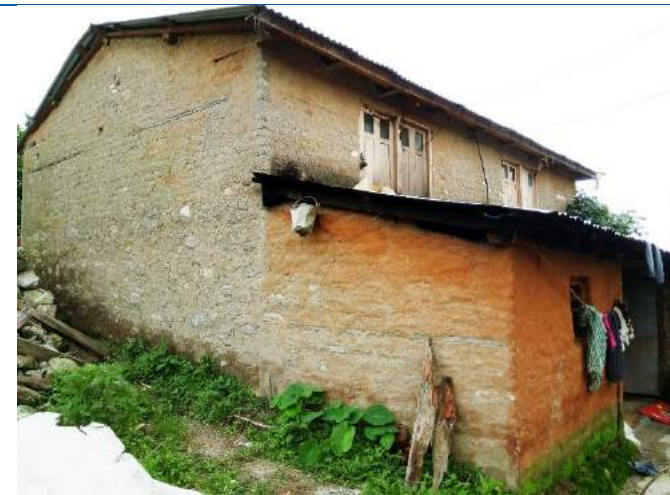
Beneficiary name: Kedar Prasad Adhikari, Ward no 1, Jhor Mahankal, Tokha Municipality. 2 storey BMM structure made from raw bricks. The owner has not done DPC works while constructing the house. 1<sup>st</sup> tranche has been received while 2<sup>nd</sup> tranche is in question as the house is non-compliance.

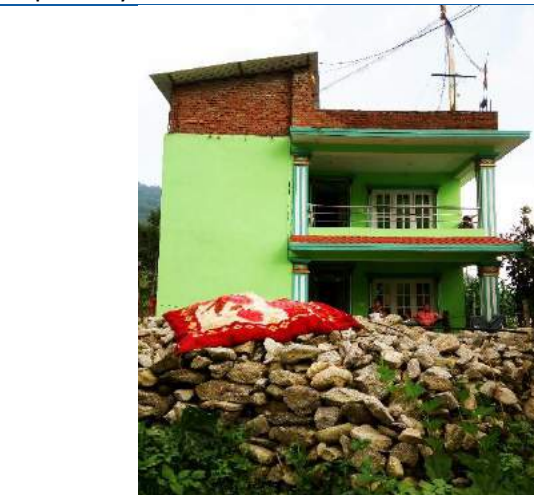
Beneficiary name; Bir Bahadur Tamang, Ward no 1 Jhor Mahankal, Tokha Municipality. 2 storey RC structure the house was found to be compliance and received 2<sup>nd</sup> tranche. 3<sup>rd</sup> tranche is in process at the municipality.

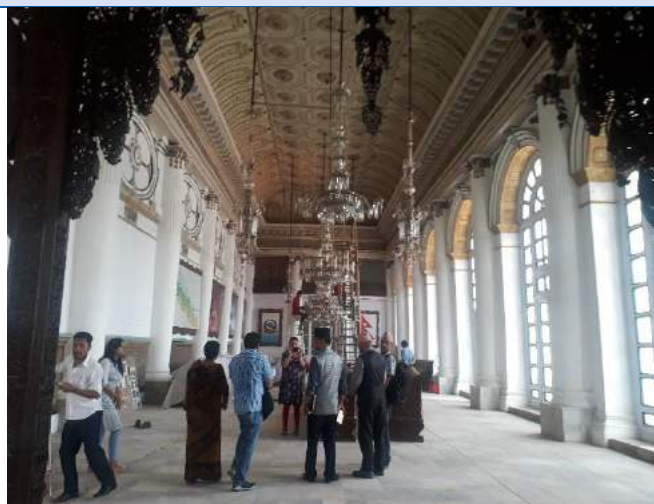
Interior part of Gaddi Baithak.

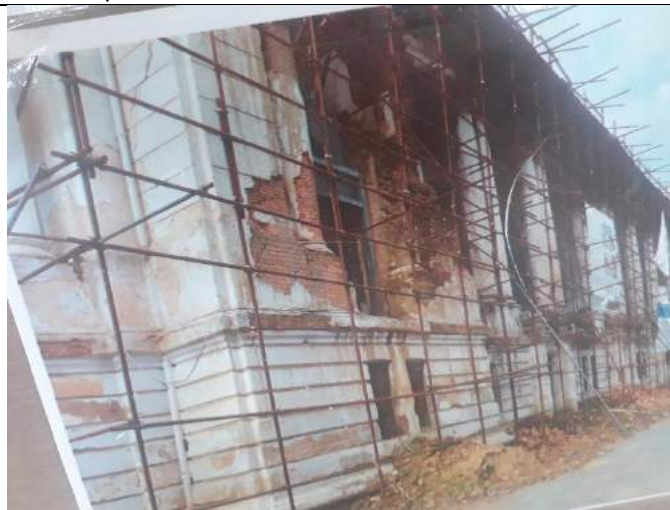
A photo of the damaged building before restoration.  
Source: Miyamoto International Relief, Nepal

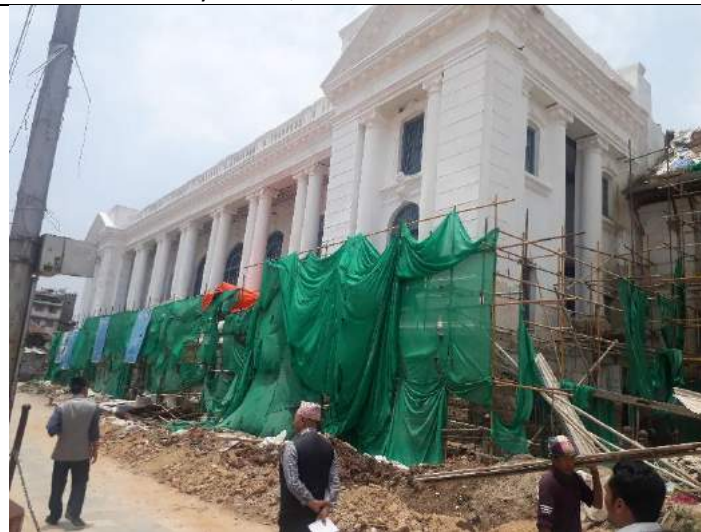
The project includes the restoration of damaged parts and the seismic upgrade or strengthening of the entire building of 810 sq. m area. Though building was partially damaged, two columns were severely damaged which is tied with timber brass. Timber brass is used in parapet, lime is used on bands and ceiling is decorated with craved metal in similar design before the earthquake. Similarly, 40 inches of wall is made of stone and lime. The project was started from Oct 2017. It took 8 months to complete the project excluding the design preparation and approval period which was very appreciated by NRA DLPIU GMaLI during and after this site visit. The official inauguration of the *Gaddi Baithak* will be done by Honorable Prime Minister of Nepal on 27 June 2018.

An exterior part of the building after completion.

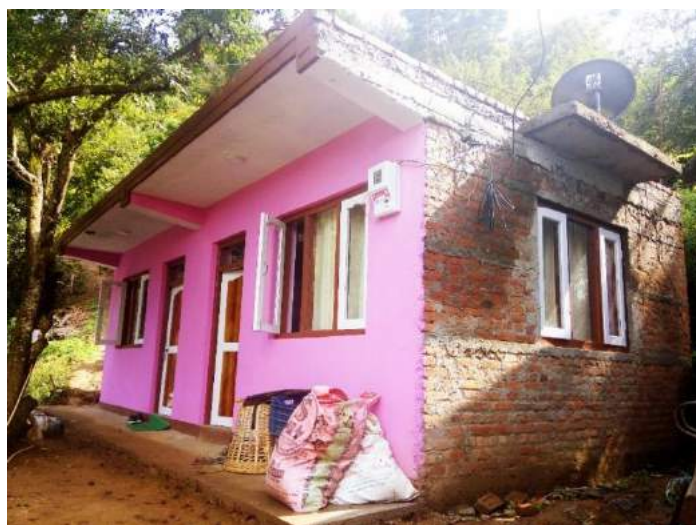
Sun Bahadur Bhaju Tamang, Ward no. 9, Humane Bhyanjyang, Dakshinkali Municipality. 1 storey load bearing structure with rigid roof. The house was found to be technically sound and compliance. The owner has been a local mason and has reconstructed this house by himself. The owner has successfully received 3<sup>rd</sup> tranche.

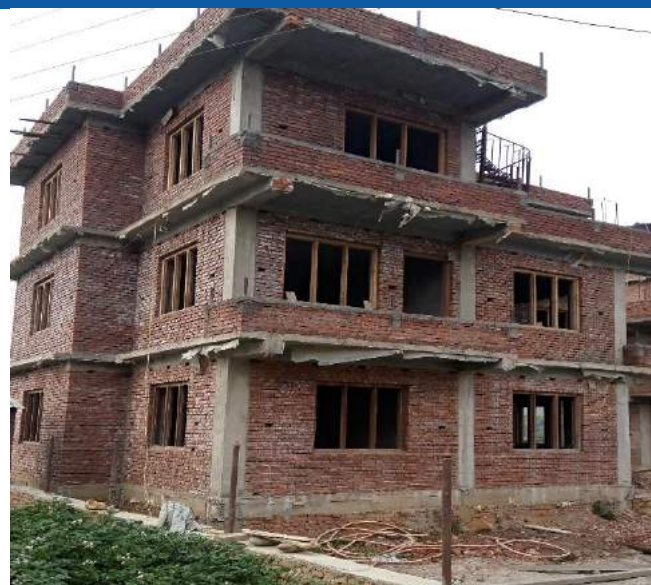
Sisneri, Ward No. 9, Lamatar, Mahalaxmi Municipality, RCC structure house with use of band and cladding in door and windows. The owner has received 2<sup>nd</sup> tranche and applied for 3<sup>rd</sup> tranche too.

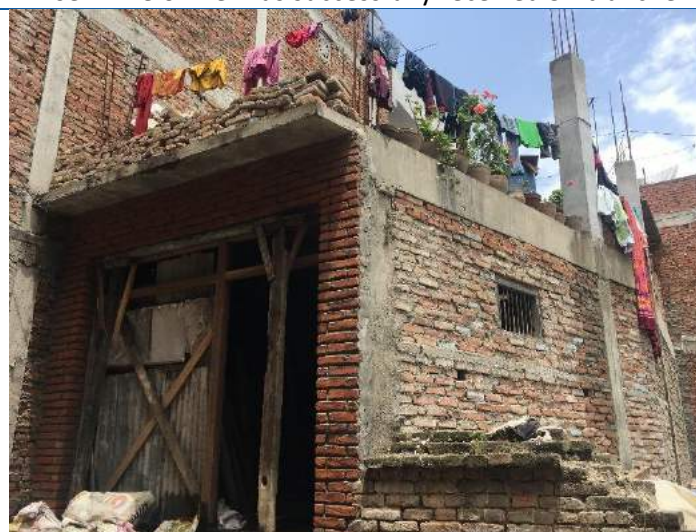
Rajesh Ranjitkar, Ward no 5, Madhyapur Thimi Municipality. 1 storey RC frame structure. The beneficiary has received 2<sup>nd</sup> tranche and has submitted application for the inspection of the 3<sup>rd</sup> tranche.

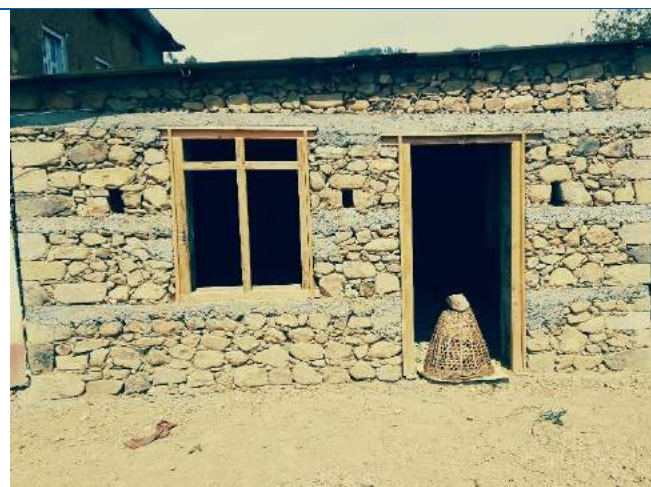
Thulogaun, Nallu, Sisneri, Ward No. 4, Konjosyom Rural Municipality. 2 roomed 1 storey SMC house with CGI roof has already received 2<sup>nd</sup> tranche. Beneficiary has applied for 3<sup>rd</sup> tranche.

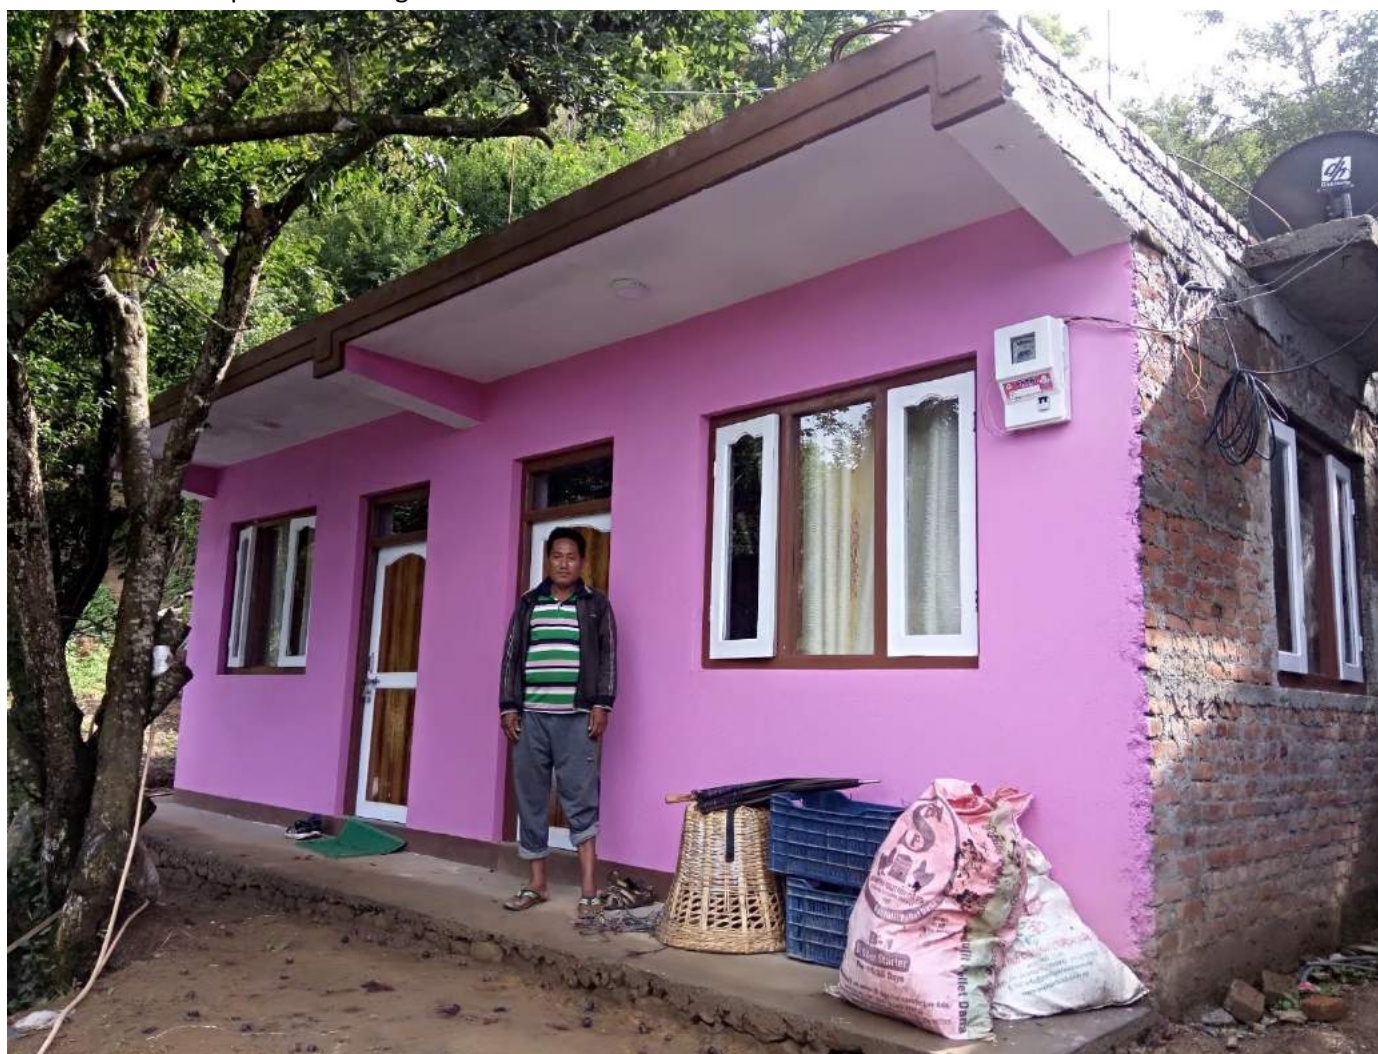
Mr. Tamang's wall system house of single storey were found to meet minimum requirements during inspection for 2<sup>nd</sup> tranche by engineers of Dakshinkali Municipality. He almost waited for 5 months to receive 2<sup>nd</sup> tranche from the date of application. He is elated as he has received 3<sup>rd</sup> tranche too and he feels proud in sharing his mason skills and inputs in his neighbours for better reconstruction.
