# District Report

## Kathmandu Valley

3 -16 August 2018

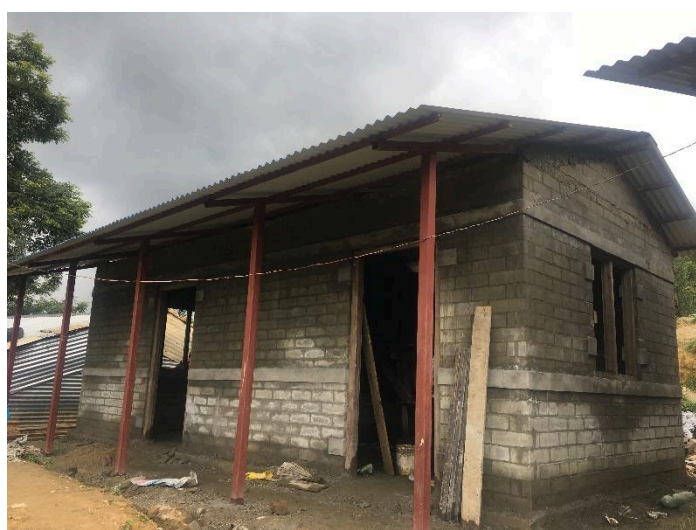
Beneficiary name: Mr. Ramesh Khatri, Lele, Ward no. 6, Godawari Municipality. One storey two roomed house made from CSEB. The house constructed is supported by Samaritan's Purse with the reconstruction Partner Build UP Nepal. The beneficiary has received the 1<sup>st</sup> tranche from the government.  
Photo Credit: HRRP-KTM Valley team

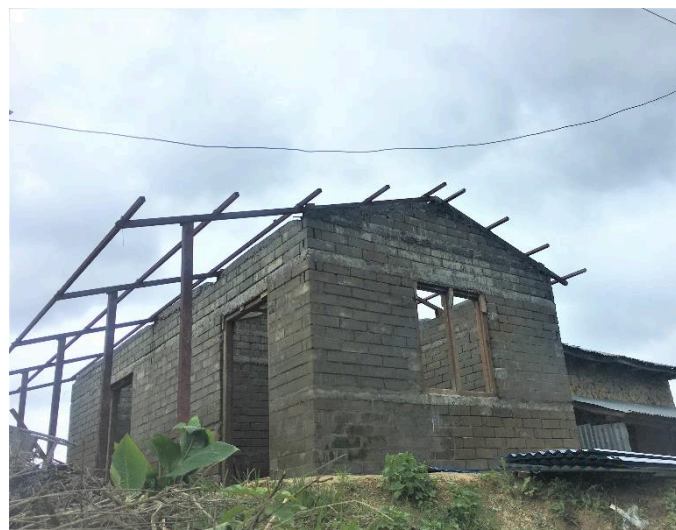
Beneficiary name: Ms. Thulimaya Kunwar is a single woman from Lele, Ward no. 6, Godawari Municipality. One storey two roomed house made from CSEB. The house constructed is supported by Samaritan's Purse with the reconstruction Partner Build UP Nepal. The roofing work of the house is remaining. The beneficiary has received the 1<sup>st</sup> tranche from the government.  
Photo Credit: HRRP-KTM Valley team

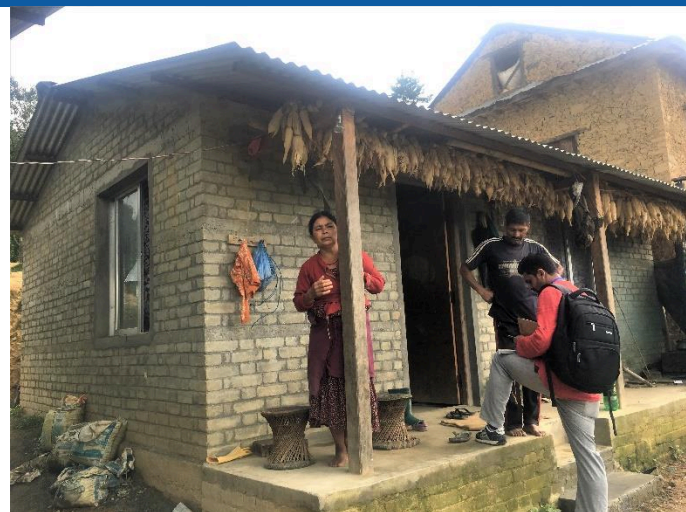
Beneficiary name: Mr. Bharat Karki, Lele, Ward no. 6, Godawari Municipality. One storey two roomed house load bearing structure constructed using concrete bricks. The house constructed is supported by Shangrila Orphanage Home. The beneficiary has received the 1<sup>st</sup> tranche from the government. (Date: August 2, 2018)  
Photo Credit: HRRP-KTM Valley team

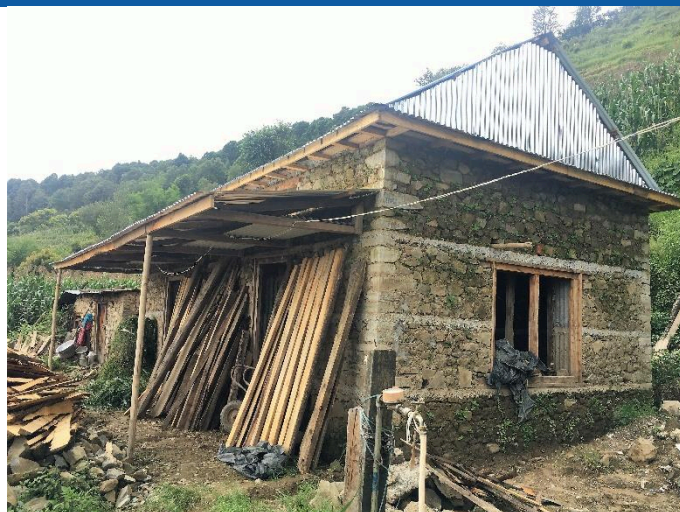
Beneficiary name: Guna raj Subedi, Sudal, ward no. 8, Changunarayan Municipality. One storey plus attic two roomed house load bearing structure constructed stone in mud mortar. The beneficiary has requested for the 2<sup>nd</sup> and 3<sup>rd</sup> tranche. During the monitoring visit the house was found to be complaint. (Date: July 23, 2018)  
Photo Credit: HRRP-KTM Valley team

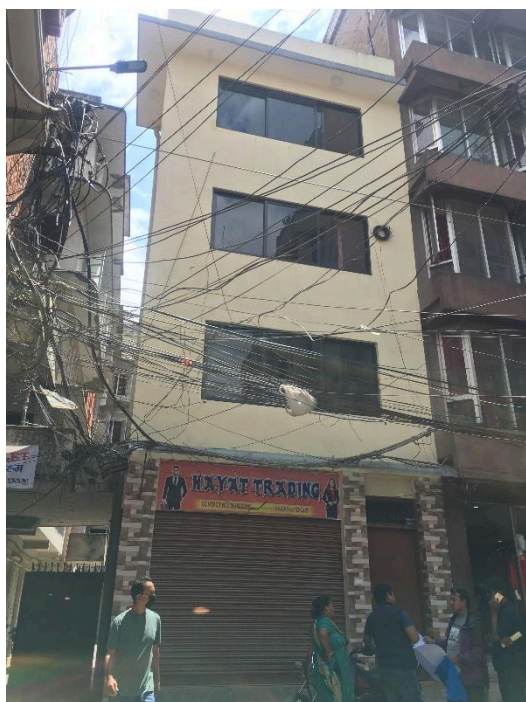
Beneficiary name: Ms. Harsha Laxmi Tuladhar, Indrachowk, Ward no 24, Kathmandu Metropolitan City. 4 storey RC structure. The beneficiary has received the 2<sup>nd</sup> tranche from the government and have requested for the 3<sup>rd</sup> tranche. (Date: July 24, 2018)  
Photo Credit: HRRP-KTM Valley team

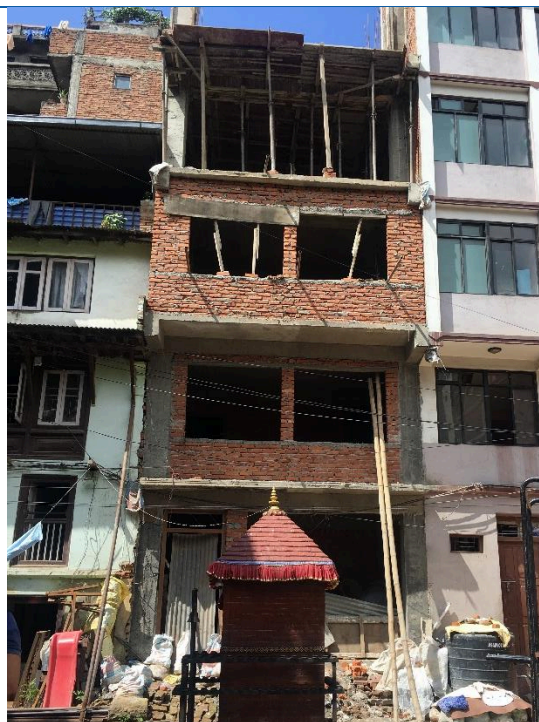
Beneficiary name: Mr. Shyam Maharjan, Bharmatol, Teku, Ward no. 12, Kathmandu Metropolitan City. 4 storey RC structure. The beneficiary has received the 2<sup>nd</sup> tranche from the government and have requested for the 3<sup>rd</sup> tranche. (Date: July 24, 2018)  
Photo Credit: HRRP-KTM Valley team

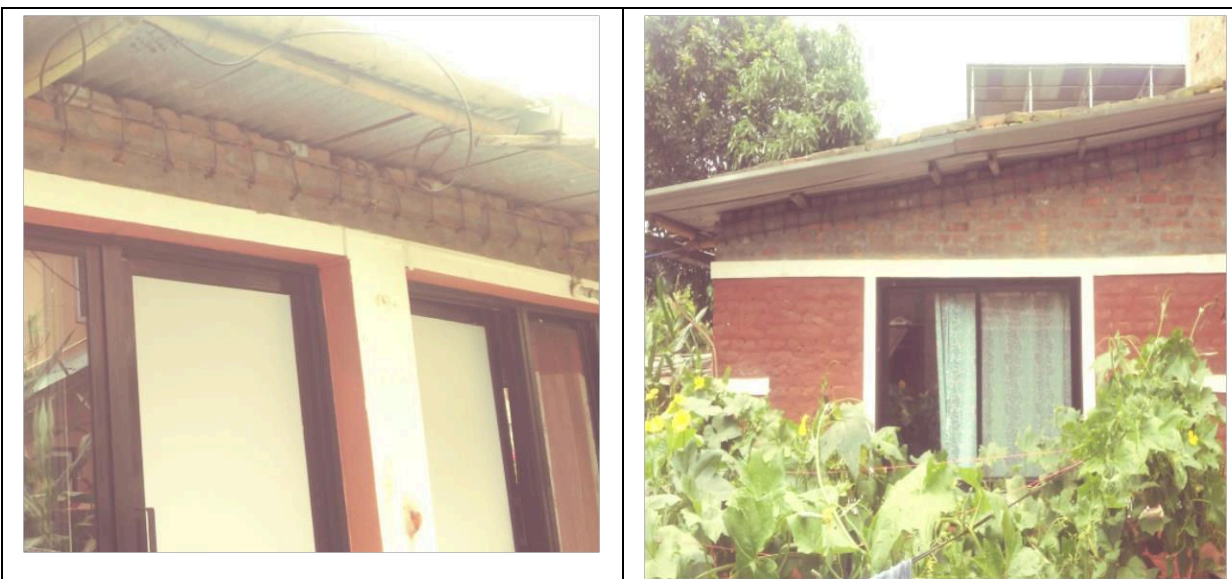
#### 1. Kali Bista – Bagdol, Ward no. 4, Lalitpur Metropolitan City

The beneficiary was not able to claim for the 3rd tranche as the roof band was found to be missing during the inspection. The beneficiary was suggested to add the roof band for the house to be eligible for the 3rd tranche. As per the suggestion of the engineer a roof band was added to the existing structure as indicated in the correction and exception manual.

Additional of the RC roof band at the top-level of wall as a corrective measure to a non-compliance structure.

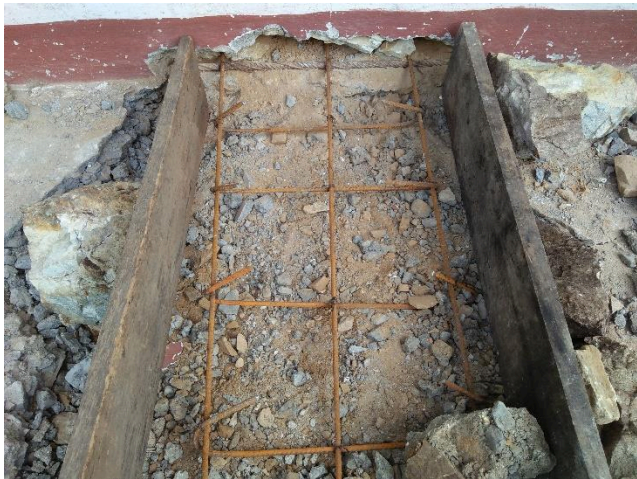
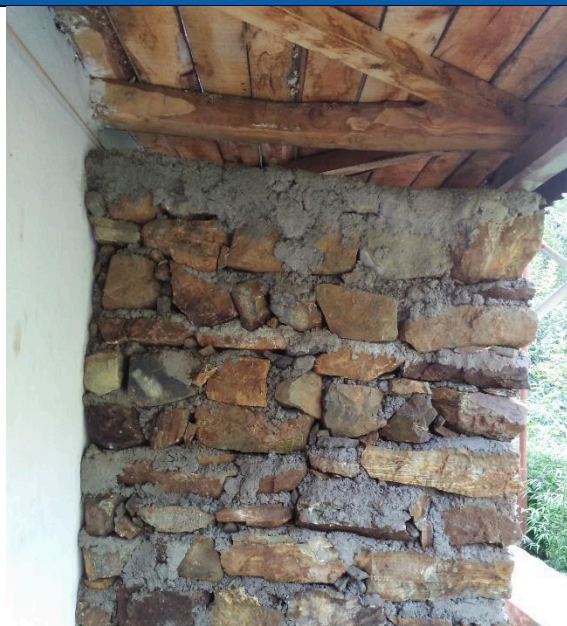
#### 2. Tej Bahadur Satyal – Gotikhel – Ward no 3, Mahankal Rural Municipality

The beneficiary was not able to claim for the 3rd tranche as the size of room was found to be more than 13.5 sq.m. during the inspection. The technical staff suggested the addition of cross wall or buttress wall for the house to be compliance. Mr. Satyal applied the correction measures and added a buttress wall as per the technical specification provided in the correction and exception manual with the support and guidance from the technical staff. With the correction measure the house was categorized as compliance and his files for the 3rd tranche was forwarded to GMaLI-Lalitpur.

Steel bars of new wall bands inserted inside the existing wall. The connection of the buttress wall and the existing wall has been made and prepared for the re-concreting.

The buttress wall with RC band after the completion. The buttress wall is used to increase the strength and stiffness to long walls.
