## Monthly District Report

### Lalitpur, Bhaktapur

27 September - 21 October 2019

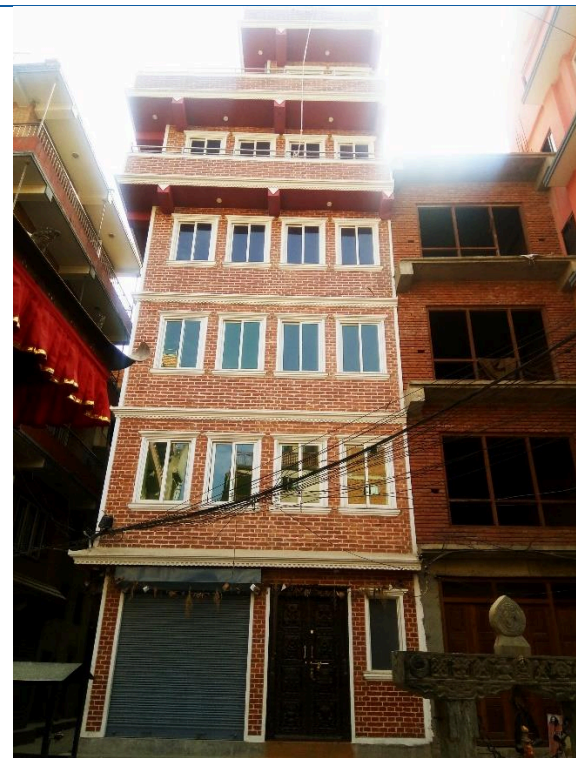
Image: Mr. Bagacha Maharjan, Ward no 17, Lukhusi, Lalitpur Metropolitan City. 5 ½ storey RCC framed structure house has received all three tranches from government. However after accessing 3<sup>rd</sup> tranche, the owner has added extra storeys (1.5 storeys). The engineer advised that the house will not receive construction completion certificate.

| Challenge | Way Forward |
|---|---|
| Addition of extra storeys after accessing 3 <sup>rd</sup> tranche has in fact raised question over resiliency of houses. | Building permit approval and number of needful storeys are provided on the basis of size of land. Any addition in the storeys in fact increases risk of the rebuild houses. Ward offices should be responsible in disseminating key messages of risks and threats of adding extra storeys other than mentioned in the building drawing. Concerned ward office and municipality office should properly disseminate information of abiding by the building bylaws. The key messages of constructing resilient structures should be the highlighted in information sharing sessions by Ward office. |

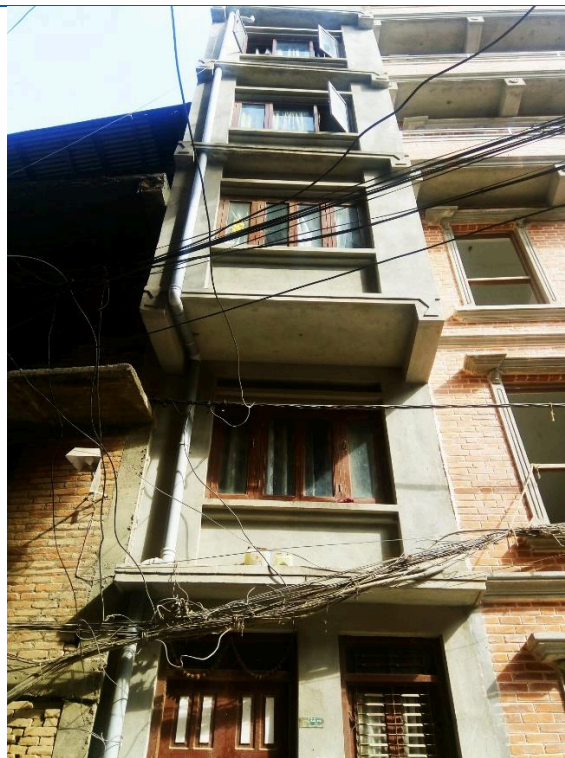
Image: Ward no 17, Lukhusi, Lalitpur Metropolitan City. 5 ½ storey RCC framed structure house has received upto 2<sup>nd</sup> tranche. The owner has added extra storeys which was not mentioned in building permit (not as per drawing), further 1 room has been added in cantilever side.

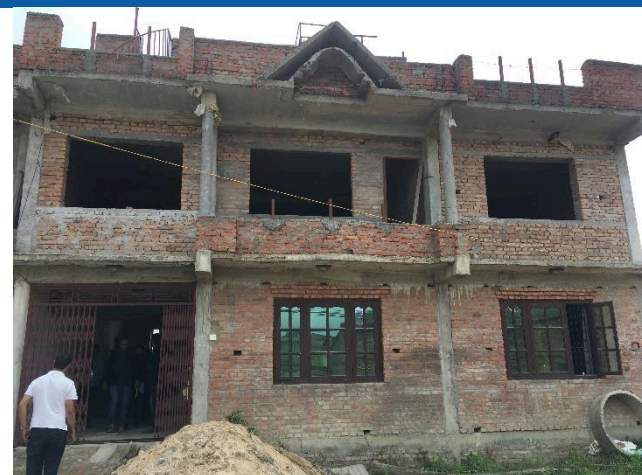
Beneficiary name: Santa Bishunke, Ward no 3, Changunarayan Municipality has non compliance structure of 9"x12" column which came out unsafe during analysis. The structure was completed immediately after earthquake.

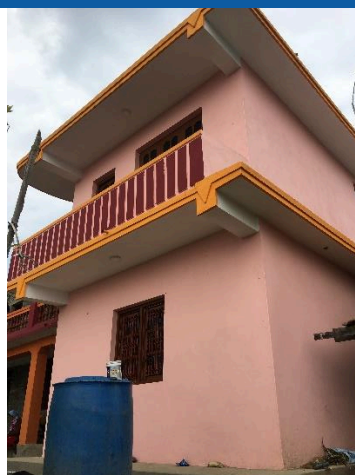
Beneficiary name: Shyam Krishna Nepal, Ward no 7, Changunarayan Municipality has structure of confined masonry. The house was terms non compliance as the structure is not as per the building drawing. The beneficiary is still using the damaged house after repair and maintenance.

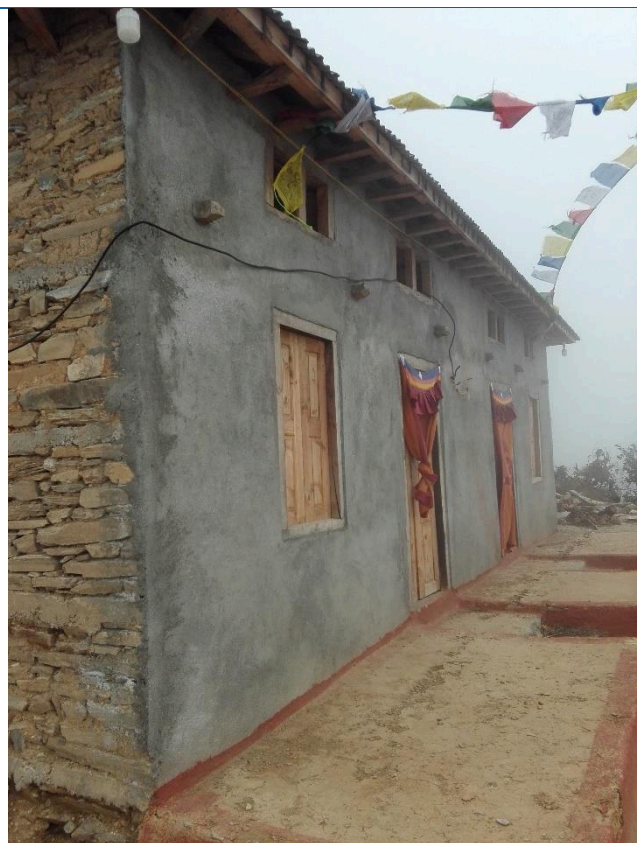
Beneficiary Name: Surya Bahadur Gole, Ward no 4, Kaleshwor, Mahankal Rural Municipality. One storey plus attic SMM structure with RC bands has cemented front finishing

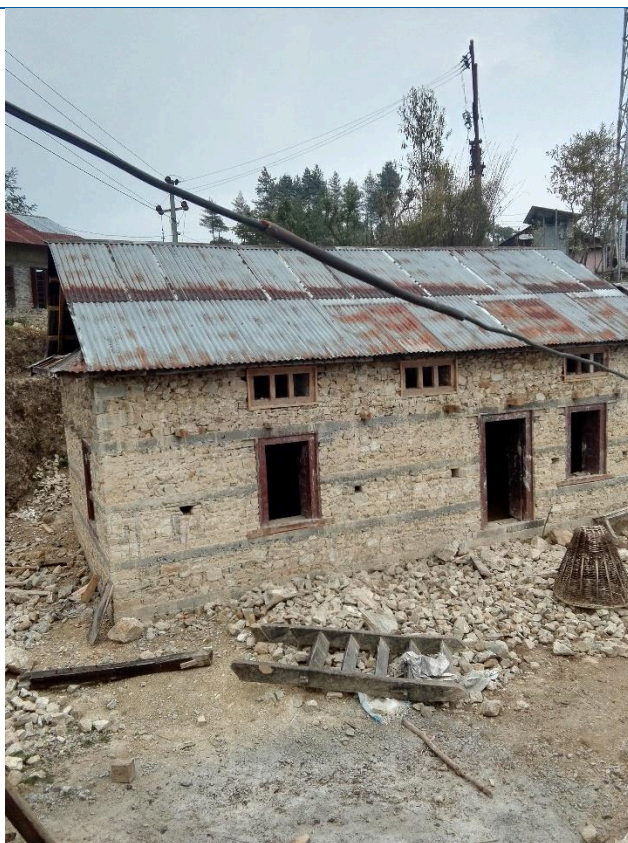
Beneficiary Name: Hari Prasad Dahal, Kaleshwor, Ward no 4, Mahankal Rural Municipality. One story plus attic SMM structure with RC bands has received upto 2<sup>nd</sup> tranche. The owner has requested for 3<sup>rd</sup> tranche during the time of inspection.
