## District Report

### Makwanpur

23 November – 6 December 2018

## Housing Typology Report

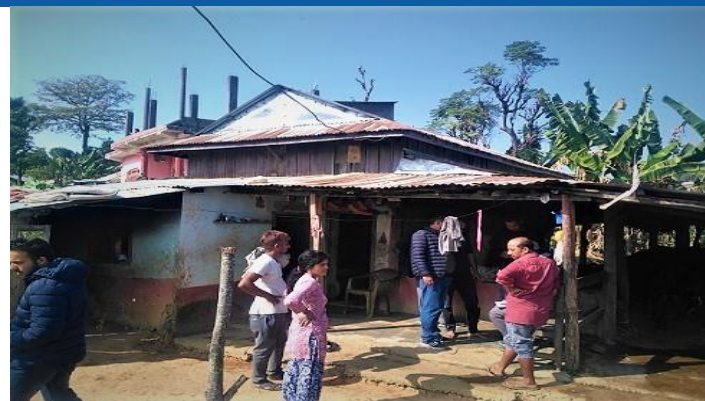
**Figure 3:** House owner; Narayan Prasad Dhungana, Makwanpur Gadhi RuralMunicipality-03, he is a retrofitting beneficiary and received first tranche but he doesn't agree for correction and he has apply for beneficiaries change process retrofitting to reconstruction. But still from technical view point this house may eligible for government tranche after some earthquake seismic resistant elements provided.

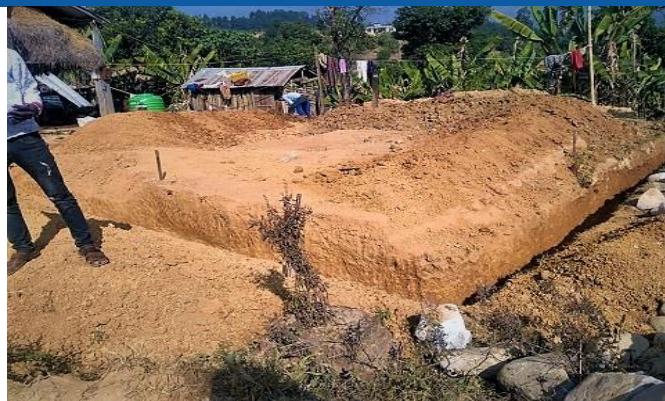
**Figure 4:** House owner; Durga Prasad Dhungana, Makwanpur Gadhi RuralMunicipality-03, also he is a retrofitting beneficiary and received first tranche and he has apply for beneficiaries change process retrofitting to reconstruction. And result couldn't publish till to date but he started own house for reconstruction. Generally we provide 3'\*3' size of foundation but still not provided sufficient size. We suggested for some correction of foundation.

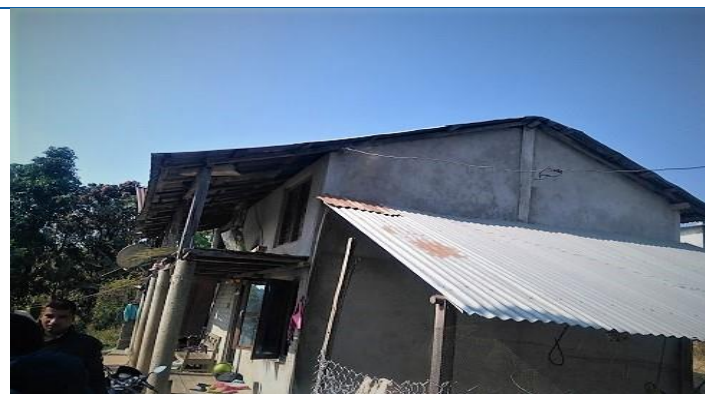
**Figure 5:** House owner; Tara Nath Sapkota, Makwanpur Gadhi RuralMunicipality-03, he is a reconstruction beneficiary and he constructed own house before deploying the government engineer. Now this house has not eligible for government grants because of he has not provided seismic resistant elements like as vertical post, horizontal bands, too thing etc. He used block material with two stories. DSEs recommended for correction but also he does not agree for correction. It is an example of issues almost in Makwanpur district these types of problems have faced by government engineers.

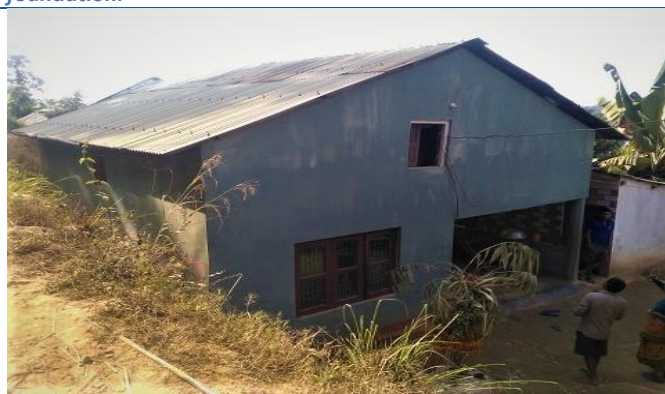
**Figure 6:** House owner; Khadak Prasad Lamsal, Makwanpur Gadhi RuralMunicipality-03, he is a reconstruction beneficiary and he constructed own house before deploying the government engineer. Now this house has not eligible for government grants because of he has not provided seismic resistant elements like as vertical post, horizontal bands, too thing etc. He used block material with two stories with huge opening. DSEs recommended for correction but also he does not agree for correction.
