Housing Recovery and  
Reconstruction Platform

# Housing Typologies: Earthquake Affected Districts

September 2018

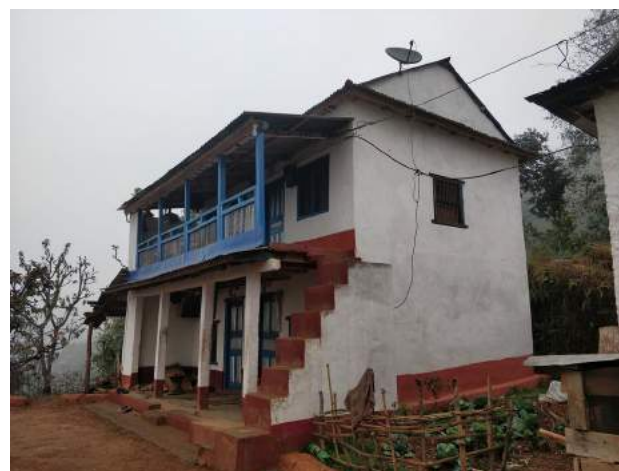
**Location:** Syangja, Bhirkot Municipality, Ward No. 5

**Other:** this 1.5 storey house is non-compliant and the house owner has been advised to carry out correction measures to receive the remaining tranches. The government engineers recommended that timber vertical posts, timber banding at foundation and sill level, and RC banding at gable band be added.

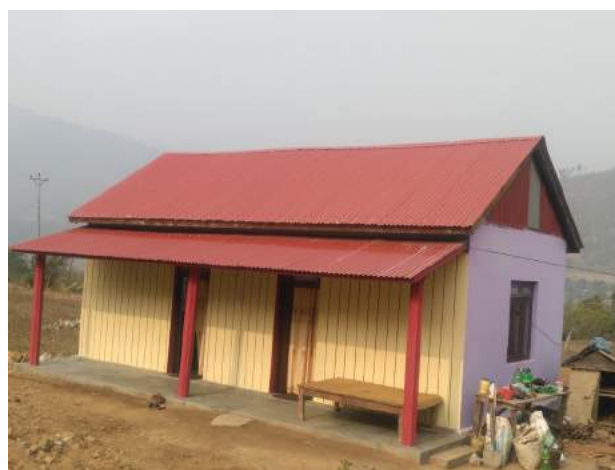
**Location:** Makwanpur, Raksirang Rural Municipality, Ward No. 3

**Tranche Status:** received all three tranches

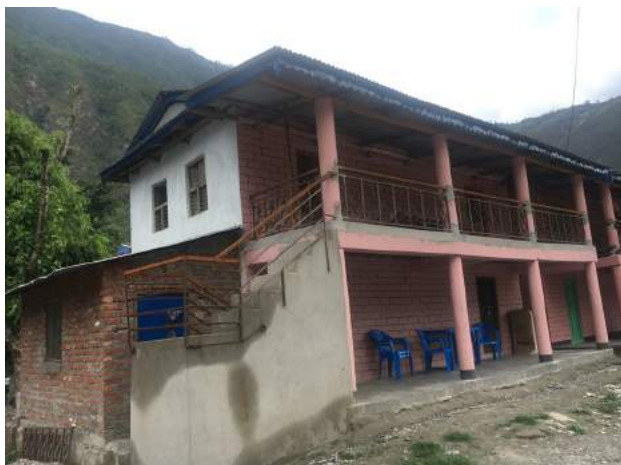
**Location:** Okhaldhunga, Maney Bhanjang Rural Municipality, Ward No. 7

**Tranche Status:** received all three tranches

**Other:** RC bands have been used.

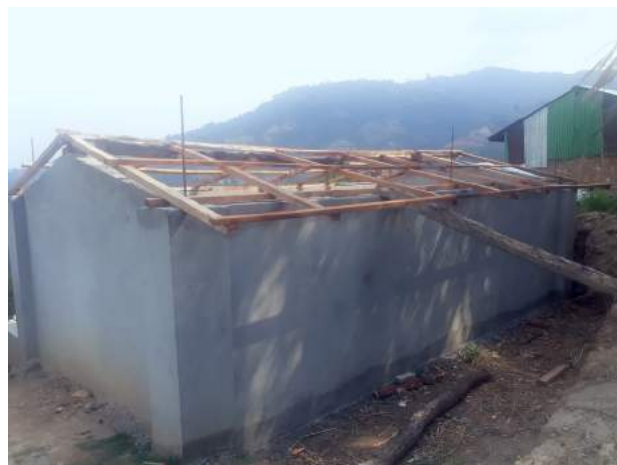
**Location:** Kathmandu, Shankarapur Municipality, Ward No. 1

**Tranche Status:** not approved for second tranche

**Other:** the house owner does not have a building permit or house design. The house was not approved for the second tranche because the room size exceeds allowed limits and corrections are required.

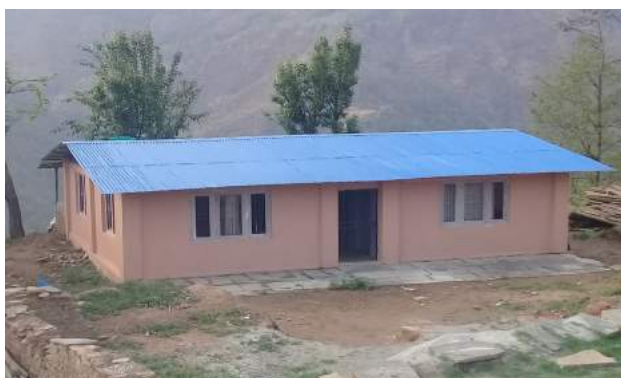
**Location:** Sindhupalchok, Paanchpokhari Thangpal Rural Municipality, Ward No.9, Thangpaldhap, Taar

**Tranche Status:** unknown

**Other:** the house owner spent approximately 1,000,000 NPRs on the construction.

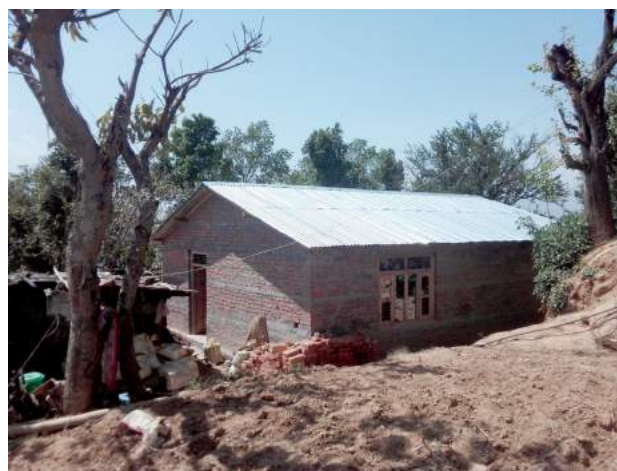
**Location:** Sindhupalchok, Nawalpur Rural Municipality, Ward No. 6

**Tranche Status:** received second tranche

**Other:** RC bands have been used.

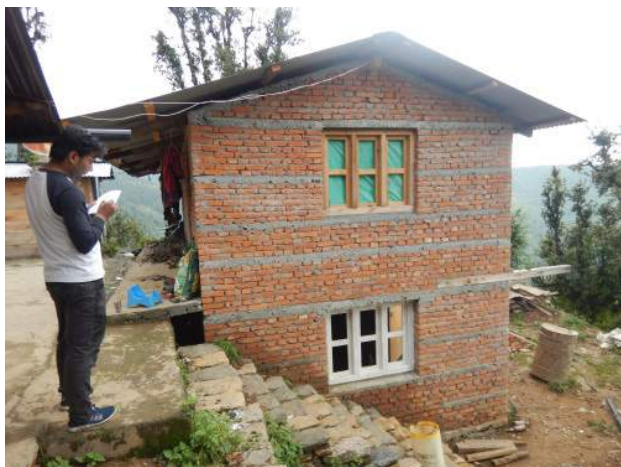
**Location:** Dolakha, Jiri Municipality, Ward No. 6

**Tranche Status:** received first tranche

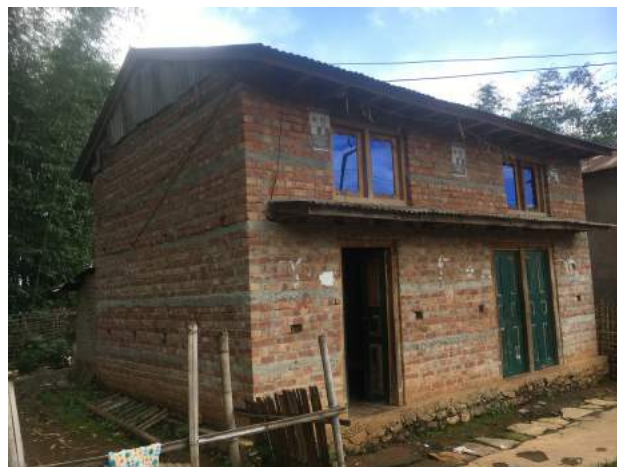
**Location:** Okhaldhunga, Siddhicharan Municipality, Ward No. 4

**Tranche Status:** received all three tranches

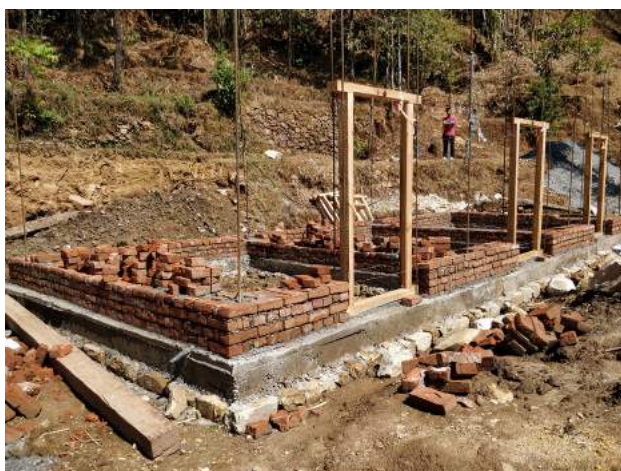
**Location:** Baglung, Baglung Municipality, Ward No. 3

**Tranche Status:** unknown

**Other:** the house owner is taking support from the government engineers for the construction of their house.

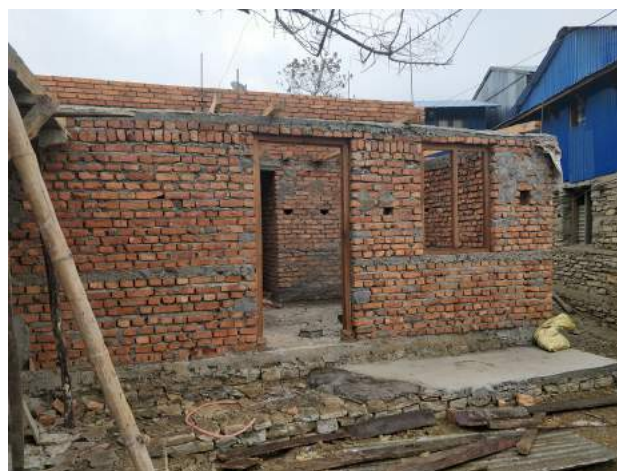
**Location:** Lamjung, Rainas Municipality, Ward No. 5

**Tranche Status:** unknown

**Other:** this house is not fully compliant as vertical reinforcement at the openings is missing.

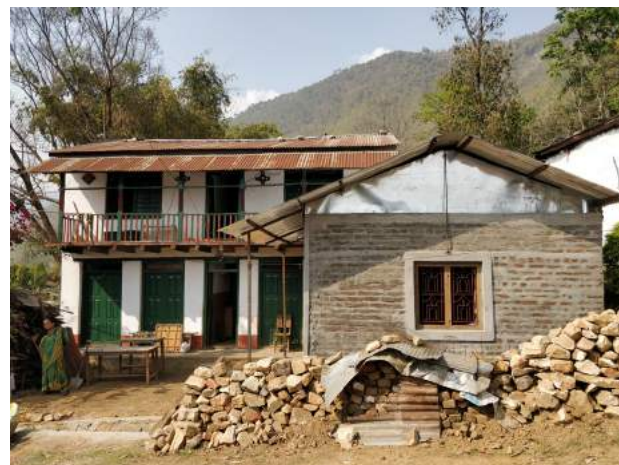
**Location:** Parbat, Kusma Municipality, Ward No. 4

**Other:** vertical and horizontal reinforcement has not been properly included so the house has not been approved for the third tranche. The government engineer has recommended corrections, but the house owner does not want to carry out the corrections.

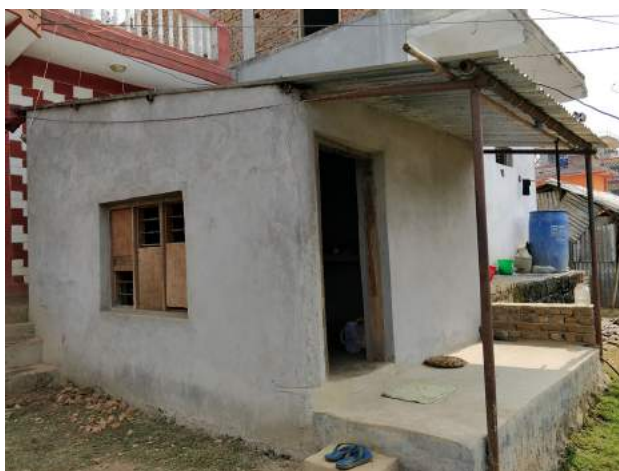
**Location:** Tanahun, Bhanu Municipality, Ward No. 2

**Tranche Status:** received first tranche

**Other:** home owner does not know anything about the process to receive the second tranche of the grant. The house has not yet been inspected by the government engineers.

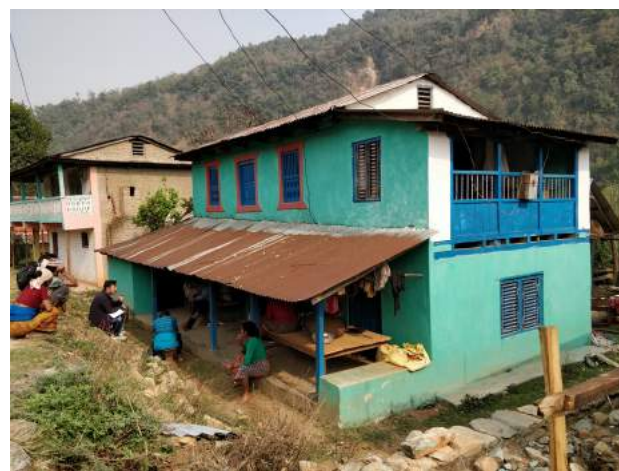
**Location:** Parbat, Modi Rural Municipality, Ward No. 6

**Tranche Status:** unknown, eligible for retrofit grant

**Other:** the house owner has repaired the house but has not been able to retrofit it as the engineers in the district have not received any training on retrofitting and are unable to provide solutions.

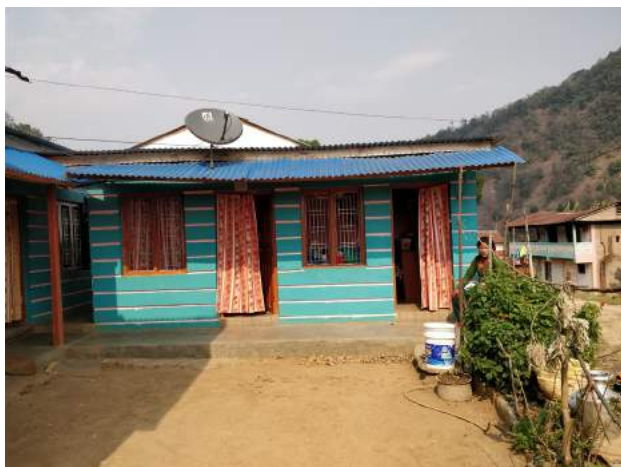
**Location:** Parbat, Modi Rural Municipality, Ward No. 6

**Tranche Status:** received first tranche

**Other:** house is non-compliant and house owner needs to apply corrections to receive the second and third tranches.

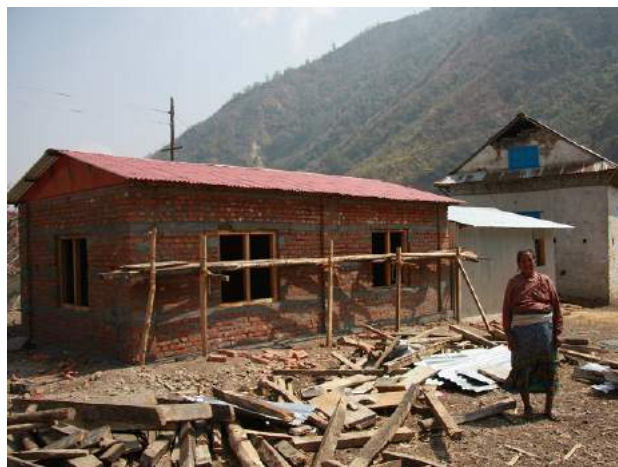
**Location:** Makwanpur, IndraSarowar Rural Municipality, Ward No. 6

**Tranche Status:** approved for third tranche

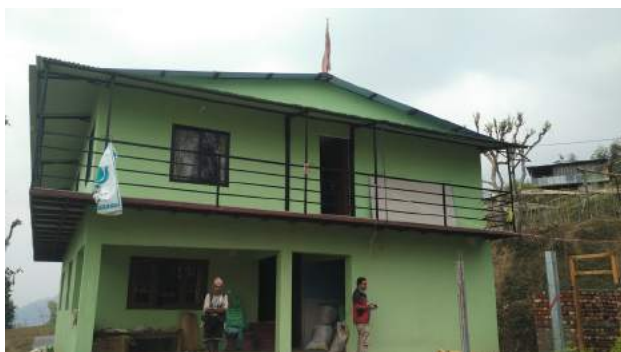
**Location:** Nuwakot, Belkotgadhi Municipality, Ward No. 13

**Tranche Status:** received second tranche

**Other:** non-compliant and not approved for the third tranche as it exceeds the limit of one storey plus attic.

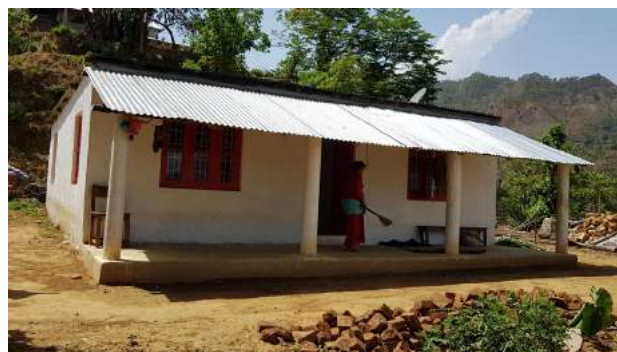
**Location:** Nuwakot, Suryagadhi Municipality, Ward No. 4

**Tranche Status:** received all three tranches

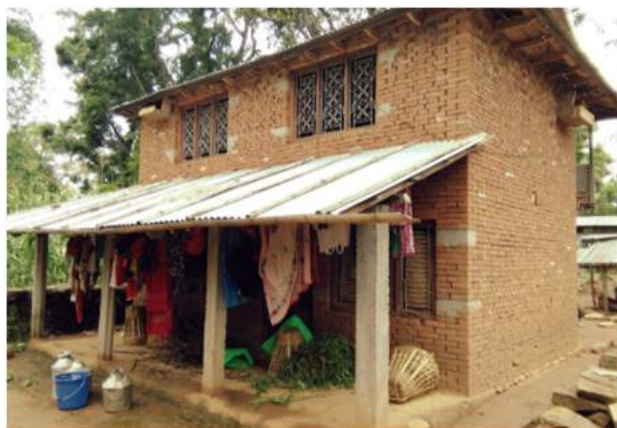
**Location:** Dhading, Salyantar

**Tranche Status:** unknown

**Other:** earthquake resilience elements such as bands are missing and the structure exceeds the building code limit of one storey plus attic.

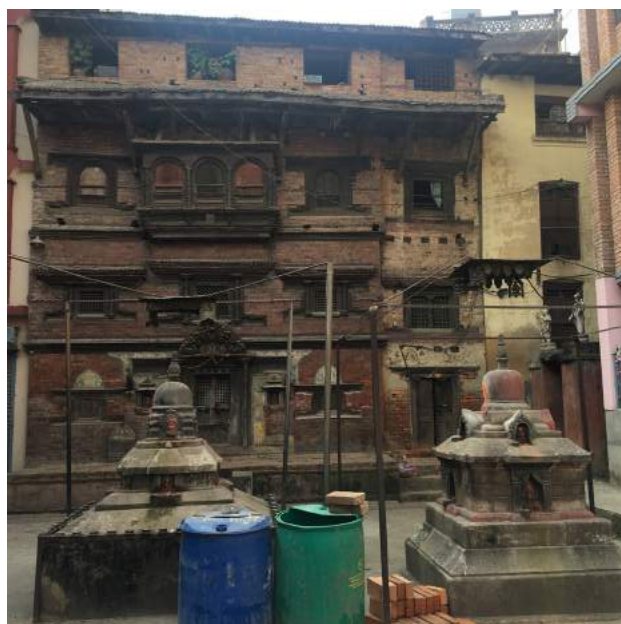
**Location:** Lalitpur, Lalitpur Metropolitan City

**Tranche Status:** unknown

**Other:** traditional brick and mud mortar masonry house, built around a courtyard, near Patan Durbar Square. This house was built pre-earthquake and exceeds the building code limit of one storey plus attic (the building may predate the building code!).

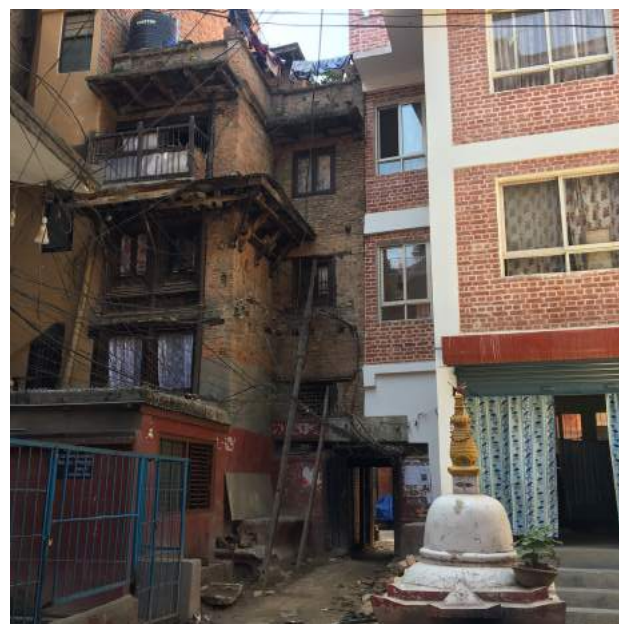
**Location:** Lalitpur, Lalitpur Metropolitan City

**Tranche Status:** unknown

**Other:** traditional brick and mud mortar masonry house struggles for space between two newer buildings near Patan Durbar Square. This house was built pre-earthquake and exceeds the building code limit of one storey plus attic (the building may predate the building code!).

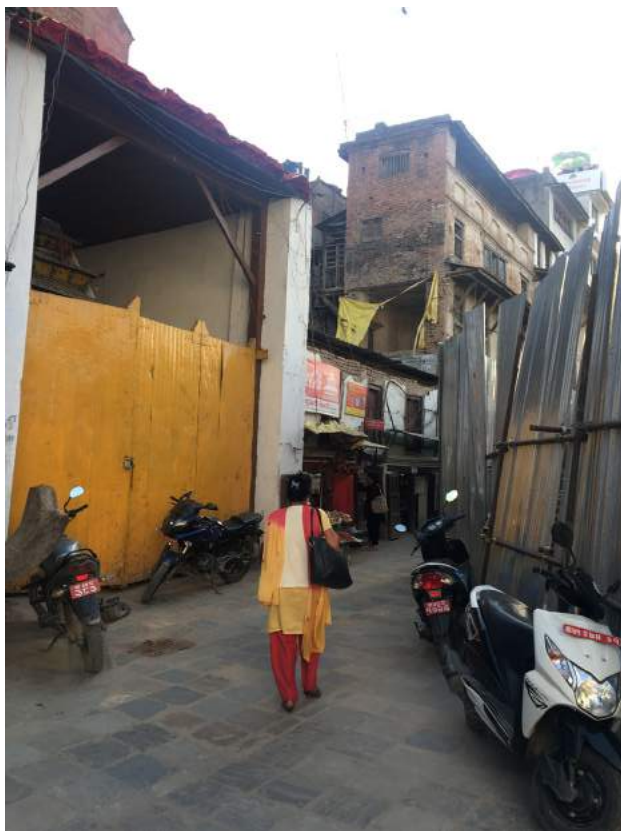
**Location:** Kathmandu, Kathmandu Metropolitan City

**Tranche Status:** unknown

**Other:** brick and mud mortar masonry buildings around the Kathmandu Durbar Square. These buildings were built pre-earthquake and exceed the building code limit of one storey plus attic (the buildings may predate the building code!).

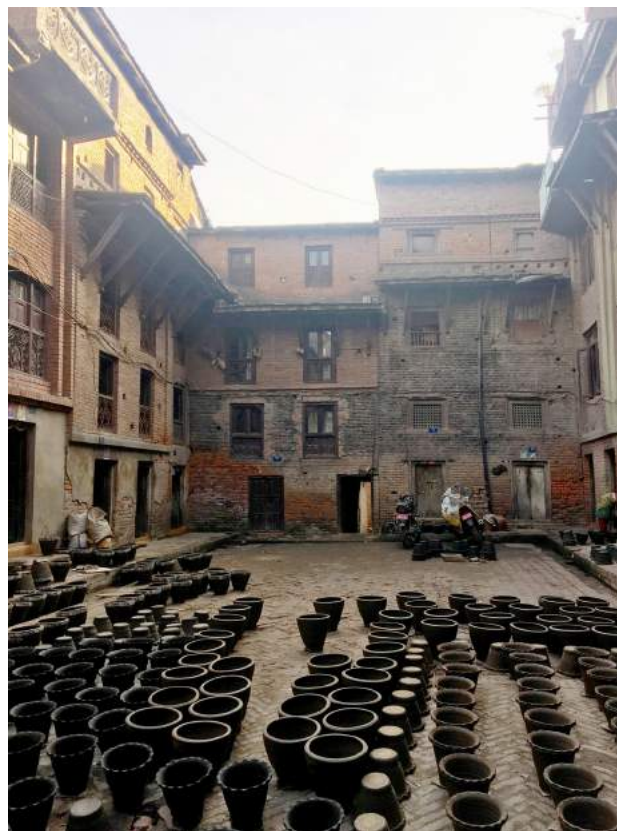
**Location:** Bhaktapur, Madhyapur Thimi Municipality

**Tranche Status:** unknown

**Other:** traditional brick and mud mortar masonry buildings around a courtyard in Thimi. These buildings were built pre-earthquake and exceed the building code limit of one storey plus attic (the buildings may predate the building code!).

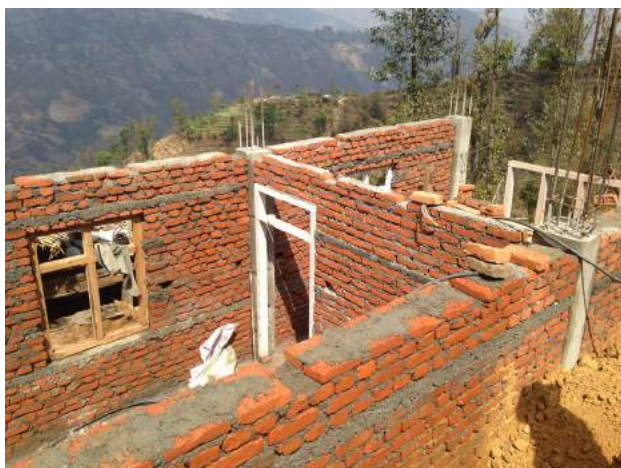
**Location:** Dhading, Thakre Rural Municipality

**Tranche Status:** unknown

**Other:** brick and cement mortar masonry infill used.

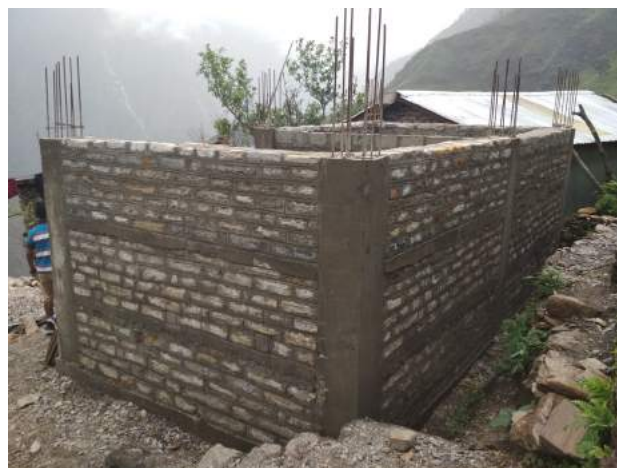
**Location:** Gorkha, Dharche Rural Municipality, Ward No. 2

**Tranche Status:** received first tranche

**Other:** stone and cement mortar masonry with RC bands used for the walls. The house owner has relocated from Kerauja to Lamabesi and has received the land ownership certificate (laal purja).

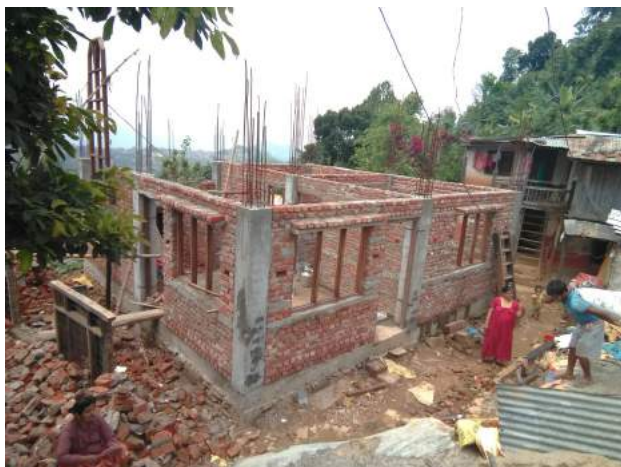
**Location:** Gorkha, Gorkha Municipality, Ward No. 8

**Tranche Status:** received second tranche

**Other:** brick and cement mortar masonry infill used for the walls.

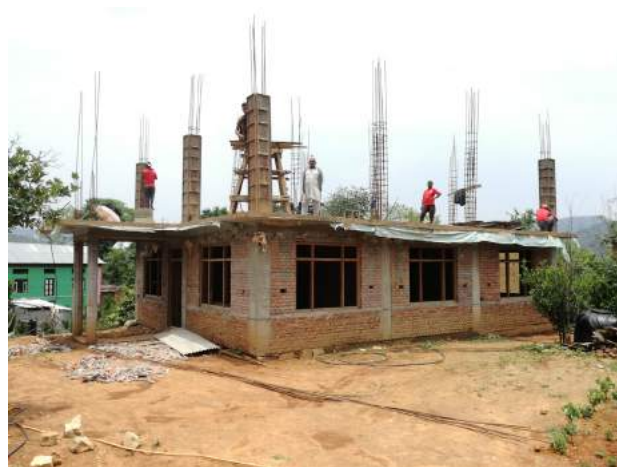
**Location:** Kavrepalanchok, Panauti Municipality, Ward No. 11

**Tranche Status:** unknown

**Other:** the house owner is building this house with a skilled but untrained mason who has been working for more than 15 years. The other workers are all new masons. Some corrections had to be made to the columns before they were poured.

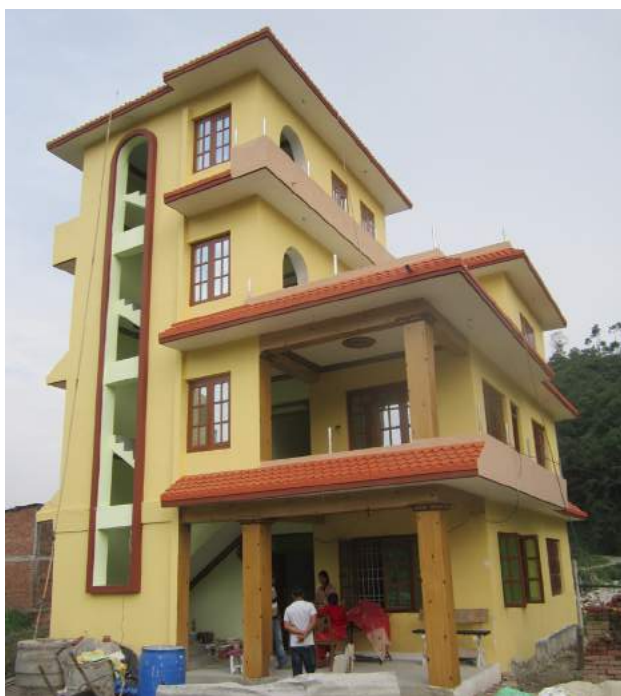
**Location:** Kavrepalanchok, Banepa Municipality, Ward No. 11

**Tranche Status:** received third tranche

**Other:** approved for third tranche following a non-compliance check carried out by the District Support Engineer (DSE) who did a full structural analysis of the house.

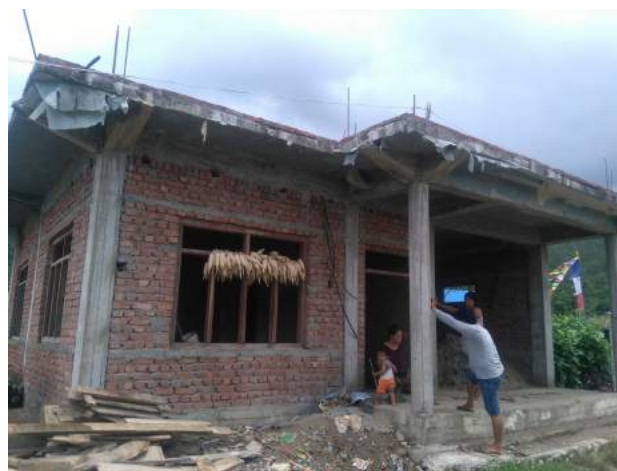
**Location:** Makwanpur, Hetauda Sub-Metropolitan City, Ward No. 3

**Tranche Status:** received first tranche

**Other:** brick and cement mortar masonry infill used for the walls.

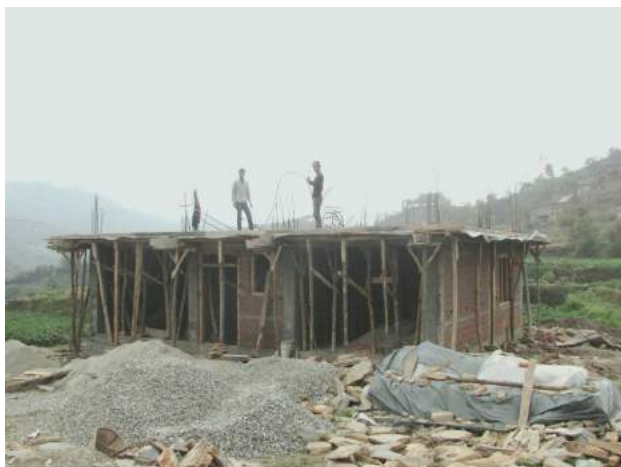
**Location:** Makwanpur, Thaha Municipality, Ward No. 9

**Tranche Status:** received second tranche

**Other:** fully compliant house with 12"x12" columns. The reconstruction grant has been funded by Tearfund and socio-technical assistance has been provided by Lumanti.

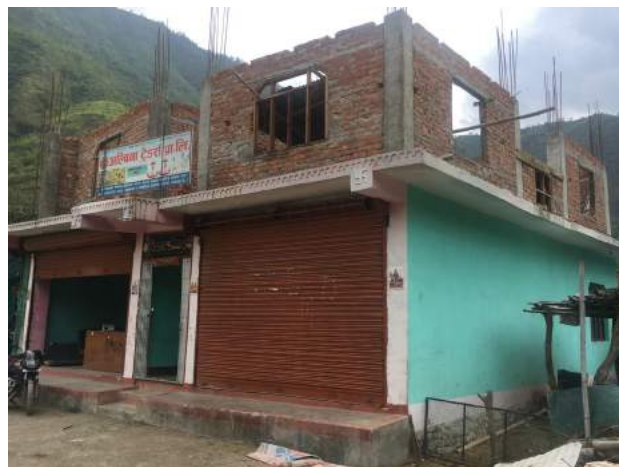
**Location:** Okhaldhunga, Maney Bhanjang Rural Municipality, Ward No. 7

**Tranche Status:** received first tranche

**Other:** the house is non-compliant as it has been constructed with an eccentric footing and improper grid for the columns.

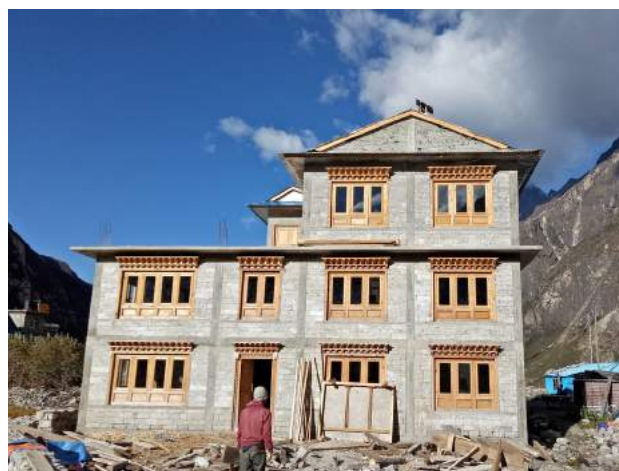
**Location:** Rasuwa, Gosaikunda Rural Municipality, Ward No. 4

**Tranche Status:** received first tranche

**Other:** a three storey, RC frame structure with stone masonry infill walls.

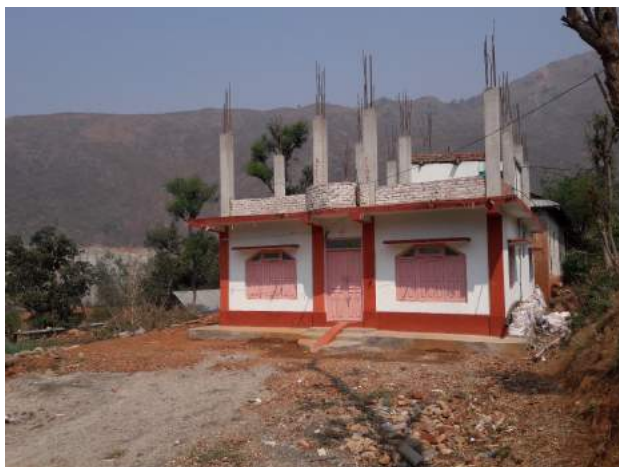
**Location:** Sindhuli, Sunkoshi Rural Municipality, Ward No. 6

**Tranche Status:** received all three tranches

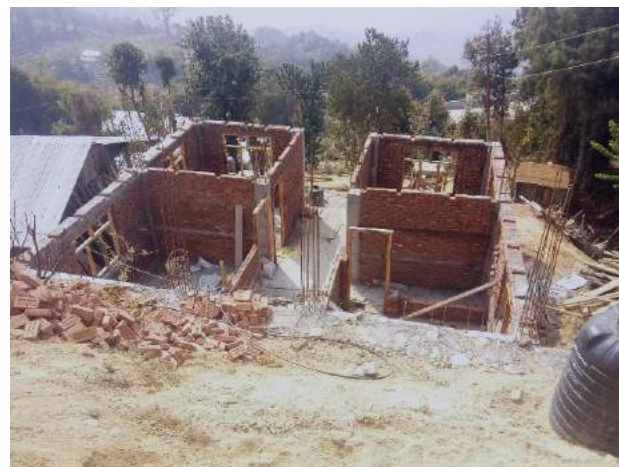
**Location:** Dolakha, Baiteshwor Rural Municipality, Ward No. 6

**Tranche Status:** approved for second tranche

**Other:** a four room RC structure.

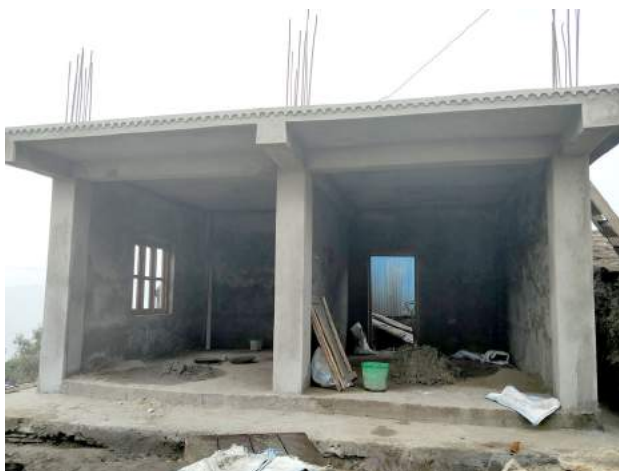
**Location:** Lamjung, Rainas Municipality, Ward No. 5

**Tranche Status:** unknown

**Other:** one bay RC frame structure with 12"x12" columns. The structure has two rooms and has been built to allow for the possible addition of extra storeys in future.

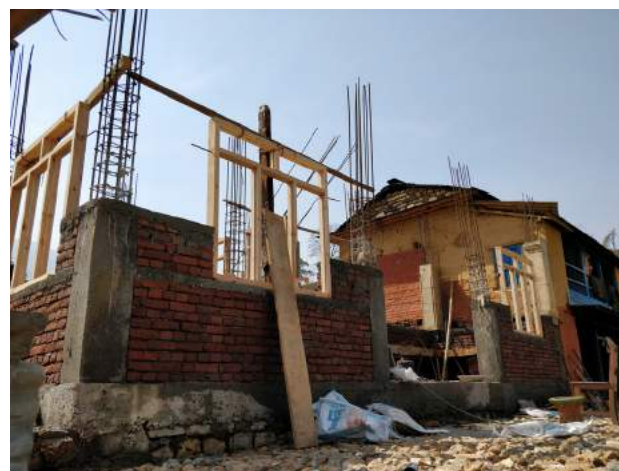
**Location:** Myagdi, Beni Municipality, Ward No. 1

**Tranche Status:** unknown

**Other:** the house owner took a loan from the bank for the construction at 25% interest per annum. They have taken support from the government engineer during construction.

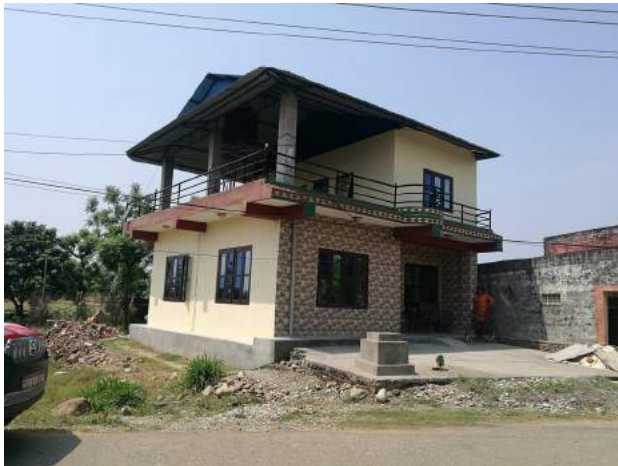
**Location:** Chitwan, Khairahani Municipality, Ward No. 2, Ladari

**Tranche Status:** received all three tranches

**Other:** two storey, two room structure with 12"X12" columns, with potential for extension in future.

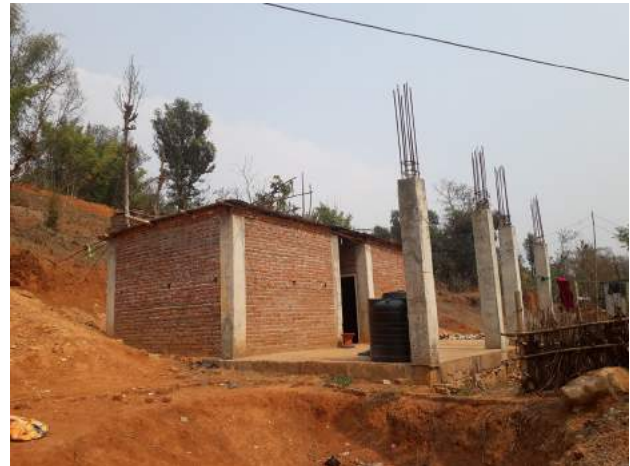
**Location:** Tanahun, Bhanu Municipality, Ward No. 2

**Tranche Status:** unknown

**Other:** due to road right of way conflict and formation of new municipality and the municipal building requirements the house owner is not allowed to construct a rigid floor, so they have used CGI for a temporary roof and have brick infill walls.

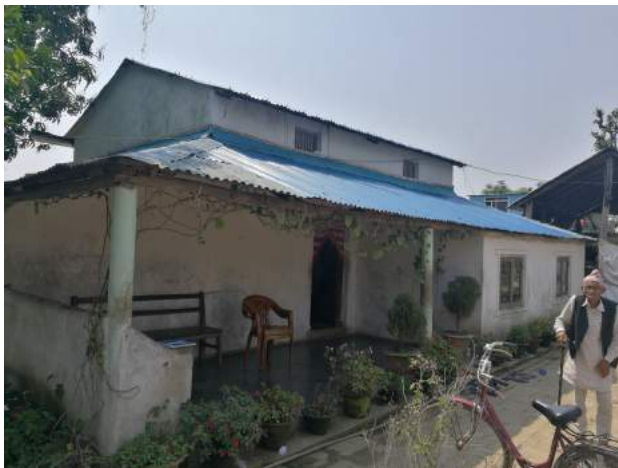
**Location:** Chitwan, Rapti Municipality, Ward No. 8

**Tranche Status:** first tranche received

**Other:** this is what is known locally as a 'one day' house. These houses are constructed using precast RC columns which are placed at the corners, connections, and partitions and then brick and cement mortar masonry is used as infill. The precast columns are installed 2-3 feet under the ground and there are no bands or vertical posts at openings. The houses get their name from the fact that the frame can be erected in just one day. The house has two storeys, with two rooms on each floor. It is reported that at least 30% of houses being reconstructed post-earthquake have used this design. As the houses are non-compliant, the house owners cannot progress beyond the first tranche of the GoN housing reconstruction grant.

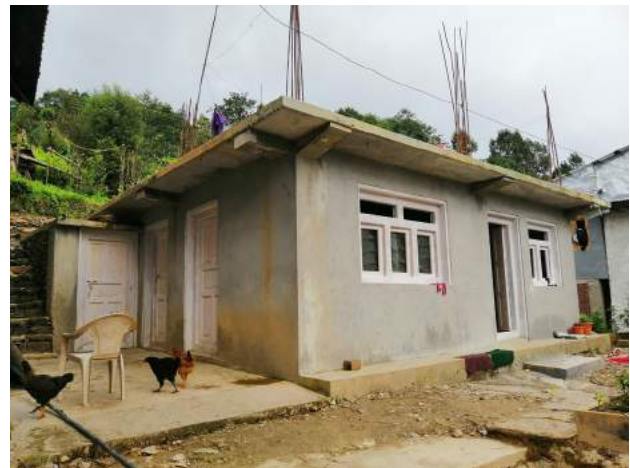
**Location:** Solukhumbu, Solududhakunda Municipality, Ward No. 6

**Tranche Status:** recommended for third tranche

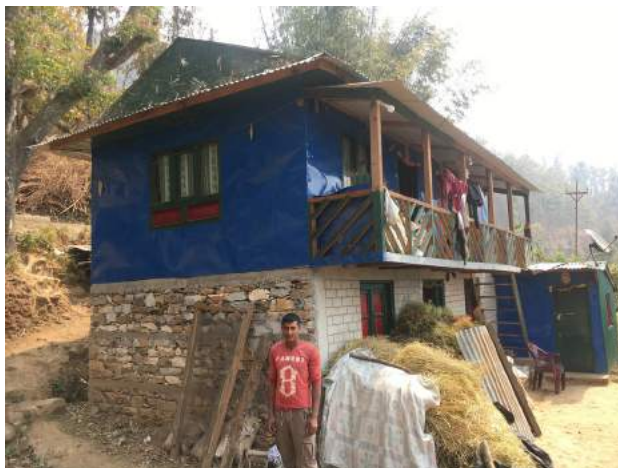
**Location:** Okhaldhunga, Molung Rural Municipality, Ward No. 2

**Tranche Status:** received second tranche

**Other:** the ground floor has been constructed using stone and mud mortar masonry and the first floor is timber frame with CGI sheeting. The house has not been approved for the third tranche as it was found to be non-compliant during inspection.

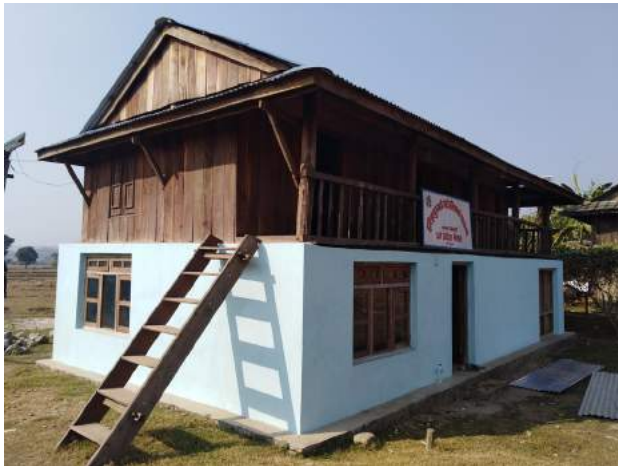
**Location:** Sindhuli, Hariharpurgadhi Rural Municipality, Ward No. 2

**Tranche Status:** approved for third tranche

**Other:** the ground floor has been constructed using brick masonry and the first floor is timber frame.

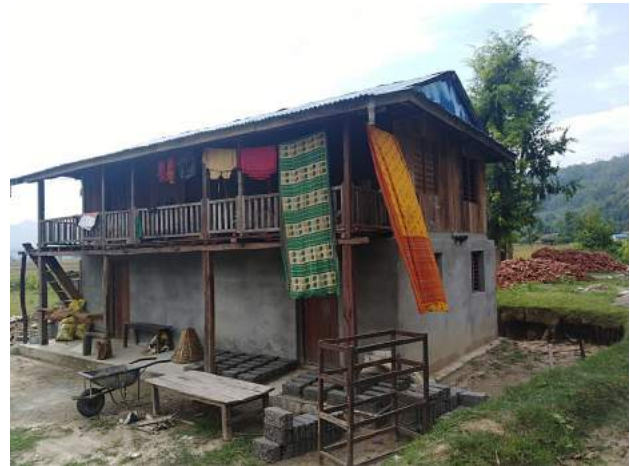
**Location:** Sindhuli, Tinpatan Rural Municipality, Ward No. 3

**Tranche Status:** received second tranche

**Other:** the ground floor has been constructed using brick masonry and the first floor is timber frame. The house has not been approved for the third tranche due to the timber first floor.

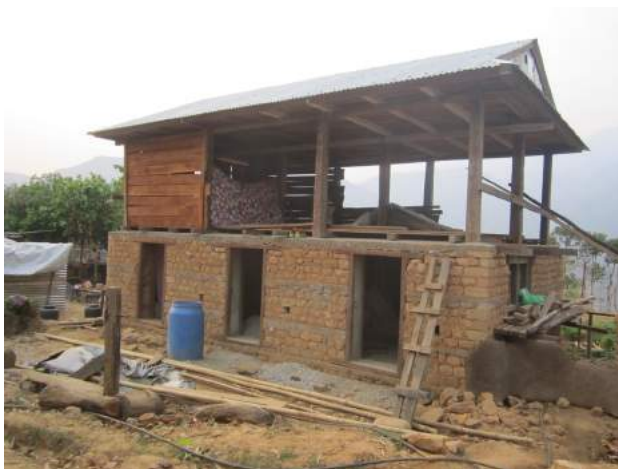
**Location:** Kavrepalanchok, Mahabharat Rural Municipality, Ward No. 8

**Tranche Status:** received second tranche

**Other:** constructed based on local knowledge and traditional building practices. The owner needs to apply some corrections to receive the third tranche.

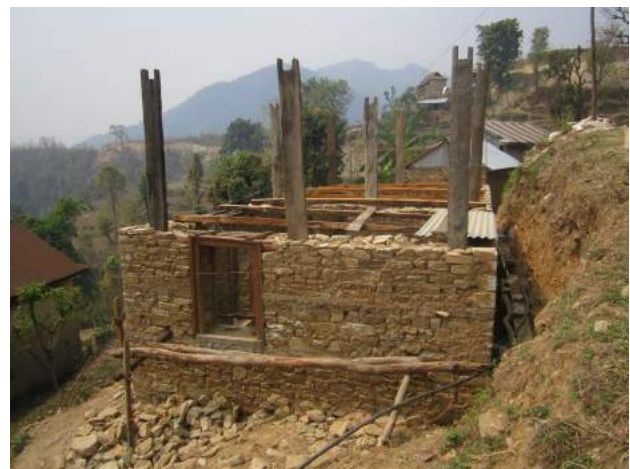
**Location:** Kavrepalanchok, Khanikhola Rural Municipality, Ward No. 6

**Tranche Status:** unknown

**Other:** ground floor is constructed with stone and mud mortar masonry and the first floor will be timber frame. After the release of the NRA's Hybrid Structure Manual, the house owner opted for this design in consultation with the government engineers.

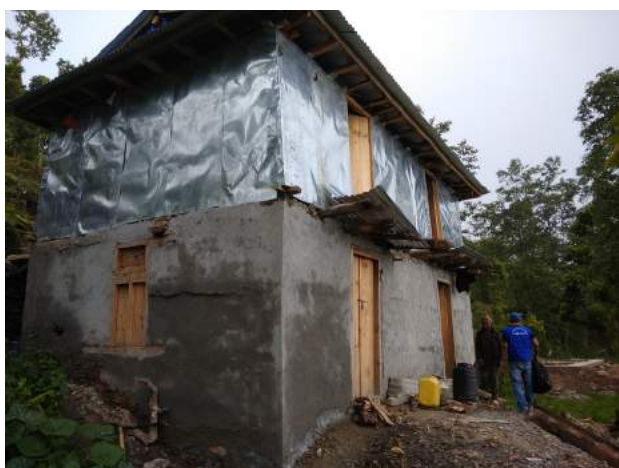
**Location:** Okhaldhunga, Siddhicharan Municipality, Ward No. 2, Nisankhe

**Tranche Status:** received second tranche

**Other:** hybrid structure with stone masonry ground floor and timber and metal sheeting used for the first floor.

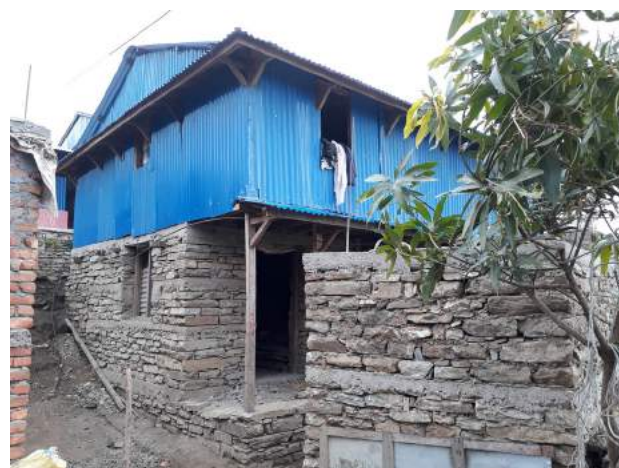
**Location:** Kolki-Rainas Urban Municipality, Ward No. 5, Lamjung

**Tranche Status:** received second tranche

**Other:** ground floor constructed using stone and mud mortar masonry with RC bands, and first floor constructed using CGI and timber. This household was supported by Lutheran World Relief (LWR) / COPPADES up to second tranche, but LWR / COPPADES only had agreement to support up to 200,000 NPRs so the third tranche will come from the Government and there is a risk that the house will be non-compliant.

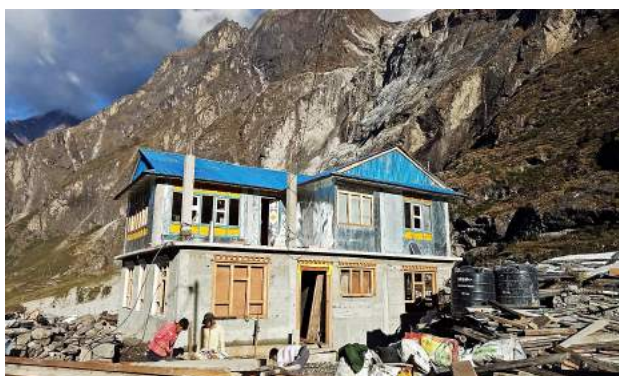
**Location:** Rasuwa, Gosainkunda Rural Municipality, Ward No. 4

**Tranche Status:** received first tranche

**Other:** a hybrid structure with dry stone masonry ground floor and timber frame first floor.

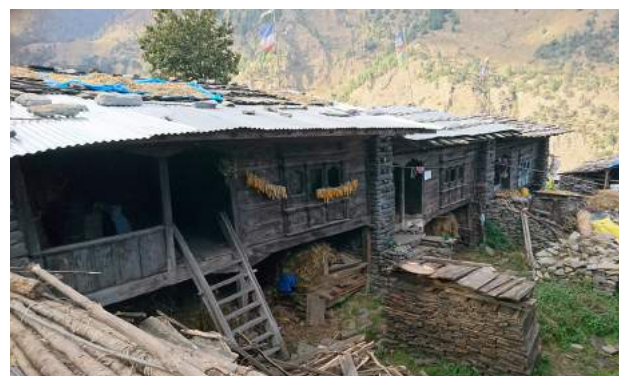
**Location:** Rasuwa, Parbati Kunda Municipality, Gatlang

**Tranche Status:** unknown

**Other:** these traditional structures are two storey and are constructed with three sides from dry stone masonry and the front face is timber frame.

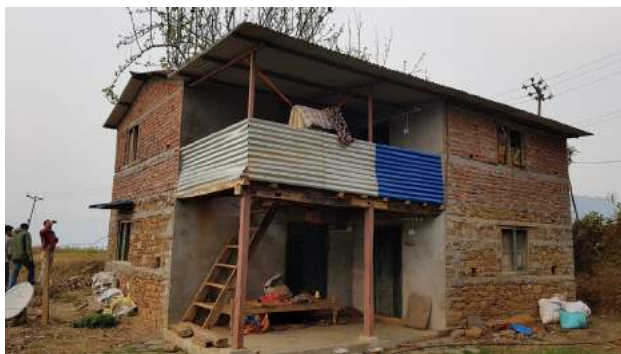
**Location:** Nuwakot, Belkotgadi Municipality, Ward No. 13

**Tranche Status:** first tranche received

**Other:** the house has been found to be non-compliant. The ground floor has been built with stone and mud mortar masonry with RC bands and the first floor is brick and cement mortar masonry with RC bands.

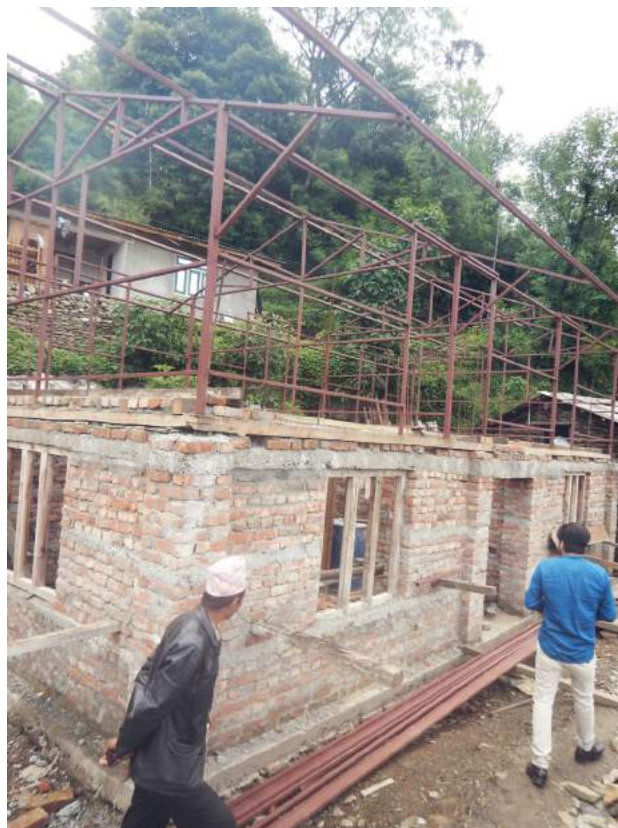
**Location:** Dolakha, Jiri Municipality, Ward No. 6

**Tranche Status:** received second tranche

**Other:** brick and cement mortar masonry with RC bands used for ground floor and steel frame used for first floor.

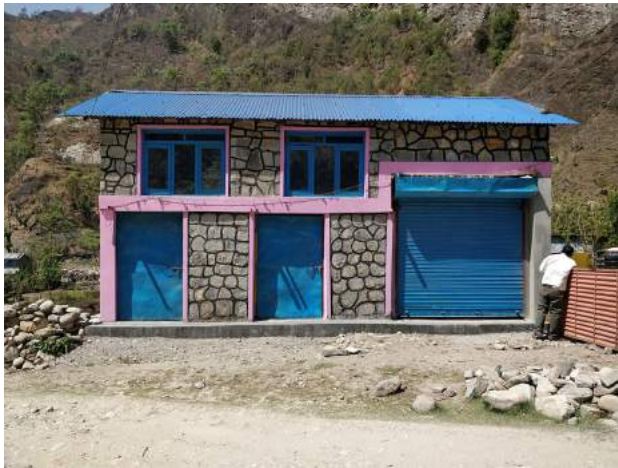
**Location:** Myagdi, Annapurna Rural Municipality, Ward No. 6

**Tranche Status:** received first tranche

**Other:** this steel frame structure uses stone masonry for the infill walls and has a metal floor. The house owner completed construction of the house just 4 months after the 2015 earthquake. The government engineers have found the house to be non-compliant. The total cost of construction was approximately 1,000,000 NPRs and the house owner took a loan of 600,000 NPRs, at 25% annual interest for the construction. The house owner works as a construction and agriculture labourer earning 300 NPRs per day.

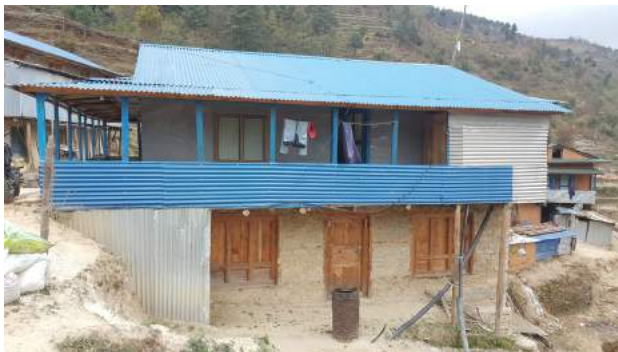
**Location:** Solukhumbu, Solu Dudhkunda Municipality, Ward No. 11, Tignasa

**Tranche Status:** received first tranche

**Other:** constructed with stone and mud mortar masonry on the ground floor and timber frame with CGI sheets for the first floor. RC bands have been provided at plinth level and timber bands have been used at the lintel and sill level. The opening sizes and locations are not appropriate.

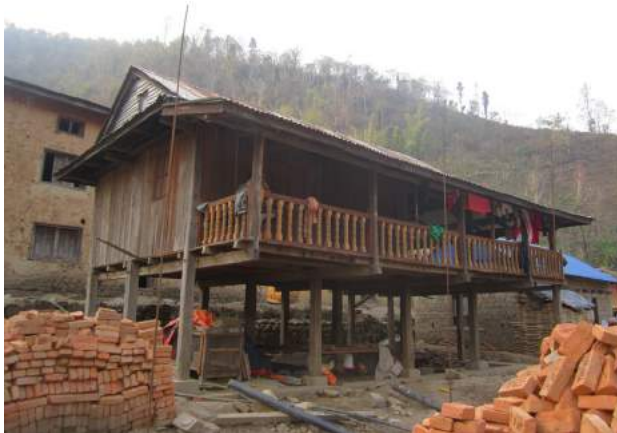
**Location:** Kavrepalanchok, Mahabharat Rural Municipality, Ward No. 8

**Tranche Status:** unknown

**Other:** the house owner chose to construct a timber frame house as timber is readily available in the area. After the release of the NRA's Hybrid Structure Manual, the government engineers suggested that the home owner should use stone masonry as infill on the ground floor, so the house owner is now collecting stones for this.

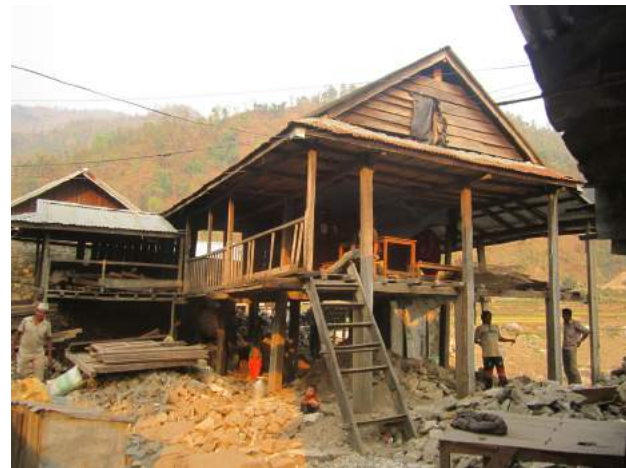
**Location:** Kavrepalanchok, Khanikhola Rural Municipality, Ward No. 5

**Tranche Status:** unknown

**Other:** the house owner chose to rebuild with a timber frame structure as this is how the house was pre-earthquake.

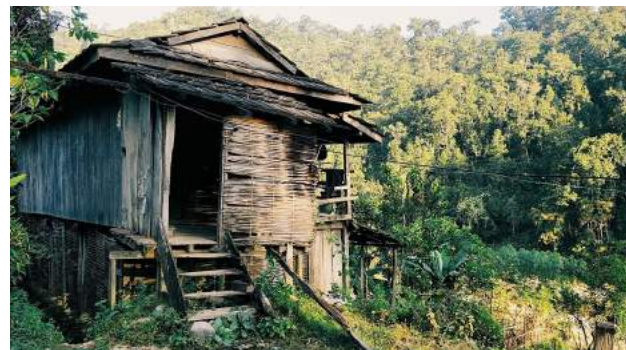
**Location:** Sindhuli, Kamalamai Municipality

**Tranche Status:** unknown

**Other:** timber frame houses are particularly prevalent in Sindhuli. This structure is two storeys.

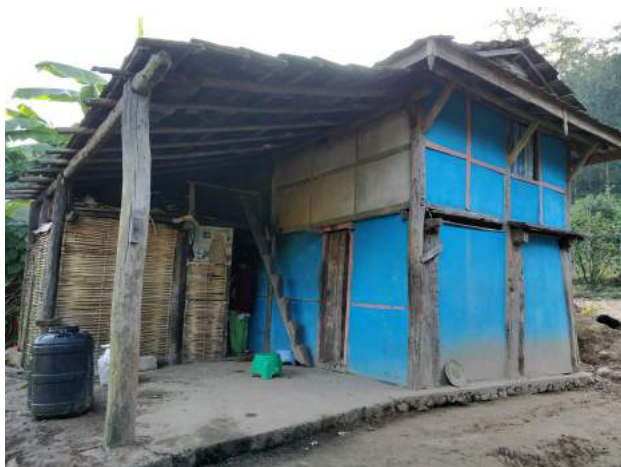
**Location:** Sindhuli, Kamalamai Municipality

**Tranche Status:** unknown

**Other:** timber frame houses are particularly prevalent in Sindhuli. This structure is two storeys.

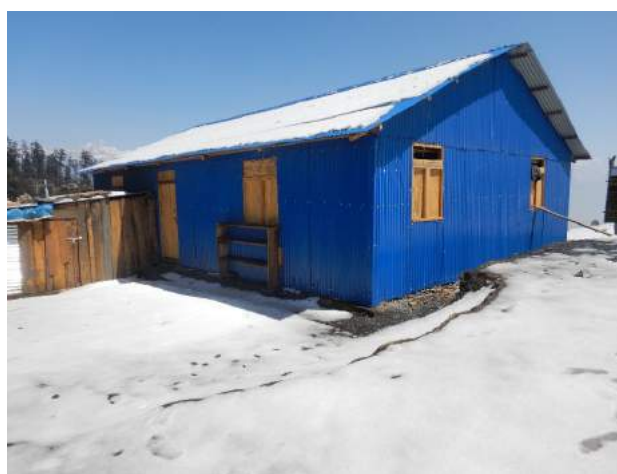
**Location:** Dolakha, Kalinchowk Rural Municipality, Ward No. 1

**Tranche Status:** received all three tranches

**Other:** one storey, timber structure with light weight CGI sheeting as roof and wall covering. The CGI sheets have been used to cover the timber frame and protect the timber from rain.

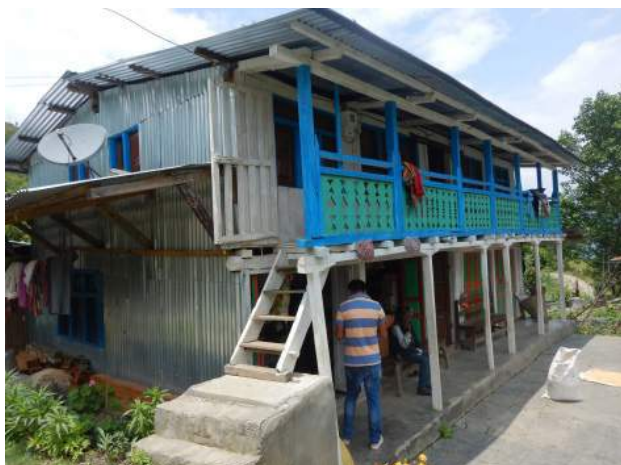
**Location:** Dolakha, Kalinchowk Rural Municipality, Ward No. 1

**Tranche Status:** received first tranche

**Other:** two storey timber structure with dry stone foundation

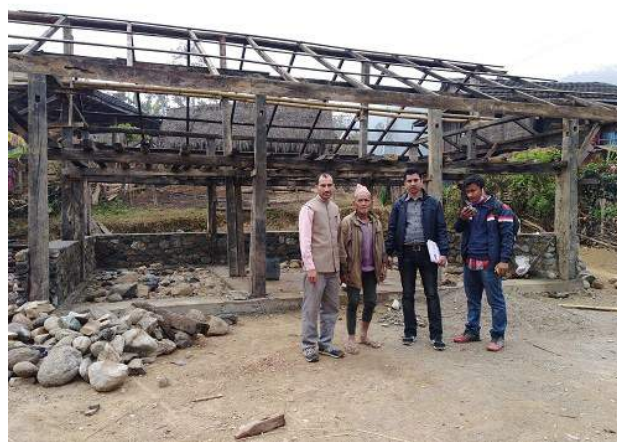
**Location:** Sindhuli, Tinpatan Rural Municipality, Belghari, Ward No. 1

**Tranche Status:** unknown

**Other:** the foundation has been completed and the house owner is waiting for design drawings for the timber structure.

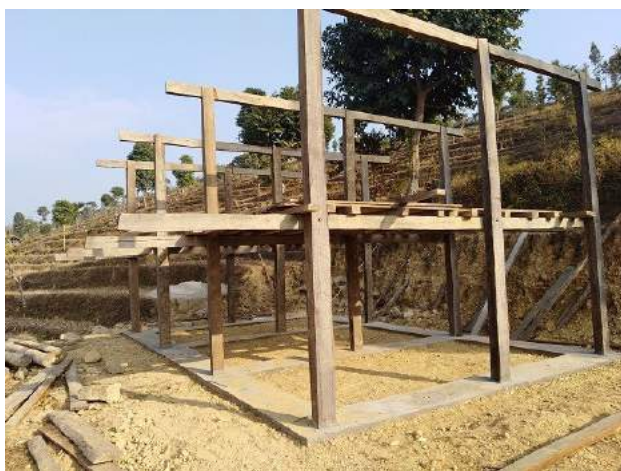
**Location:** Sindhuli, Hariharpurgadhi Rural Municipality, Ward No. 1

**Tranche Status:** received first tranche

**Other:** the foundation has been completed and the house owner is awaiting inspection for second tranche

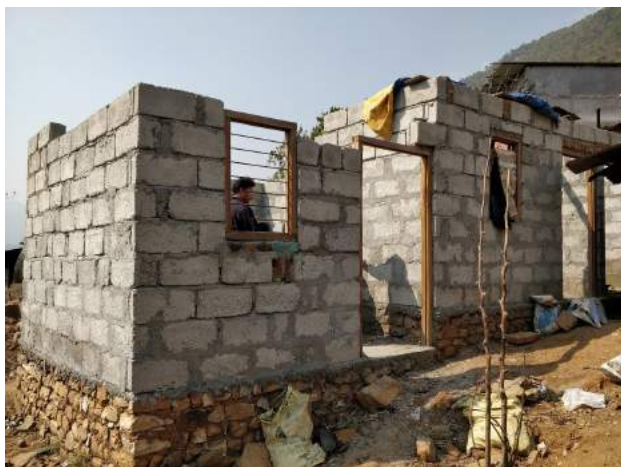
**Location:** Kaski, Lekhnath Municipality, Pokhara

**Tranche Status:** unknown

**Other:** one of more than 600 houses that have been constructed using hollow concrete blocks in this area. House owners regularly ask the government engineers for designs for HCB houses. The engineers have been providing the designs from the DUDBC Design Catalogue Volume 2, but households are not building according to these.
