Housing Recovery and  
Reconstruction Platform

# Housing Typologies: Earthquake Affected Districts

September 2018

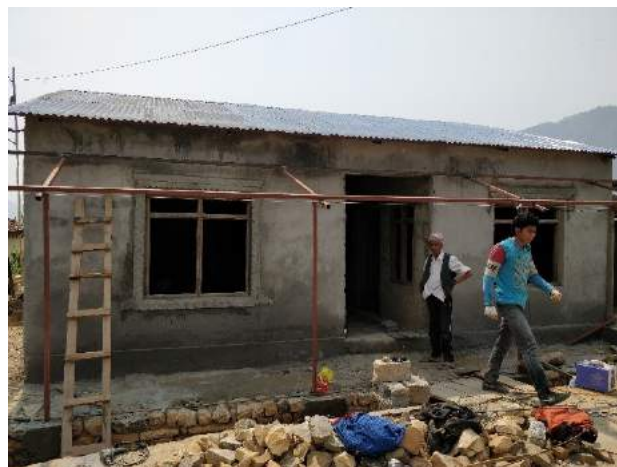
**Location:** Parbat, Modi Rural Municipality, Ward No. 6

**Tranche Status:** first tranche received

**Other:** the house owner started construction of his 5 room house, with a steel frame structure and hollow concrete blocks for the infill walls, just 1 month after the 2015 earthquake. He is still going through the grievance mechanism and he didn't know that this house would not be in line with government standards as there was no guidance available previously and the inspection engineers were not deployed until December 2017.

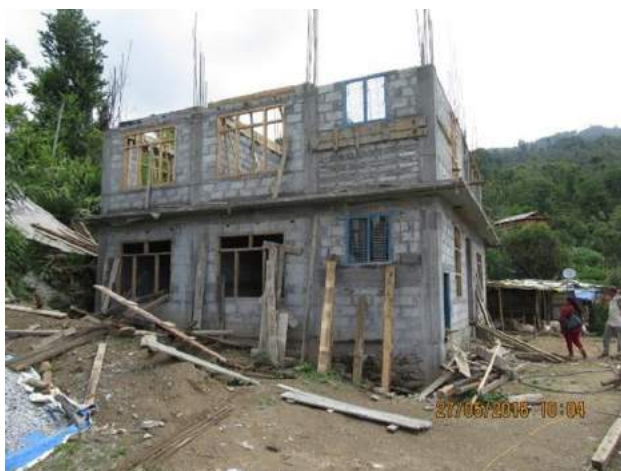
**Location:** Dolakha

**Tranche Status:** unknown

**Other:** RC frame building with HCB infill.

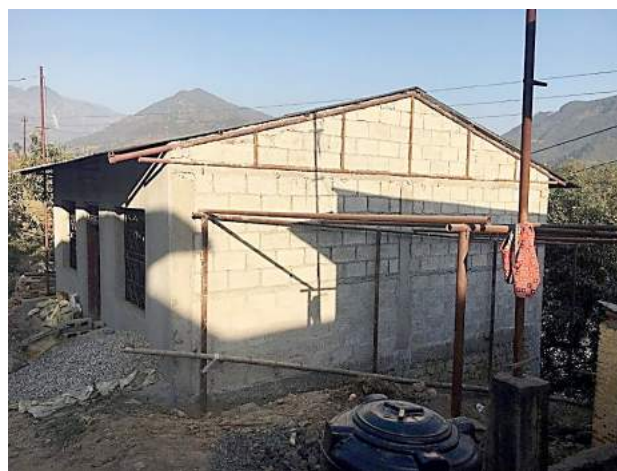
**Location:** Nuwakot

**Tranche Status:** unknown

**Other:** HCB house with steel truss for roof.

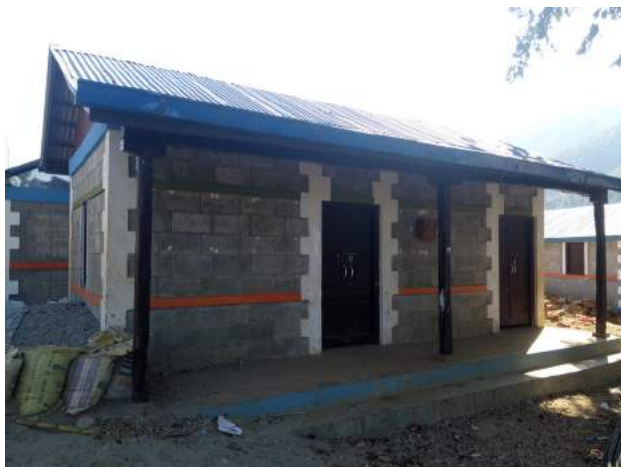
**Location:** Sindhupalchowk, Bhimtar

**Tranche Status:** N/A (constructed by World Vision)

**Other:** one storey, two room house constructed by World Vision.

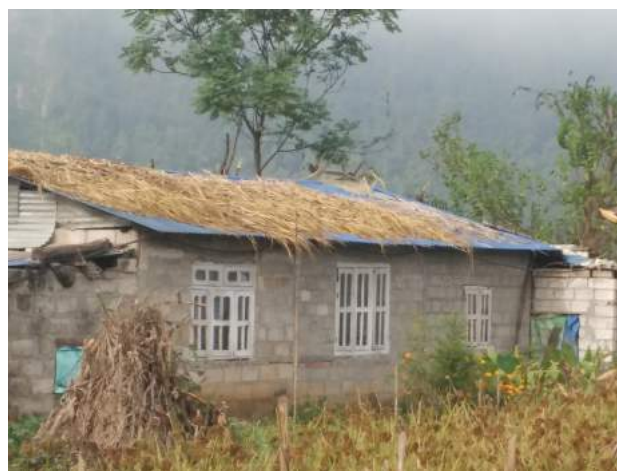
**Location:** Nuwakot, Bidur Municipality, Battar, Ward No. 4

**Tranche Status:** received all three tranches

**Other:** house owner chose to construct with HCBs because they felt they were cheaper, more easily available, and provided better protection from the cold. The house owner had not received any technical assistance but the mason that worked on the construction had worked with HCBs previously.

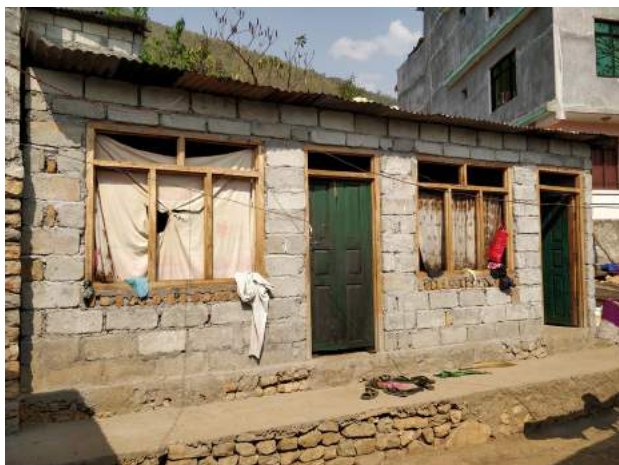
**Location:** Parbat, Kusma Municipality, Ward No. 4

**Tranche Status:** received first tranche

**Other:** this house is non-compliant as it does not meet the requirements published in the two HCB type designs in the second volume of the DUDBC design catalogue. The government engineers are unable to provide solutions for corrections for non-compliant HCB houses.

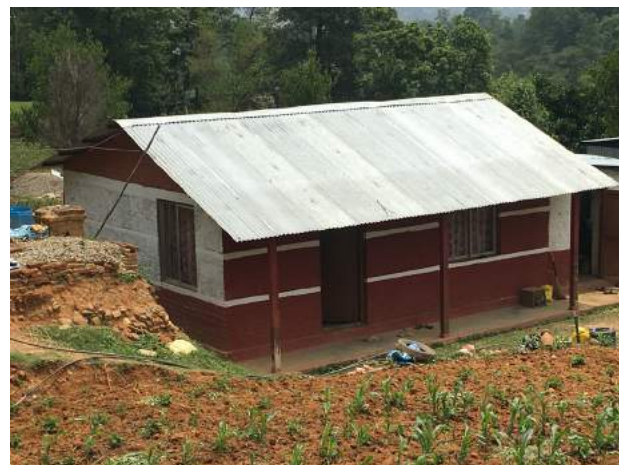
**Location:** Lalitpur, Godawari Municipality, Goretar, Ward No. 10

**Tranche Status:** received first tranche

**Other:** this house was constructed by Shangri-La Orphanage Home (household should not have received first tranche in addition to house directly constructed by Shangri-La Orphanage Home).

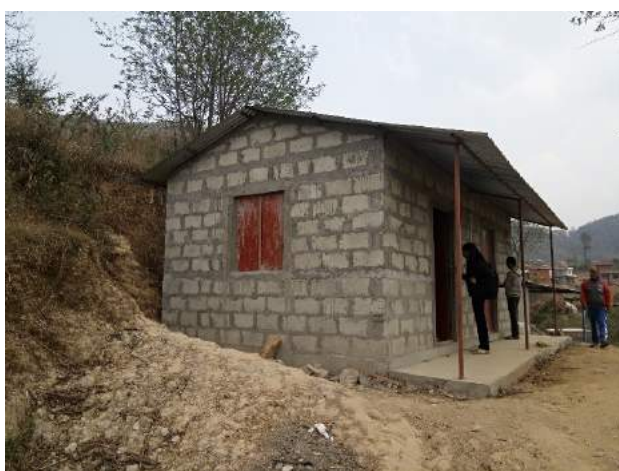
**Location:** Lalitpur, Godawari Municipality, Lele, Tikabhairab, Ward No. 6

**Tranche Status:** unknown

**Other:** this house was supported by Batas Foundation. The house was found to be non-compliant during inspection as the gable band is missing and the sill and lintel bands are placed at a distance of just 3 feet.

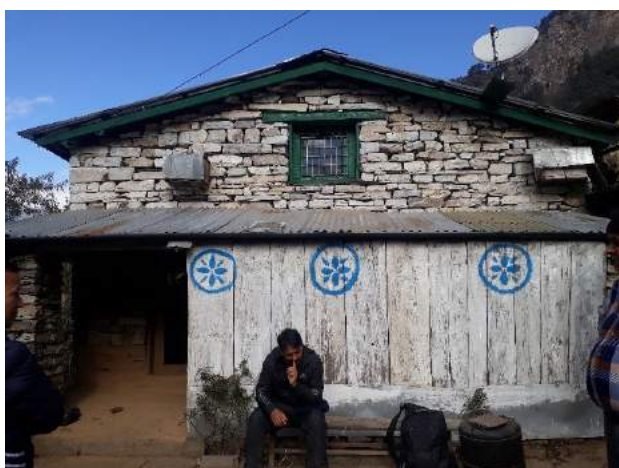
**Location:** Gorkha, Kerauja, Dharche Rural Municipality, Ward No. 2

**Tranche Status:** first tranche recieved

**Other:** two storey house which has been found to be non-compliant. Correction measures are very difficult to apply so it is challenging for the house owner to progress through the reconstruction process. People construct two storey houses in this area as they need the space for their living requirements.

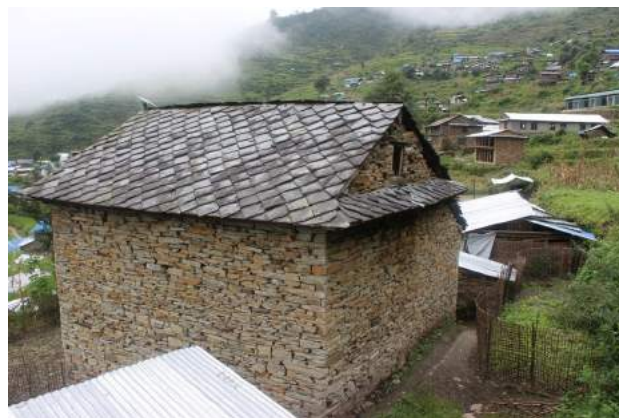
**Location:** Dhading, Tipling

**Tranche Status:** unknown

**Other:** dry stone masonry house with no earthquake resistant elements.

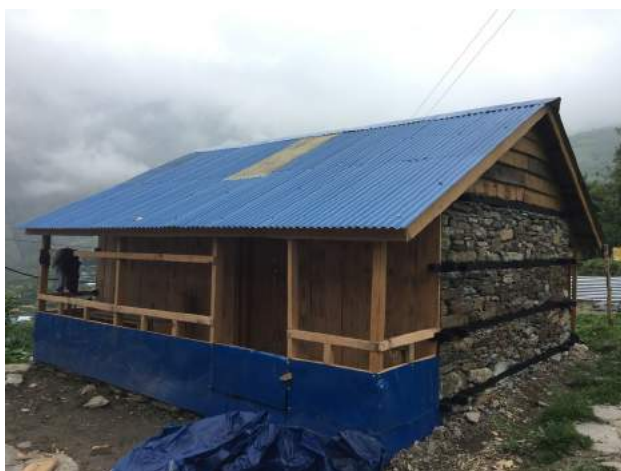
**Location:** Dhading, Rubee Valley, Ward No. 1

**Tranche Status:** received second tranche

**Other:** one storey, one room house with all required earthquake resistant elements, including horizontal and vertical banding and double framed openings.

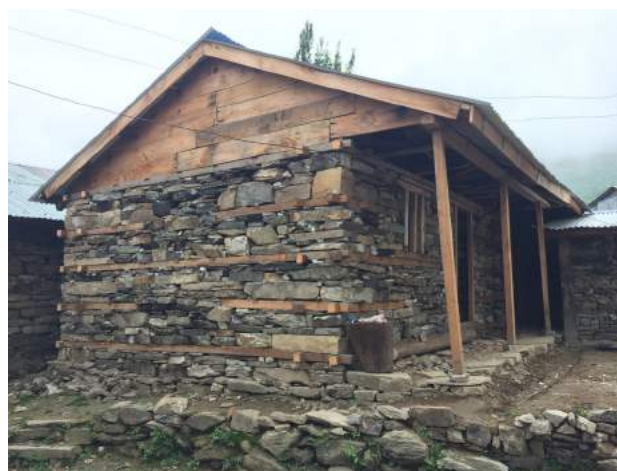
**Location:** Dhading, Rubee Valley, Ward No. 1

**Tranche Status:** received second tranche

**Other:** one storey, one room house with all required earthquake resistant elements, including horizontal and vertical banding and double framed openings.

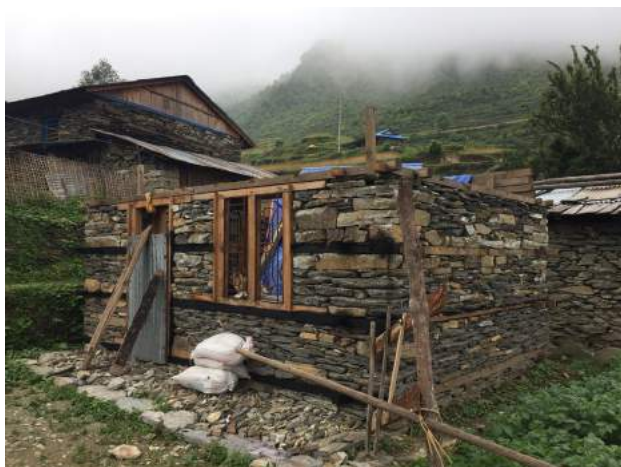
**Location:** Dhading, Rubee Valley, Ward No. 1

**Tranche Status:** received first tranche

**Other:** one storey, one room house with all required earthquake resistant elements, including horizontal and vertical banding and double framed openings.

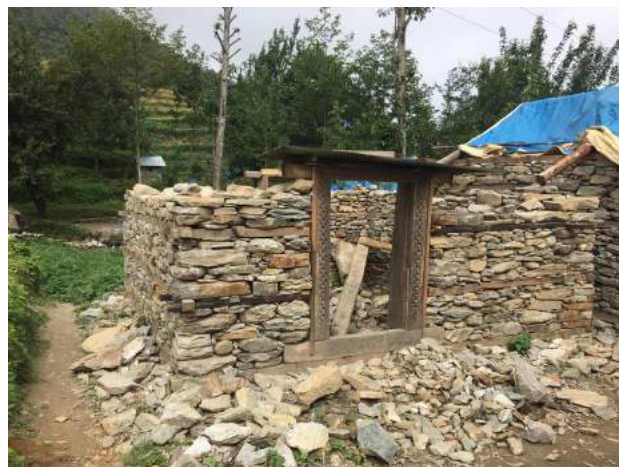
**Location:** Dhading, Rubee Valley, Ward No. 1

**Tranche Status:** received second tranche

**Other:** one storey, one room house with all required earthquake resistant elements, including horizontal and vertical banding and double framed openings.

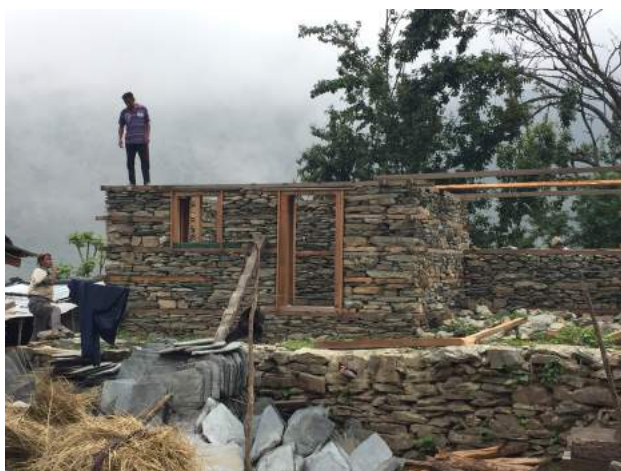
**Location:** Dhading, Rubee Valley, Ward No. 1

**Tranche Status:** received first tranche

**Other:** one storey, one room house with all required earthquake resistant elements, including horizontal and vertical banding and double framed openings.

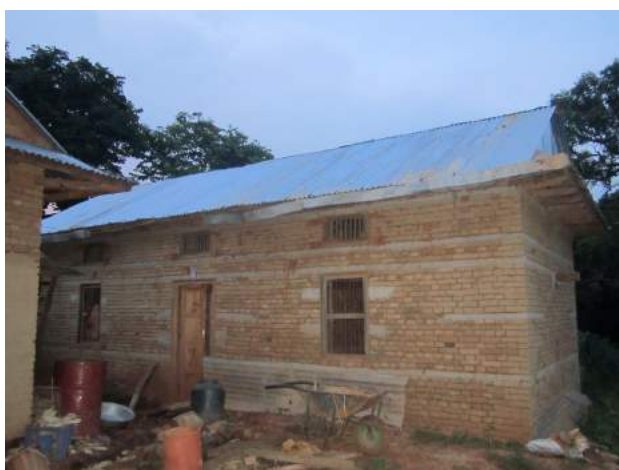
**Location:** Kavrepalanchok, Panchkhal Municipality

**Tranche Status:** unknown

**Other:** this house was assessed by HRRP technical staff as part of the support to the NRA for the development of an inspection checklist for houses constructed with sun-dried adobe bricks. The house includes all required earthquake resistant elements and the house owner has also received a municipal permit for the design.

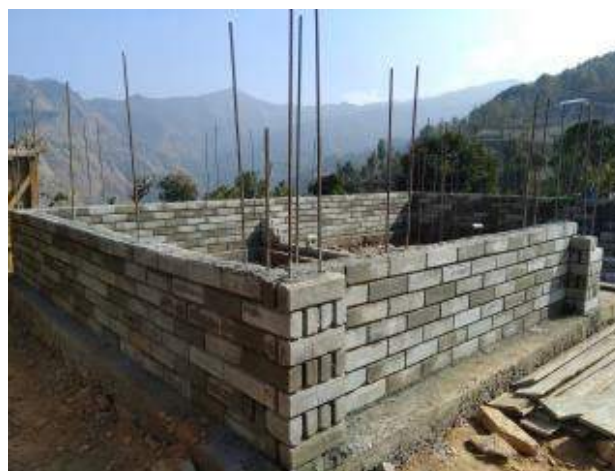
**Location:** Ramechhap, Sunapati Rural Municipality, Hiledevi, Ward No. 3

**Tranche Status:** received first tranche, not approved for second tranche as they missed the July deadline for tranche disbursement

**Other:** two-room house under construction. The CSEB blocks are produced by a company that is providing free transportation of blocks within a 10km radius. The producer estimates that a two-room house can be constructed for 650,000 NPRs.

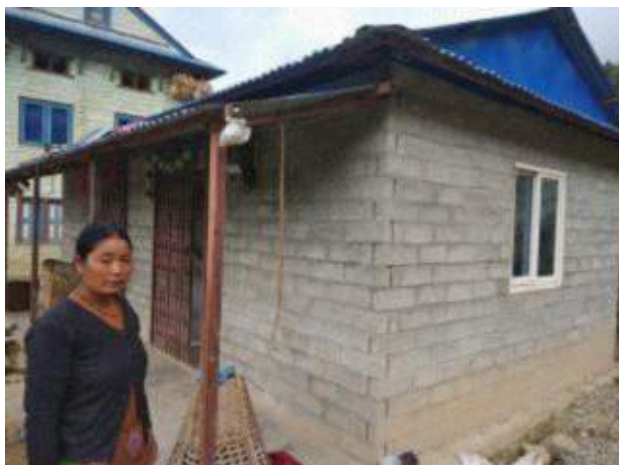
**Location:** Ramechhap, Sunapati Rural Municipality, Dimipokhari, Ward No. 2

**Tranche Status:** received second tranche

**Other:** two room house that cost 500,000 NPRs to construct.

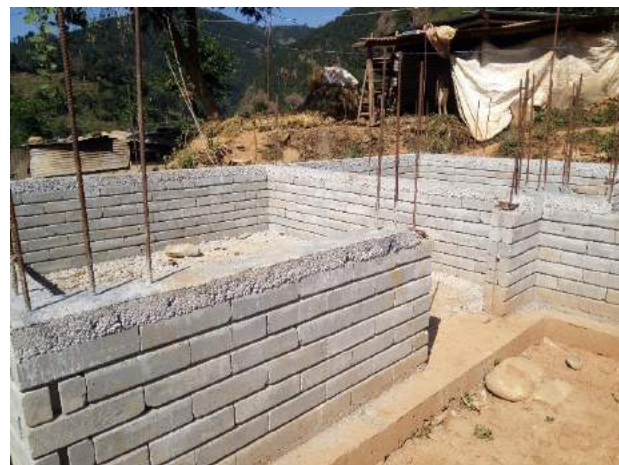
**Location:** Sindhupalchok, Majhi Basti, Bhimtar, Indrawati Rural Municipality

**Tranche Status:** unknown

**Other:** house constructed by Sweta Shree Foundation.

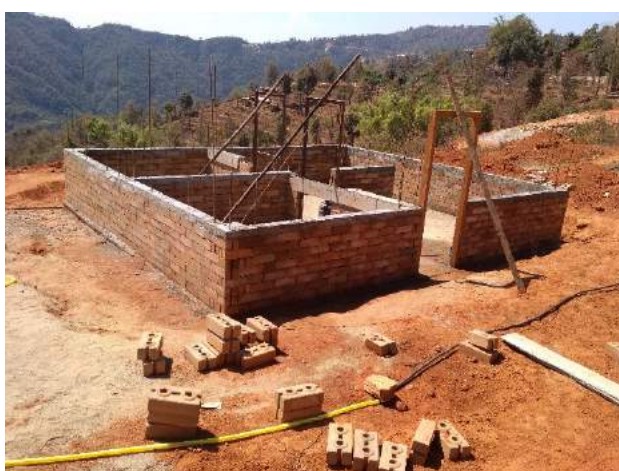
**Location:** Nuwakot, Bhimsen Rural Municipality, Ward no.5

**Tranche Status:** N/A, house directly constructed by OXFAM

**Other:** constructed in an integrated settlement in Baguwa.

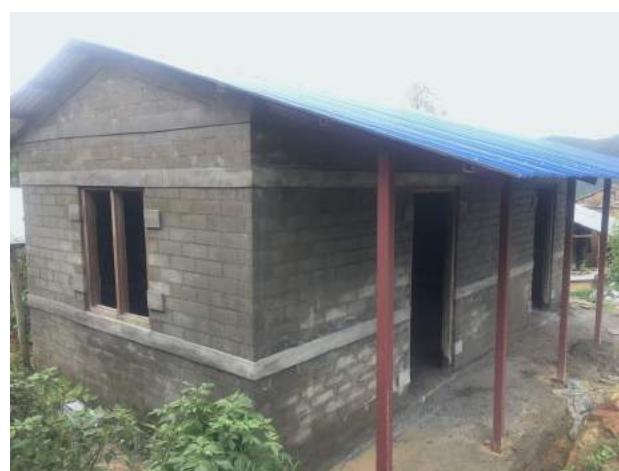
**Location:** Lalitpur, Godawari Municipality, Ward No. 6

**Tranche Status:** received first tranche

**Other:** two room house built by Samaritan's Purse with technical support from Build Up Nepal (household should not have received first tranche in addition to house directly constructed by Samaritan's Purse).

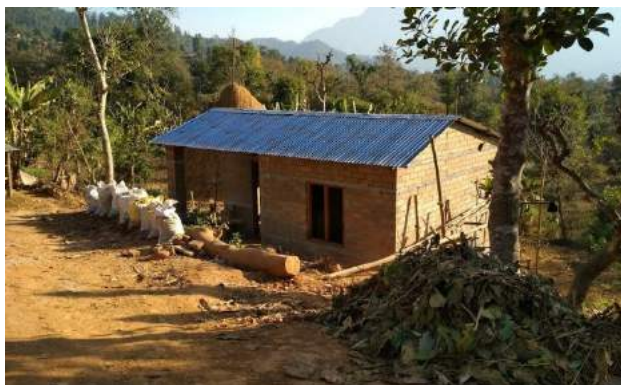
**Location:** Gorkha, Palungtar Municipality, Ward No. 8

**Tranche Status:** unknown

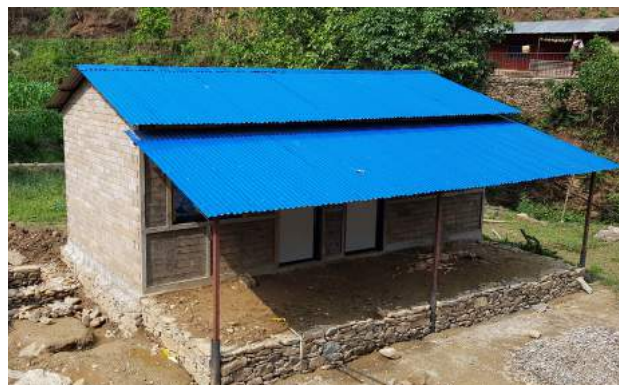
**Location:** Nuwakot, Bidur Municipality, Ward No. 6

**Tranche Status:** approved for third tranche

**Other:** supported by ICIMOD

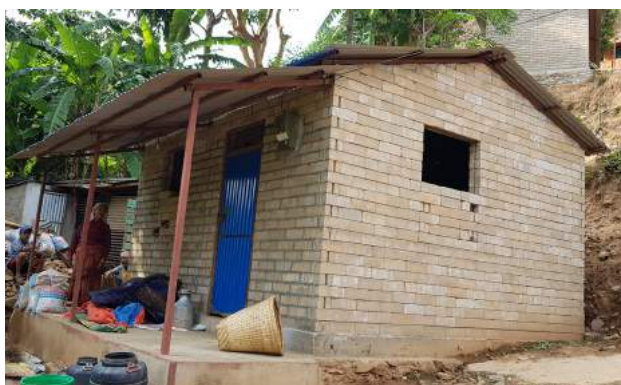
**Location:** Nuwakot, Bidur Municipality, Ward No. 6

**Tranche Status:** approved for third tranche

**Other:** supported by ICIMOD

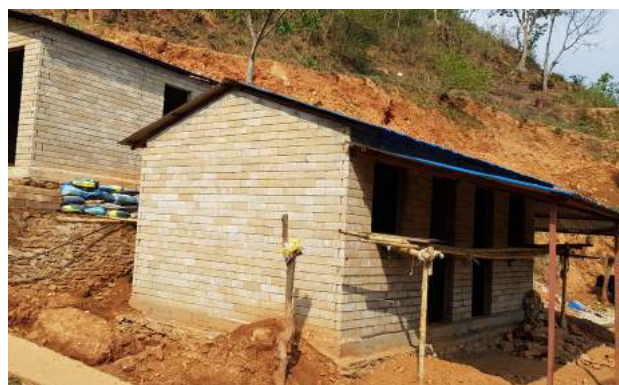
**Location:** Nuwakot, Bidur Municipality, Ward No. 6

**Tranche Status:** approved for third tranche

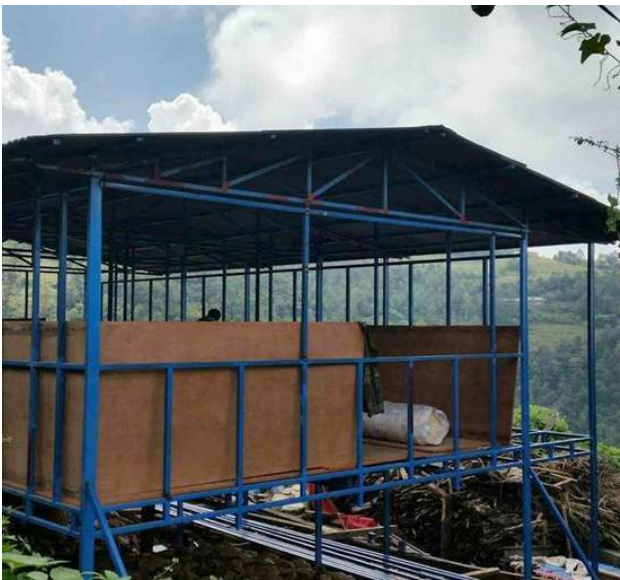
**Location:** Okhaldunga, Sidhhicharan Municipality

**Tranche Status:** unknown

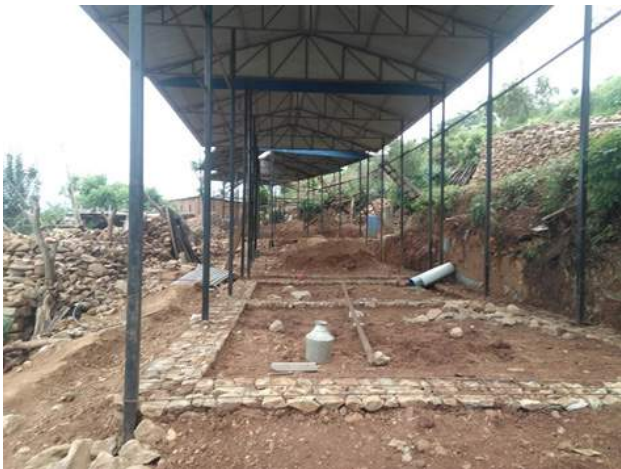
**Location:** Sindhuli, Kamalamai Muni Municipality

**Tranche Status:** unknown
