## District Report

### Rasuwa

4 - 17 January 2019

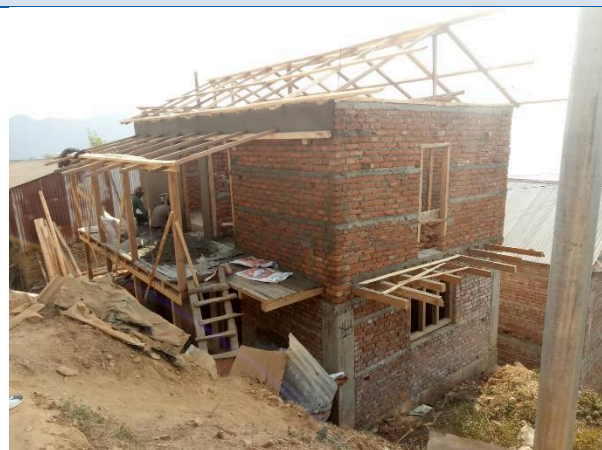
Caption: **Ward NO.5, Kalika RM, Rasuwa**  
**Name of Beneficiary:** Netra Prasad Poudel  
**Tranche Update:** Third Tranche Received

The home owner has already received the third tranche of the GoN housing grant and then built the first floor after receiving the third tranche. In order to receive the third tranche, the house had to be analyzed by the District Support Engineer (DSE) as the columns in the ground floor are 9"x12" which does not meet the required standards. Altogether there are 6 columns in the house and the walls are 9". The DSE recommended use of light CGI roofing, and construction of an interior partition wall, as the room sizes also did not meet the required standards. After completion of the structure up to the roof band the house was approved for the third tranche. After receiving the third tranche the owner constructed the two room, 4" masonry wall system structure as the first floor, and now the whole structure is more vulnerable. The distribution of construction completion certificates has begun in this area, but the home owner will not be able to receive the certificate without making significant corrections to the structure.

| Modification of structure after receiving the third tranche. | Structure analysis of the building /significant correction measures. | DSE/DLPIU Building | ASAP |

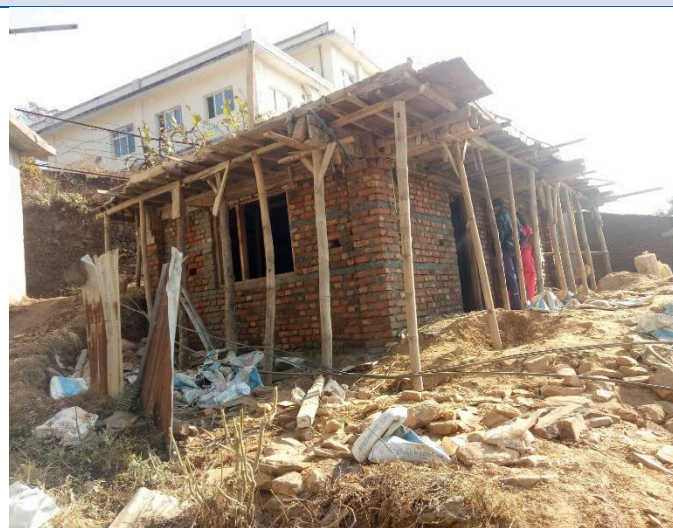
Caption: **Ward NO.5, Kalika RM, Rasuwa**  
**Name of Beneficiary:** Bhawanath Poudel  
**Tranche Update:** Second Received

**Housing Typology:** Load bearing Brick Masonary in cement mortar house with 9" wall consisting of 14" Copla and rigid slab roofing resting in beam.

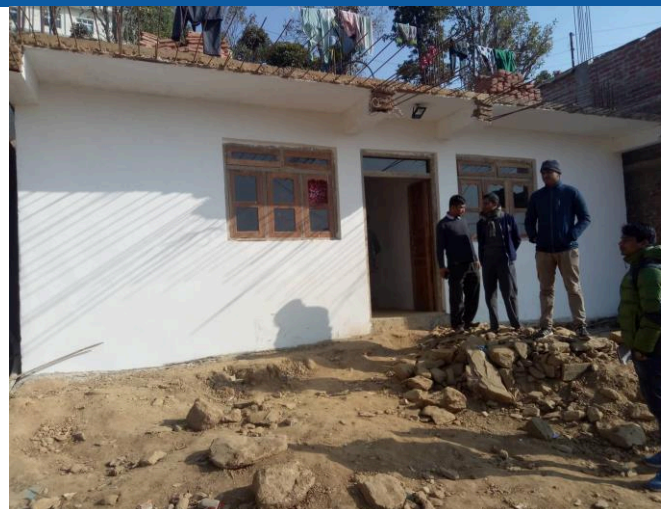
**Caption** Ward NO.5, Kalika RM, Rasuwa  
**Name of Beneficiary:** Ram Prasad Poudel  
**Tranche:** Received Third tranche  
**Housing Typology:** RCC four rooms structure with passage in between. The structure consists of all the bands at different levels. There are 15 columns (12"x 12") in the structure, each column consists of 8 rebars of which 4 nos. @12mm and 4 nos. @16mm. The construction of the house is completed.

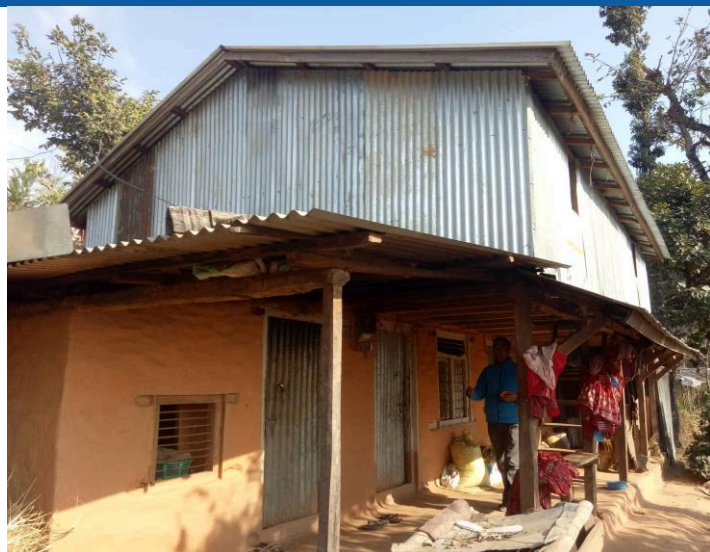
**Caption:** Ward NO.5, Kalika RM, Rasuwa  
**Name of Beneficiary:** Arjun Poudel  
**Tranche:** First Received  
**Housing Typology:** Hybrid structure with lower as load bearing Stone Masonary in mud mortar and upper storey CGI sheet structure. The lower structure is two room house and upper storey is one room.
