## District Report

### Okhaldhunga

4 – 17 January 2019

### Visit 1

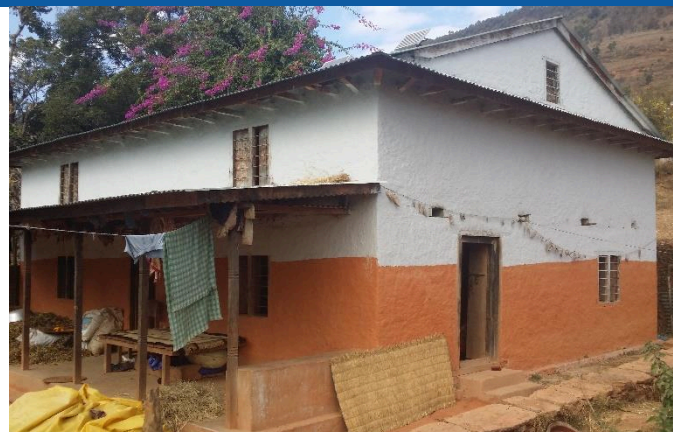
*Figure 3 House of Kedar Prashad Ojha Siddhicharan Municipality Ward no 1 Tinpile Taluwa*

Beneficiary has received first tranches only and has not get any house has four room this house was constructed immediately after the earthquake asper the beneficiary he has spent about 20 lakhs for the house and has taken loan in 5% interest. The beneficiary is not interested in the correction since he doesn't believe in correction. **Picture Credit:** Prakash Basnet DC HRRP

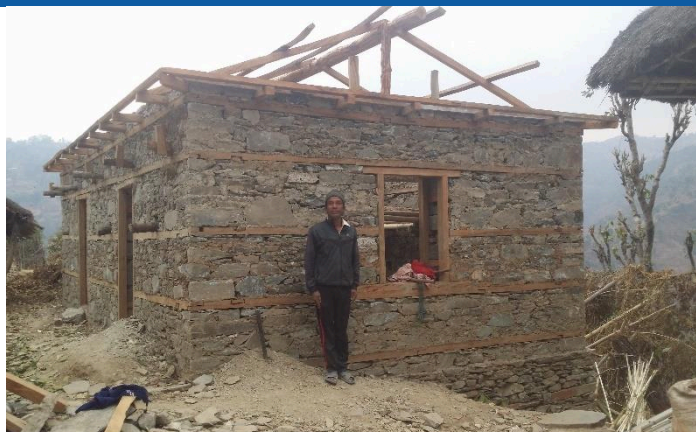
*Figure 4 House of Bamila Pariyar Ward no 5 of Chisankhugadi Rural Municipality Serna*

House is compliance with stone in mud mortar with wooden bands bands provided properly and has received first and second tranche of the government and third tranche has been recommended by the engineer.

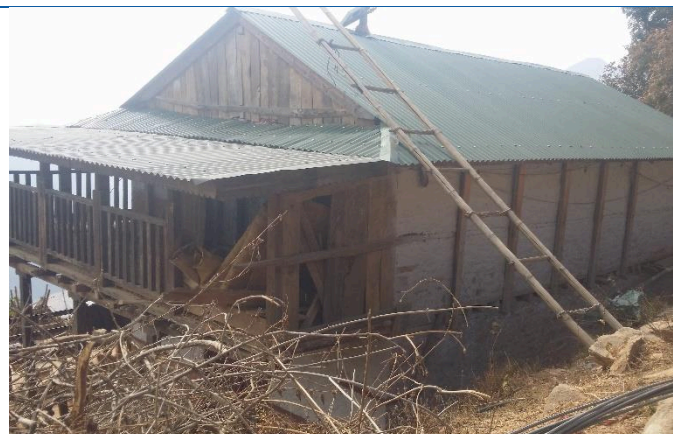
*Figure 5 House of Debika Shrestha Siddhicharan Municipality ward no 1*

The house was noncompliance exceeding attic height and bands were provided in 3 feet house was made with stone in mud mortar. Correction was made as per the suggestion of District support engineers by providing the wooden bands and corner stich bands and the beneficiary has received all three tranches from the government.

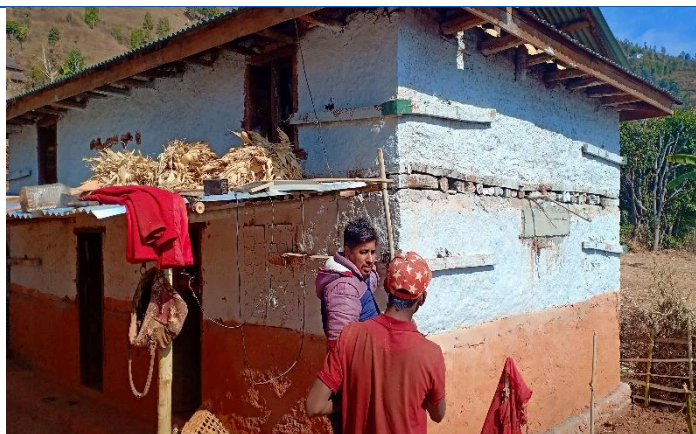
*Figure 6 House of Yek bahadur Pariya Siddhicharan Municipality ward no 1 Taluwa*

The beneficiary has received first and second tranches and has been recommended for the third tranches the house was noncompliance since it missed some of the bands after the correction was made by providing the missing bands as per the suggestion of DSE the house was made compliance

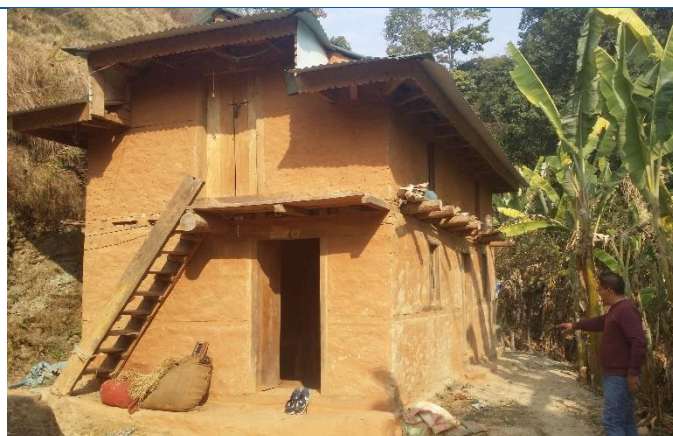
**Figure 7** Kumar Prashad Bhattari Serna ward no 5 of Chisankhugadi Rural Municipality

Only One house of Serna which has not got the second and third tranches at serna, house is missing the plinth band and the other band are provided in 3 feet gap the house is made up of stone in mud mortar. DSE has suggested correction for the house for the second and third tranches.

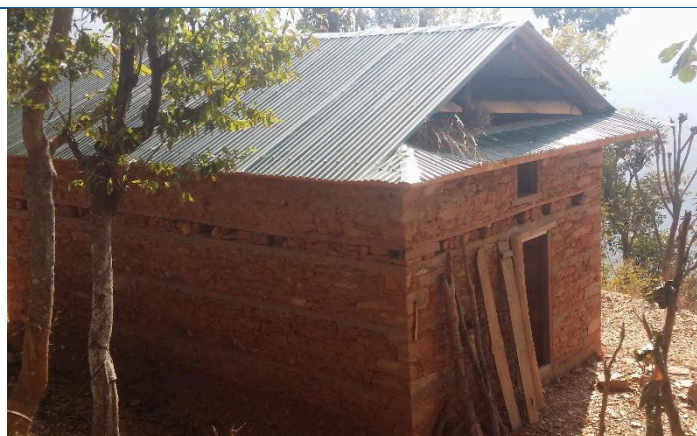
**Figure 8** House of Jit Bahadur Shrestha Siddhicharan Municipality ward

House made with stone in mud mortar with wooden bands

Provided at appropriate place. The beneficiary has received first and second tranches from the government and third tranches

has been recommended by the field engineer.
