# Retrofitting Springboard Project

April 4<sup>th</sup>, 2017

# Northern Reaches Research – Outline

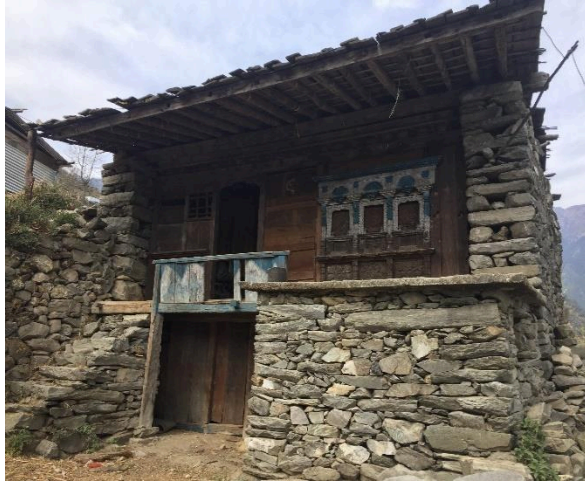
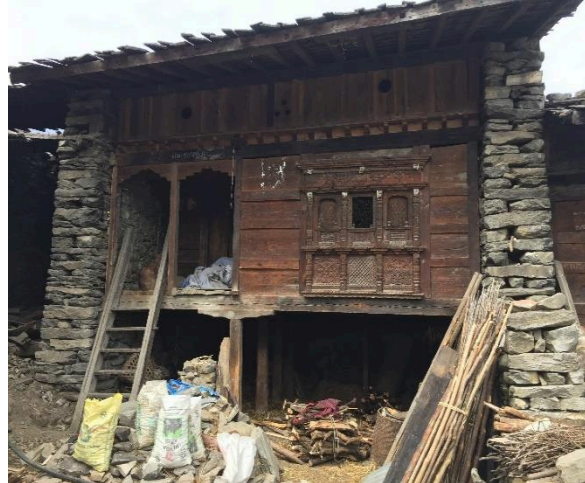
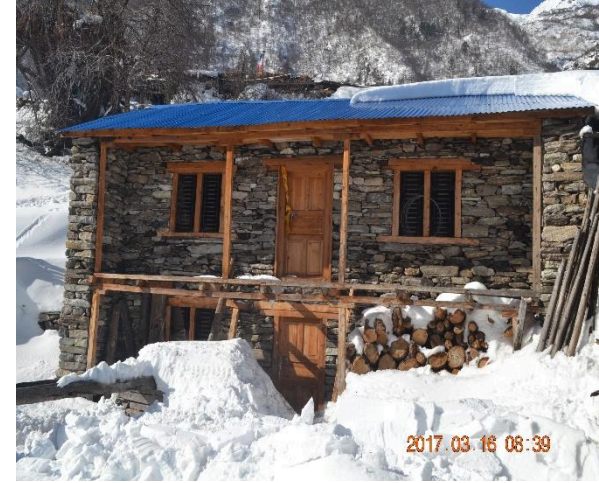
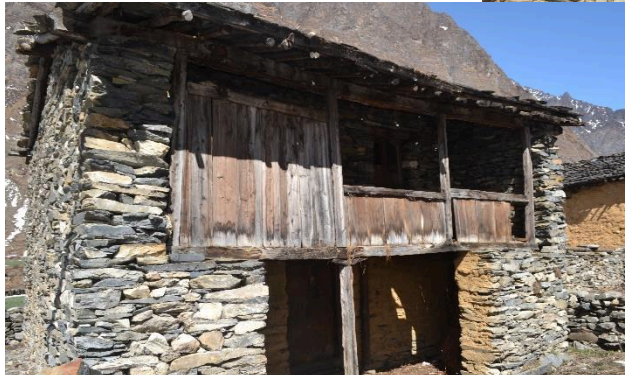
Stand alone, most with open fronts.

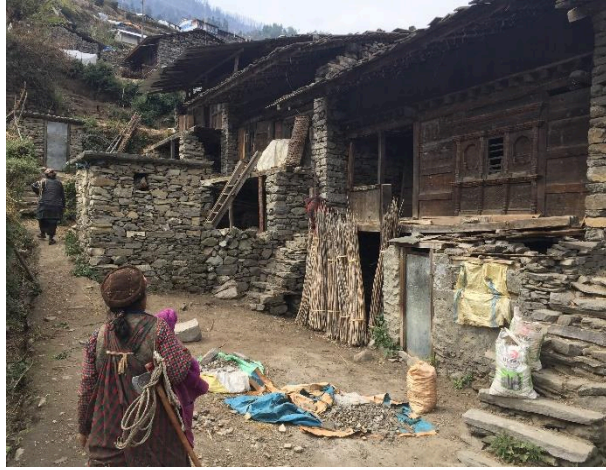
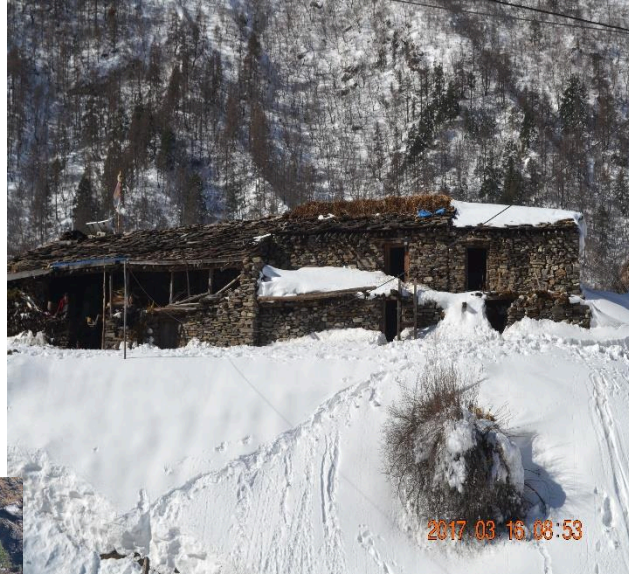
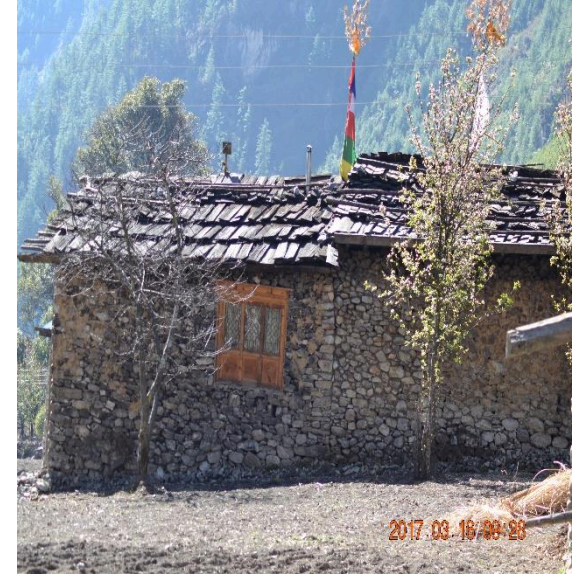
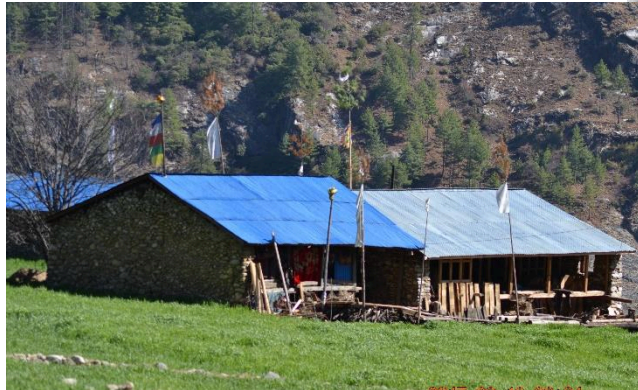
Clustered, adjoining houses

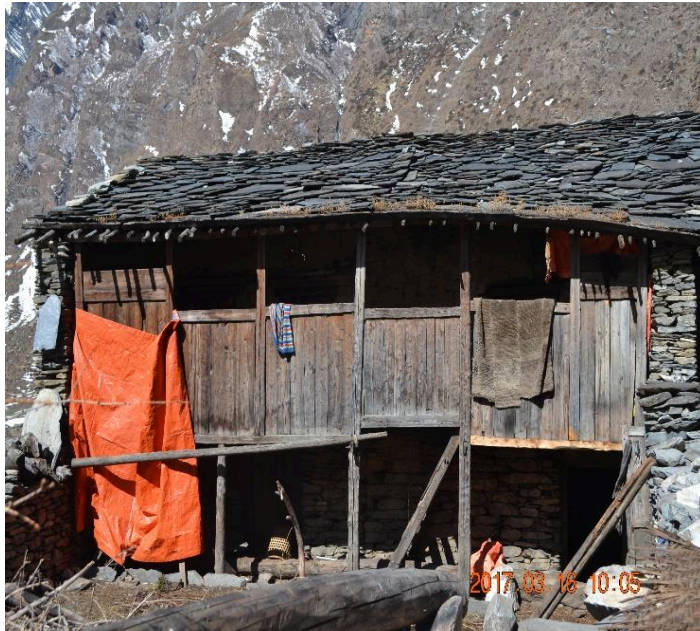
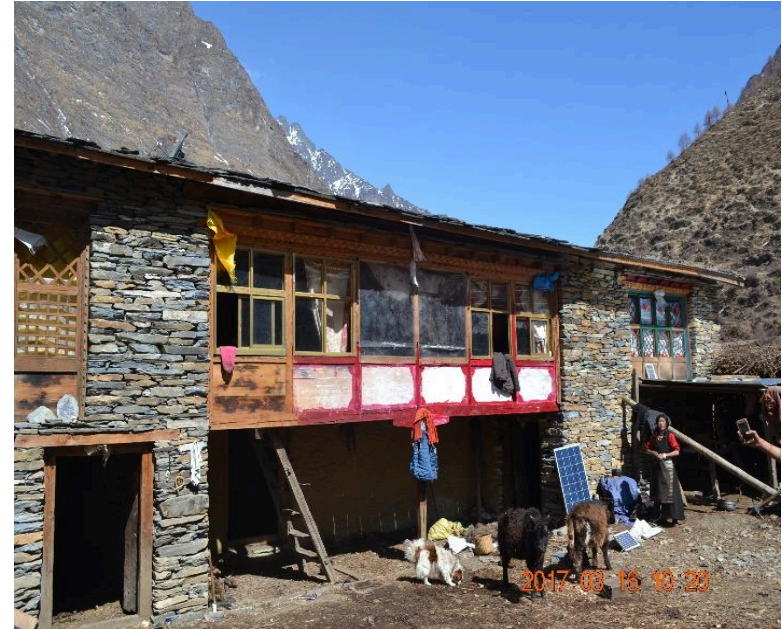
Extensive longitudinal walls and open front.

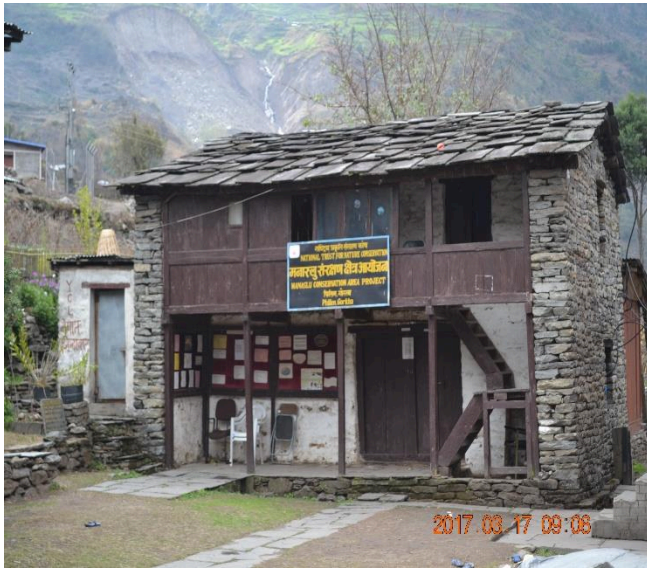
Heavy roofing

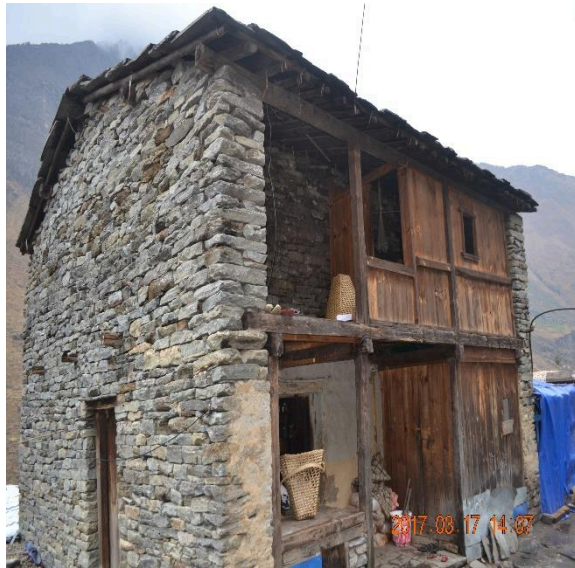
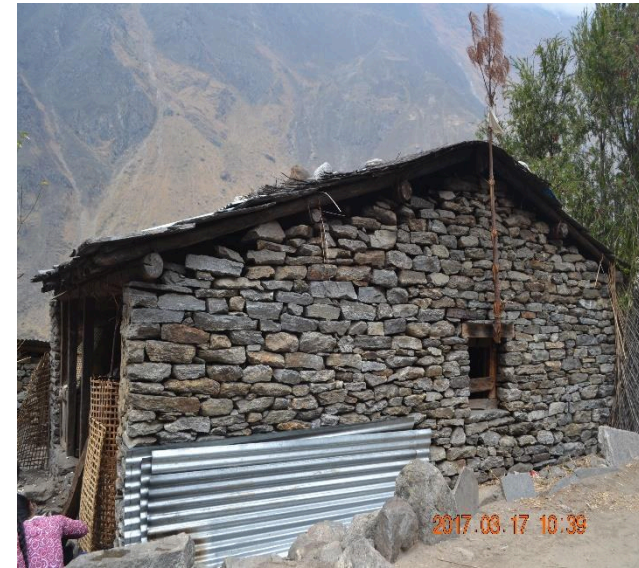
Single storey, open front and heavy roofing.

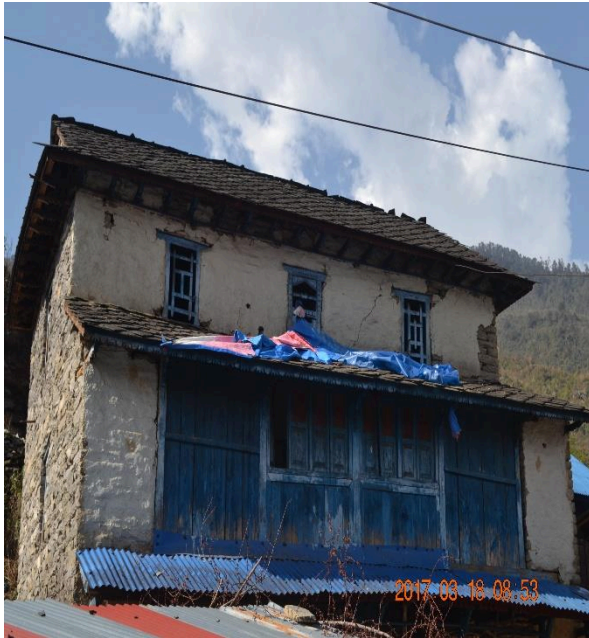
Mud plaster

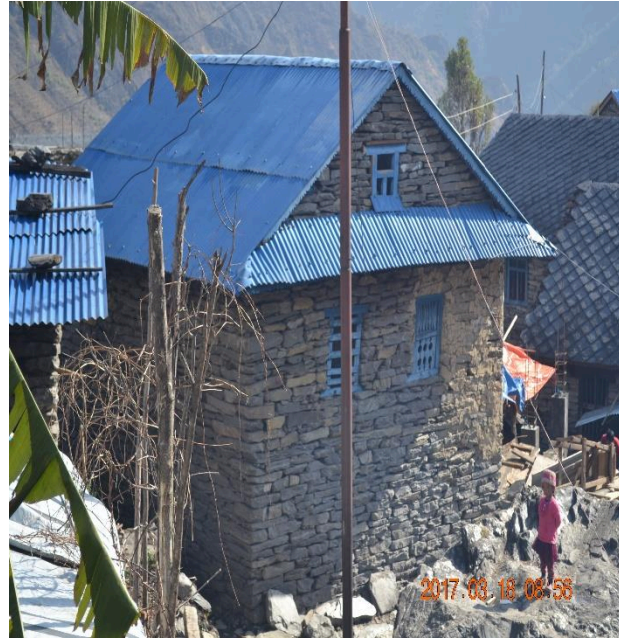
Steep gables

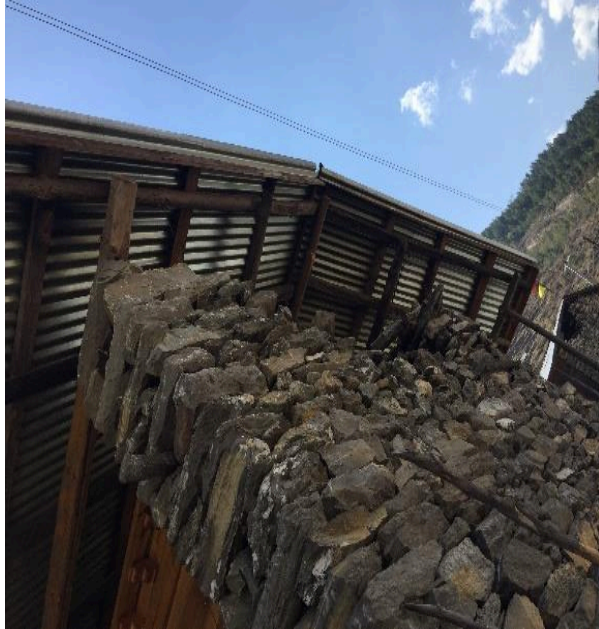
Unsupported and built in  
laminates

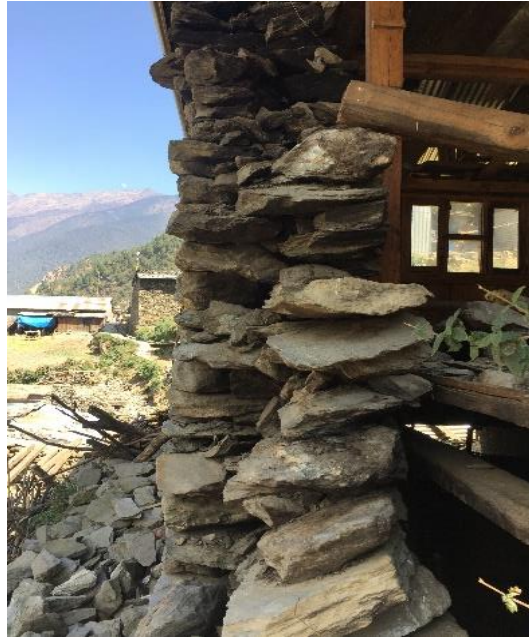
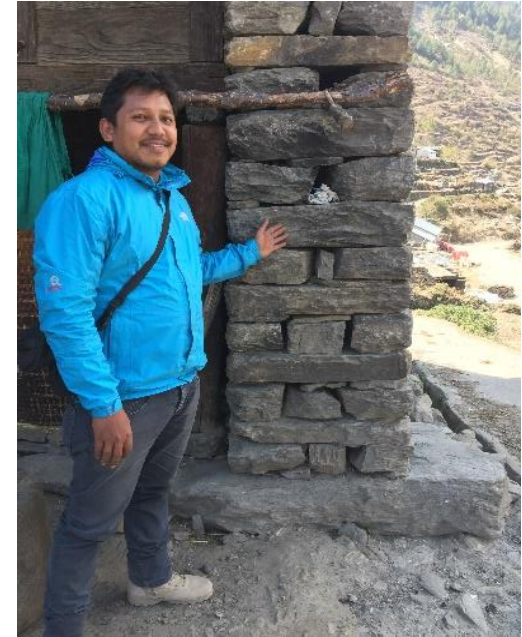
Thick dry walls

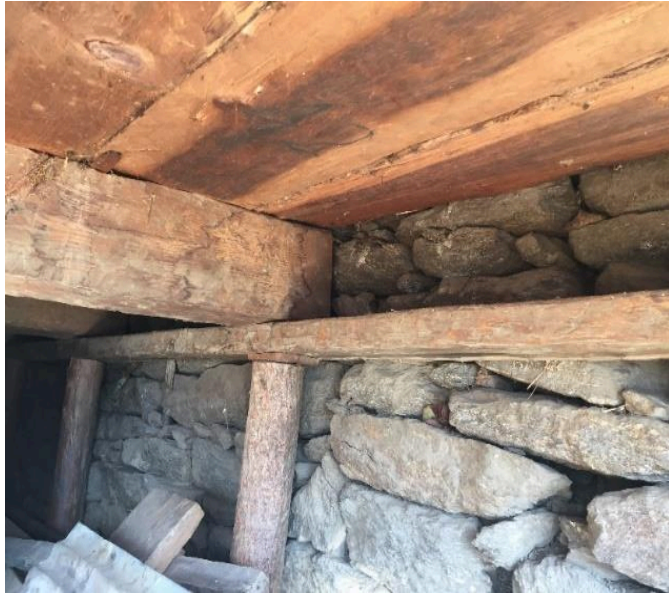
Typical ground floor to  
side wall condition

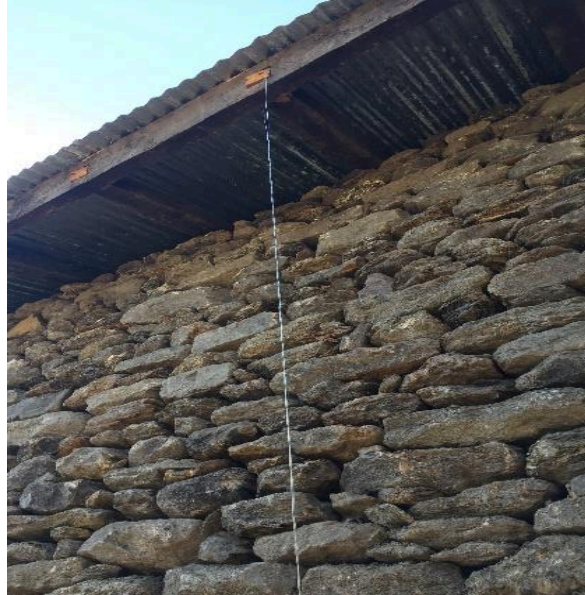
Rafter tie connection

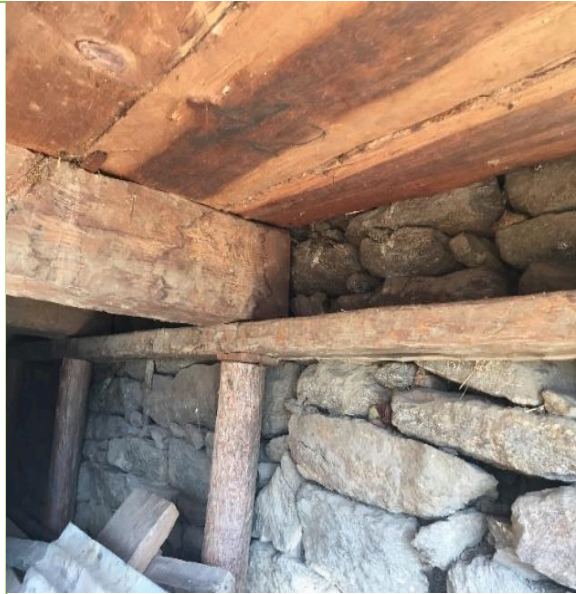
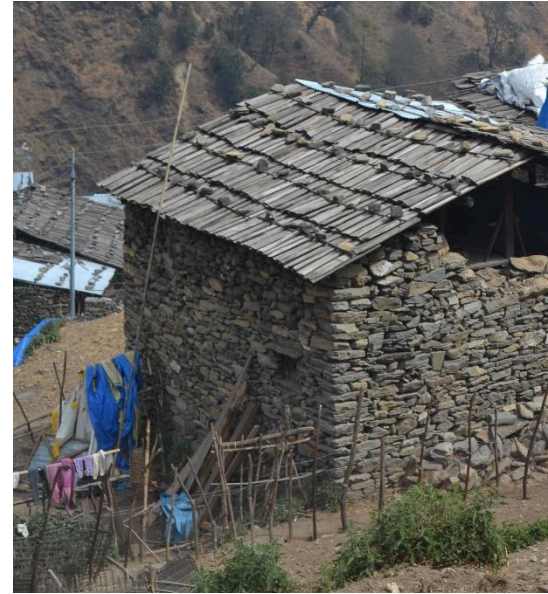
- ❑ Short Wall Out-Of-Plane
- ❑ Weak attachment between end walls and diaphragms.
- ❑ Damage to and subsequent collapse of end walls due to out-of-plane demands.
- ❑ Wooden slab diaphragm unable to transfer shear loads.

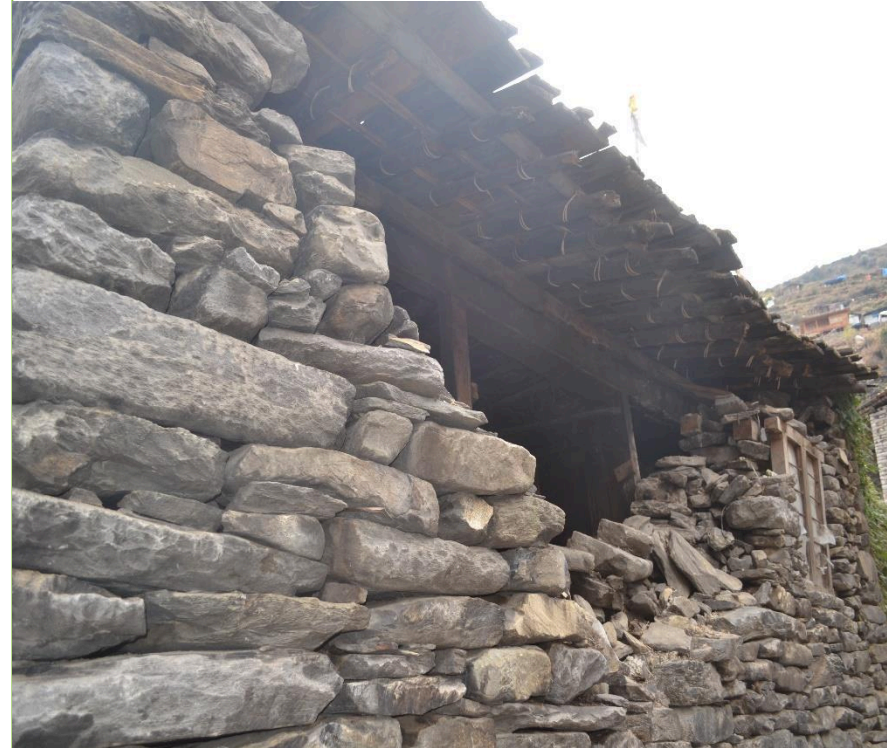
- ❑ Wall Delamination in both directions
- ❑ The thick walls ( $\geq 45\text{cm}$ ) constructed of interior and exterior facing stones. Required bonding elements are sometimes missing or inadequate.
- ❑ Wall delamination occurs, can lead to subsequent collapse.

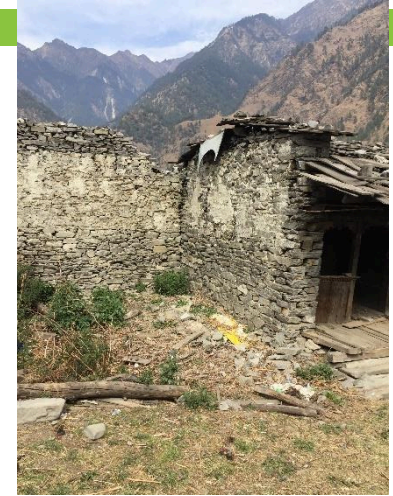
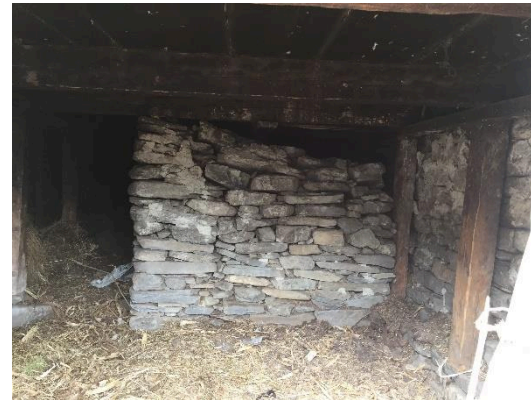
- Walls likely to be very strong in-plane
  - Much stronger than mud-and-stone
  - Little evidence of in-plane failures
    - Possibly out-of-plane collapse occurred first
  - Ground floor stone walls at frontage helped reduce complete collapse where present
- Thickness provides rocking resistance out-of-plane
  - Provided wythes tied-together
  - Some well-constructed walls still standing

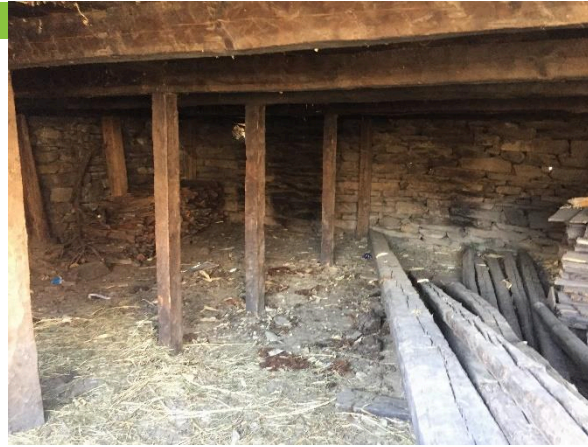
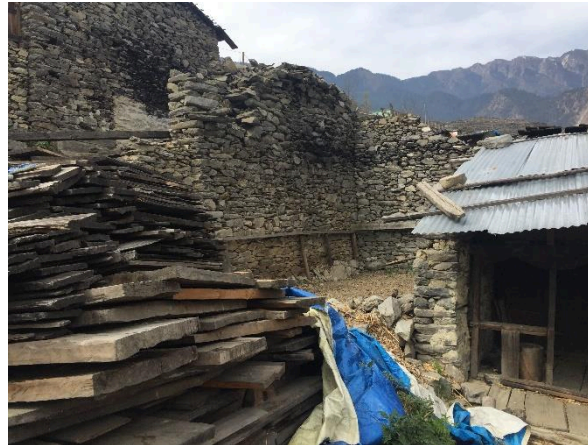
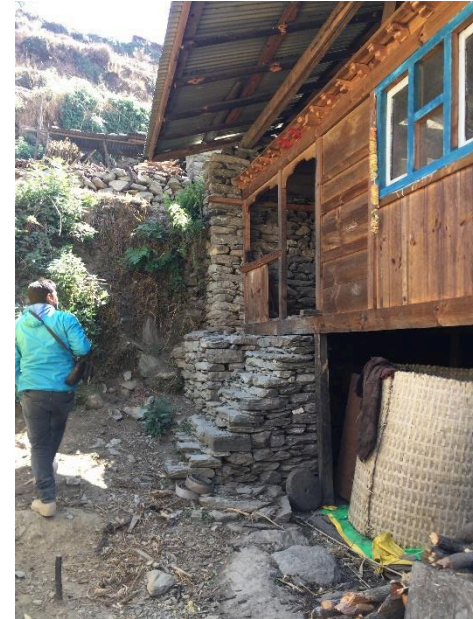
- Floor supported independently by wood posts and beams
  - First floor (almost always), Attic (often)
  - Roof (seldom), beams rest on walls
- Large and long timbers
  - Posts 75mm-100mm square or round
  - Beams up to 100mmx150mm
    - Continuous across building
    - No longer available in these lengths
    - Usually undamaged in collapse and reused (robust)
    - Typically in good condition
