# District Report

## Kathmandu Valley

30 March – 5 April 2018

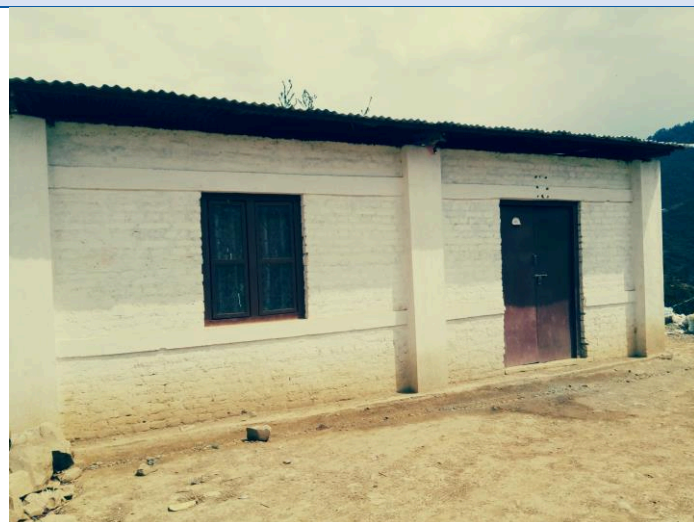
Thulogaun, Nallu, Sisneri, Ward No. 4, Konjyom Rural Municipality. Brick in cement mortar house with CGI roof. The house owner has received 3<sup>rd</sup> tranche.

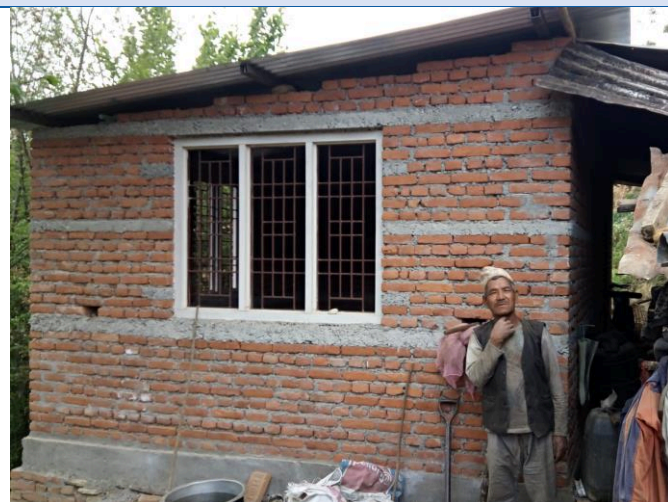
Thulogaun, Nallu, Sisneri, Ward No. 4, Konjyom Rural Municipality. Brick in cement mortar house with CGI roof. The house were suggested as noncompliance and house owner were informed to follow up with technical personnel in Ward office for applying corrective measures. The owner has received 2<sup>nd</sup> tranche.

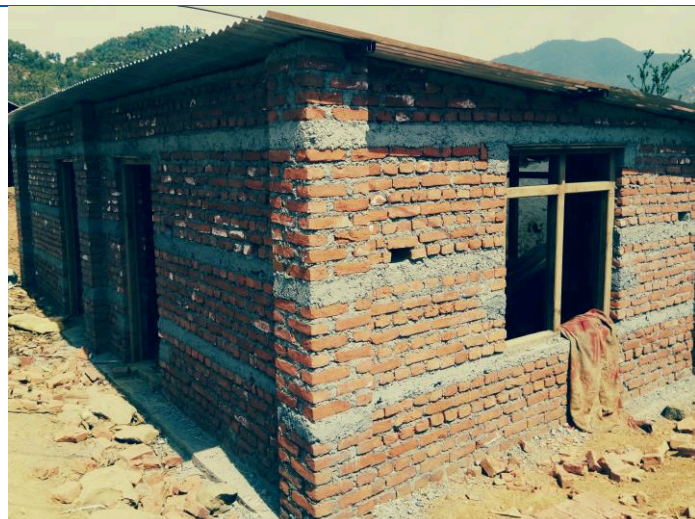
Thulogaun, Nallu, Sisneri, Ward No. 4, Konjosyom Rural Municipality. Brick in cement mortar house with CGI roof. The owner has applied for 3<sup>rd</sup> tranche.

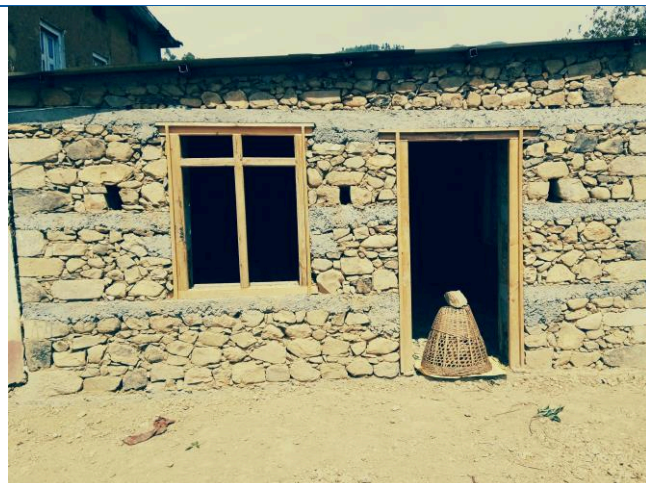
Thulogaun, Nallu, Sisneri, Ward No. 4, Konjosyom Rural Municipality. Brick in cement mortar house with CGI roof. The owner has forwarded file for 3<sup>rd</sup> tranche.

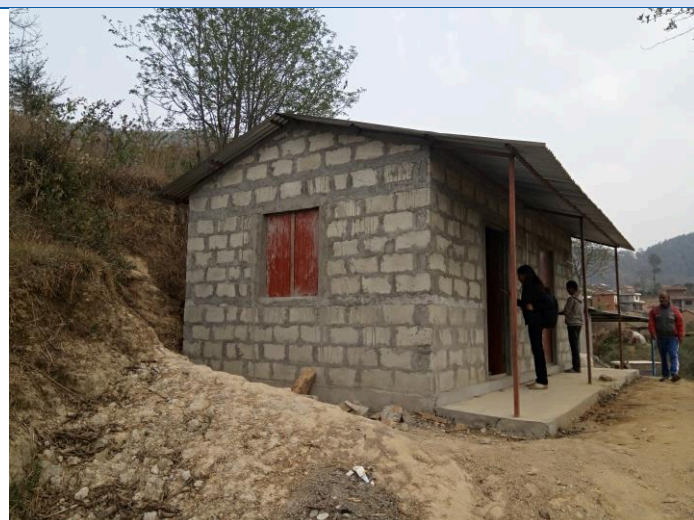
The reconstruction status of 8 houses were monitored and observed by the monitoring team. The 2 roomed houses made by Batas foundation were found to be non compliance in which gable band were missing along with placement of Sil and Lintel band at the distance of 3 feet only. Similarly, missing of corner stitch were observed in the houses made by Lumanti. Material support of worth three hundred thousand rupees were provided by Lumanti, in which the beneficiaries also contributed in either cash or kind for reconstruction of houses.

Tikabhairab, Ward no. 6, Lele, Godawari Municipality. House made from Blocks, supported by Batas Foundation. Gable band missing and Sil and Lintel is placed at distance of 3 feet only. House were termed in non compliance category by the monitoring team though the construction have already completed.

Houses that were under non-compliances cases as identified by the M & E consultant were suggested to apply corrective measures to become eligible for 2<sup>nd</sup> tranche and for further tranche too.

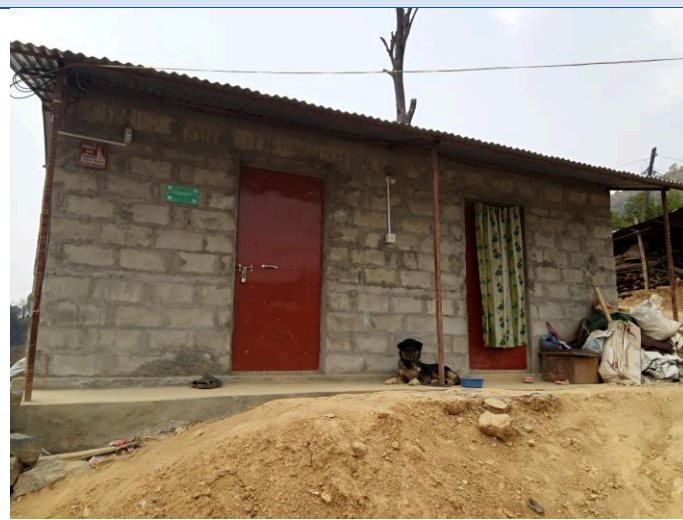
Tikabhairab, Ward no. 6, Lele, Godawari Municipality. House made from Blocks, supported by Batas Foundation. Gable band missing, Sil and Lintel is placed at distance of 3 feet only. House were termed in non compliance category by the monitoring team though the construction have already completed.

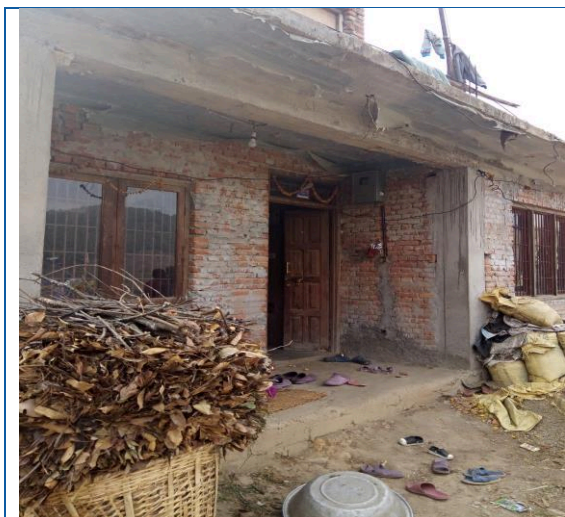
Pahade, Ward no. 5, Lele, Godawari Municipality. RCC frame structure house. The house owner were suggested to apply corrective measures to claim 3<sup>rd</sup> tranche by approaching technical personnel of Godawari Municipality.

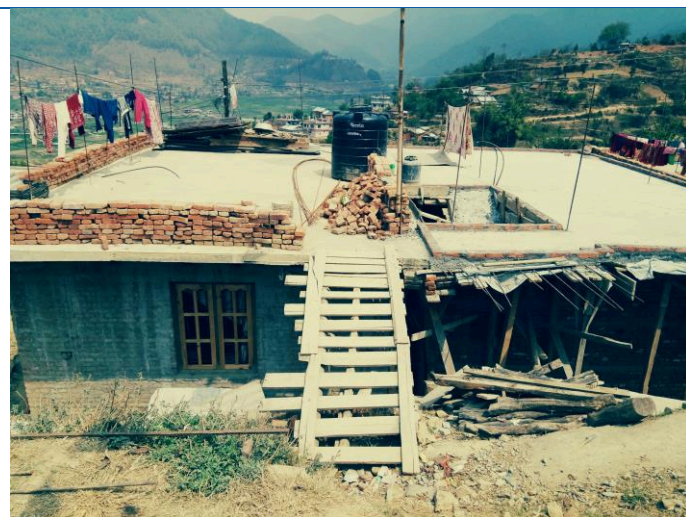
Pahade, Ward no. 5, Lele, Godawari Municipality. RCC frame structure house reconstructed with materials support from Lumanti. Corner stitch were found missing in the house. The house owner were suggested to apply corrective measures by approaching technical personnel of Godawari Municipality.

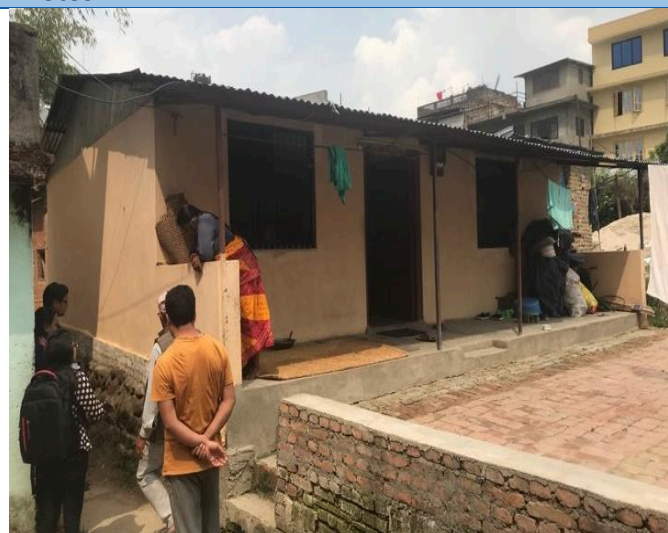
Dharmasthali, Ward no 13, Tarkeshwor Municipality. BMC, single storey house having 6 inches block wall, with brick and CGI roof. The house owner has applied 2<sup>nd</sup> tranche. The house were termed noncompliance after inspection as lack of bands and cracks were seen. M & E Consultant, CLPIU-MOUD advised the house owner to either rebuild the house or wait for guidelines from GON to address issues for these types of houses. It has no any bands, many cracks are already visible.

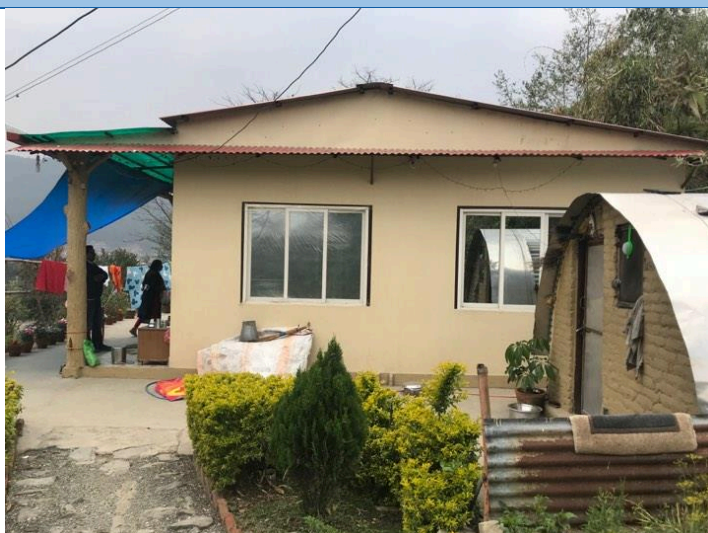
Dharmasthali, Ward no 13, Tarkeshwor Municipality. BMC house with CGI roof. Upon inspection, the house were build differently than the building drawing. It has only bands at windows. Having 4-inch steel post and 4 inches wall. The house were termed non-compliance and the owner were advised to revise the building drawing. The owner has received 1<sup>st</sup> tranche.

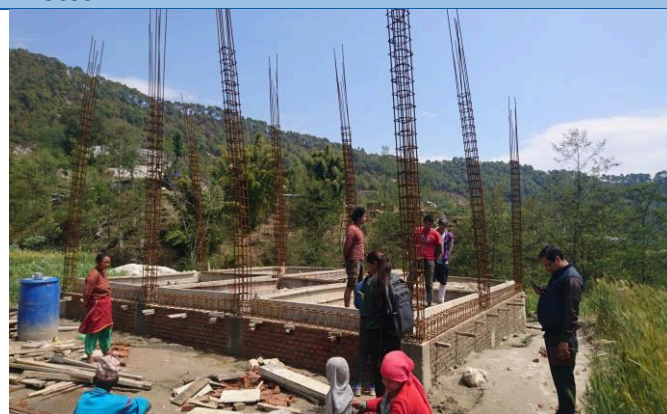
| Kaudol, Ward no 2, Budanilkantha Municipality. RCC building with a target of 1 storey. However, one of the DPC main bars was not inside the column reinforcement that made the house to be non compliance. | Kaudol, Ward no. 2, Budanilkantha Municipality. Load bearing building with CGI roof. The house is compliant up to DPC level. |
