# District Report

## Kathmandu Valley

11 - 24 May 2018

## Field Visit Report-1

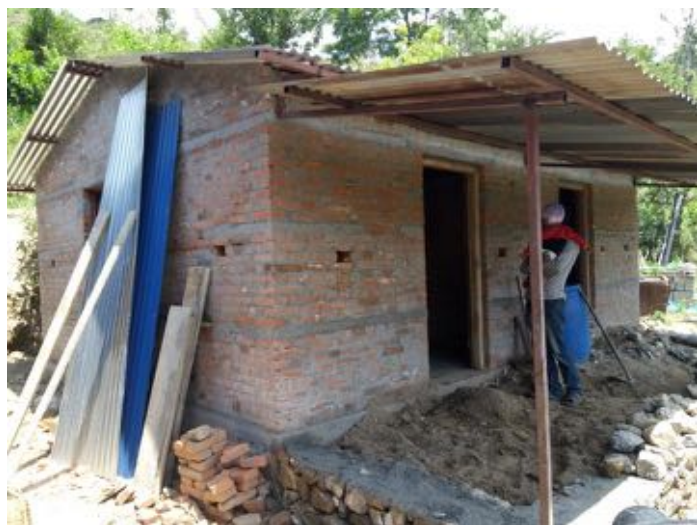
Beneficiary name: Arjun Shrestha, Ward no. 2, Mulkharka, Gokarneshwor Municipality. The house is brick masonry in cement mortar and has been built as per the design catalogue. Corner stitch has been properly kept but gable band were missing. The owner was suggested to improve the house by keeping gable band in order to become eligible for 2<sup>nd</sup> and 3<sup>rd</sup> tranche.

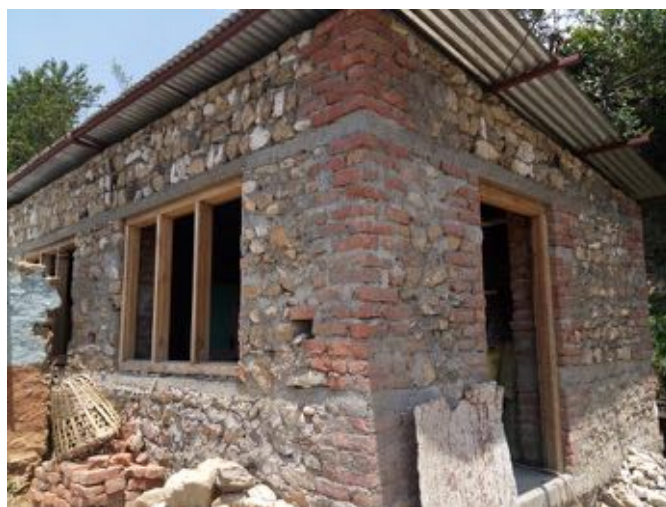
Beneficiary name: Buddhi Bahadur Lama, Ward no. 2, Mulkharka, Gokarneshwor Municipality. The house is hybrid structure with mostly brick and stone masonry at the corners. The house is under inspection for 2<sup>nd</sup> and 3<sup>rd</sup> tranche. M & E consultant suggested that through minimal corrections the owner could receive 2<sup>nd</sup> tranche but 3<sup>rd</sup> tranche might be difficult.

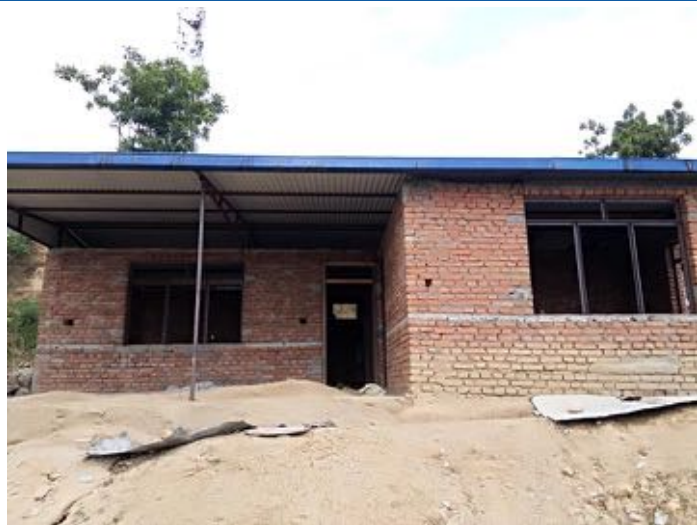
Beneficiary name: Chabi Lal Gurung, Ward no. 2, Mulkharka, Gokarneshwor Municipality. The house is of load bearing structure with CGI roofing. During inspection the gable bands were found to be missing. The owner was suggested to improve with gable band placement for receiving the succeeding tranche.

| Gable band were missing in load bearing structure with CG roof. | Beneficiaries should follow up with engineers for technical assistance especially during wall raising and roofing work. Similarly, the concerned technical staffs should also follow up with the ward office for reconstruction status in the communities so that they can visit and support houses for technically sound reconstruction. | Beneficiaries, local bodies, DLPIU engineers. | As soon as possible or before Ashad 2075 end. |

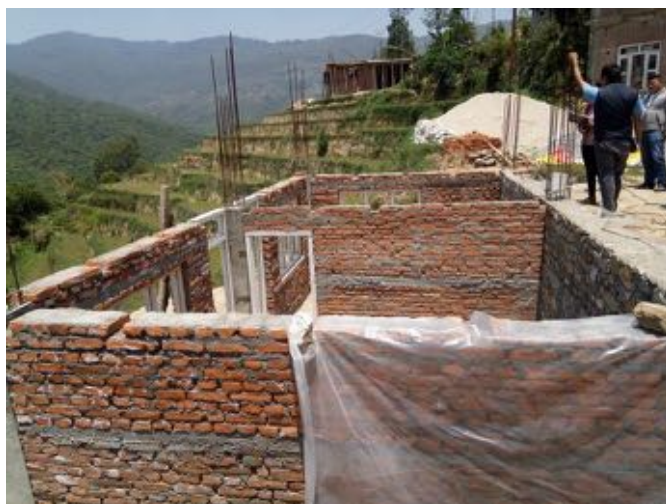
Beneficiary name: Man Bahadur Tamang, Ward no. 2, Mulkharka, Gokarneshwor Municipality. The house is single bay, brick masonry in cement mortar. The owner were suggested to conduct structural analysis whereby coordinating with engineers of Gokarneshwor Municipality for being eligible for the 2<sup>nd</sup> and 3<sup>rd</sup> tranche.

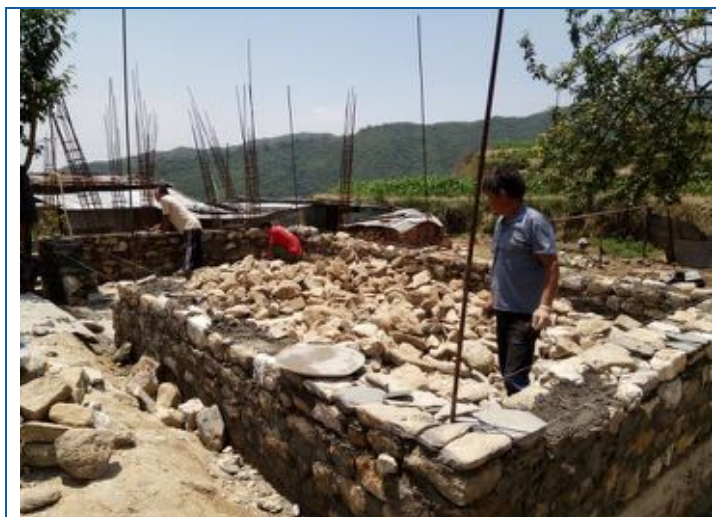
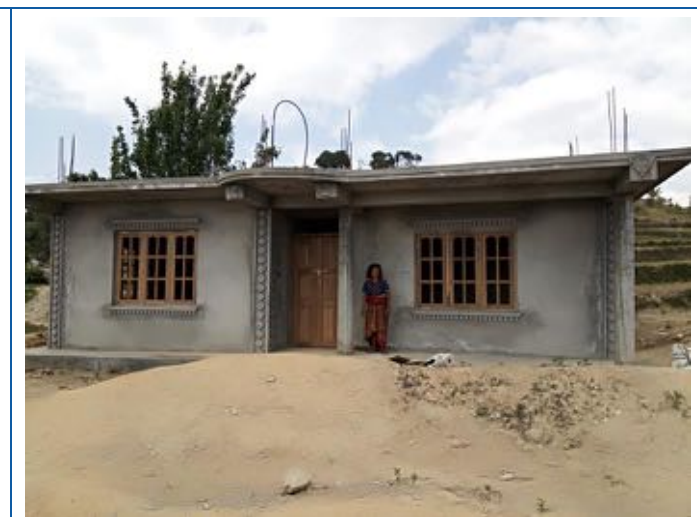
| <p>Beneficiary name: Pabitra Tamang, Ward no. 2, Tallo Tole, Mulkharka, Gokarneshwor Municipality. The house under construction is stone masonry in cement mortar. The inspection team informed the owner as well as the trained mason to keep vertical reinforcement so that 2<sup>nd</sup> tranche is possible.</p> | <p>Beneficiary name: Tirtha Bahadur Tamang, Ward no. 2, Tallo Tole, Mulkharka, Gokarneshwor Municipality. The house is being inspected for the 2<sup>nd</sup> and 3<sup>rd</sup> tranche. The house is RCC frame structure. The inspection revealed that the house is eligible for the 2<sup>nd</sup> tranche.</p> |

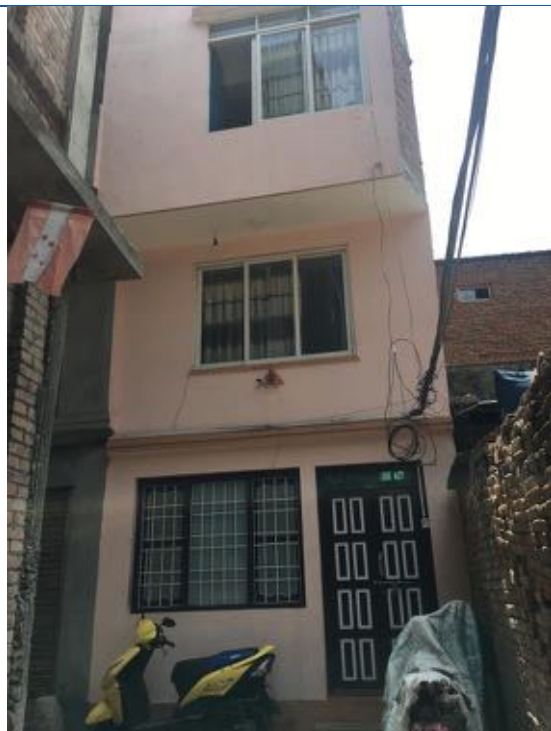
Beneficiary Name: Chandra Laxmi Bhasima, Ward no 5, Madhyapur Thimi Municipality. 4 storey RC frame structure. The house was non-compliance during the inspection due to the room size. After the structural analysis the house was found to be safe. The beneficiary has completed the procedure for the 2nd and 3rd tranche.

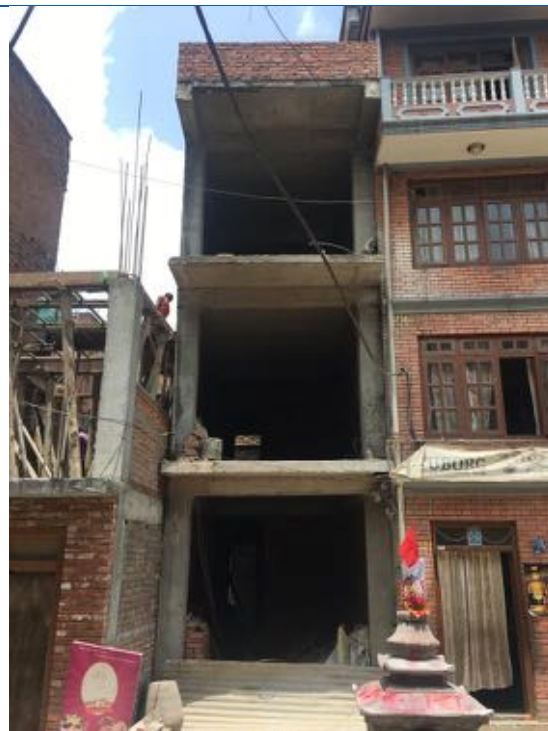
Beneficiary Name: Radha Krishna Shrestha, Bhulakhel, Ward no 5, Madhyapur Thimi Municipality. 3 storey RC frame structure. Till date the RC frame of the house has been completed with wall still remaining to be constructed. The beneficiary has received all the tranches.

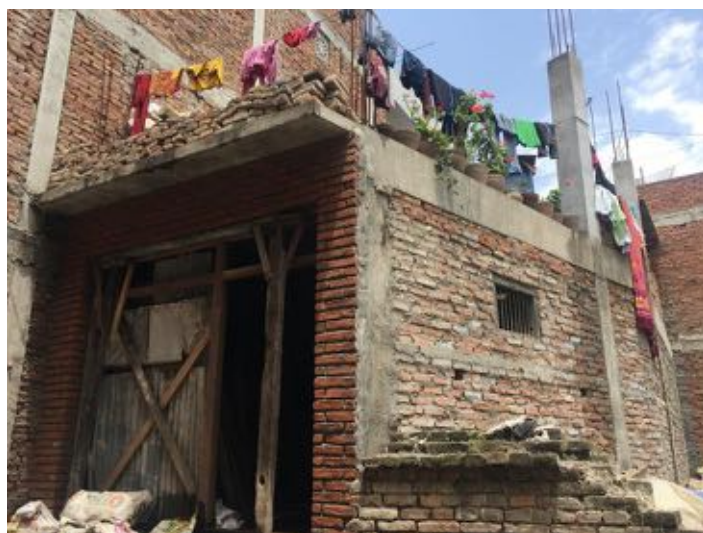
Beneficiary Name: Rajesh Ranjitkar, Ward no 5, Madhyapur Thimi Municipality. 1 storey RC frame structure. The beneficiary has received 2nd tranche and has submitted application for the inspection of the 3rd tranche.

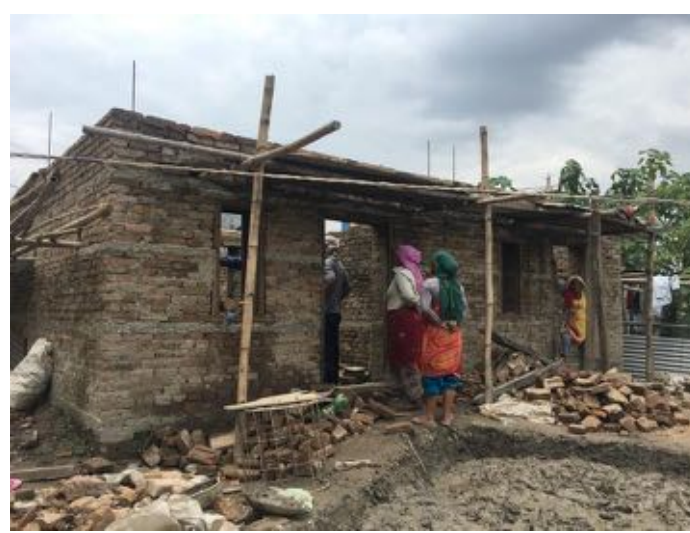
Beneficiaries Name: Babu Saheb Dhaubhanjar and Babu Kaji Dhaubhanjar, Nikosera, Ward no 9, Madhyapur Thimi Municipality. 1 storey brick in mud mortar structure. Two houses attached to each other belong to brothers. The salvage material such as old bricks, wood has been used during the construction of the new houses. Both beneficiaries have received the 2nd tranche.

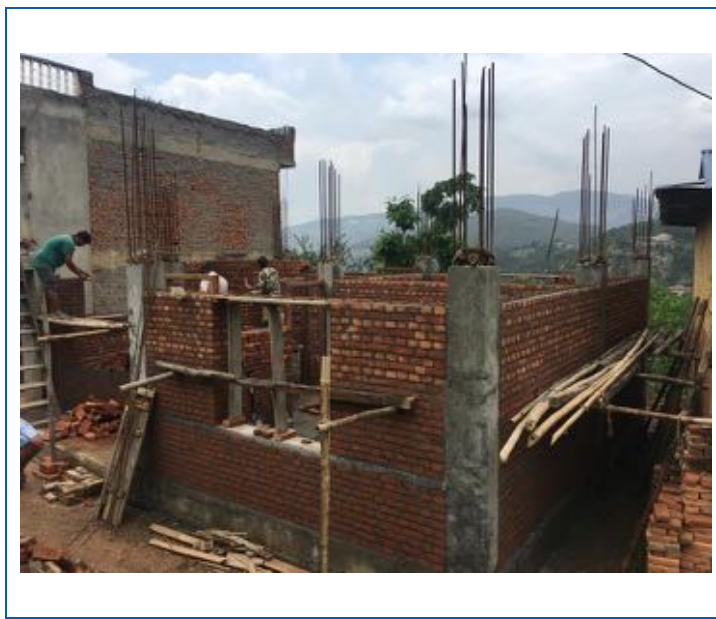
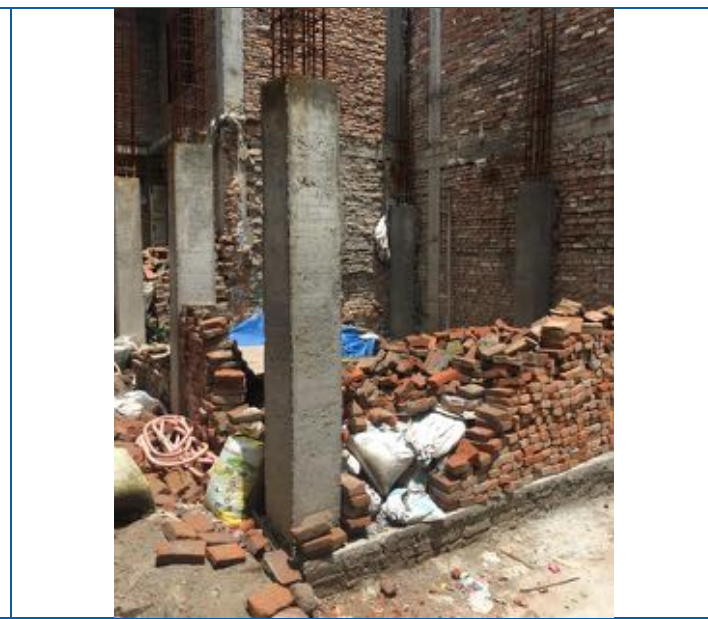
| <p>Beneficiary Name: Raj Kumar Karki, Ward no 5, Suryabinayak Municipality. 1 storey RC frame structure. The beneficiary has received 1st tranche and has not requested for the remaining tranche as he thought the remaining tranche will be received only after completing the structure. The reinforcement has been provided in the band were not properly tied so the masons were given instruction to properly tie the reinforcement and making hook at the corner for the proper functioning of the band.</p> | <p>Beneficiary Name: Kanchi Kandeu, Ward no 5, Madhyapur Thimi Municipality. 1 storey RC frame structure. The house belongs to a single woman. Due to the poor economic condition she has not been able to prepare the house design and proceed for the remaining tranche. She wishes to be listed under the vulnerable category for the additional support from the government.</p> |

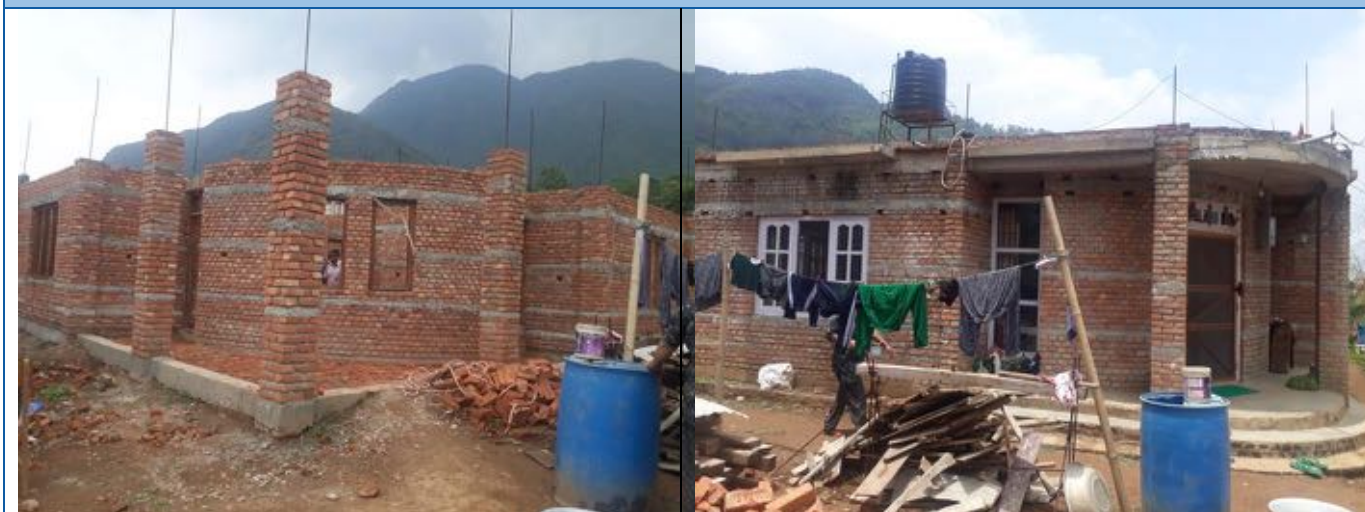
Beneficiary name: Dilip Bohora, Machchhegau ward no. 4, Kirtipur municipality, Kathmandu district. 1 storey , 4 rooms, 9" wall BMC structure, 1. The beneficiary has received 2<sup>nd</sup> tranche. The vertical reinforcement has been missed on openings and on cross wall. The arch attached with window is not tied with any reinforcement and to the beam.

Machchhegau ward no. 4, Kirtipur municipality, Kathmandu district. 1 storey BMC with arch design, 9" wall. The beneficiary has received 2<sup>nd</sup> tranche and forwarded to DSE for structure analysis for 3<sup>rd</sup> tranche.

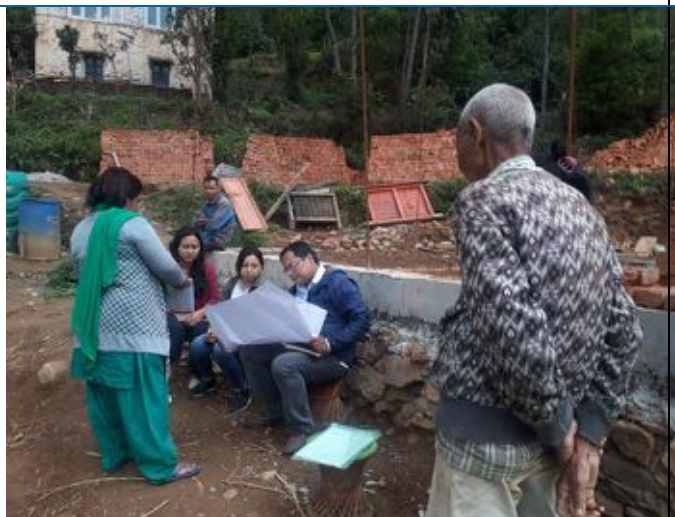
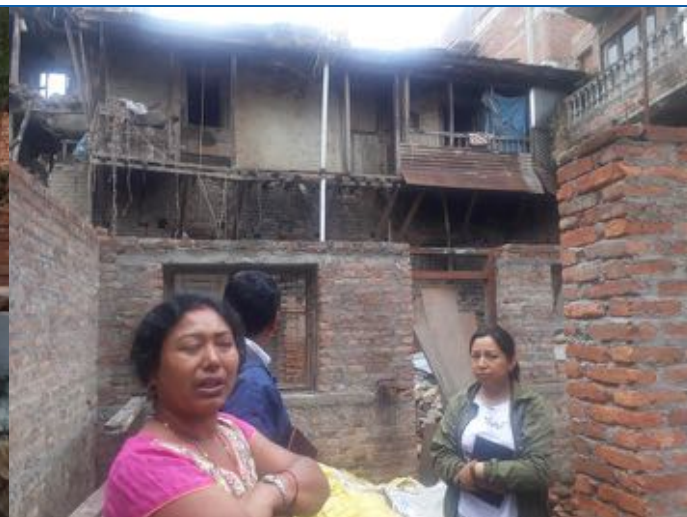
Beneficiary name: Rita Thapa Gharti, Magar tole, Ward no. 4, Kirtipur municipality, Kathmandu district. Only one have started reconstruction among total 7 beneficiaries in the tole. Rest of them are expecting extension of deadline and are not well informed/aware of NRA criteria where the 1<sup>st</sup> tranche has to be returned if the beneficiary fails to reconstruct the house.

Lachhi, ward no. 5, Kirtipur municipality, Kathmandu district. BMC, 2 rooms, 2.5 storey. Vertical reinforcement bar is missing in openings. The structure behind the house under construction is a severely damaged house where the family has been living.

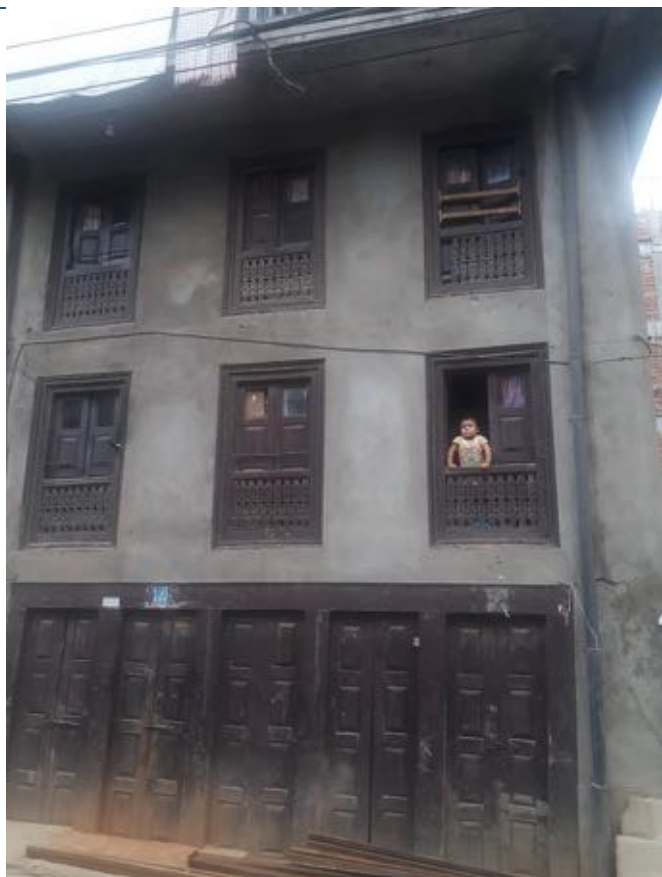
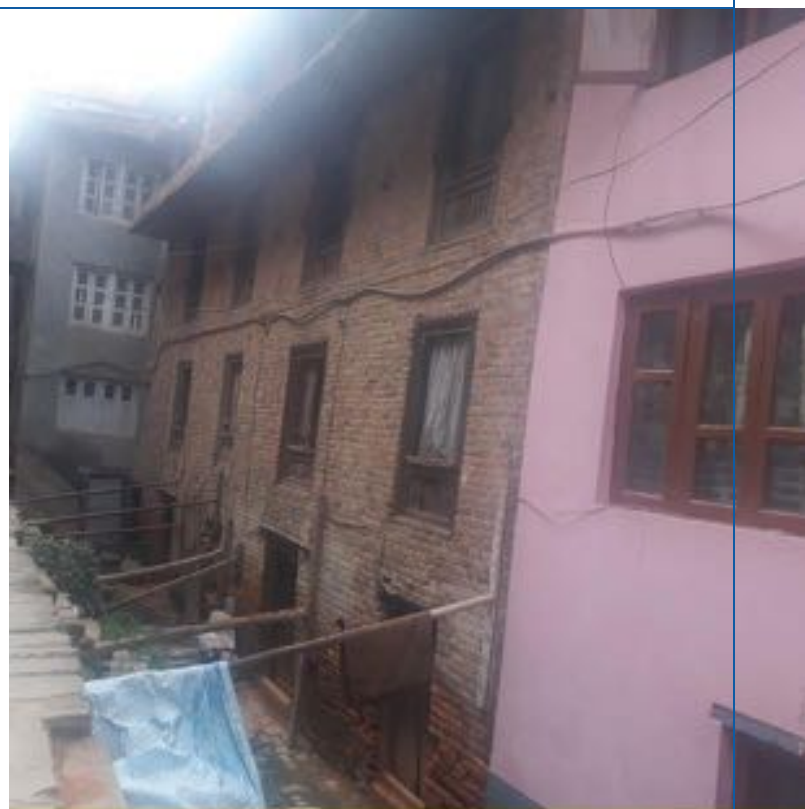
| Lachhi ward no. 5, Kirtipur municipality, Kathmandu district. A photo of cracked house where people are still living on. Many families are living on such houses under risk in the core areas. | Baghbhairav, ward no. 2, Kirtipur municipality, Kathmandu district. People are living inside such extremely damaged houses in the core area. Many damaged houses are not destroyed and cleared the debris in the core areas. |

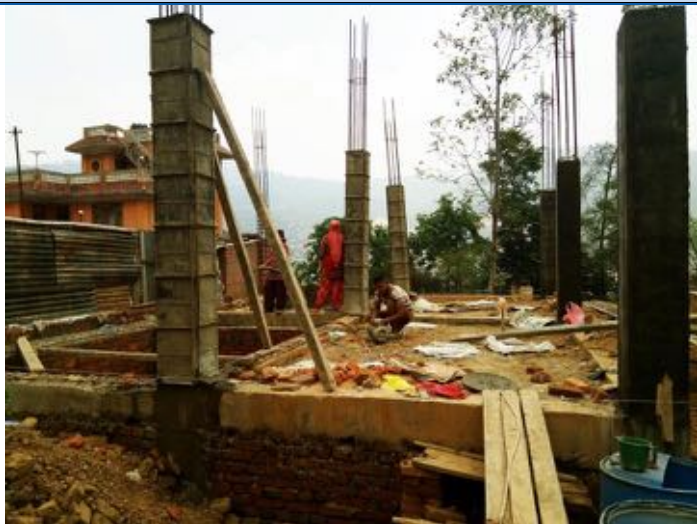
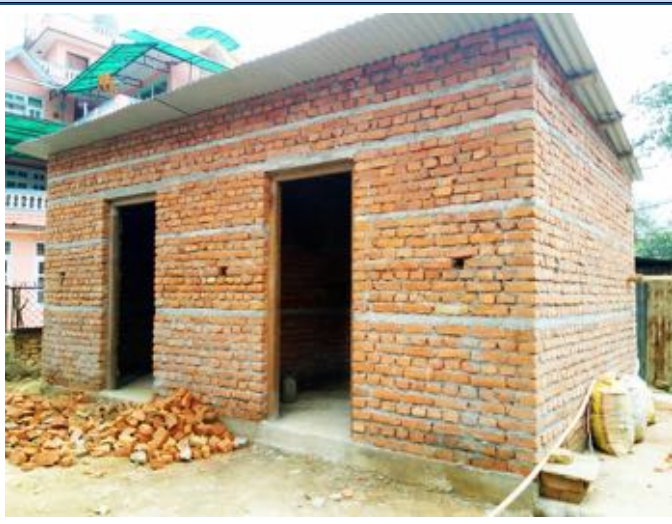
| | <p>A total of 6 houses in reconstruction phase were observed by the monitoring team. Majority of frame structure building are in the process of reconstruction in the observed areas that have claimed for 2<sup>nd</sup> tranche and 3<sup>rd</sup> tranche as well. Some of the observed houses have completed construction, while DPC works of some houses were still on-going during the visit. For the houses that were found non-compliance, M &amp; E consultant suggested the house owners to apply relevant correction and exception procedures whereby coordinating with engineers at Chandragiri Municipality. Similarly, for some non compliance houses, application of correction and exception procedures was suggested to follow to become eligible for succeeding tranche. M &amp; E Consultant requested Ward officials to publish notifications about claiming Ashad deadlines in ward office as well as in public places of the respective Wards.</p> | | |
|---|---|---|---|
| <p>Beneficiary name: Indra Thapa Magar, Ward no. 5, Baansthali, Chandragiri Municipality. This RCC frame structure house has met minimum requirements from foundation and DPC level while building drawing is yet to be approved from the municipality.</p> | | <p>Beneficiary name: Kush Karki, Ward no. 5, Baansthali, Chandragiri Municipality. 2 –roomed BMC structure with CGI roof. The house has met minimum requirements to become eligible for 2<sup>nd</sup> tranche while a complete document is required to inspect for 3<sup>rd</sup> tranche as suggested by M &amp; E Consultant.</p> | |

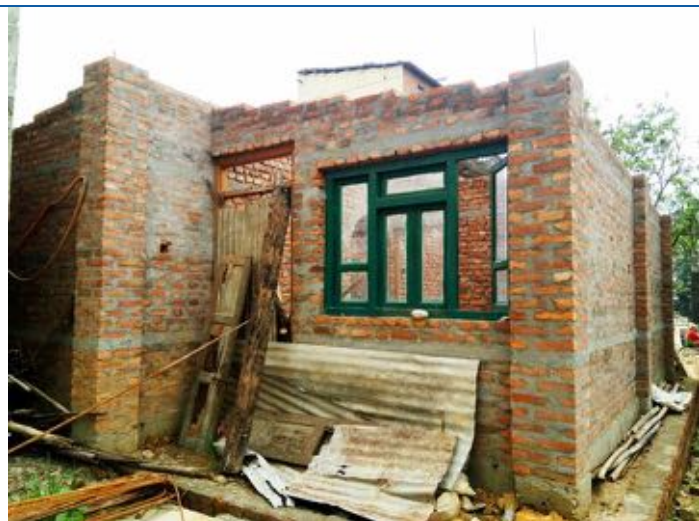
Beneficiary name: Bhagwati Thapa Magar, Ward no. 5, Baansthali, Chandragiri Municipality. Wall system house with CGI roof in plan. The house is non compliance as it doesn't have corner stitch and roof bands are missing. Similarly, vertical reinforcement is also missing from two side of window and door. 2<sup>nd</sup> tranche has been forwarded from municipality. The beneficiary were suggested to apply correction and exception procedures whereby keeping compulsory C-hook for connecting the rod with the CGI roof.

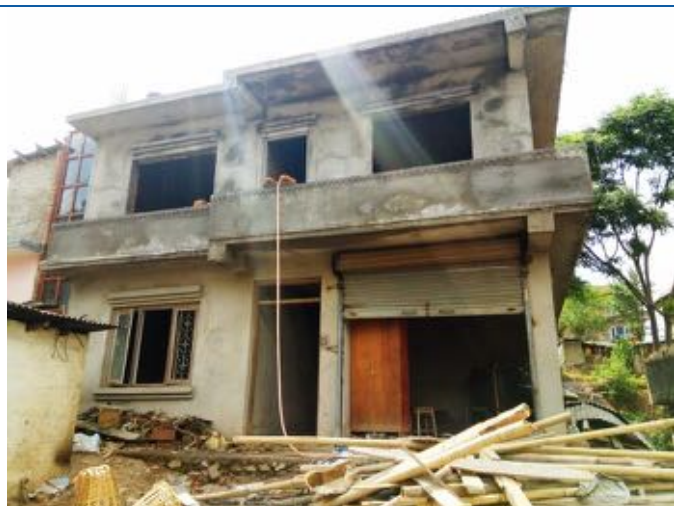
Beneficiary name: Shyam Krishna Sarki, Ward no. 8, Mathillo Tole, Chandragiri Municipality. 2 storey frame structure house. Owner has received 2<sup>nd</sup> tranche. Inspection for 3<sup>rd</sup> tranche has been forwarded. The beneficiary revealed that the house were completed long time back but due to lack of money remaining works were not carried out.

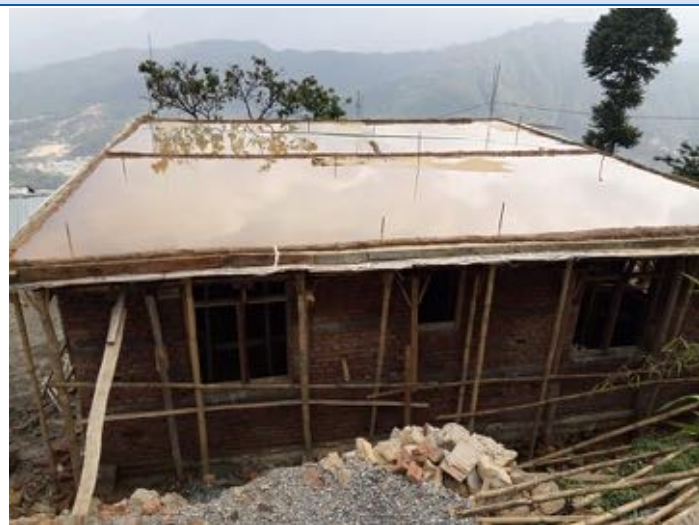
Beneficiary Name: Prem Bahadur Tamang, Ward no. 8, Thaple, Nagarjun Municipality. Masonry structure with wall system house. The owner is eligible for 2<sup>nd</sup> tranche as suggested from inspection. However, the beneficiary was informed to amend the building drawing from CGI roof to cement casting roof in order to receive 3<sup>rd</sup> tranche.

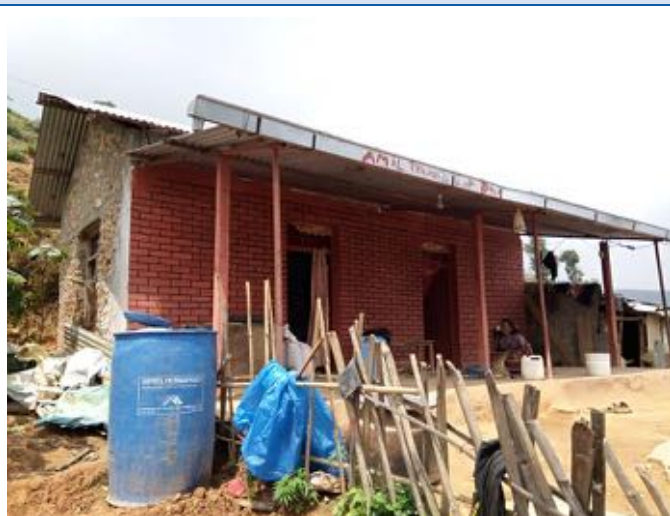
Beneficiary Name: Ram Bahadur Tamang, Ward no.8, Thaple, Nagarjun Municipality. SMC wall system house with CGI roof. Attic height was found to be over extended. 2<sup>nd</sup> tranche inspection were forwarded while M & E Consultant informed for detail discussion for solving cases of this kind of house to forward for 3<sup>rd</sup> tranche.

| Over-extended height of attic. | Beneficiaries and local masons applied the local knowledge whereby increasing the height of attic to adapt with hot and cold temperatures. Detail discussion on such cases along with careful application of correction measures and structural analysis needs be conducted. | Beneficiaries, local bodies, DLPIU engineers, CLPIU NRA-Building. | As soon as possible or before end of Ashad 2075 | |

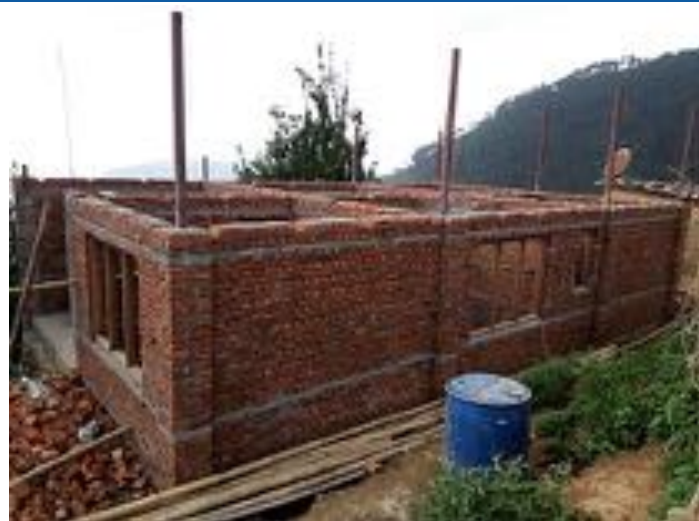
Beneficiary Name: Chandra Bahadur Tamang Lama, Ward no. 8, Dubichaur, Nagarjun Municipality. BMC, wall system structure house having steel post as vertical enforcement and corner and cross wall. 12 mm dimension bar provided in some junction walls along with sheer connected provided and corner stitch is missing. The building drawing has not been approved yet. 2<sup>nd</sup> tranche inspection were forwarded while beneficiary were recommended to conduct structural analysis for claiming 3<sup>rd</sup> tranche.

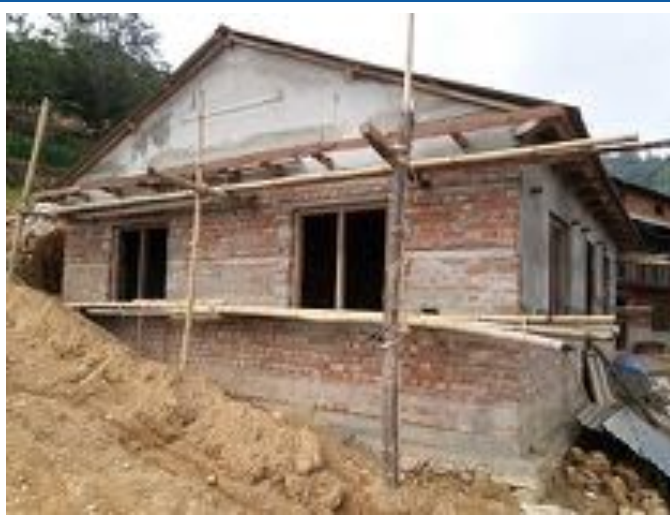
Beneficiaries Name: Sanokancha Tamang Lama, Ward no. 8, Thaple, Nagarjun Municipality. BMC wall system house were found to be missed with rafters and battens on the roof including of improperly done bracings. Attic height was also found to be over extended than the standard size. The house owner has already received 2<sup>nd</sup> tranche while for 3<sup>rd</sup> tranche claim, M & E consultant informed that a careful and detail discussion will be conducted to address cases of this kind of house.

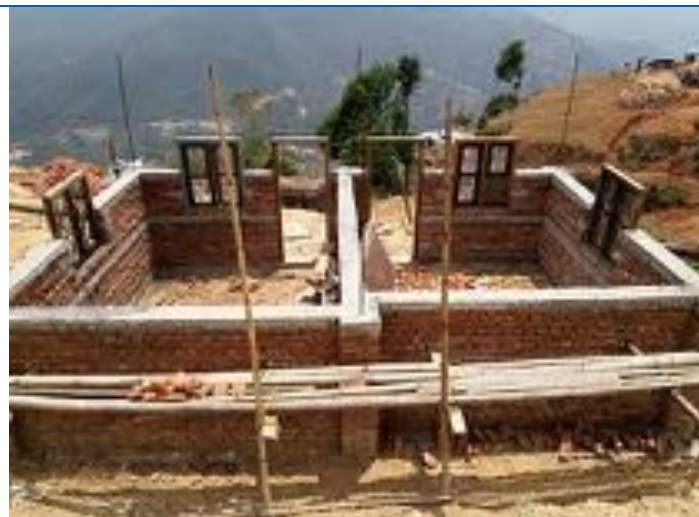
Beneficiary Name: Parikshya Tamang Ward no. 8, Thaple, Nagarjun Municipality. BMC wall system house with improper placement of sil band and missing of steel on two sides of window and door. The 2<sup>nd</sup> tranche inspection was forwarded while the owner was suggested to apply correction measures to become eligible for 3<sup>rd</sup> tranche.

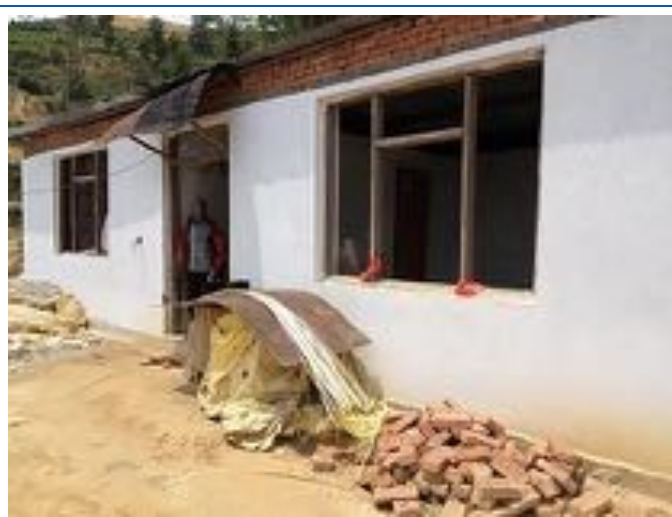
Beneficiary Name: Santosh Tamang, Ward no. 8, Thaple, Nagarjun Municipality. BMC wall system house with missing of roof bands while lintel band were kept properly. 2<sup>nd</sup> tranche inspection were forwarded while the owner was suggested to apply correction measures to become eligible for 3<sup>rd</sup> tranche.

| | Roof band were missing along with corner stitch in most of the houses under construction. | For the houses that have already completed construction with roofing and houses that have raised wall only must apply correction measures in order to become eligible for the successive tranche. Engineers should provide the onsite technical support for the houses that needs application of such correction measures. | Beneficiaries, local bodies, DLPIU engineers. | Before end of Ashad 2075. |

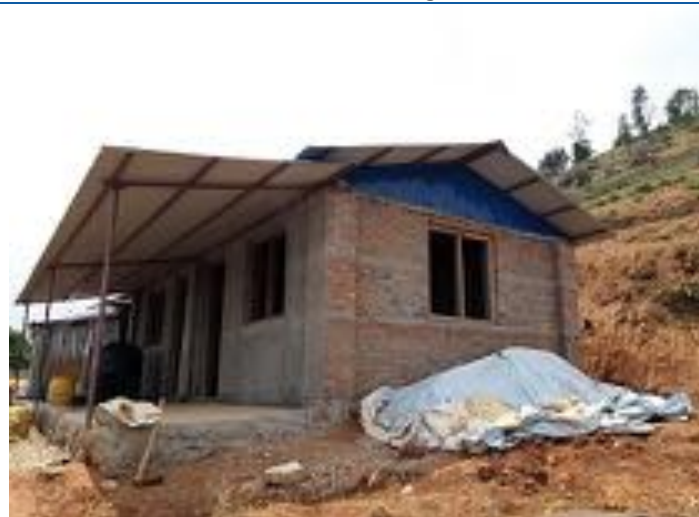
Beneficiary name: Thulokancho Tamang, Ward no. 8, Thaple, Nagarjun Municipality. BMC wall system house with CGI sheet as roofing material. Lintel band hasnot properly touched the window while lightweight portion of CGI sheets were used to connect the wall with the roof. 2<sup>nd</sup> tranche inspection were forwarded while the owner were suggested to apply correction measures to become eligible for 3<sup>rd</sup> tranche.

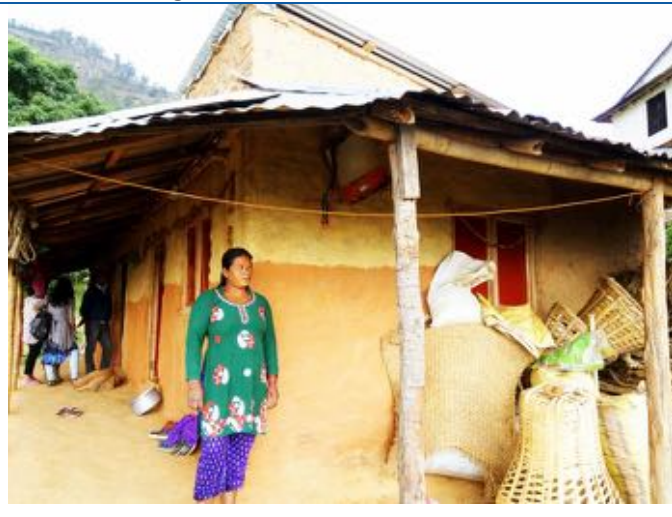
Beneficiary name: Shyam Bahadur Tamang, Ward no. 8, Dubichaur, Nagarjun Municipality. Stone masonry structure wall system house with CGI roof. The beneficiary has received 1<sup>st</sup> tranche. The house were found to be non-compliance as suggested by M & E Consultant that the application of correction measures is not easy.
