## Monthly District Report

### Lalitpur, Bhaktapur

12 July- 22 August 2019

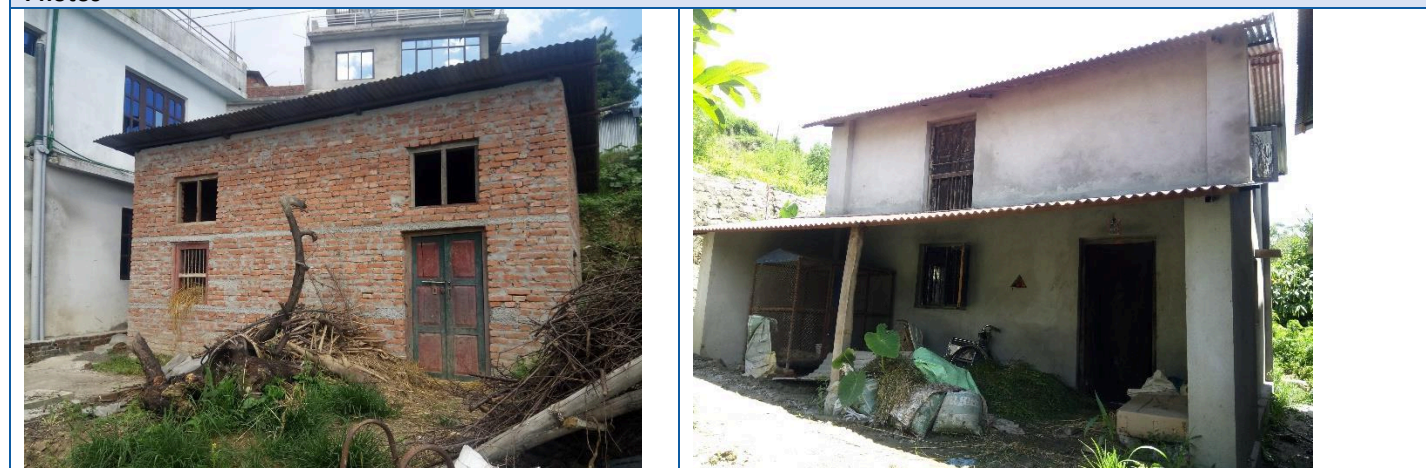
| Beneficiary name: Deepak Phnuyal, Ward no. 8, Sudal, Changunarayan Municipality, 1 storey plus attic wall system BMC house has 2 rooms. Owner has used salvaged material and has received 1 <sup>st</sup> tranche only. In order to make the house complaint, the owner was suggested to keep a long band right down the roof band and right above the windows in center. The rebuild house is being used as storage of fodder and as shed for cattle. | Beneficiary name: Kanchhi Dangal, Ward no. 8, Sudal, Changunarayan Municipality, 1 storey plus attic wall system BMC house has 2 rooms. Attic height increased and salvaged material has been used. Ground floor has 9 inch wall, corner stitch and bands has claimed to be kept by the owner who has received 1 <sup>st</sup> tranche and applied 2 <sup>nd</sup> and 3 <sup>rd</sup> tranche together. Currently the rebuild house is being used as storage of fodder and as shed for cattle. |

| Challenges / Issues Identified | Solutions Provided | Decision Taken | Responsible | Timeframe |
|---|---|---|---|---|
| Beneficiaries are so much concerned and attentive about accessing government grants only rather than rebuilding a compliant and liveable houses | Application of correction methods using chicken wire mess and wall jacketing was suggested to beneficiaries. | Concerned beneficiaries will do their best to apply correction methods to their rebuild houses. | Beneficiaries | As soon as possible |

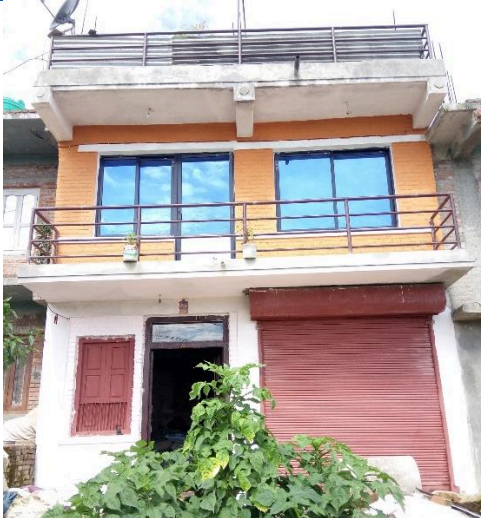
| Beneficiary name: Ashkumar Kasula, Ward no. 9, Nagkhel, Suryabinayak Municipality, 5 rooms 2 storey RCC house is complaint and has received all 3 tranche from government. | Beneficiary name: Chaityaram Byanju and Shankar Das Byanju ( <i>multiple beneficiaries</i> ), Ward no. 9, Nagkhel, Suryabinayak Municipality, 2 rooms in each house 1 storey RCC house is complaint and has received all 3 tranche from government. The two rooms each belongs to multiple beneficiary which is separated by two door each. | |

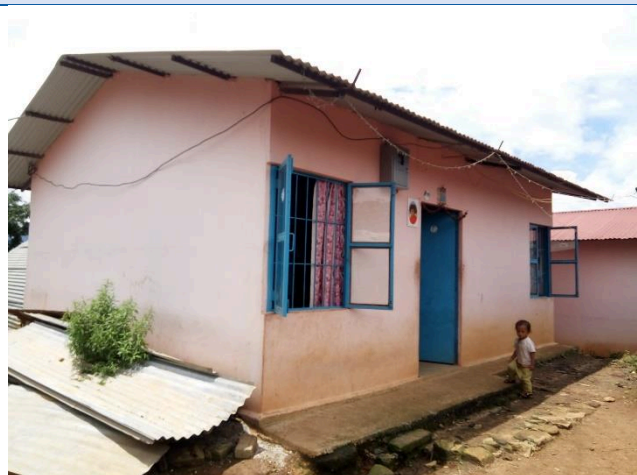
Image: A typical house made from support of Satya Sai Kendra at Ward no. 6, Shikharpa, Godawari Municipality. 3 rooms with bamboo infill as wall and plastering are done but no toilet. Steel post are used as frames and CGI sheets as roofing material.

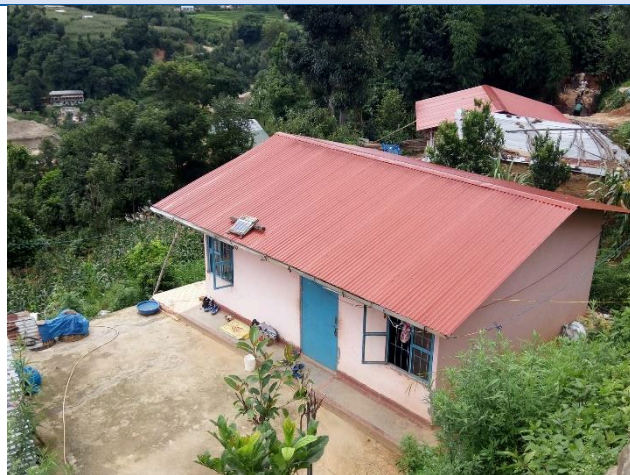
Beneficiary name: Sanumaiya Nagarkoti, Ward no. 6, Shikharpa, Godawari Municipality, 3 rooms with bamboo infill as wall and plastering are done but no toilet. Steel post are used as frames and CGI sheets as roofing material.

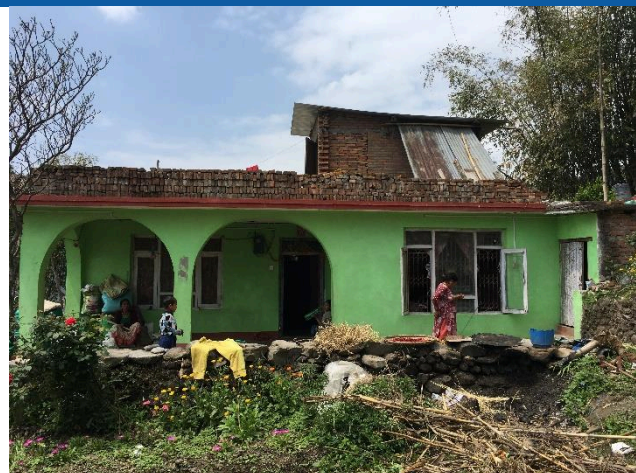
Beneficiary name: Ward no. 5, Changunarayan Municipality, 1 storey load bearing BMC. Non-compliance structure (missing beam, bands). The house was constructed immediately after earthquake.

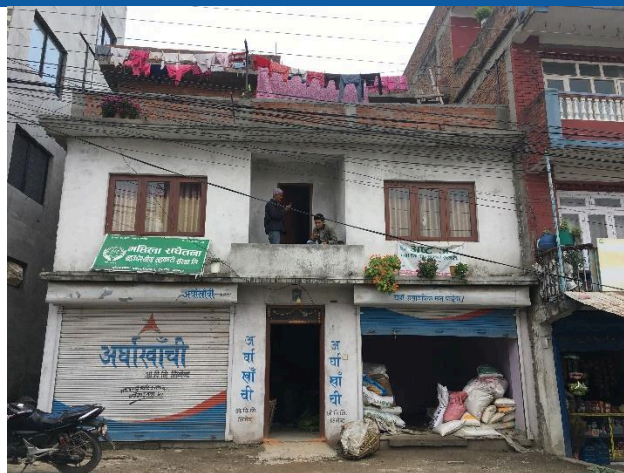
Beneficiary name: Jiban Poudel, Ward no. 2, Changunarayan Municipality, Bhaktapur, RC frame structure, non-compliance (9"X12" column- unsafe during analysis), constructed immediately after earthquake

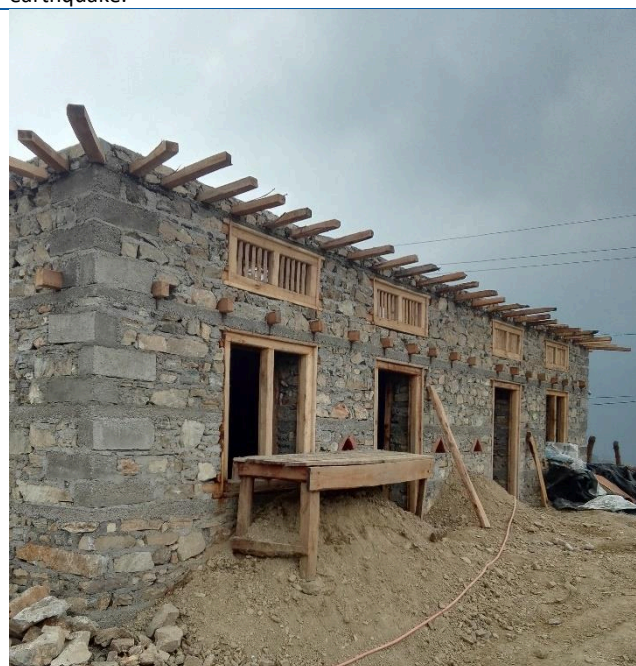
Beneficiary Name: Hubbaraj Sapkota, Ward no. 4, Kaleshwor, Mahankal Rural Municipality. Load bearing 1 storey SMC house plus attic has requested for 3<sup>rd</sup> tranche during inspection. Date: 180915

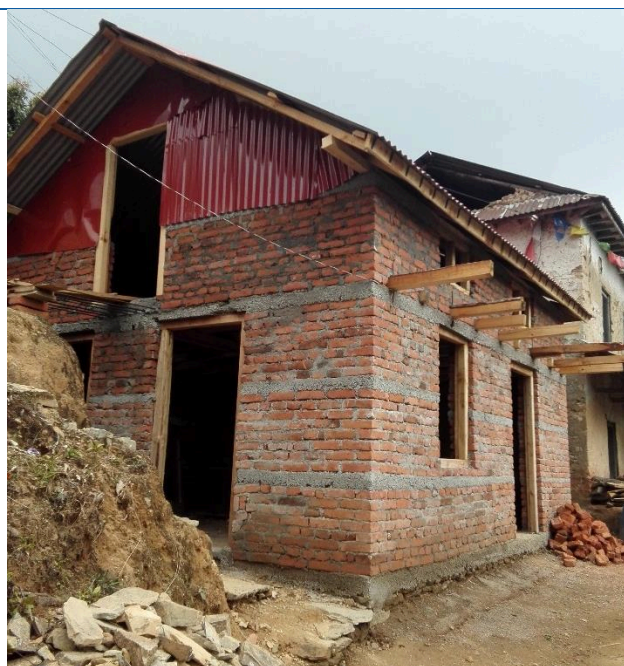
Beneficiary Name: Bhakta Bahadur Waiba, Ward no. 4, Kaleshwor, Mahankal Rural municipality. Load bearing 1 storey BMC house plus attic has requested for 3<sup>rd</sup> tranche during inspection. Date: 180915
