# District Report

## Sindhupalchok

3-9 November 2017

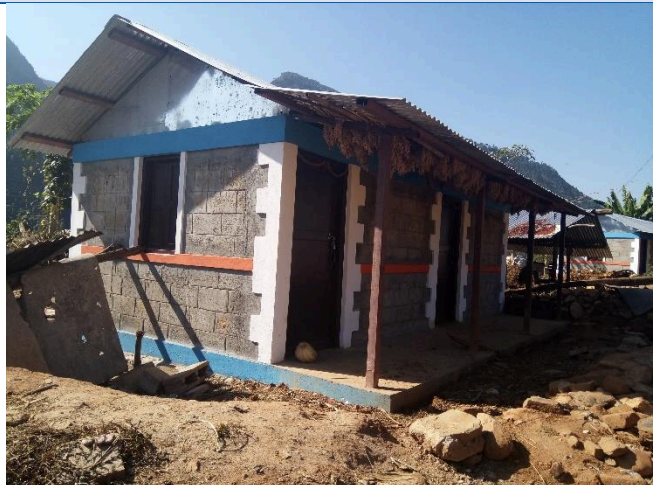
Majhi Basti, Bhimtar, Indrawati Gaupalika, Sindhupalchok. A house made up of hollow concrete blocks constructed in OJT by World Vision, ARSOW Nepal and Build Change.

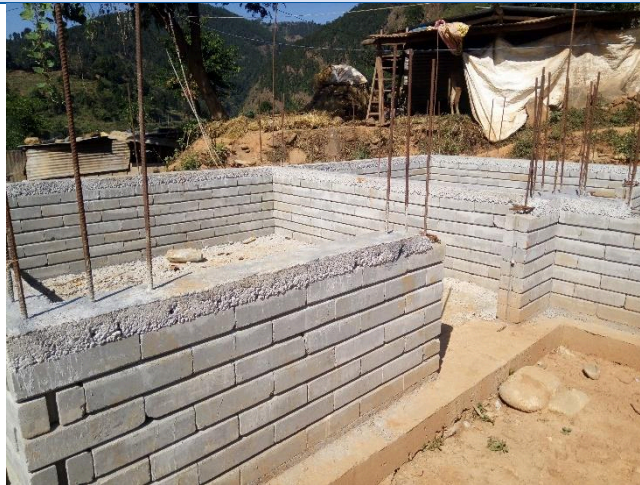
Majhi Basti, Bhimtar, Indrawati Gaupalika, Sindhupalchok. A house made up of interlocking blocks constructed by Sweta Shree Foundation.

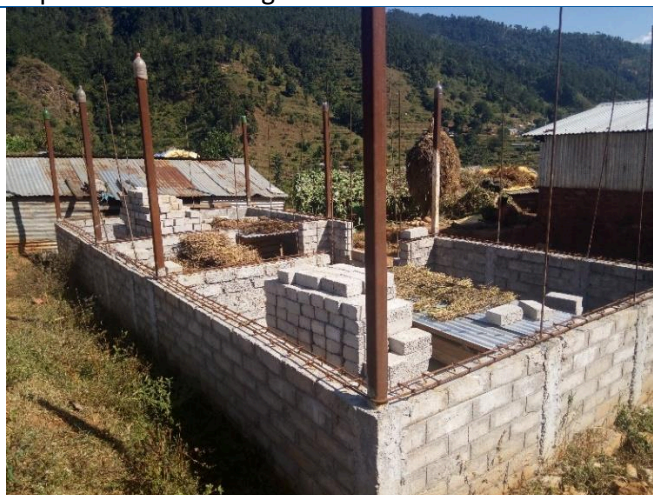
| Date | Location | Participants | |
|---|---|---|---|
| <ul style="list-style-type: none"><li>• WOREC Nepal hasn’t been able to process files for 2<sup>nd</sup> tranche as the houses have vertical posts of 75mm*75mm instead of reinforced bars.</li></ul> | Approval required from the Government | <ul style="list-style-type: none"><li>• Government and WOREC Nepal</li></ul> | End of Poush |

Majhi Basti, Bhimtar, Indrawati Gaupalika, Sindhupalchok. A house made up of solid concrete blocks constructed by WOREC Nepal. The houses have vertical posts of 75mm\*75mm instead of reinforced bars and they are on hold for the 2<sup>nd</sup> tranche.

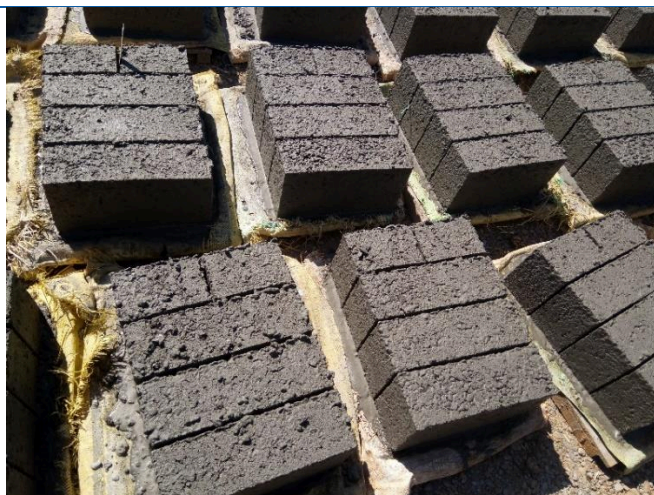
Majhi Basti, Bhimtar, Indrawati Gaupalika, Sindhupalchok. Production of solid concrete blocks. At a single time, 3 solid concrete blocks and 2 cutoff blocks are produced. The blocks are in the ratio of 1:3:6 and the test has been performed and approved.

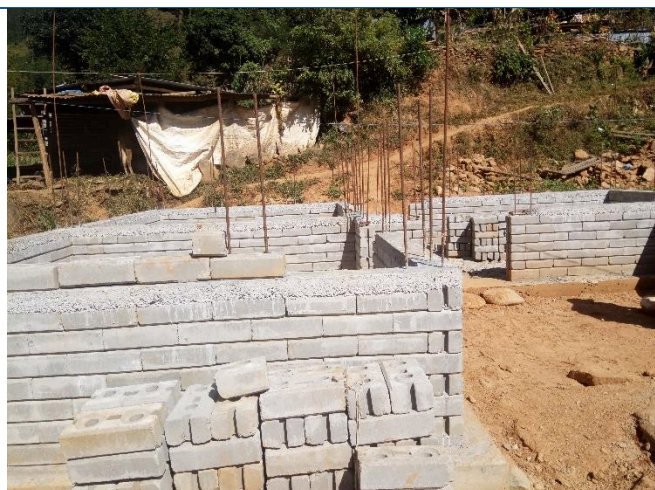
Majhi Basti, Bhimtar, Indrawati Gaupalika, Sindhupalchok. A house made up of interlocking blocks constructed by Sweta Shree Foundation.

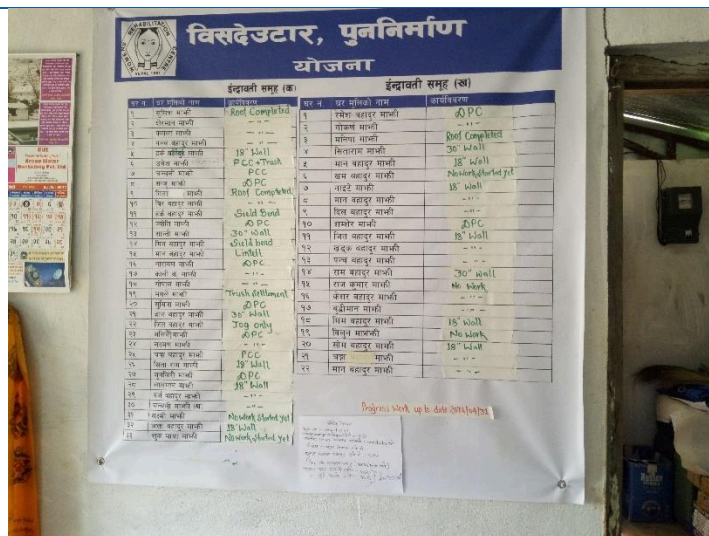
Majhi Basti, Bhimtar, Indrawati Gaupalika, Sindhupalchok. The progress of the houses made by WOREC Nepal however, the files haven't been forwarded for 2<sup>nd</sup> tranche.

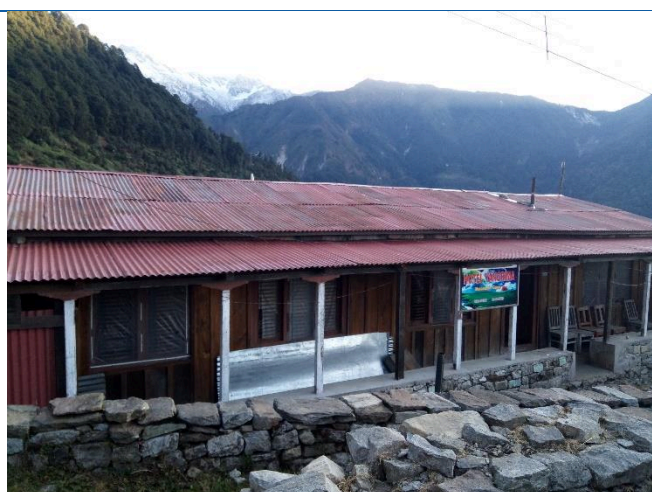
Melamchighyang, Helambu. An example of the type of house that the locals prefer.

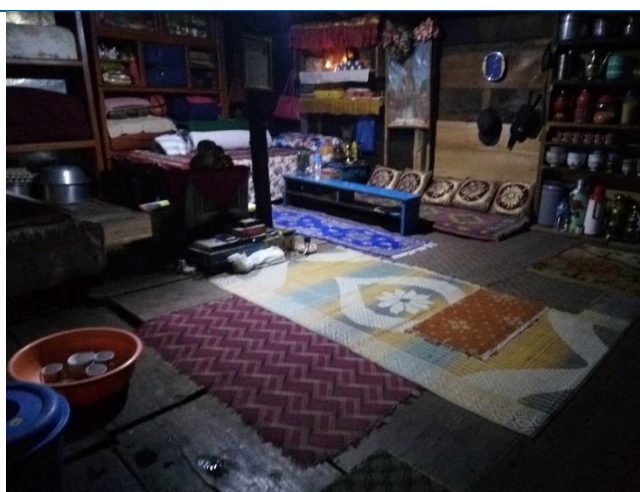
Melamchighyang, Helambu. The kitchen and room lie together in their culture.
