## Makwanpur

4 – 17 January 2019

## Field Visit /Joint Field Monitoring Visit Reports

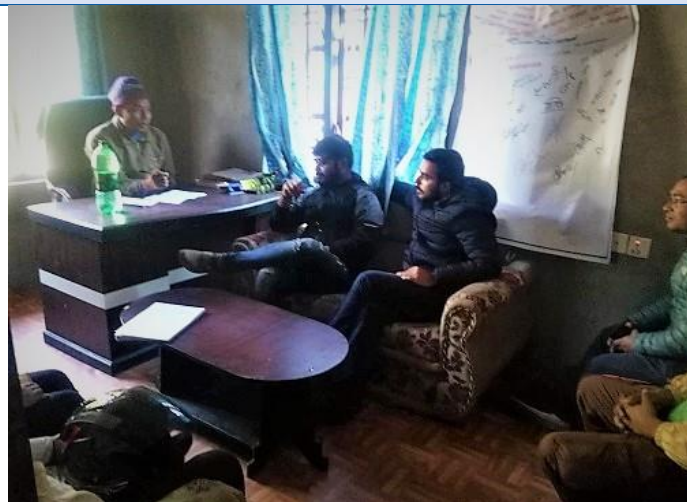
*Figure 1: Technical coordination meeting has been organized in Manhari Rural Municipality-06; the agendas were present scenarios of reconstruction, final inspection of completed houses, CS entry and plan to distribute the completion certificate, non-compliance issues and AoB.*

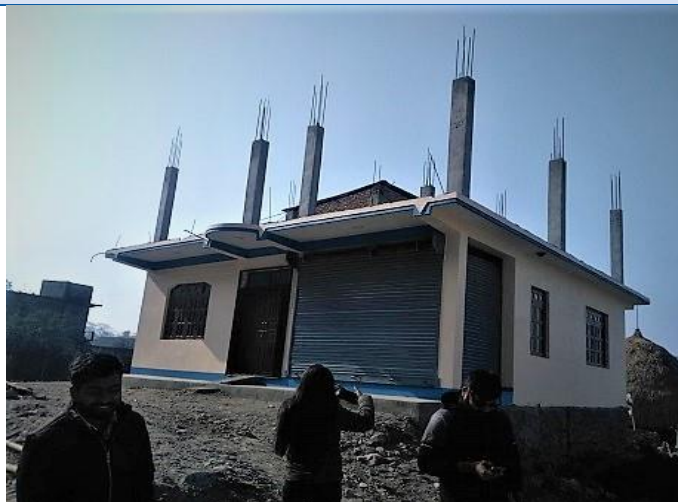
*Figure 2: Manhari Rural Municipality-06, house owner- Khadak Man Sherstha, RCC frame structure, received second tranche and verified for third tranche. Almost houses are constructing with hollow concrete block masonry in Manhari Rural Municipality. In some places of Manhari RM, also RCC frame structure constructed. In this case of house, 12'x12" pillar size provided but he doesn't provide sufficient rod like as 8nos. of rod, after analysis done by DSE, this house was eligible for third tranche.*

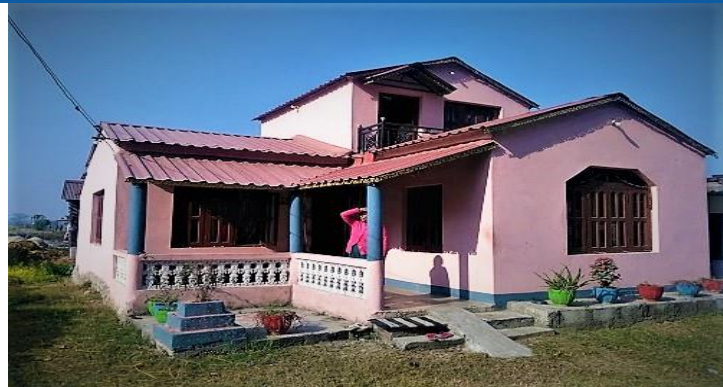
*Figure 3: House owner; Laxmi Adhikari, Manhari Rural Municipality-6, load bearing brick masonry materials used in this house, second tranche received by house owner but for third tranche, required some correction. We can see in plan view, this house look like as L-shaped but in actually in field connected by wall in middle portion, we judged during field visit, 3rooms, used brick materials, all seismic resistant components provided, light roof, strongly truss connected with wall and one storey. We suggested for third tranche after that ward engineer planning to submit the file for third tranche.*

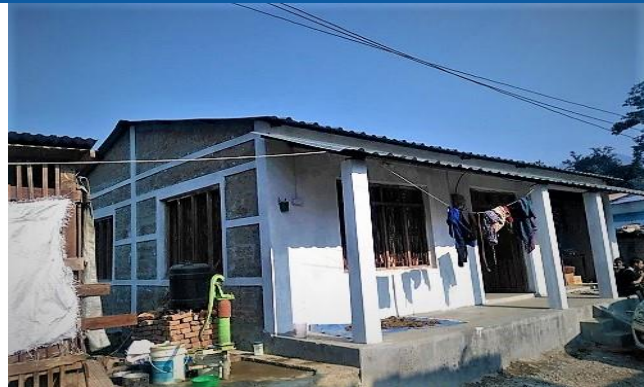
*Figure 4: House owner; Dul Kumar Rijal, Manhari Rural Municipality-06, Load bearing brick in cement mortar used and 4nos. of rooms with flexible roof. All seismic resistant elements were provided and he received all three tranches of government reconstruction grant. The total tentative cost of this is house is around 15lakh.*

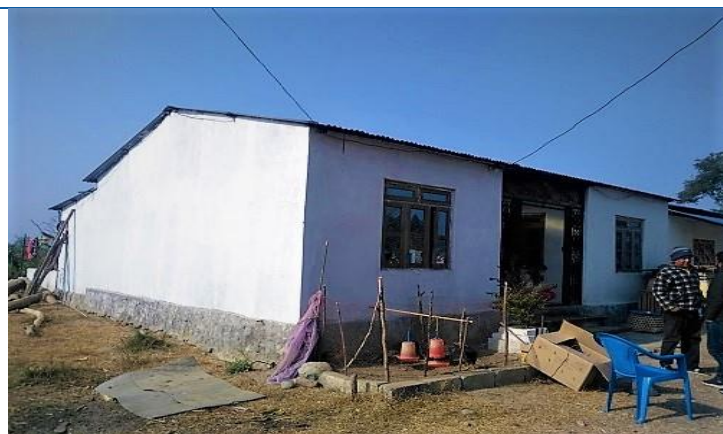
*Figure 5: House owner; Rajendra Rimal, Manhari Rural Municipality-06, two types of materials used, block masonry and brick in cement mortar. In outer portion brick masonry used and in partition wall, hollow concrete block used, according to house owner. First of all this house had constructed before deployed the government technicians. Now, we could not prove it, how types of material used, provide or does not provided bands. But we believe the house owner and we (DSE) recommended used some correction. Like as wall tightening with horizontal and vertical bands and meet to compliance and strong and finally earthquake resistant structure. Always we suggested to beneficiaries in field level in simple way. In case of this house, we recommended for collection materials like as Gabion wire, chicken wire mesh (kukhure Jali), drill machine, hammer, nail etc. similarly, remove the plaster for existing portion and in every 30cm interval of wall from the some below of GL, create hole by drill machine after put the chicken wire mesh for stronger. In every hole tight by GI wire mesh with Chicken wire mesh. Finally we can do it and make partition wall strong connected with outer portion of vertical post. Sometimes in field level, we said to technicians used jacketing method.*

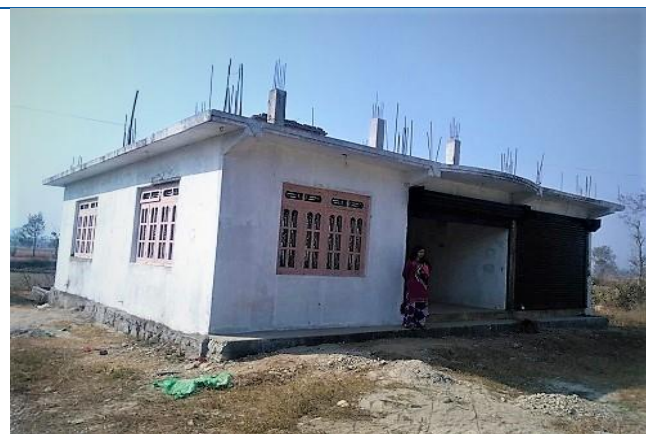
*Figure 6: House owner; Lila Ram Karki, Manhari Rural Municipality-06, RCC frame structure, during joint monitoring, our technicians never carry the engineers tools; like as tape, diary etc. it is a truth. In case of this building. Technicians were conformed for huge opening. But actually in filed we measure the span to span length of pillar and it doesn't exceed 4.5\*4.5 (in m). We strongly advised to technicians, sure confidence before work done and finally this house became (eligible) for third tranche.*
