# District Report

## Sindhupalchok

5-8 February 2018

### Field Visit Reports

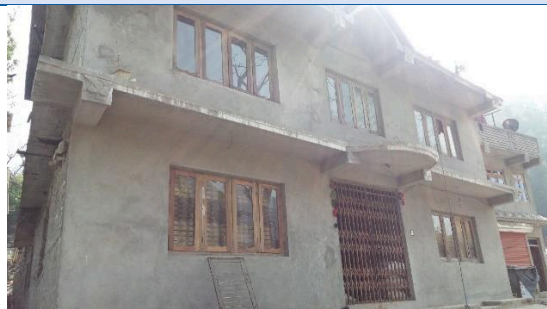
| Date | Location | Participants | |
|---|---|---|---|
| 2. Houses of single room with size less than 117 sq ft have been constructed. | | | |

Pic: A beneficiary had already constructed a non-compliant house (pic below) so she made this small one sized room to get the tranche.
