# Fortnightly District Report

## Kathmandu Valley

1 – 14 February 2019

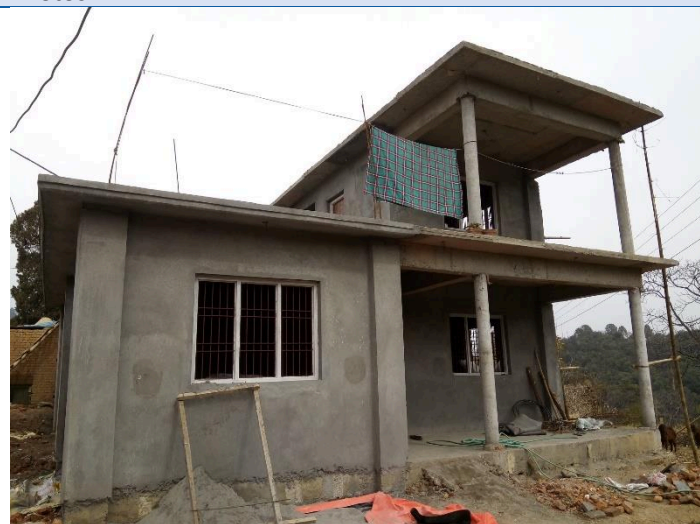
Beneficiary name: Akrur Acharya, Ward no 7, Ratmate, Gopaleswor, Dakshinkali Municipality. 1.5 storey, 4 roomed BMC structure. The cantilever part of this house is supported by 4 show columns just started from plinth beam to 1<sup>st</sup> floor beam. The beneficiary has received all three tranches from government. A total of 34 lakh were spend in reconstruction of this structure as reveled by beneficiary. During M & E visit, District Support Engineer has discovered flaws on column, so the beneficiary was suggested to provide jacketing to the columns for that the house to be safe. Further, DSE of DLPIU Building Kathmandu will study the file of this house in detail.

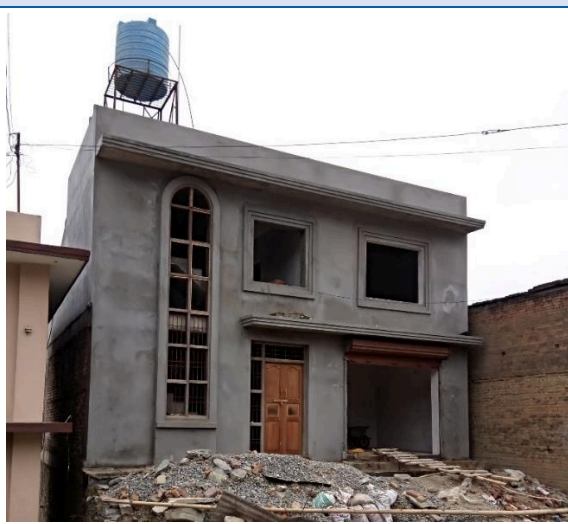
Beneficiary name: Sanubhai Acharya, Ward no. 7, Yutiki, Dakshinkali Municipality. 2 storey RC frame structure. The beneficiary has received all 3 tranches from government.

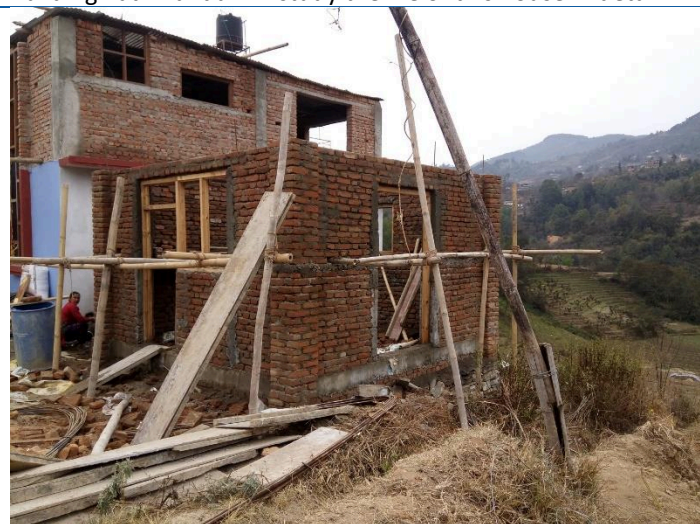
Beneficiary name: Laxman Rimal, Ward no .7, Yutiki, Dakshinkali Municipality. Single storey 1 room BMC house with CGI sheets has missed majority of bands. Beneficiary has received 1st tranche only and were suggested to keep bands to become eligible for further tranches.

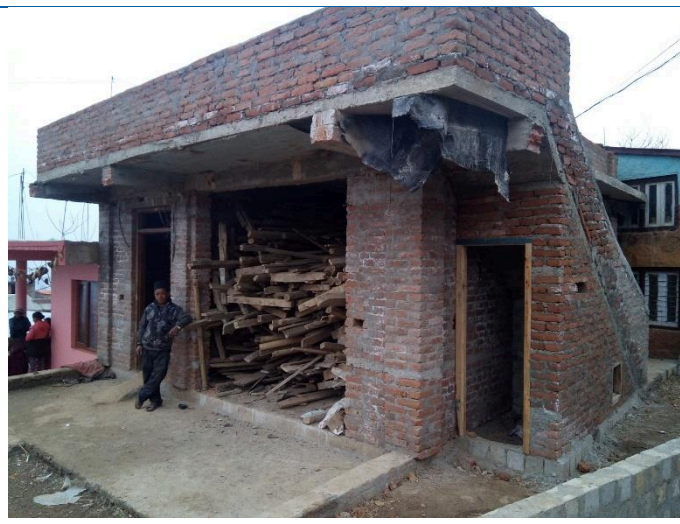
Beneficiary name: Kale Nagarkoti, Ward no. 1, Champadevi, Dakshinkali Municipality. Single storey BMC structure has 2 rooms with rolling shutters. M & E consultant has suggested to keep I- beam on two sides of shutters to make the structure safe. The beneficiary has received up to 2nd tranche from government.

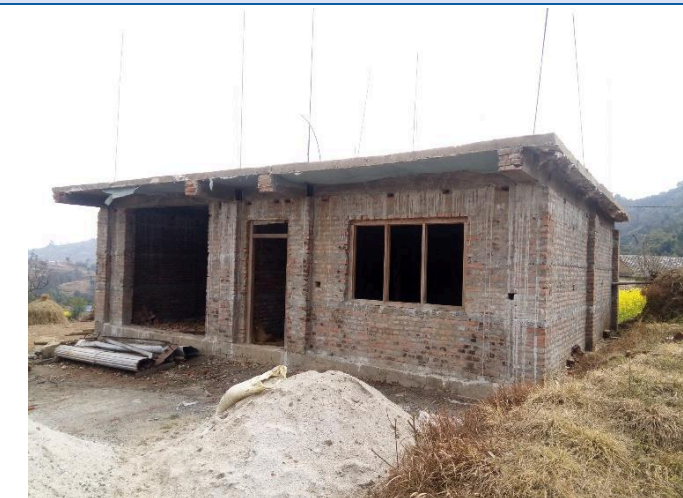
Beneficiary name: Gyanu Lama, Ward no. 3 Jaharsinghpauwa, Shankharapur Municipality, Kathmandu. Single storey, 4 roomed BMC house has plan to keep 1 rolling shutter. The beneficiary has received up to 2<sup>nd</sup> tranche. M & E consultant have suggested beneficiary to keep reinforcements and to do casting of 4 inch on two sides each to be eligible for the grant.

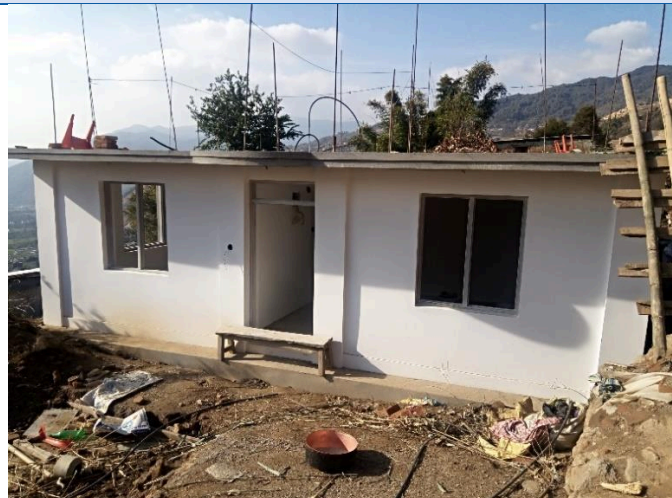
Beneficiary name: Biman Moktan, Ward no. 8, Moktan Tole, Bajrayogini, Shankharapur Municipality, Kathmandu. 4 roomed BMC house has approved building drawing up to 1<sup>st</sup> storey only. Beneficiary has received up to 2<sup>nd</sup> tranche. M & E Consultant have suggested this house as complaint house and is eligible for 3<sup>rd</sup> tranche too. Beneficiary were suggested not to add another storey.

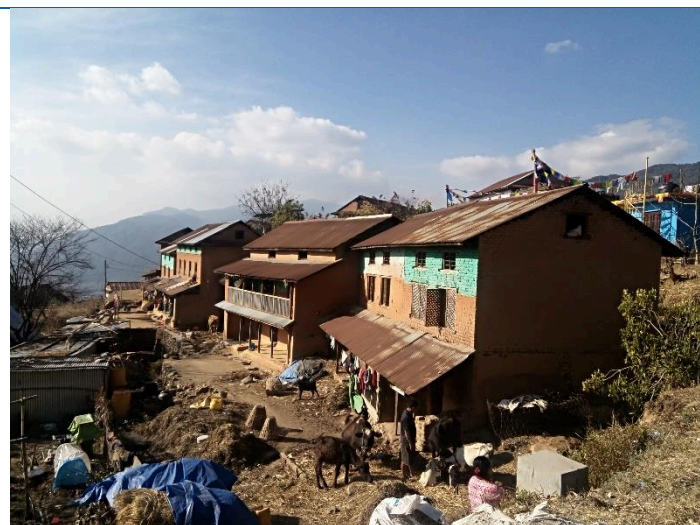
Ward no. 8, Moktan Tole, Bajrayogini, Shankharapur Municipality. Out of 591 beneficiaries of Ward no .8, around 60-65 houses belong to beneficiaries of Moktan Tole. 2015 Gorkha Earthquake had damaged most of the BMM 2 storey with attic houses in Moktan Tole. Majority of beneficiaries of Moktan Tole have received 1st tranche however very less have started reconstruction of their houses. Few beneficiaries have accessed up to 3rd tranche while few of them have submitted documents for 2nd and 3rd tranche together.

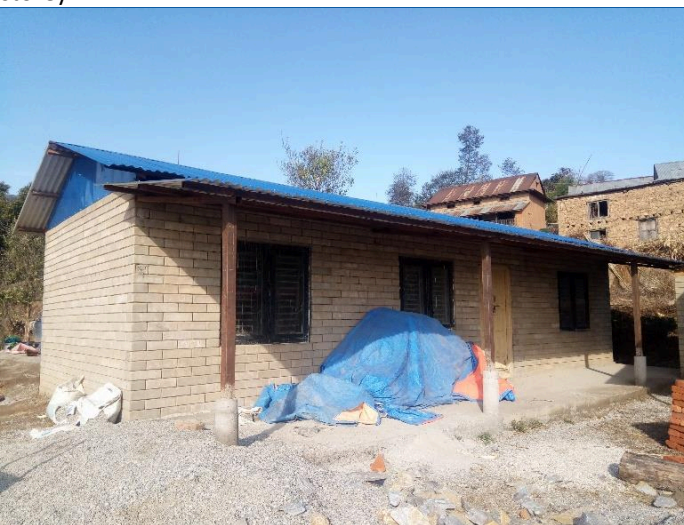
Beneficiary name: Som Maya Tamang, Ward no. 8, Moktan Tole, Bajrayogini, Shankharapur Municipality. 3 roomed single storey house is made of interlocking bricks with CGI roof. Beneficiary has accessed up to 2nd tranche. M & E Consultant have suggested this house as a complaint house and is eligible for 3rd tranche too and thus informed ward engineer to forward documents for 3rd tranche approval.

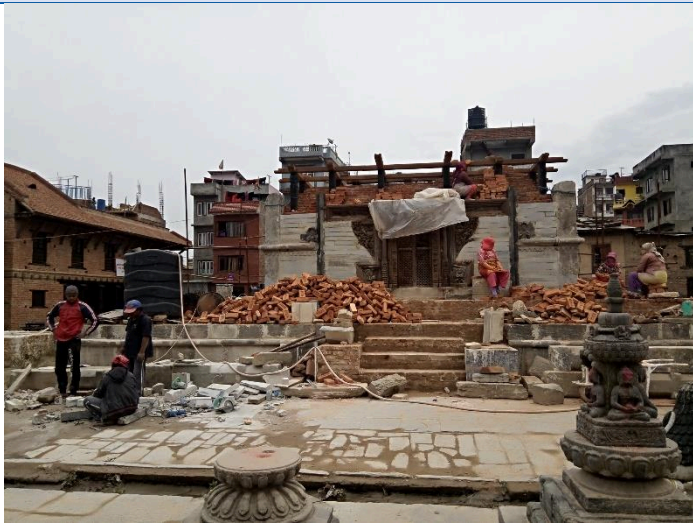
| The reconstruction and restoration project of the Rato Machhindranath Temple located at Ward no. 22 Bungamati, Lalitpur Metropolitan City is underway. Government of Srilanka is providing support for reconstruction of culturally important heritage monument. NRA is directly coordinating | | Photo: The reconstruction of <i>Satta</i> - in Nepali (religious houses in English) was supported by UN-Habitat after it was damaged by the 2015 earthquake. Cultural authenticity of this culturally important religious house was maintained during its reconstruction process. Bungamati Area Reconstruction | |

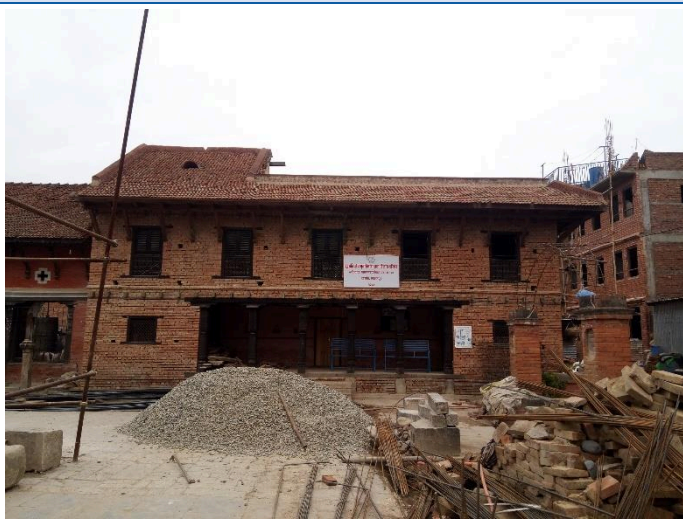
This house on reconstruction process is standing alone in between the earthquake damaged BMM houses on same row at Ward no. 22 Bungmati, Lalitpur Metropolitan City. The earthquake damaged houses belongs to multiple beneficiaries who are still residing in temporary shelters.

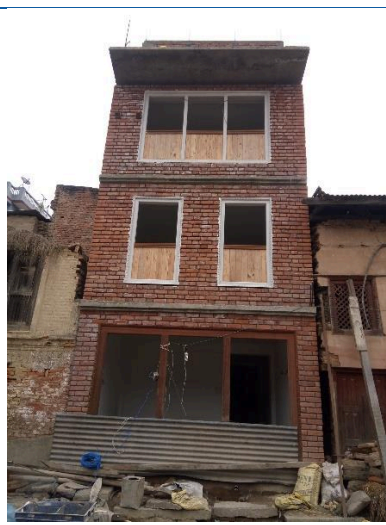
Beneficiary name: Ramkrishna Tuladhar, Ward no. 22, Bungmati, Lalitpur Metropolitan City. Single bay and 3.5 storey BMC structure has received 1<sup>st</sup> tranche only and applied for 2<sup>nd</sup> tranche. The beneficiary still resides in temporary shelters.

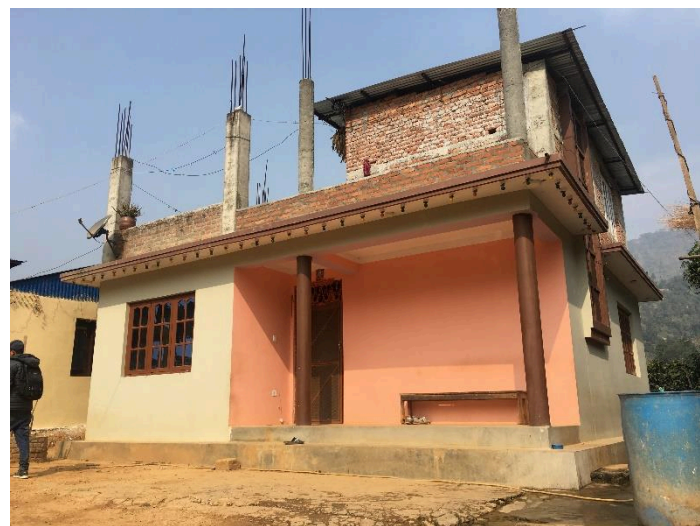
Beneficiary name: Mangal Tamang Ward no. 8, Pakhure, Nagarjun Municipality. RC frame structure has 3 rooms with single storey. The beneficiary has received all tranches

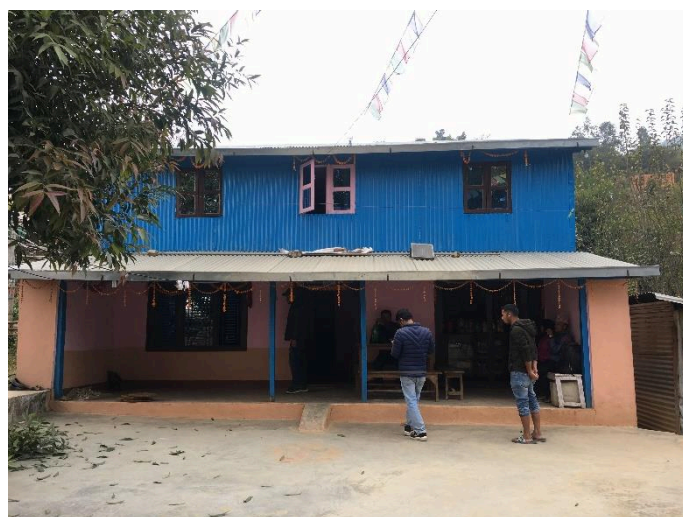
Beneficiary name: Dhalak Bahadur Tamang, Ward no 8, Bhirkot. Load bearing BMC structure with CGI covering in the second floor. The beneficiary has already received 2<sup>nd</sup> tranche and requested for 3<sup>rd</sup> tranche but as the room size is larger the house was found to be non-compliance. The correction measure was suggested to be eligible for the tranche.

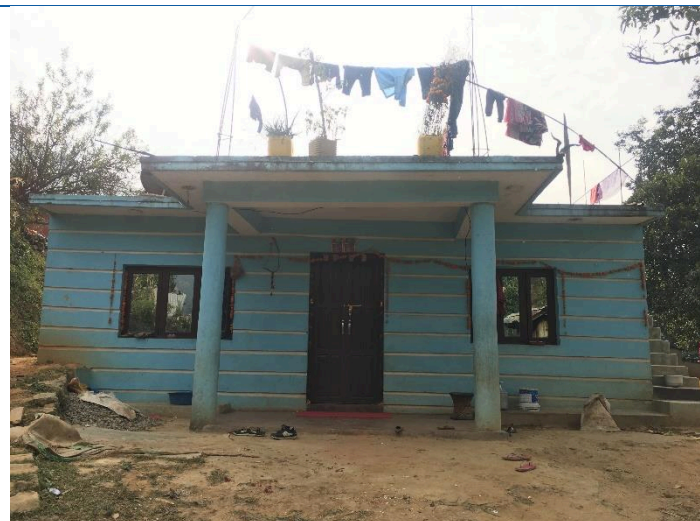
Beneficiary name: Shyam Prasad Gartaula, Ward no 8, Pakhure, Nagarjun Municipality. Load bearing BMC structure in 1 storey house with 4 rooms. Beneficiary has received all three tranches.
