# District Report

## Kathmandu Valley

26 January – 1 February 2018

## Field Visit Reports

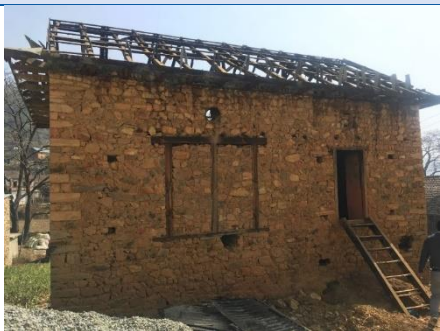
| Photos | |
|---|---|
| Ward no. 9, Dakshinkali Municipality, Kathmandu district, one roomed stone in mud mortar with two storey and attic. The house is being retrofitted with financial support from OXFAM and the beneficiary has also received 1 <sup>st</sup> tranche from government also. | The foundation of the column is casted, such type of column has placed in corner and at the distance of 2.1m. |
