Housing Recovery and  
Reconstruction Platform

# Hollow Concrete Blocks: Production and Use in Earthquake Affected Districts

May 2018

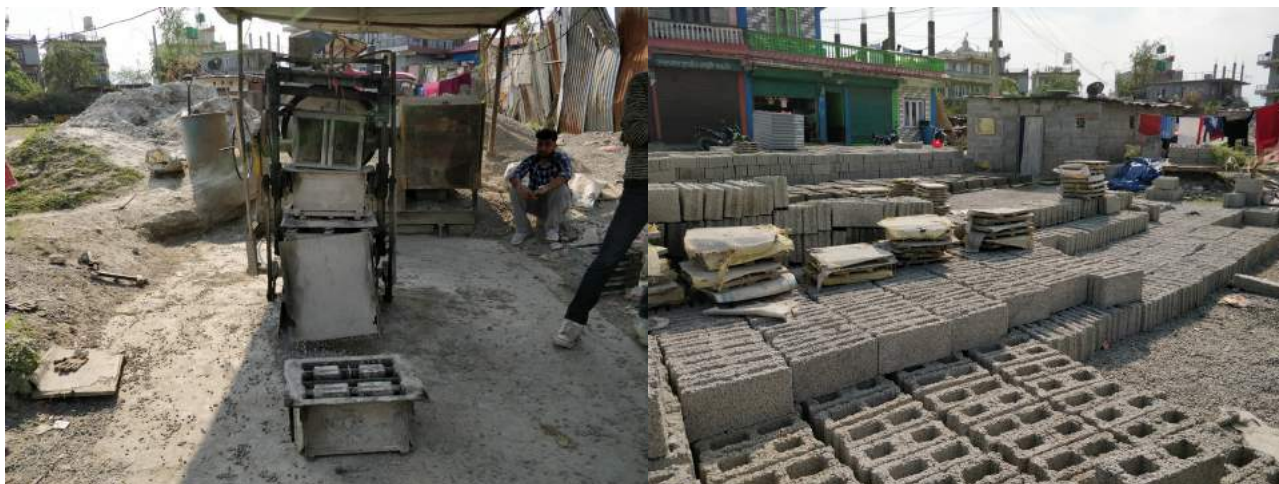
Lekhnath Municipality, Pokhara, Kaski: hollow concrete block production at 'Pokhara Block Udhog'. They produce 30 blocks from one bag of cement, and blocks cost between 40 and 60 NPRs per piece depending on the quality. They produce a maximum of 400 blocks per day.

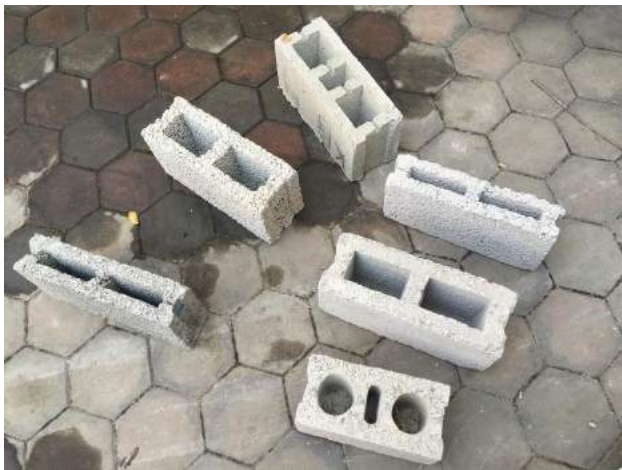
Variety of quality and shape of blocks available.

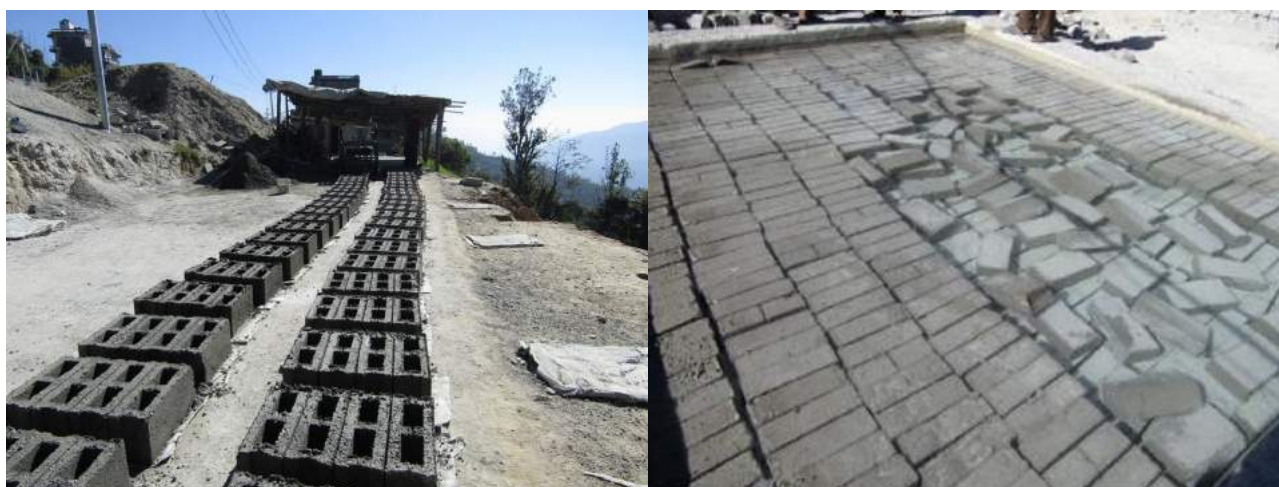
The average curing time across all producers is just 11 days and in the most recent set of data collected, Gorkha is the only district with an average curing time of greater than 14 days (16 days). It is worrying that there seems to be a trend in curing times reducing from the first round of data collection to the second. This can be seen in Kavre, Makwanpur, Nuwakot, and Sindhupalchok and only Dhading saw a small increase in the average curing time. Most HCB producers cure the HCBs for only seven days, but there are also HCB producers curing blocks for as little as three days. A small percentage of HCB producers cure the blocks for between 20 and 30 days. Several HCB producers indicated that they are aware that seven days is not sufficient curing time but they sell at this point due to high demand. It is possible that the reduction in curing times between round 1 and round 2 data collection could be linked to ever increasing demand. This is a worrying trend as it may indicate that the quality of HCBs is decreasing further due to demand.

Blocks are laid in the sun after production in Dolakha (L) and blocks submerged in a pond in Dolakha (R).

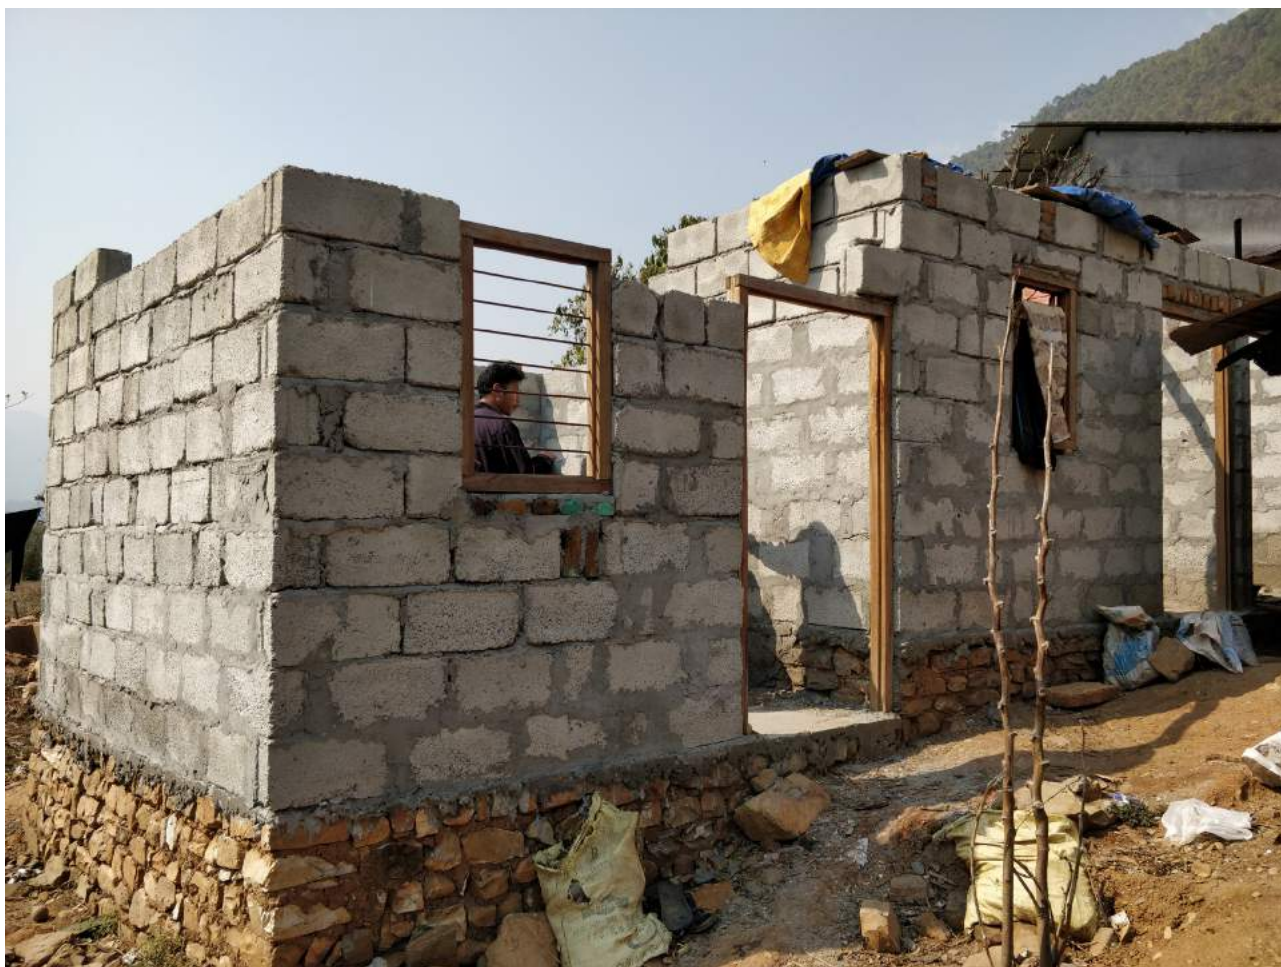
*Lekhnath Municipality, Pokhara, Kaski: one of more than 600 houses that have been constructed using hollow concrete blocks in this area. Households in the area regularly ask the GoN engineers for designs for HCB houses. The engineers have been providing the designs from the DUDBC Design Catalogue Volume 2, but households are not building according to these designs.*

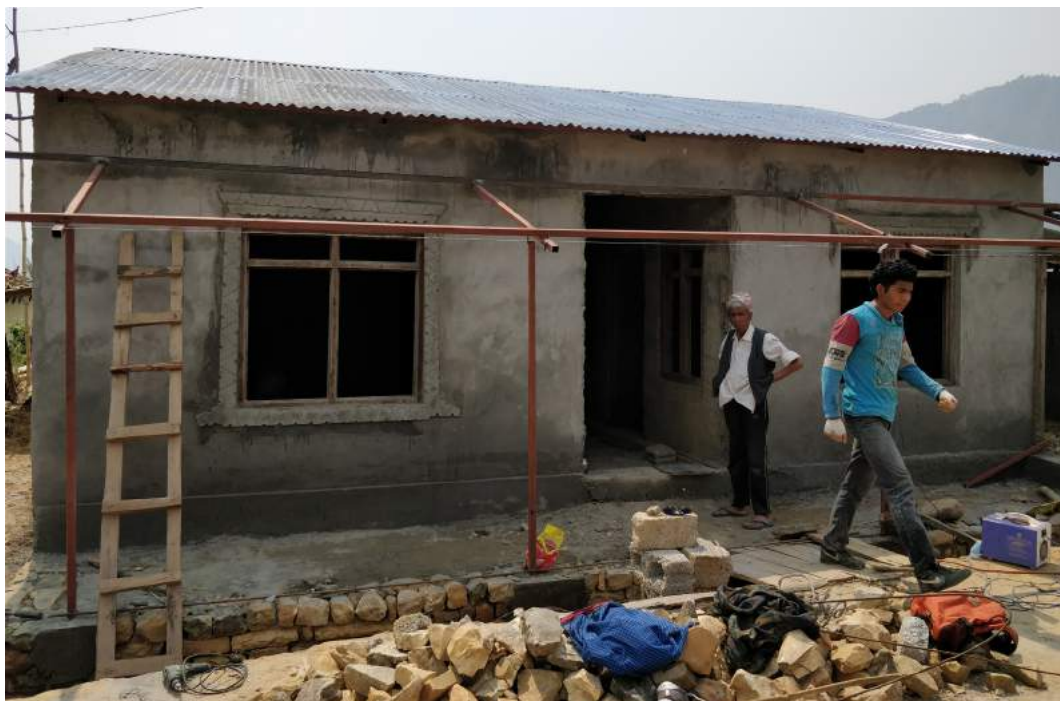
Modi Rural Municipality, Ward No. 6, Parbat (one of the 18 moderately affected districts): Purna Bahadur BK started construction of his 5 room house, with steel frame structure and hollow concrete blocks for the infill walls, just 1 month after the 2015 earthquake. He is still going through the grievance mechanism and he didn't know that this house would not be in line with government standards as there no guidance available previously and the inspection engineers have just been deployed.

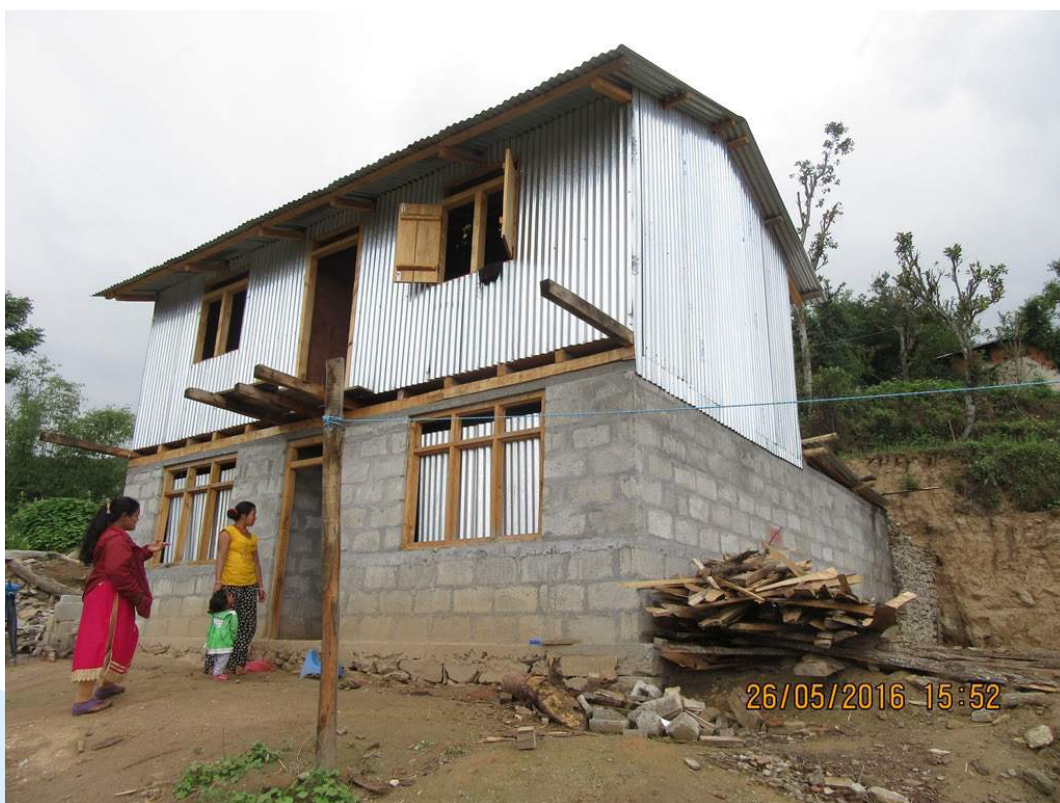
Hybrid construction in Dolakha with HCB construction on ground floor and timber and CGI first floor.

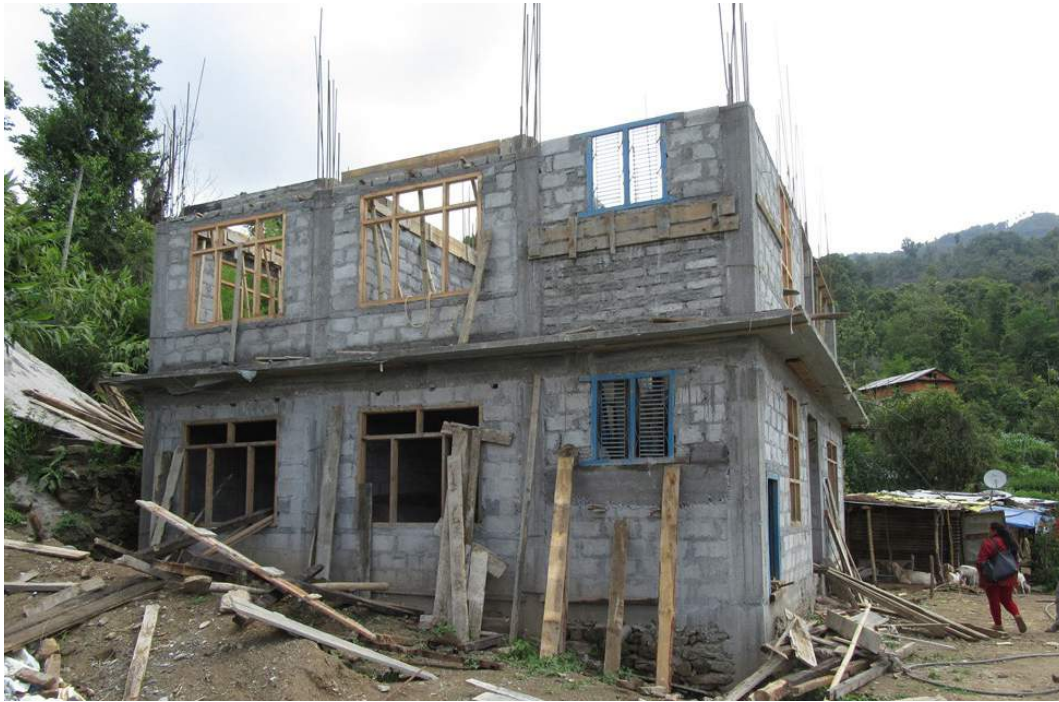
*RC frame building with HCB infill in Dolakha.*

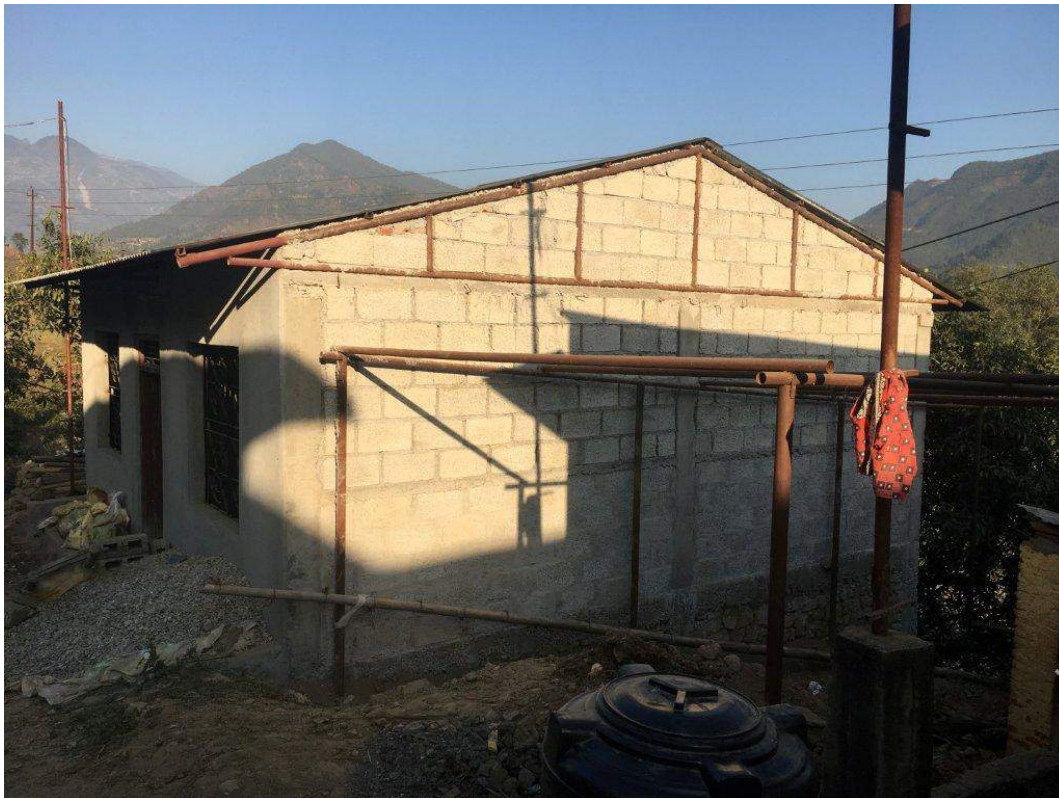
*HCB house with steel truss for roof in Nuwakot.*

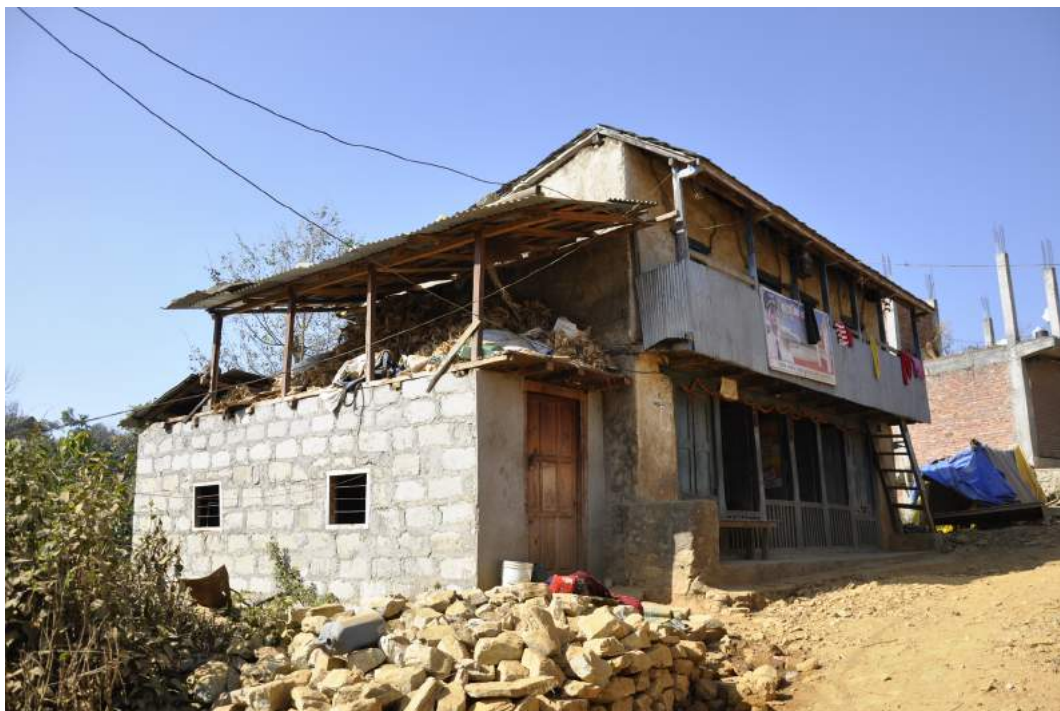
*HCB extension to a stone masonry house in Dhading.*

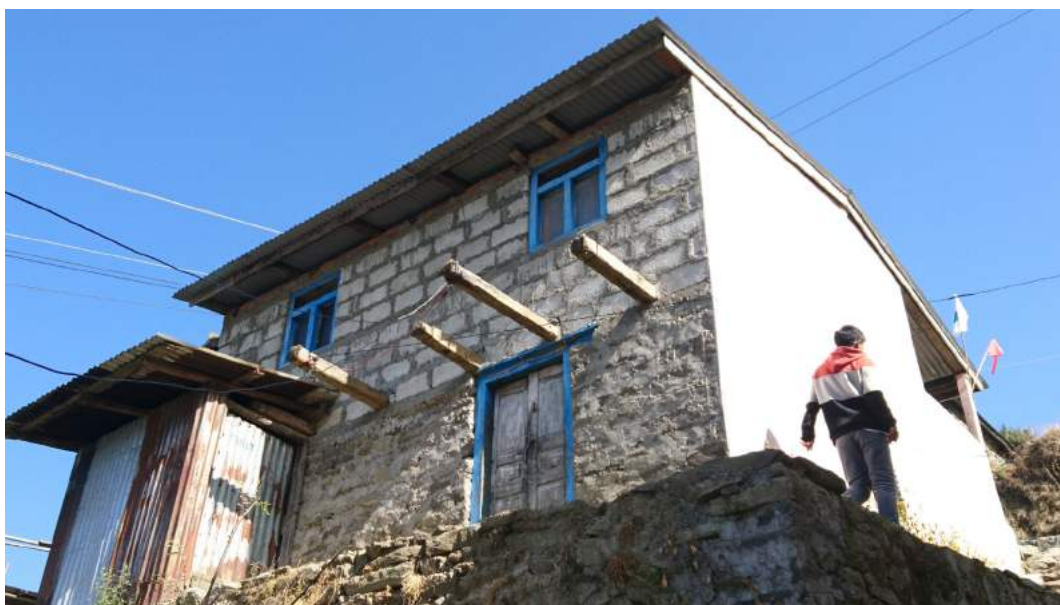
*HCB Construction Rasuwa.*
