# Rasuwa Glacial Flood

Situation Report #1  
(as of 10 July 2025)

Government of Nepal  
Ministry of Home Affairs  
**National Disaster Risk Reduction and Management Authority**  
Singhadurbar, Kathmandu

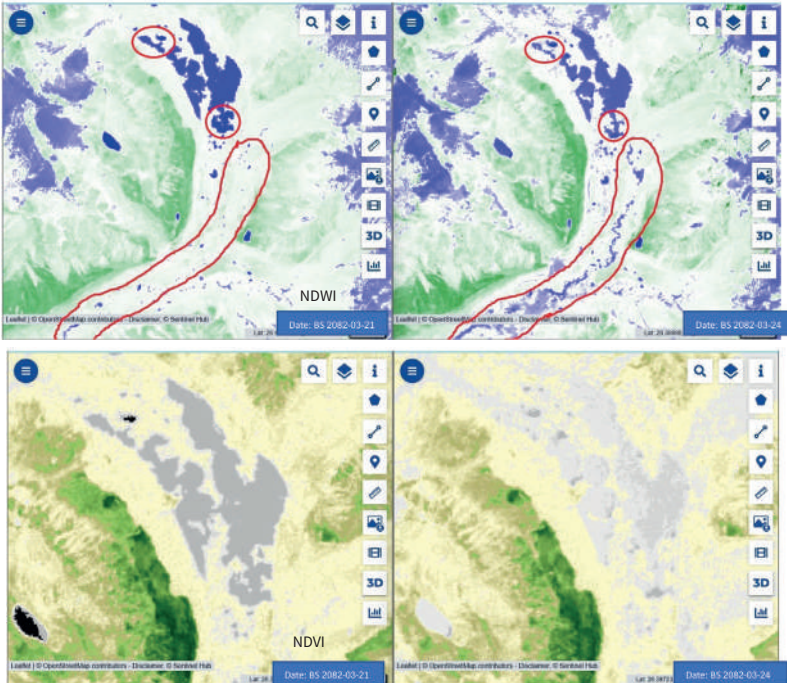
(Source : Sentinel - 2 Imagery, DHM)

Sentinel-2 imagery reveals the rapid development and subsequent discharge of a supraglacial lake on the Purepu Glacier, located approximately 35 km upstream from the Nepal–China border post.

Beginning in March 2025, supraglacial ponds started to form and gradually expanded through mid-May. From that point onward, a sharp increase in surface water was observed, culminating in a lake area of approximately **0.525 km<sup>2</sup>** by 28 June (source: ICIMOD). Continued coalescence and expansion led to the formation of supraglacial lake measuring around **0.75 km<sup>2</sup>** by 07 July (source: DHM).

On 08 July, the lake had undergone a rapid decline in area, shrinking to approximately **0.6 km<sup>2</sup>** (source: DHM). Drainage features visible on the glacier surface that day indicate that at least part of the outburst occurred supraglacially, suggesting a complex drainage pathway contributing to the downstream flash flood.
