## Monthly District Report

### Lalitpur, Bhaktapur

14 June - 14 July 2019

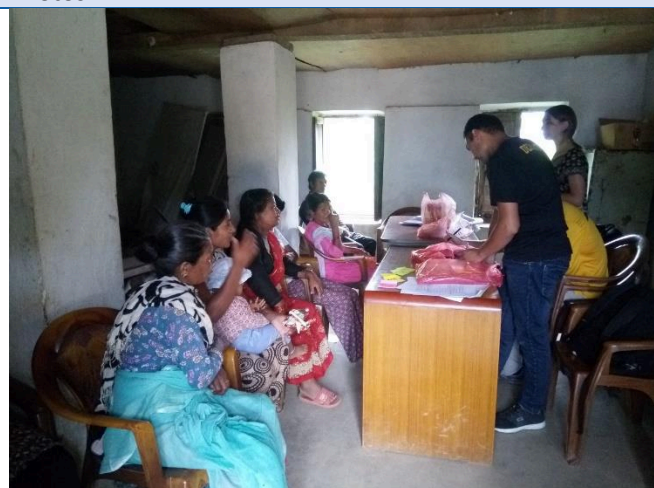
Image: Focused group discussion activity in progress. During the discussion, the participants was told to prioritize the most preferred area of the house in order to learn about perceived future disaster risk and the knowledge about mitigation. Majority of beneficiaries highlighted the need of security to livestock which is as important as their lives because of their dependency for income.

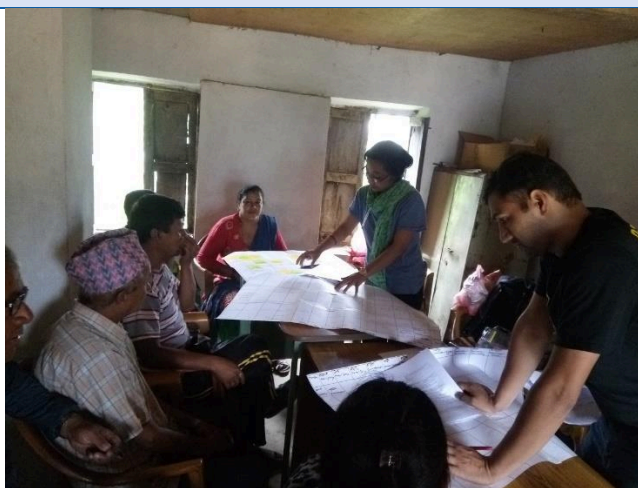
Image: Recovery timeline activity in progress. During this exercise, participants were informed to prepare recovery timeline since the period of earthquake 2015 till date. Majority of beneficiaries included residing in temporary shelter for nearly 1 year or more and headed towards reconstruction of house. The beneficiaries also prioritized the main needs during recovery period and also the drivers of recovery (things that helped them to recover their lives into normalcy)

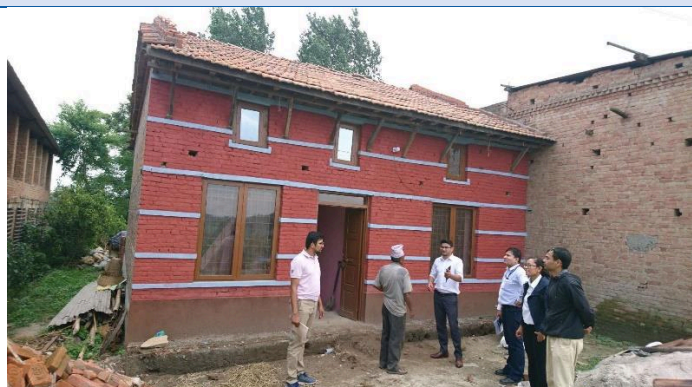
Beneficiary name: Shyam Bahadur Yandyo, Ward no 3, Changunarayan Municipality. Two storey BMM house with attic has 2 rooms. The owner has received 1st and 2nd Tranche. Attic height was more than desired value but proper bands and connections was provided so the house was certified for 3rd tranche from the inspection visit.

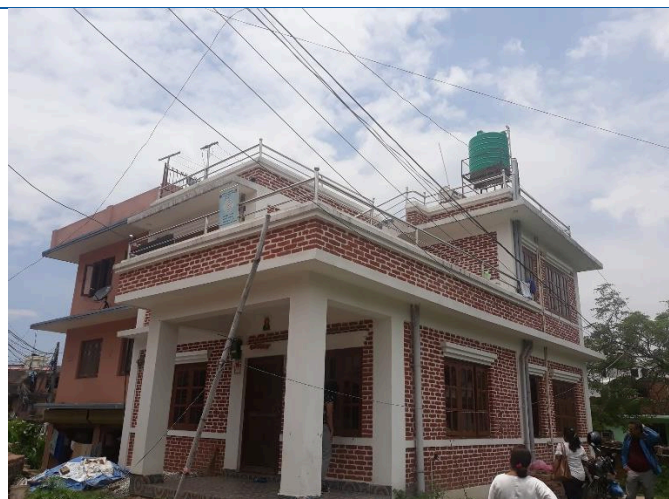
Beneficiary name: Ramkrishna Thapa, Ward no. 2, Suryabinayak Municipality. 1.5 storey RCC house has 6 rooms. Owner has received 1<sup>st</sup> tranche and applied for 2<sup>nd</sup> and 3<sup>rd</sup> tranche together.

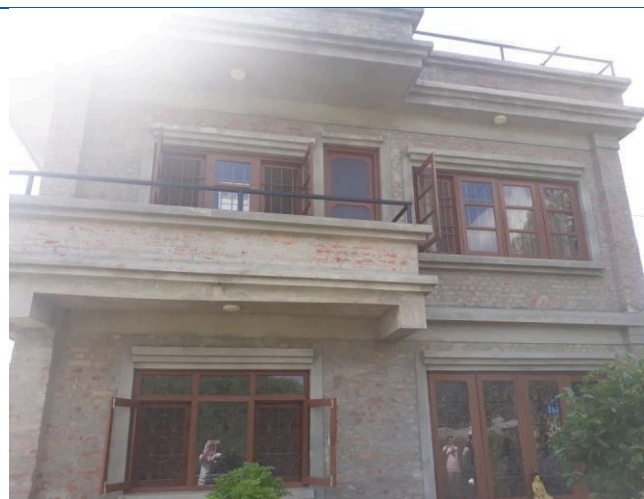
Beneficiary name: Ward no 3, Suryabinayak Municipality. Owner has received 1<sup>st</sup> tranche only and applied 2<sup>nd</sup> and 3<sup>rd</sup> tranche together. The house has missed bands from the inspection visit.

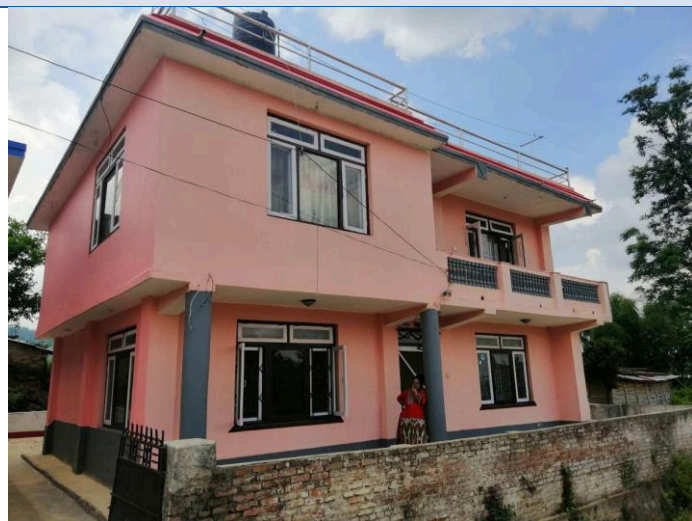
Beneficiary name: Sanu Kaji Magar, Ward no 7, Suryabinayak Municipality, BMC house with 2 stories and have taken 1<sup>st</sup> tranche till now. The owner has applied for 2<sup>nd</sup> tranche.

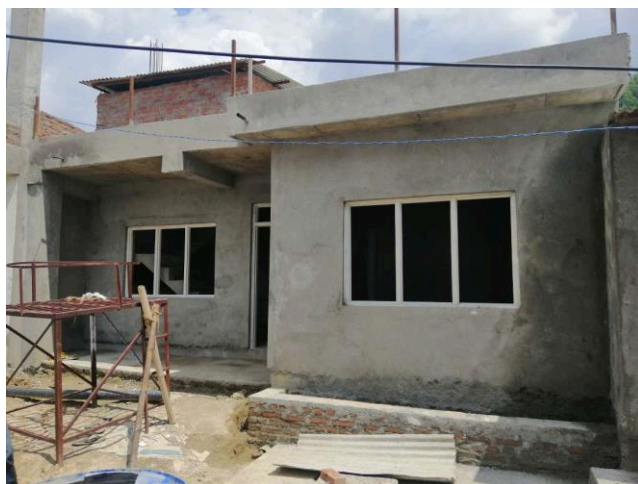
Beneficiary name: Arjun Basnet, Ward no 8, Suryabinayak Municipality. BMC house with 1 story has received 2<sup>nd</sup> tranche till now.

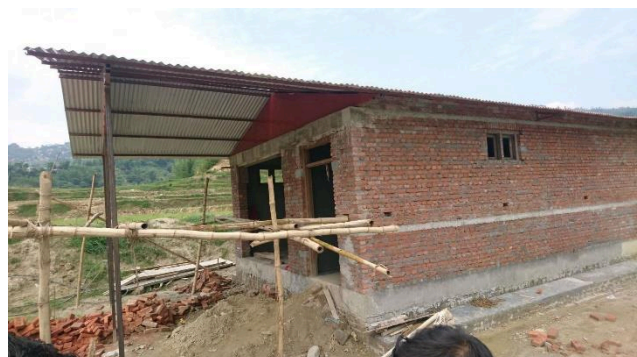
Beneficiary name: Mathura Baniya, Ward no 8, Changunarayan Municipality. Single storey wall system with shutter at front is a BMC house with flexibe roof has received 1st tranche till now. There is lack of roof bands and owner was suggested for correction by jacketing with wire mesh above lintel level

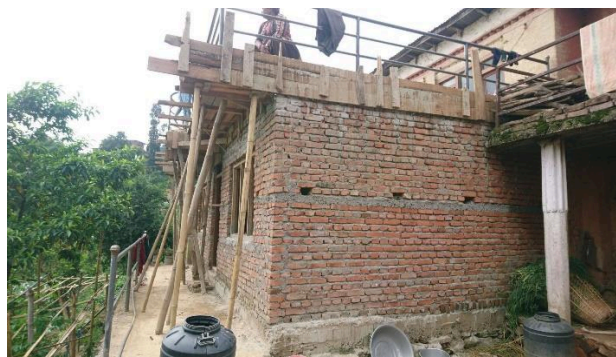
Beneficiary name: Babu Krishna Khatri, Ward no 8, Changunarayan Municipality. BMC wall system house with rigid roof with 1.5 storey has received 1st tranche. Owner has applied for 2<sup>nd</sup> and 3<sup>rd</sup> tranche together and the inspection visit has found the house in safe condition to forward further tranches.

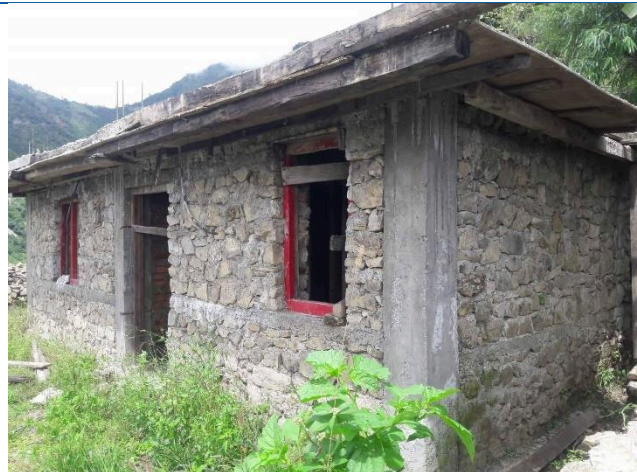
Beneficiary Name: Sun Bahadur Jimba, Bhattedanda, Bagmati Rural Municipality One storey structure with stone as infill material. The beneficiary has requested for the 3rd tranche. Dated: 180914

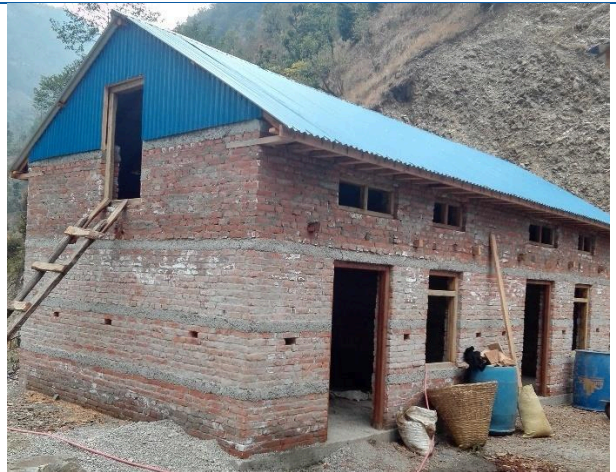
Beneficiary Name: Ajaya Syangtan, Kaleshwor, Mahankal Rural Municipality. One storey plus attic structure with RC band and CGI roof. The beneficiary has requested for 3rd tranche. Dated: 180915
