# District Report

## Kavrepalanchok

17 – 30 August 2018

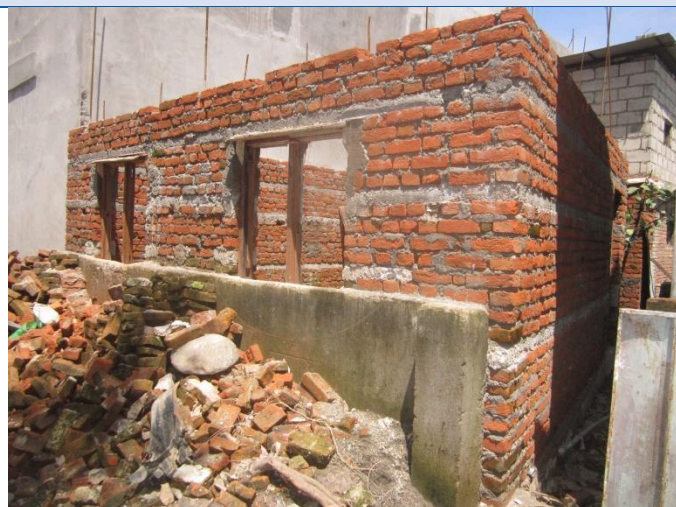
Sarita Shrestha is reconstructing her house in the land available after the necessary road setbacks. Due to the exceeding area of openings and rooms and L shape, the engineers sought the necessary correction measures which were addressed during the visit.

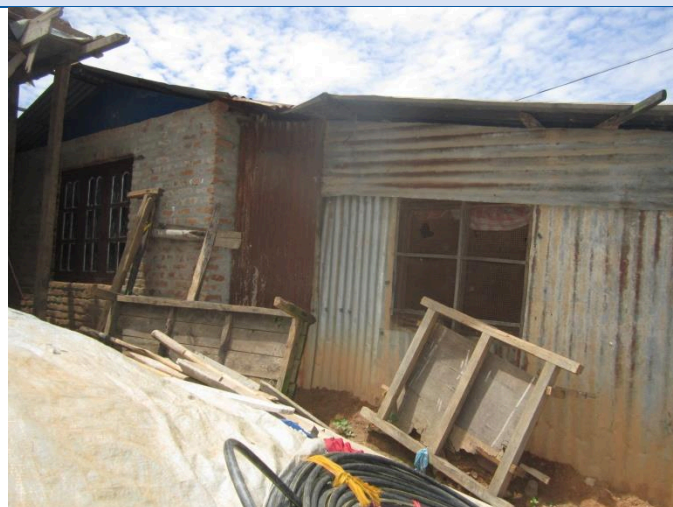
Binda Tamang constructed her house immediately after the earthquake. As she had no idea on resilient structures, none of those were used in the house. During the visit, the necessary correction measures were suggested with providing references of corrected

houses.

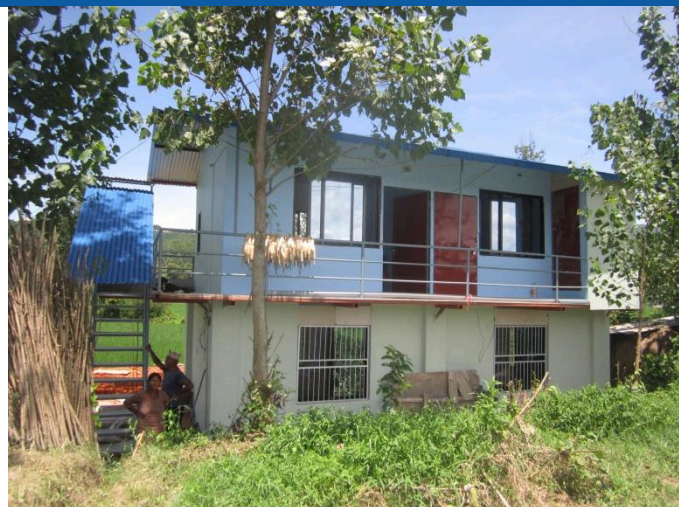
**Address:** Kavrepalanchok, Panchkhal 4

**Building Typology:** Hybrid Structure

**Description:** Kanchi Danuwar constructed the house as per the suggestions from her sons. The lower storey is a brick in cement construction with the upper storey being prefabricated structure. She has received second tranche.

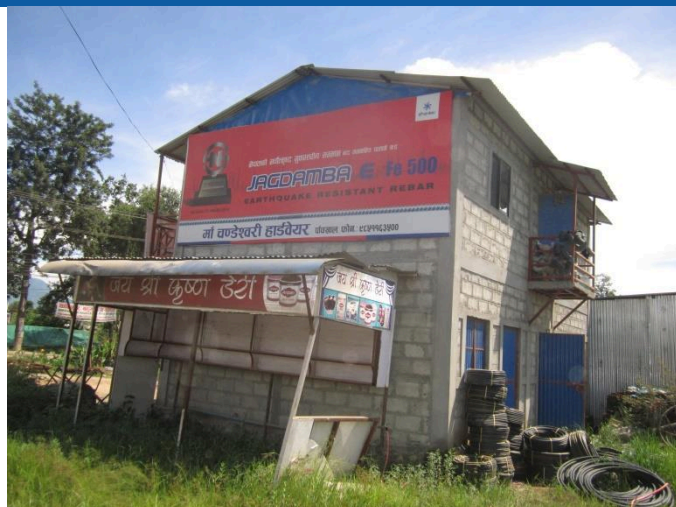
**Address:** Kavrepalanchok, Panchkhal 4

**Building Typology:** Hollow Concrete Blocks

**Description:** The high numbers of concrete blocks market encouraged the house owner to choose hollow concrete blocks for reconstruction. During the second inspection, the engineers have marked the house as non-compliant.

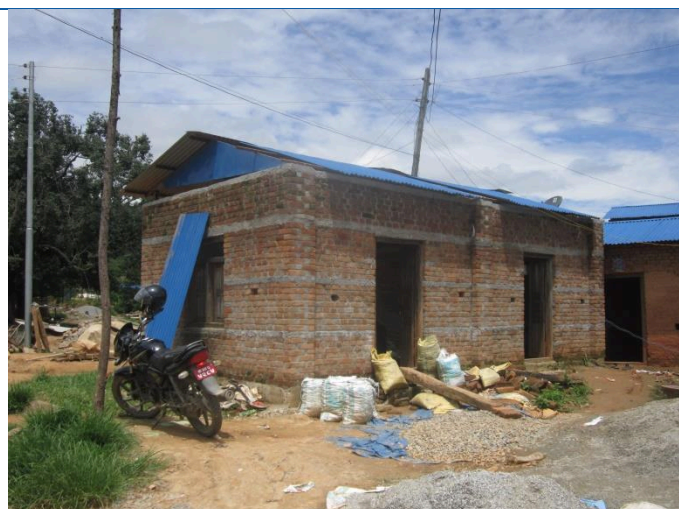
**Address:** Kavrepalanchok, Panchkhal 2

**Building Typology:** Brick in Cement

**Description:** Thuli Maya Tamangni recently has her house inspected for the third tranche.

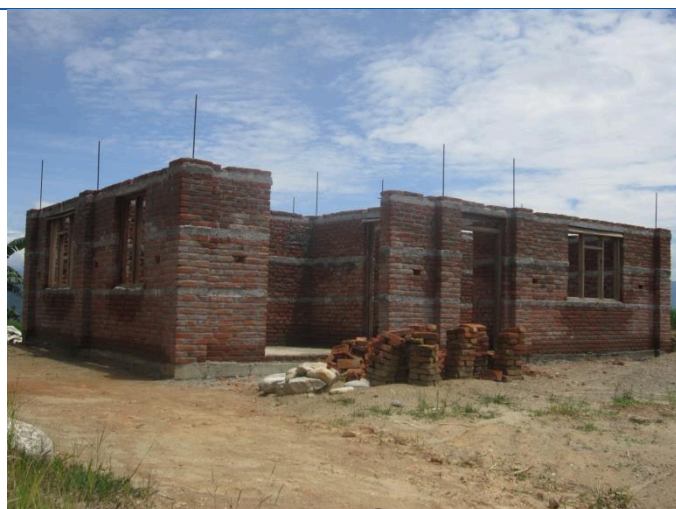
**Address:** Kavrepalanchok, Panchkhal 2

**Building Typology:** Brick in Cement

**Description:** Kanchi Maya Tamang initially had plans to construct two roomed house and received the second tranche. She later adjoined two more rooms to meet her space requirements.

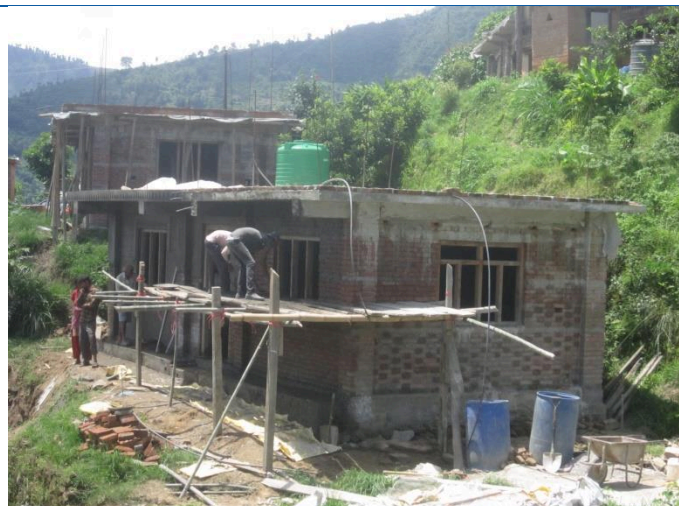
**Address:** Kavrepalanchok, Panchkhal 1

**Building Typology:** Brick in Cement

**Description:** Bishnu Prasad Parajuli has his house inspected for the second tranche. He has hired trained masons from Kailali for the construction.

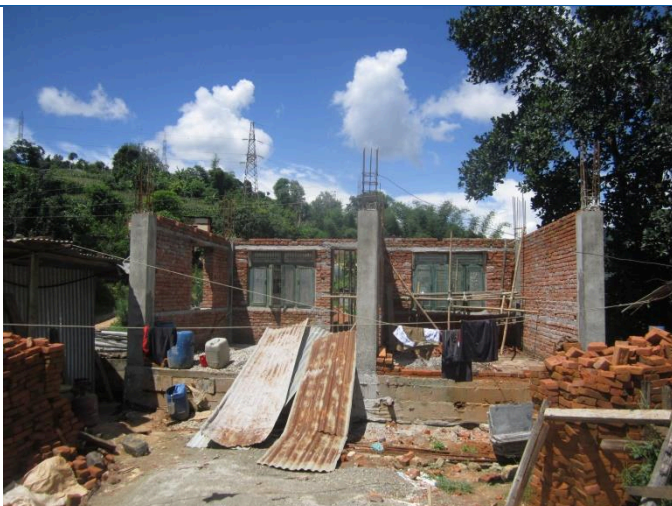
**Address:** Kavrepalanchok, Panchkhal 8

**Building Typology:** RCC

**Description:** Bishnu Prasad Parajuli has received second tranche and is furthering his constructions with the tranche.

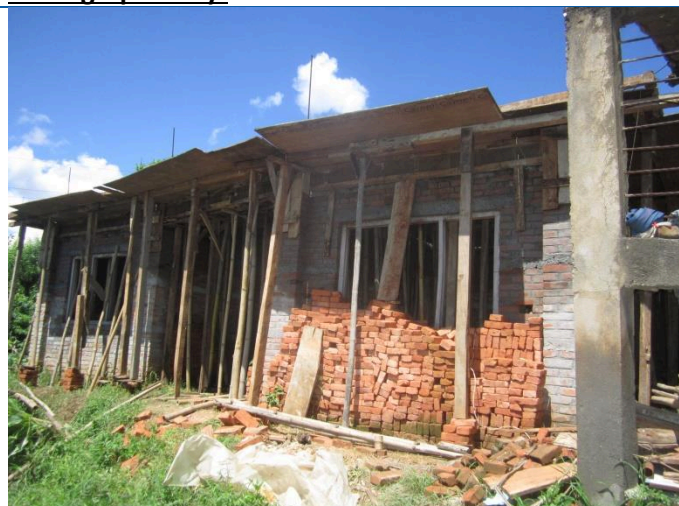
**Address:** Kavrepalanchok, Panchkhal 1

**Building Typology:** Brick in Cement

**Description:** Balam Dhungana and Sunita Dahal Dhungana each has received second tranche for the two roomed structures. The second inspection was done after the roof band was casted but before the roof was casted. The roof now covers both the houses.

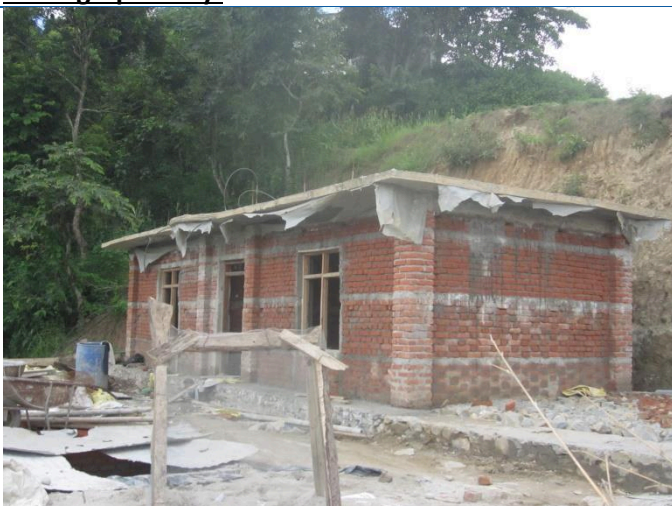
**Address:** Kavrepalanchok, Panchkhal 6

**Building Typology:** Brick in Cement

**Description:** Ram Hari Paudel has received the second tranche and has requested for the second inspection.

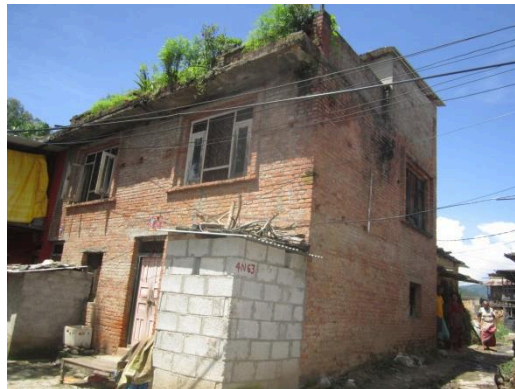
Prem Kaji Napit has been listed as a reconstruction beneficiary. Following the damages of his house, he demolished the upper storey, roofed a concrete slab without providing beams and added an extra room with no technical supervision. He wants to be switched to retrofit beneficiary and has the notion that the measures he has carried has made his house safe.

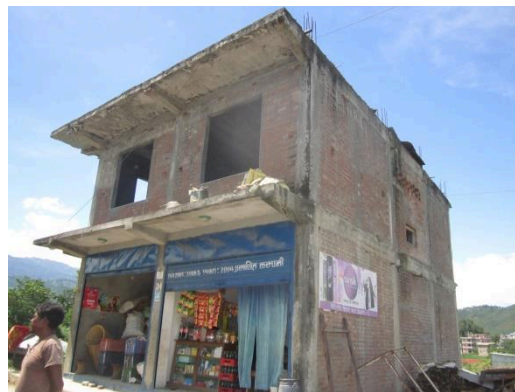
Similarly, Purna Bahadur Danuwar too has been listed as reconstruction beneficiary. But his house suffered minimum damages. He was reluctant to reconstruct a new house and wanted to be enlisted as retrofit beneficiary. During the inspection, necessary details were checked and remedial measures were suggested for the retrofit.
