## Monthly District Report

### Lalitpur, Bhaktapur

23 August – 27 September 2019

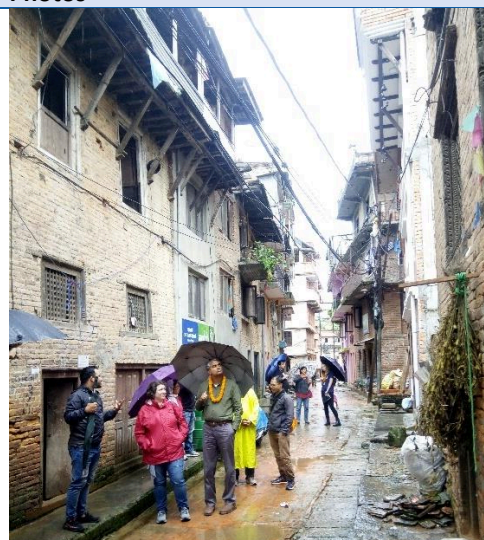
Image: Marc DSilva, Asia Regional Director, CRS International is observing the private housing reconstruction as well as the urban recovery of heritage settlements in Bungmati, Ward no 22, Lalitpur Metropolitan City.

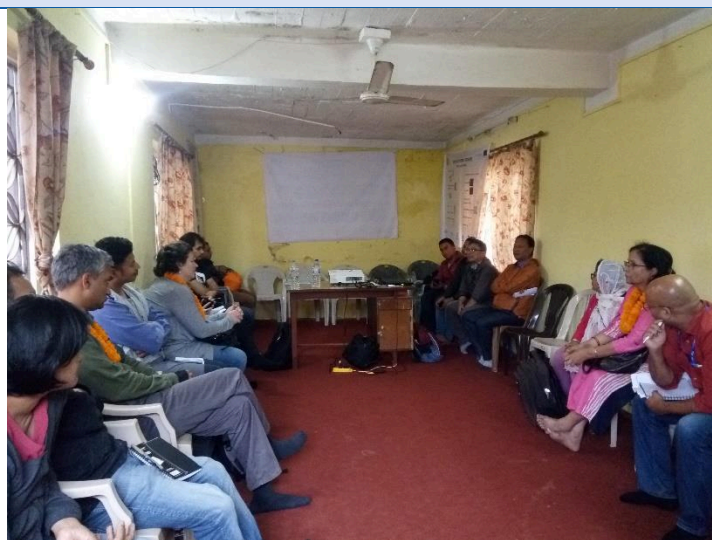
Image: Sharing by POs to the team from Asia Regional Director of CRS, programme personnel from CRS Nepal, HRRP and that is implementing private housing initiative as well as regeneration of heritage settlements and tourism promotion activities in Bungmati, Ward no 22, Lalitpur Metropolitan City

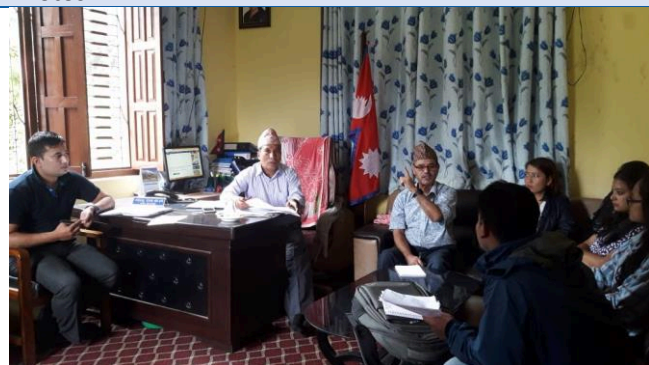
Image: Ward level coordination meeting in progress at Ward no. 9, Nangkhel, Suryabinayak Municipality. The meeting was attended by Ward Chief and Joint M & E visit team members including of M & E Consultant, M & E Specialist and engineers of concerned palika/ward

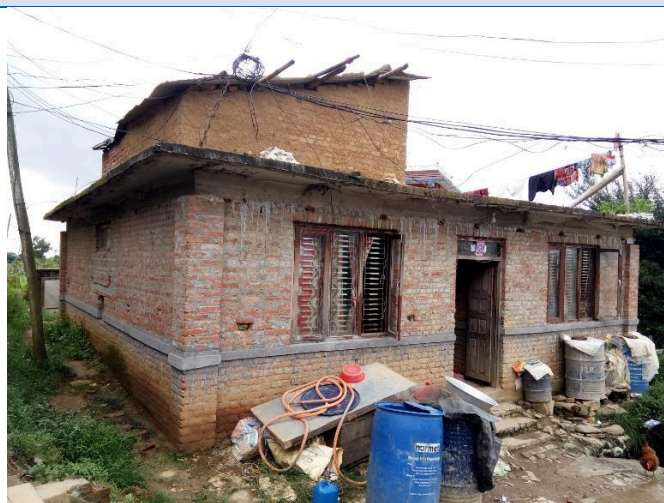
Beneficiary name: Rajan Pariyar, Ward no 9, Nangkhel, Suryabinayak Municipality. One storey wall system BMC house with rigid roof has rebuild soon after earthquake & before deployment of engineers. The beneficiary applied correction methods by keeping all kinds of bands such as lintel, sil and corner stitch. After correction methods, beneficiary accessed all three tranches from government of Nepal.

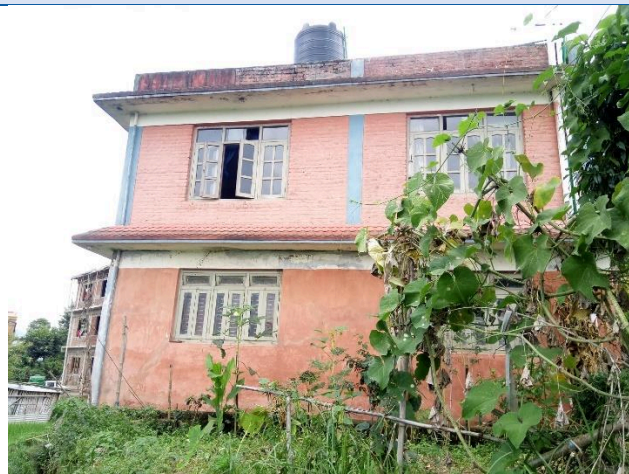
Beneficiary name: Gauri Thapa, Ward no. 8, Sipadol, Suryabinayak Municipality has 2 storey load bearing house which was damaged from 2015 earthquake. Gauri Thapa is the full reconstruction beneficiary, but the owner intended to apply retrofitting measures therefore has applied application to shift into retrofitting list. Beneficiary was suggested to contact reconstruction engineers once approves for retrofitting list.

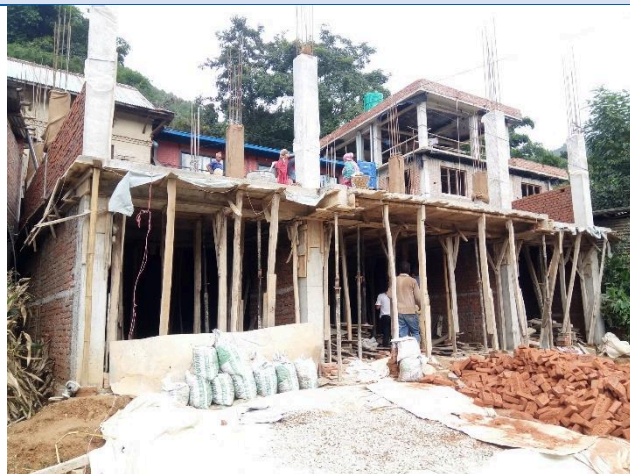
Beneficiary name: Surya Bahadur Khaitu and Indra Bahadur Khaitu, Ward no 8, Sipadol, Suryabinayak Municipality. The house belongs to multiple beneficiaries. 2.5 storey RCC pillar system structure is in rebuilding phase and owners have placed two staircase and 5 rooms in each house. Owner has already received 1<sup>st</sup> tranche only and is eligible for 2<sup>nd</sup> tranche too.

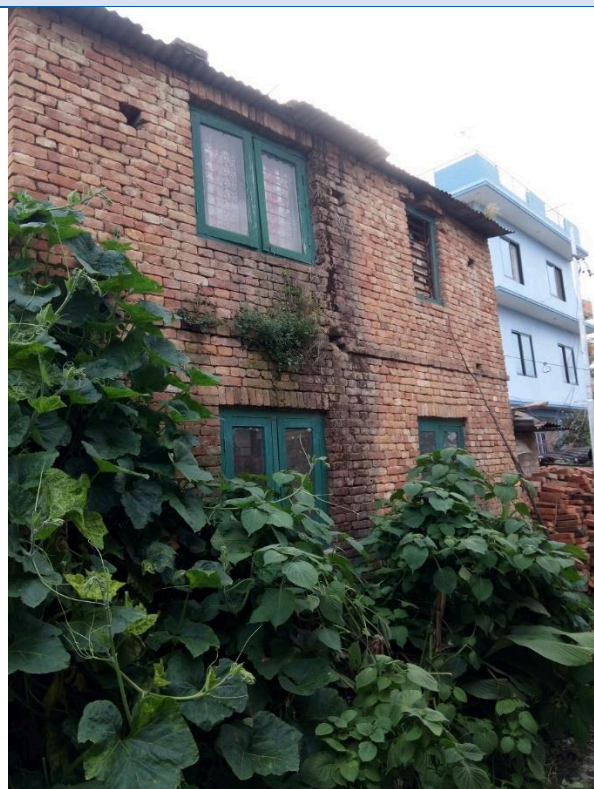
Beneficiary name: Kul Bahadur Bista, Ward no 1, Sirutar, Suryabinayak Municipality, BMM house with 2 small rooms, 1 storey plus attic have taken 1<sup>st</sup> tranche till now. The wall in other side of house is slanted from earthquake 2015. The house cannot be rebuild due to right of way issue, therefore the owner was suggested to submit applications in ward/palika office stating to retrofit the house.

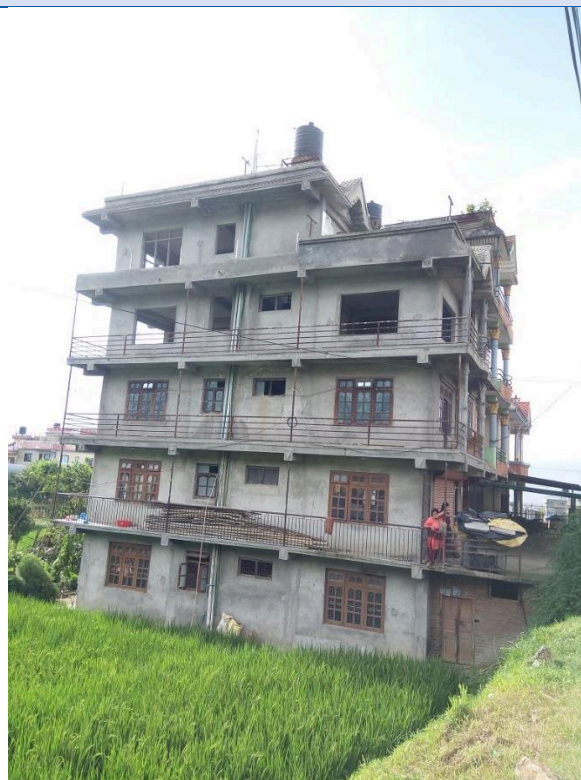
Beneficiary name: Bidur Neupane, Ward no 1, Sirutar, Suryabinayak Municipality. 5 storey RCC pillar system house was damaged due to collapse of newly built wall during earthquake 2015. The beneficiary is in retrofitting list & has received 1<sup>st</sup> tranche. DSE suggested retrofitting measures for this house and informed beneficiary to conduct retrofitting if he can offer. The house has 9'x12" inch walls.

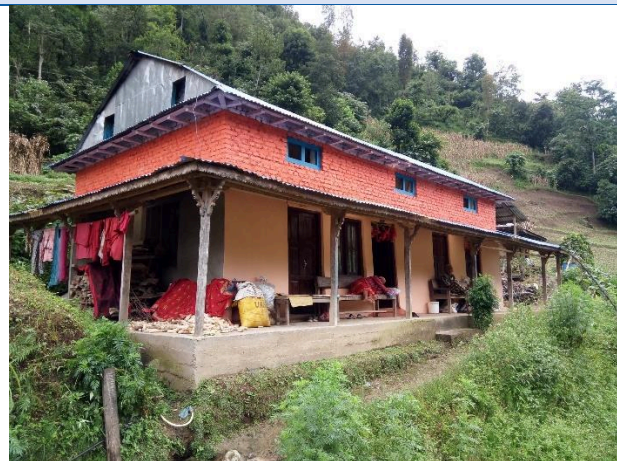
Beneficiary name: Tul Prasad Timilsina, Ward no 1, Bukhel, Mahankal Rural Municipality has 4 roomed house reconstructed with hybrid typology, wall system SMC on ground floor and BMC in attic with flexible roof. The owner has received upto 2<sup>nd</sup> tranche only. The owner revealed

that they have-not seen engineer inspecting their house. The owner was informed to contact the Palika office for tracking reasons behind delays in issuing 3<sup>rd</sup> tranche. The owner was informed about correction measures need to be applied to become complaint for access 3<sup>rd</sup> tranche.

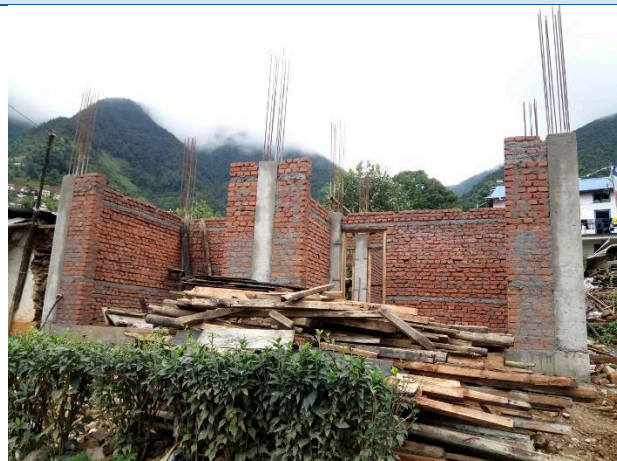
Beneficiary name: Jhirke Moktan, Ward no 5, Konjyosom Rural Municipality, Lalitpur is reconstructing RCC house with 4 rooms. The owner has received 1<sup>st</sup> tranche till and has applied for 2<sup>nd</sup> and 3<sup>rd</sup> tranche.

The beneficiary revealed that engineer deployed in Ward no 5 have not inspected the house but has informed him to send the images of reconstructed house for inspection through viber

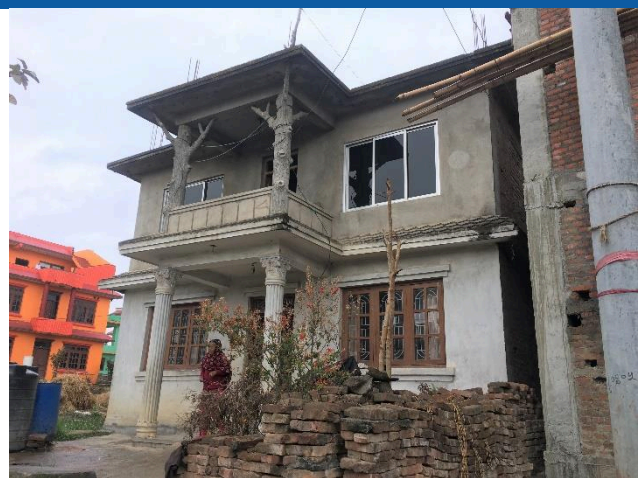
Beneficiary name: Kale Bhandari, Ward no 2, Changunarayan Municipality. RC frame structure, non-Compliance (9"x12" column) was considered unsafe during analysis, constructed immediately after earthquake

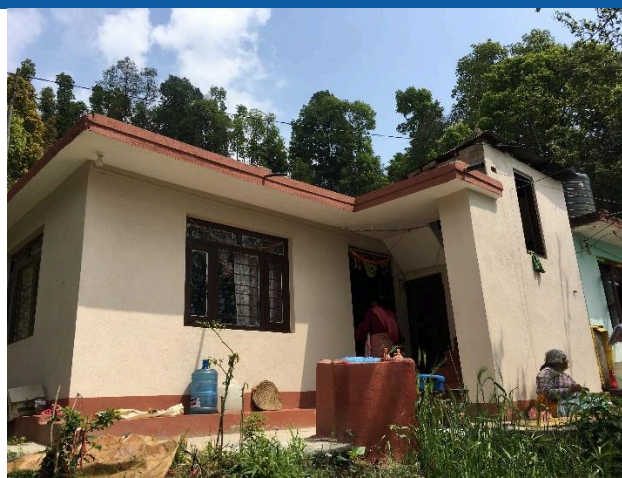
Beneficiary name: Pavitra Poudel, Ward no 4, Changunarayan Municipality. Non-Compliance (missing beam, bands, constructed immediately after earthquake)

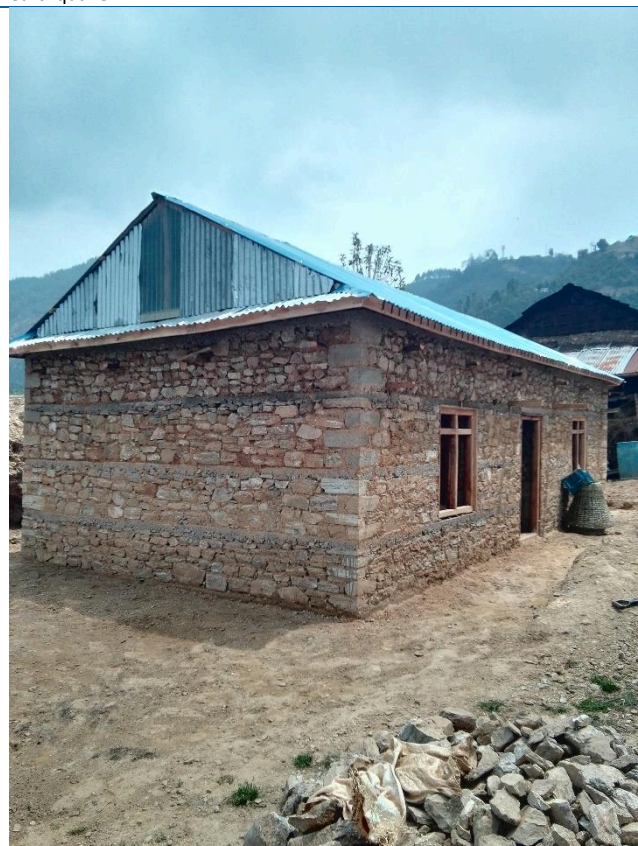
Beneficiary Name: Bhumi Nanda Timilsina, Kaleshwor, Mahankal Rural Municipality. One storey plus attic SMM structure with RC bands. The beneficiary has received 3rd tranche.

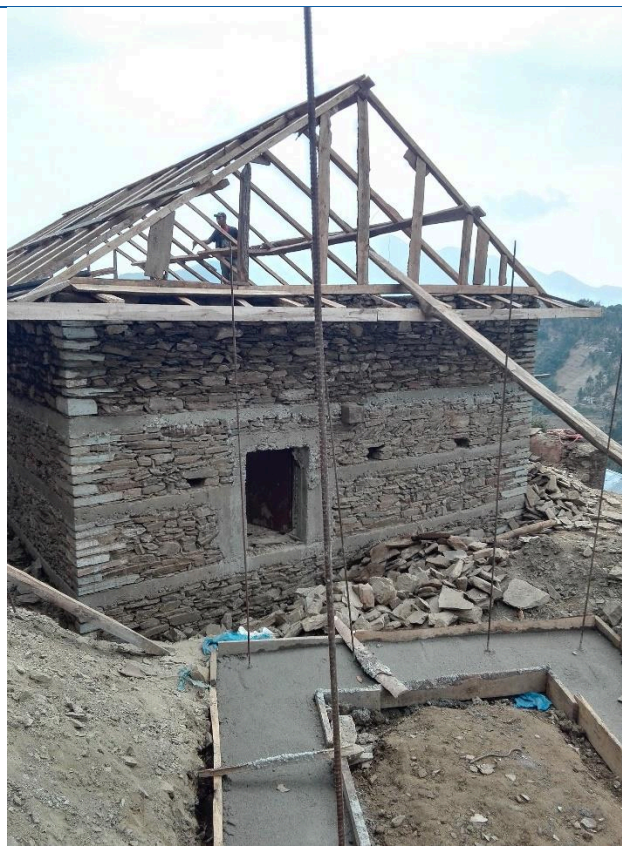
Beneficiary Name: Bishnu Prasad Dulal, Kaleshwor, Ward no 4, Mahankal Rural Municipality. 1 storey plus attic SMM structure with RC bands has requested 3<sup>rd</sup> tranche from government of Nepal
