# District Report

## Ramechhap

15-21 December 2017

### Housing Typology Report

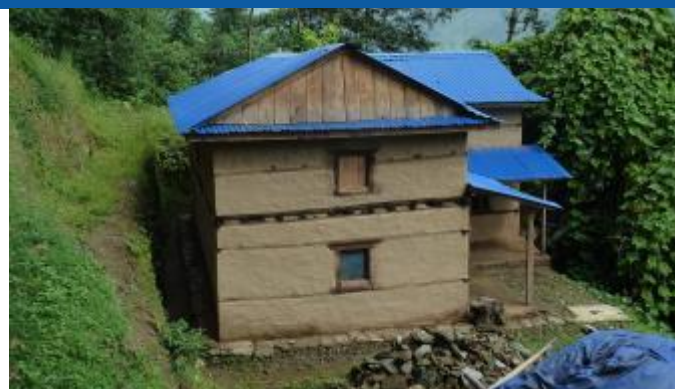
A noncompliance L shape building in Duragaun

- × Plinth level band missing and attic floor constructed with wooden band

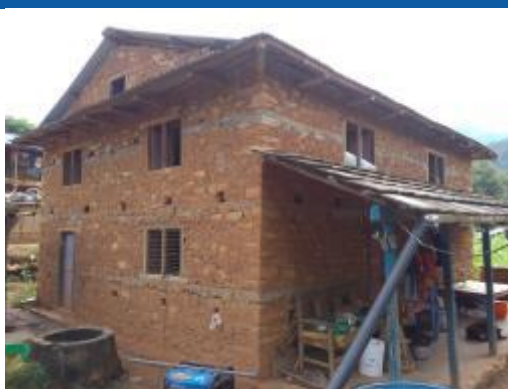
Caption: A noncompliance house in Chisapani, Manthali -8 of Adi Man Majhi which has received Recieved second Installment

- × Attic height greater than 3 feet
- ✓ RC band used
- × Gable wall constructed without gable band.

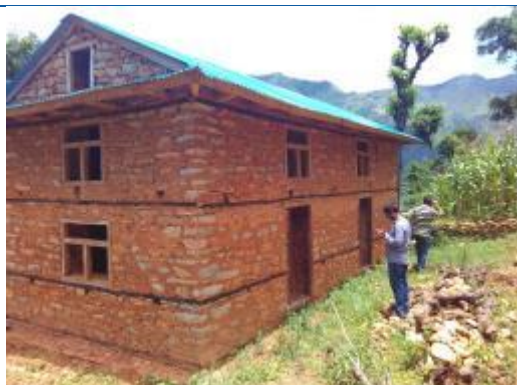
**Caption:**  
A noncompliance house in Manthali -3, Kathjor constructed during initial phase of reconstruction without technical assistance.

- ✓ Wooden band used
- × Improper positioning of bands
- × One attic on wooden band
- × Gable wall without band

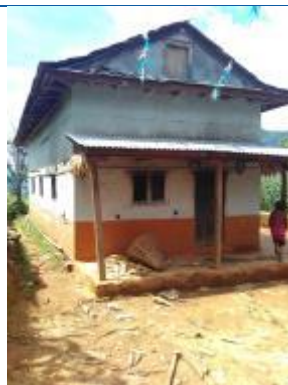
**Caption:**  
A noncompliance house in Kathajor, Manthali -3 constructed immediately after earthquake without technical assistance

- × One attic on wooden band
- × Gable wall without band
- × Horizontal and vertical bands missing

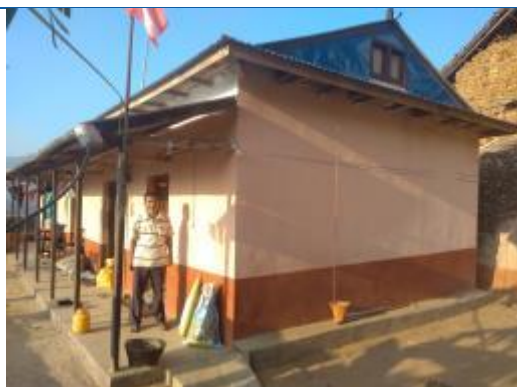
**Caption:** The house of Raj Kumar Shrestha, the resident of Kathajor ( Manthali -3) which have received second tranche of reconstruction grant. The technical assistance was provided by SDC-SW Nepal under Home owner Support Project.

- ✓ RC bands used
- ✓ One plus attic
- ✓ Light gable walls used.

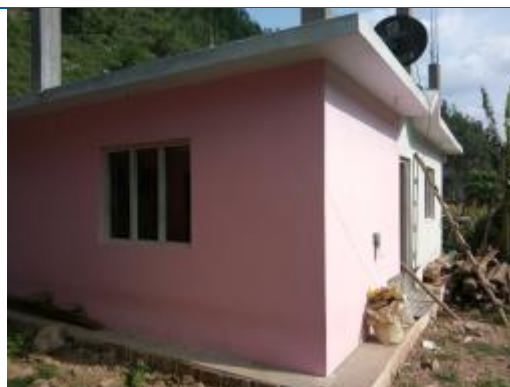
**Caption:** The house of Bhakta Bahadur Baruwal, the resident of Khimti ( Likhu RM-6) which have received second tranche of reconstruction grant. The technical assistance was provided by SDC-SW Nepal under Home owner Support Project

- ✓ RC Frame Structure
- ✓ All Seismic elements present

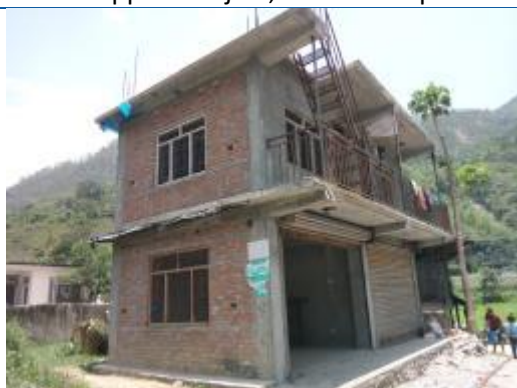
Caption: The house of Kamala Kadariya, the resident of Khimti ( Likhu RM-6) which have received second tranche of reconstruction grant. The technical assistance was provided by SDC-SW Nepal under Home owner Support Project

- ✓ RC Frame Structure
- ✓ Structurally analysed by District Support Enginner and found structurally safe
- × One bay in one direction
- × Opening in front face ground floor

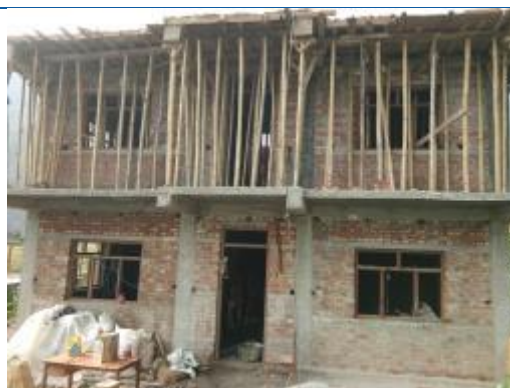
Caption: The house of Keshav Bahadur Thapa, the resident of Khimti ( Likhu RM-6) which have received second tranche of reconstruction grant. The technical assistance was provided by SDC-SW Nepal under Home owner Support Project

- ✓ RC Frame Structure
- ✓ All Seismic elements present
