## District Report

### Kavrepalanchok

15 February – 14 March 2019

## Field Visit Report

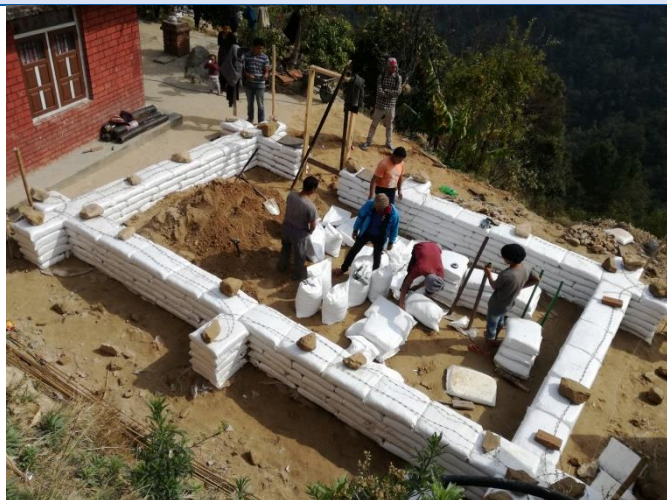
Milan Tamang is a low income beneficiary of Dhulikhel-2. So Hope Foundation has technically supported to reconstruct rice bag house. The house has been inspected for second tranche.  
Photograph By: Ishor Neupane

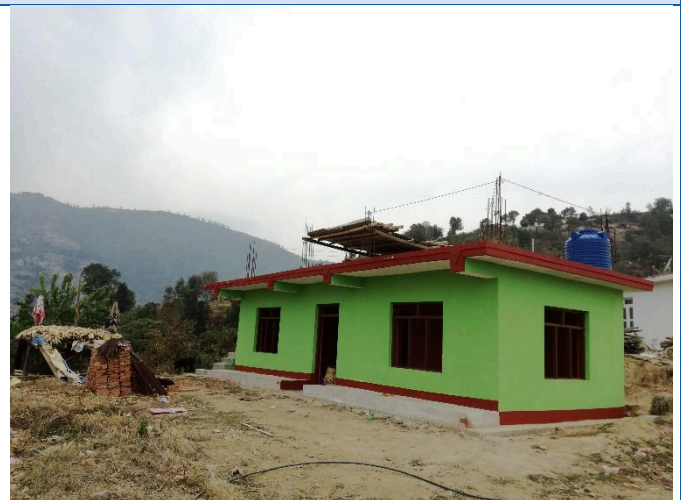
Resident of Dhulikhel-1, Gyan Bahadur Tamang reconstructed RCC house and has received third tranche.  
Photograph By: Ishor Neupane

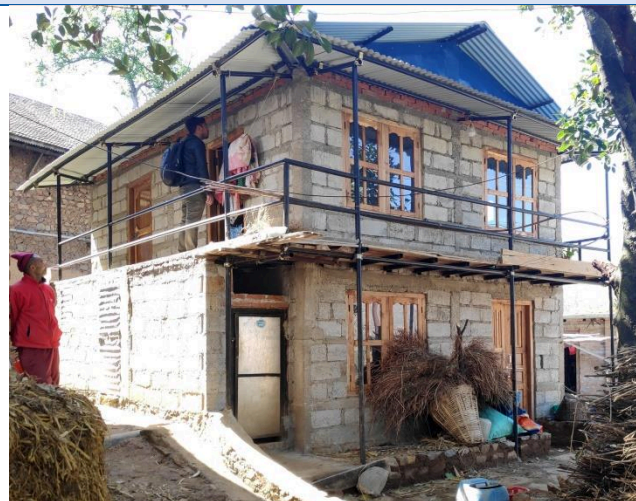
Dhan Kumar Lama of Mangaltar, Roshi-9 constructed his house using hollow concrete blocks along with three other neighbors in same design. He has received second tranche but his house was classified as non-compliant for the third tranche.

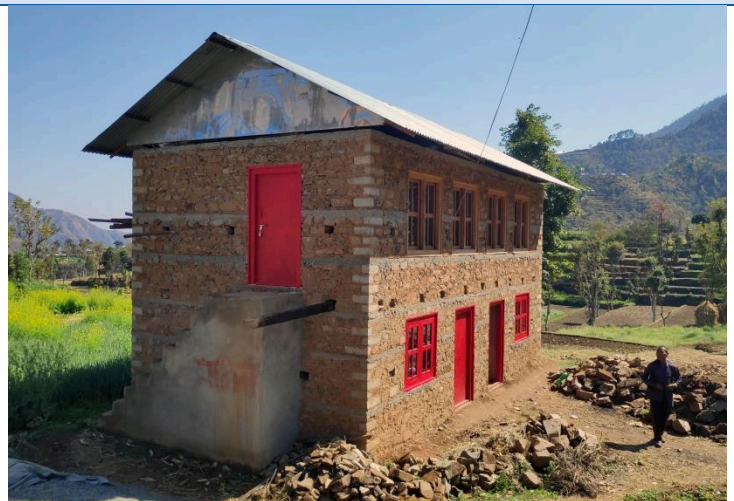
Lal Bahadur Lama of Mangaltar, Roshi-9 constructed his house similar to his pre earthquake house with no technical guidance. He has received second tranche but his house is non-compliant for the third tranche.

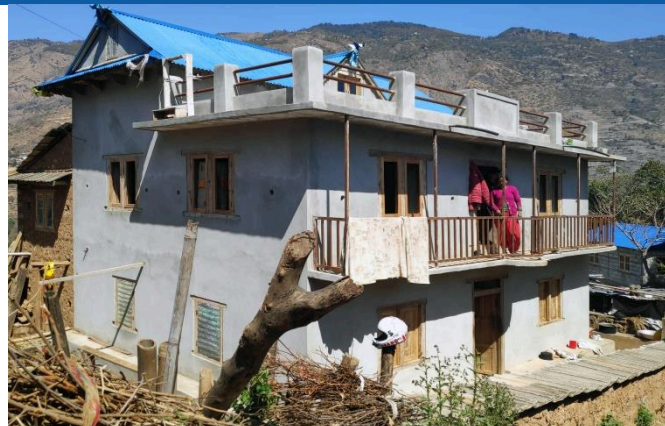
**Address:** Kavrepalanchok, Roshi-9

**Building Typology:** Stone in Mud

**Description:** Dirgha Bahadur Lama has received second tranche of housing reconstruction grant and he needs to correct his house to receive the third tranche.

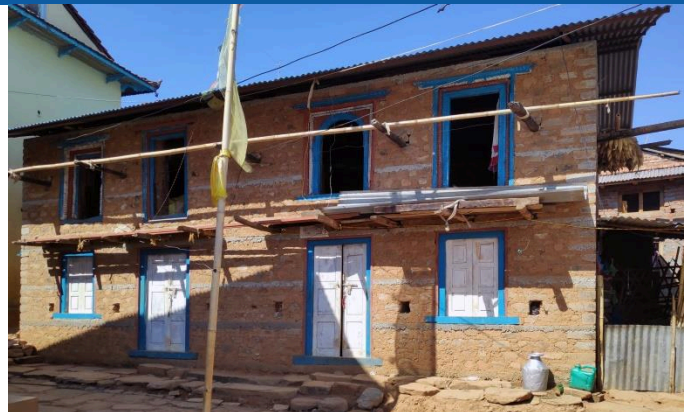
**Address:** Kavrepalanchok, Roshi-9

**Building Typology:** Stone in Mud

**Description:** Sarki Maya Tamang constructed two storied stone in mud house with larger openings similar to her pre earthquake house. So, her house was classified non-compliant for third tranche.

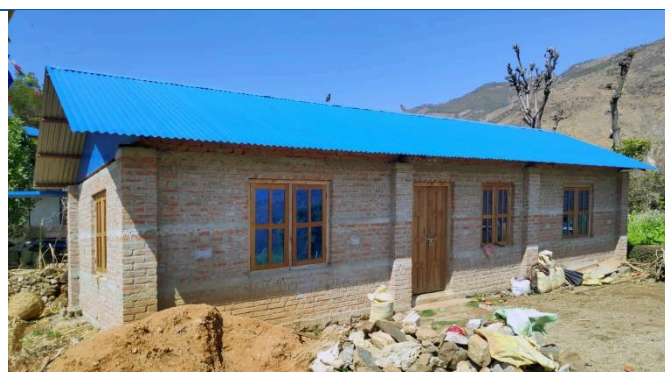
**Address:** Kavrepalanchok, Roshi-9

**Building Typology:** Brick in Cement

**Description:** Laxmi Tamangni has received all three tranches of housing reconstruction grant.

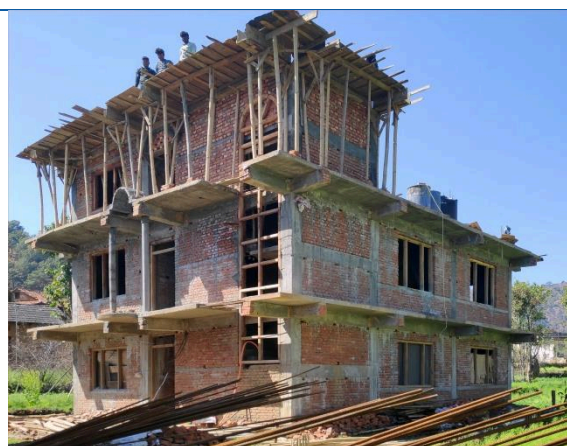
**Address:** Kavrepalanchok, Roshi-9

**Building Typology:** RCC

**Description:** This house has received second tranche of housing reconstruction grant and also been inspected for the third.

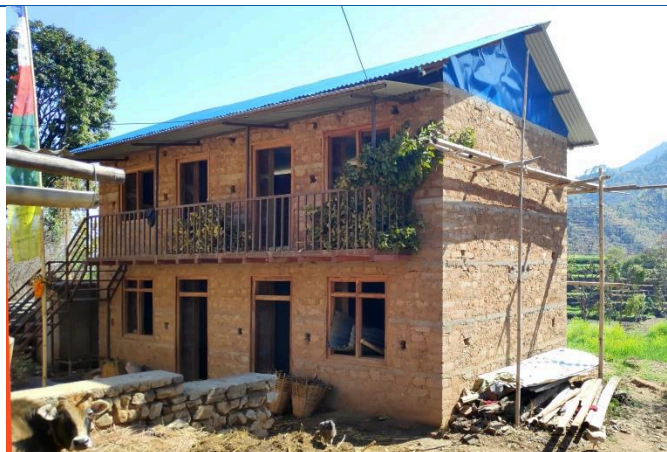
**Address:** Kavrepalanchok, Roshi-9

**Building Typology:** Stone in Mud

**Description:** Saneel Lama has received third tranche of housing reconstruction grant for his two storied SMM house.

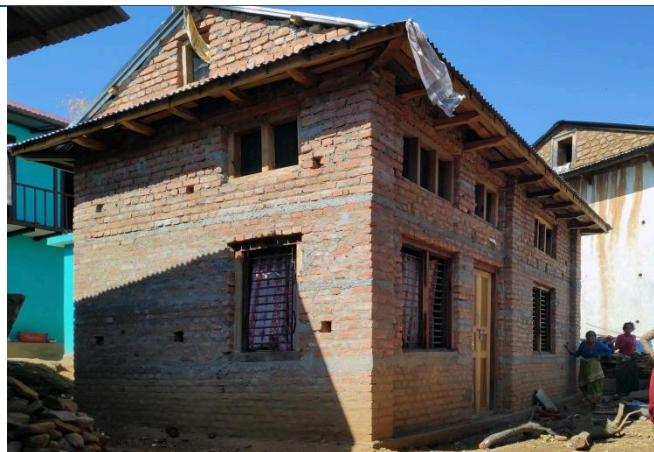
**Address:** Kavrepalanchok, Roshi-9

**Building Typology:** Brick in Cement

**Description:** Budhi Maya Lama has received third tranche of housing reconstruction grant.

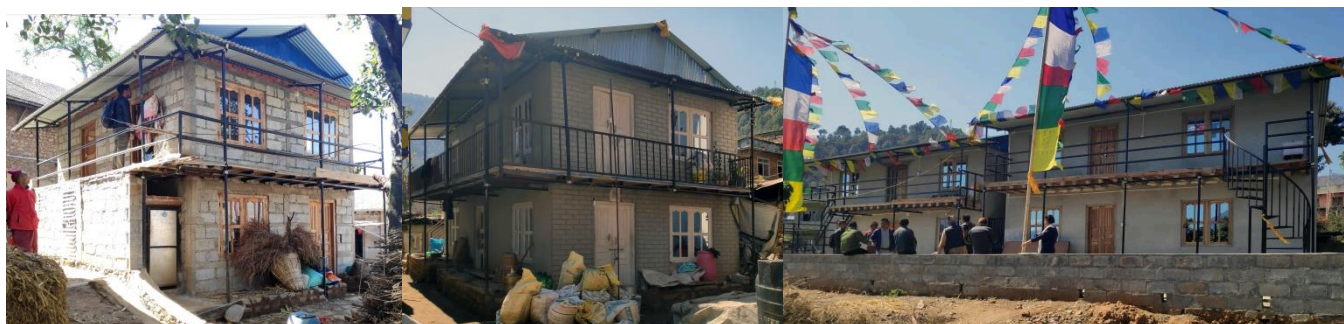
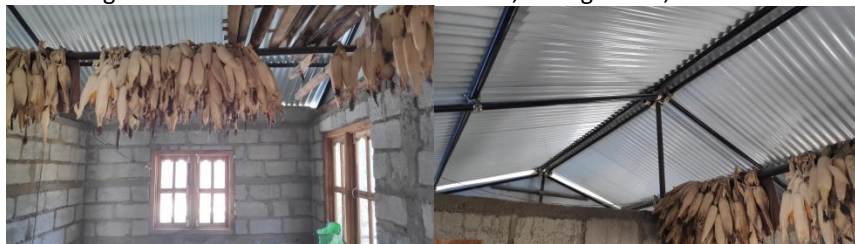
Dhan Kumar Lama, Mlangi Lama, Utar Kumar Lama and Krishna Gopal Lama opted to use Hollow Concrete Blocks for reconstructing their houses due to the ease in construction using hollow blocks. They were not aware of the standards for HCB constructions used HCBs similar to brick use. All four of them constructed together in similar plans. Though they have received second tranche, all were classified non-compliant for the third tranche.

Standard sized blocks have been used to construct two storied two room (12'X12' each) structure. 2" dia circular poles have been used at the corners and also to support the overhangs whereas 2" rectangular poles have been used for the floors. The foundation of the poles has been laid to a depth of 5' and all bands too have been laid as per the standards.

Left to Right: HCB houses of Dhan Kumar Lama, Mlangi Lama, Utar Kumar Lama and Krishna Gopal Lama

Interior of the HCB houses
