# Key Issues and Challenges in Urban Housing Reconstruction

**Er. Narakanta Sapkota**

**Monitoring and Evaluation Consultant**

**Kathmandu and Bhaktapur**

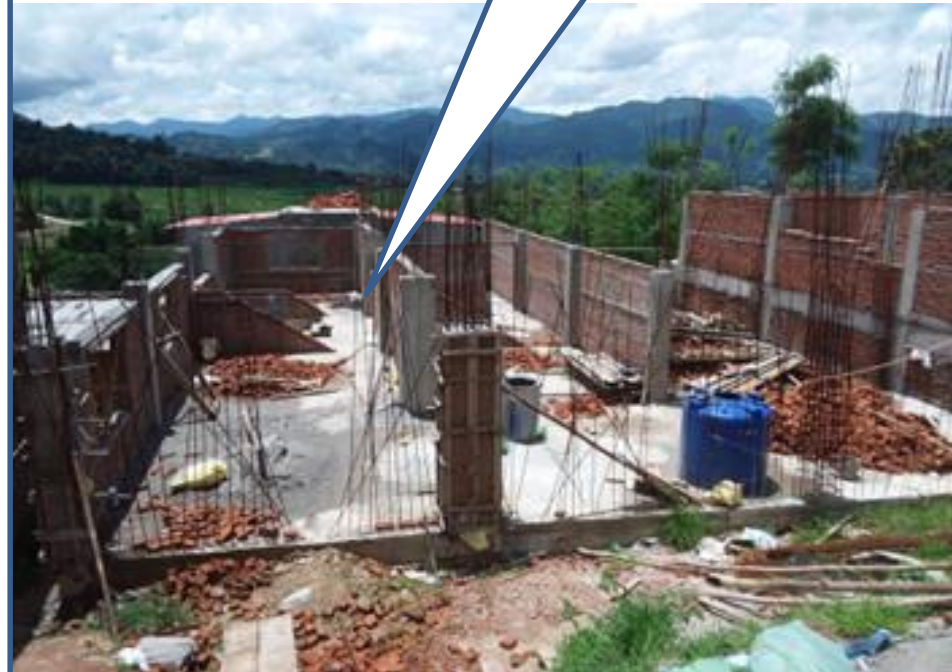
House Located in  
Changunarayan,  
Baniyatol

- No analysis report
- No approved Drawing

- Engineers of the Municipality do not enforce in low strength masonry construction.
- Prati Land (More than 400 Beneficiaries only in Changunarayan Municipality)
- No land Ownership Cards.
- Do not meet building by Laws
- Municipality approved the drawing without analysis report for the Building of RCC AB type
- Kitta Kaat Problem

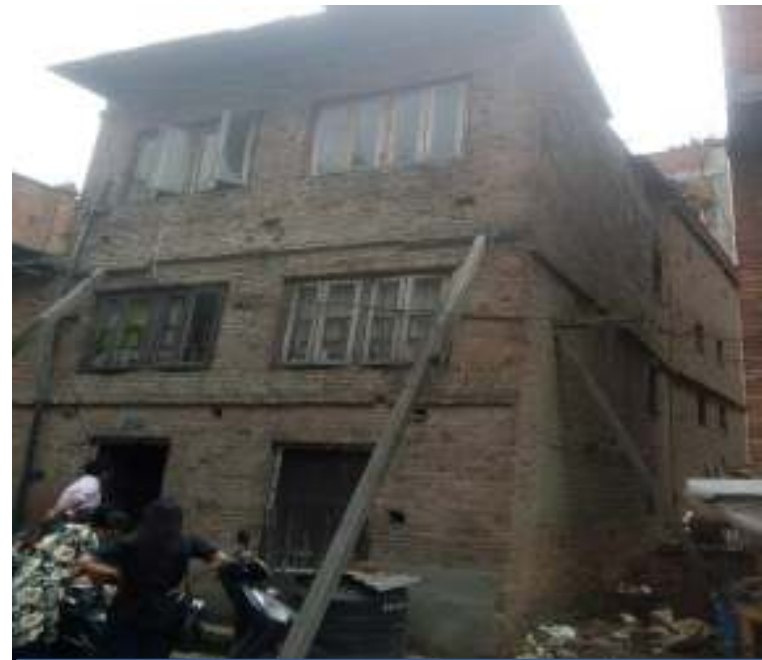
3 No of Beneficiaries in this house  
(Bhaktapur Municipality)

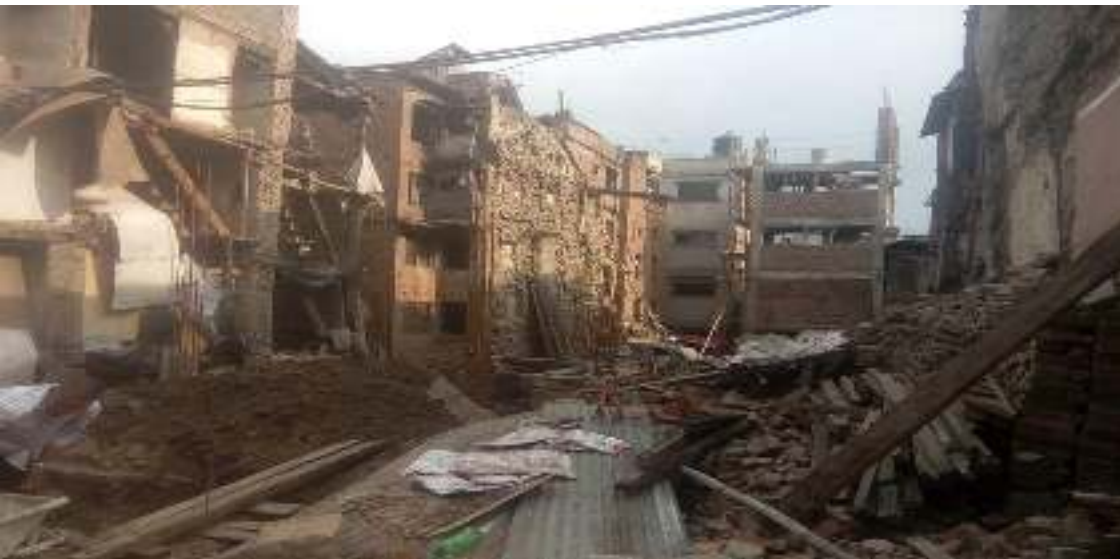
Small area for the reconstruction of the houses, adjoining structure, more than 9 no of houses are going to reconstruct in this area in Bhaktapur Municipality.

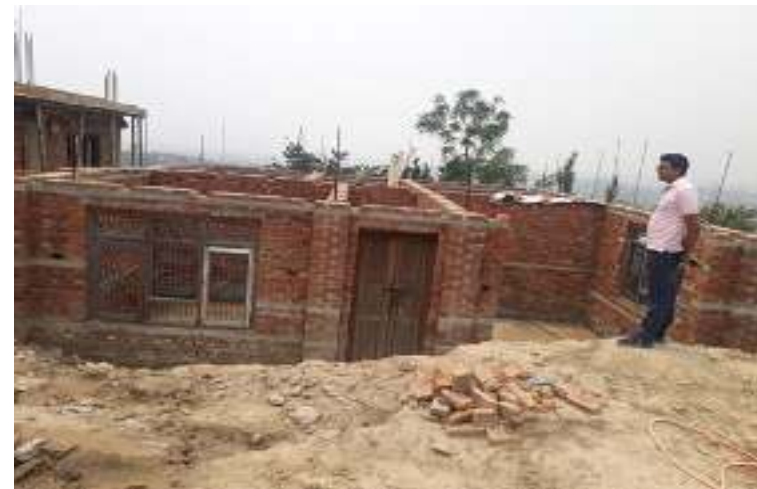
More than 115 no of houses have Mohi –Talsing problem (Changunarayan Municipality, Bageshori)

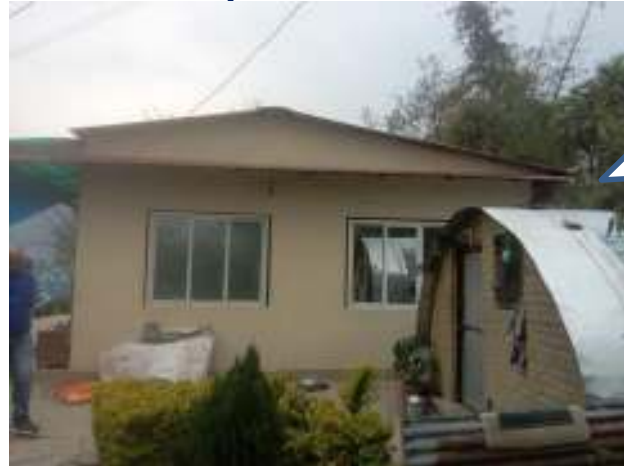
Houses  
constructed in  
Tarakeswor  
Municipality

The drawings of those houses meet the minimum requirement and get approved from the municipality but their construction does not meet the minimum requirement

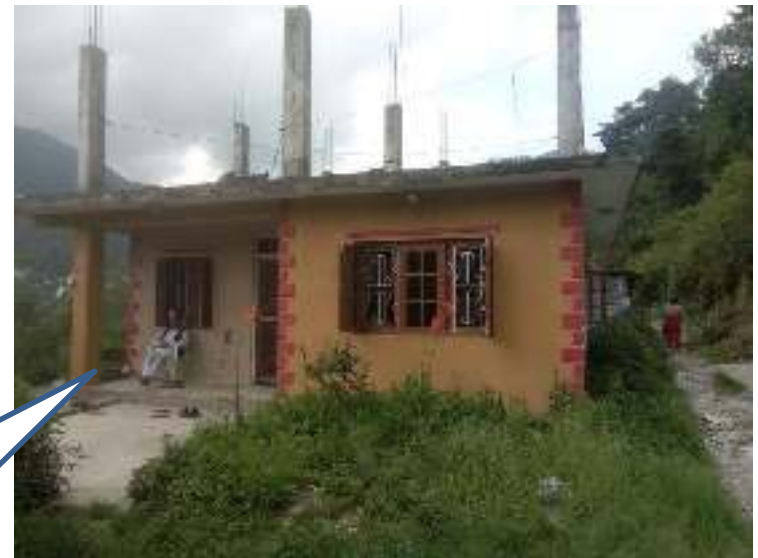
Houses  
constructed  
in Tokha  
Municipality

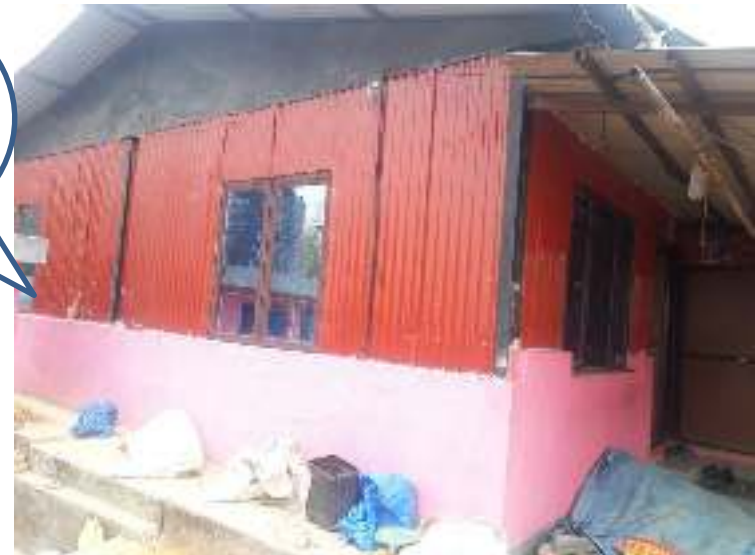
Houses  
constructed in  
Suryabinayak  
Municipality

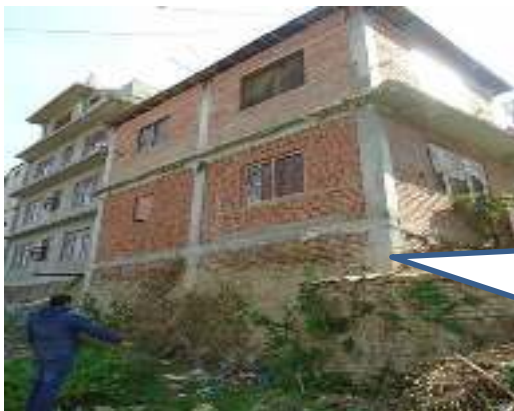
**Adjoining structure under construction , Single Bay,  
No analysis report, it takes 8 months for the approval  
of the drawing from Municipality, Changunarayan  
Municipality, Sudal**

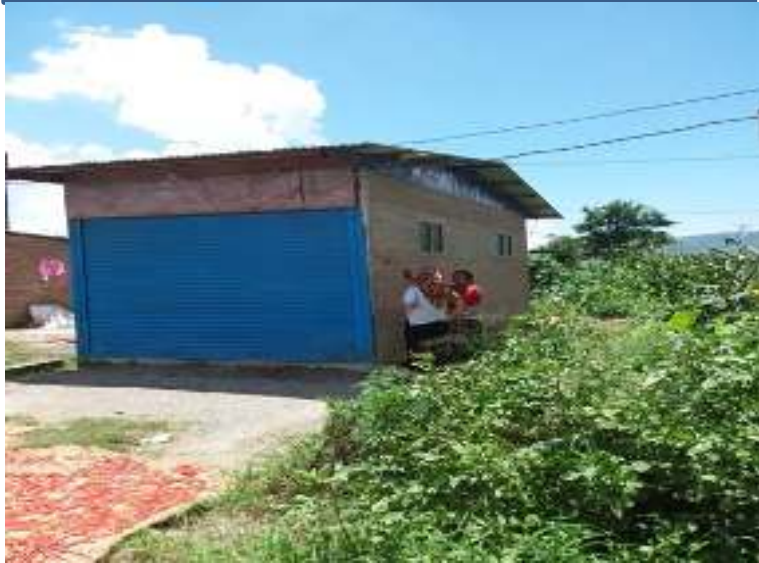
**Masonry Structure with rolling shutter, No earthquake  
resisting component, Tarakeshwor Municipality**

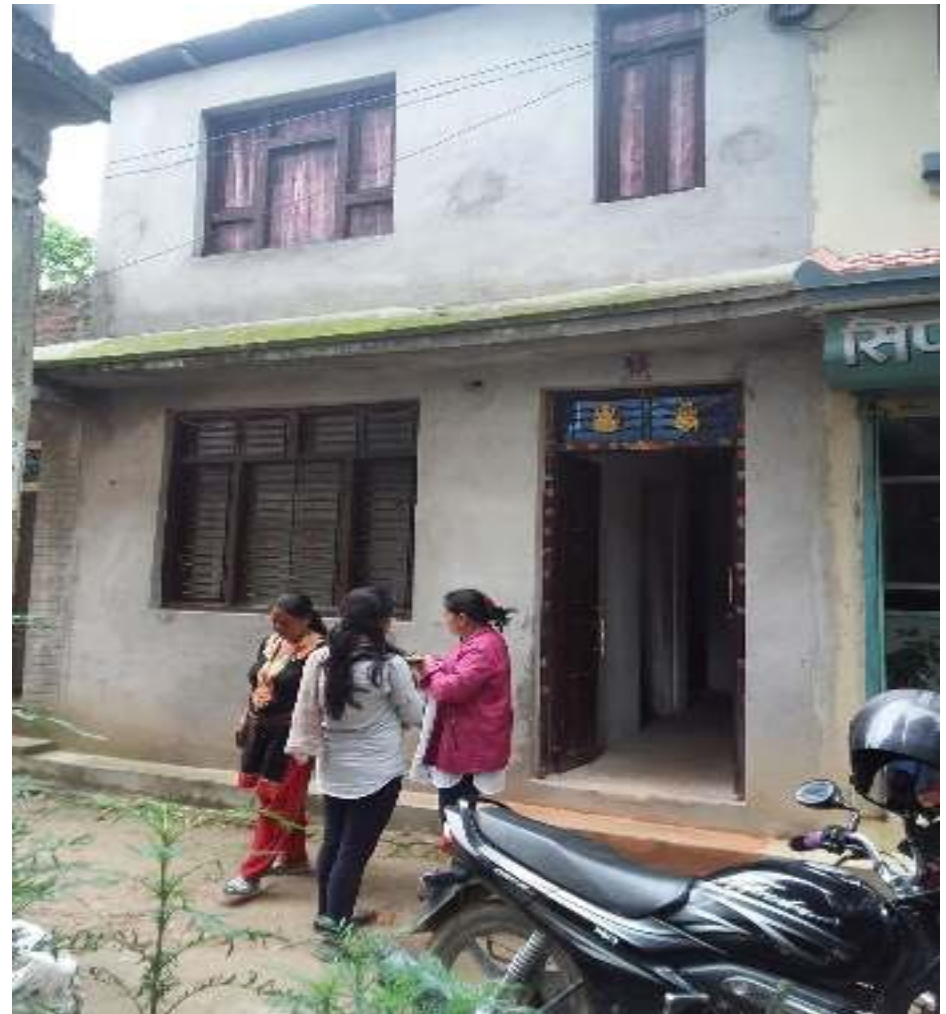
**Masonry Structure (BMC) with 9" wall in the front face (ground  
floor) and other 4.5 inch wall with no Lintel bands and Beam.  
Suryabinayak Municipality, Doleshwor. No Vertical reinforcement  
even in the approved drawing**

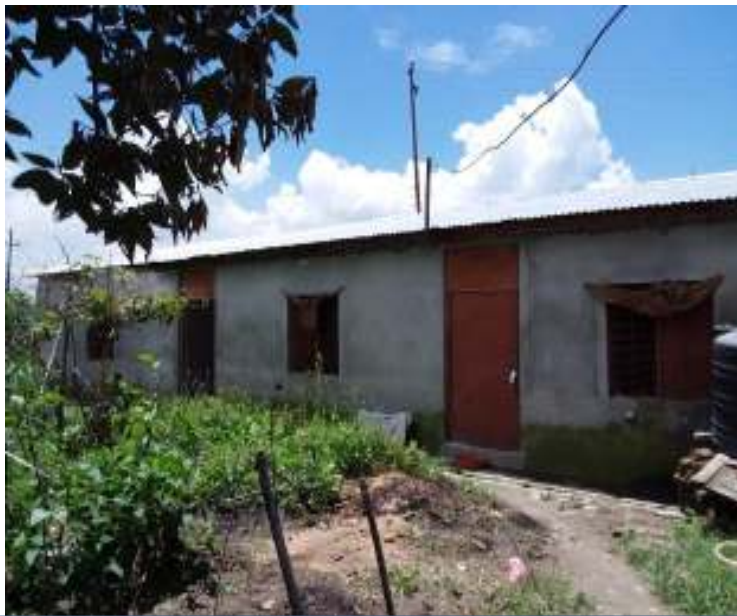
Brick masonry load bearing wall Structure , using for a poultry farming . The Structure having no Earthquake resisting element. Tarakeshwor Municipality, Sangla

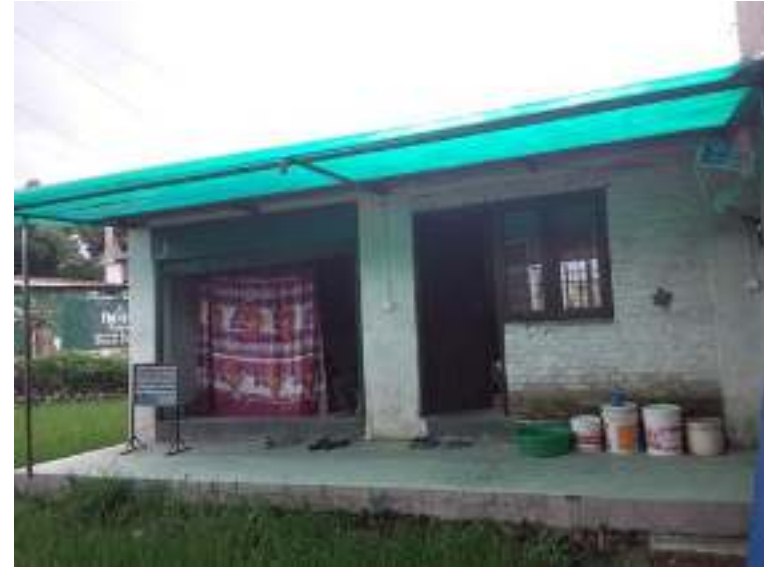
Brick masonry load bearing wall Structure, with rolling Shutter. But approved drawing from Municipality. Gokarneshwor Municipality, Uttarbahini

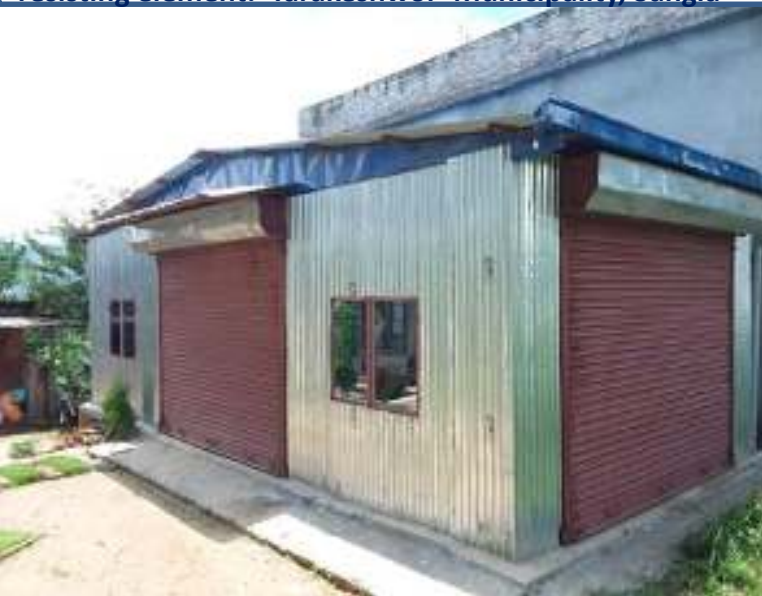
House Covering with a CGI Sheet and with Rolling Shutter, Suryabinayak Municipality, Sudal

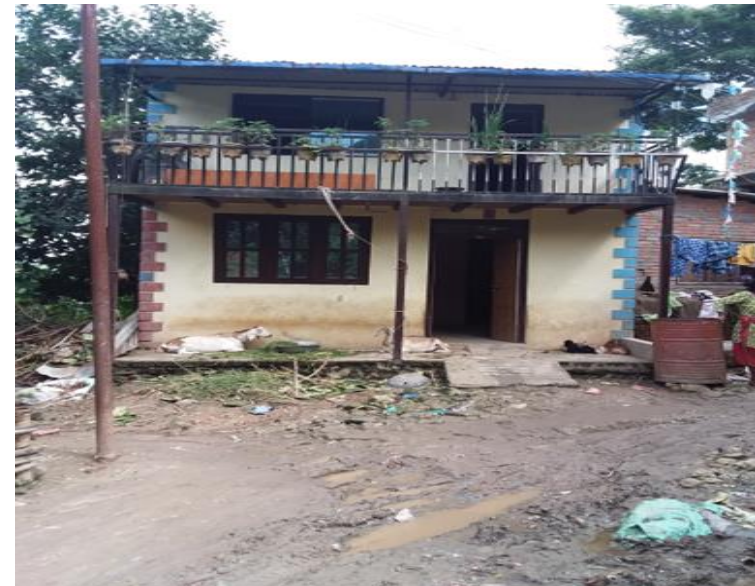
Masonry Structure (Load bearing wall) with 9" in the ground floor and 4.5" in the first floor having no beam . Gokarneshwor Municipality- Baluwa

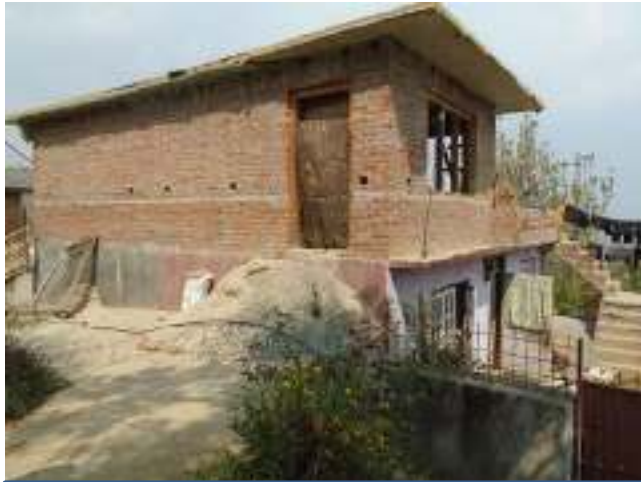
Ground floor constructed before earthquake, and apply for the tranche . Daksinkali Municipality.

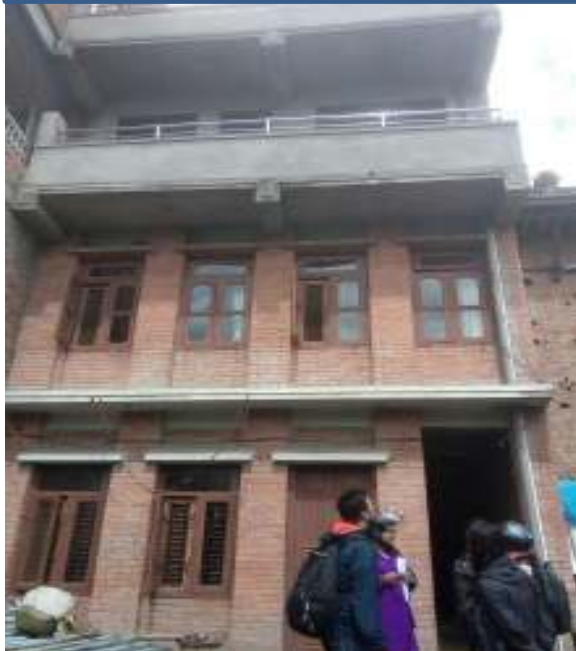
House constructed before earthquake, apply for the tranche, Pressurized the engineers for the certification of Tranche, Mashyapur Thimi Municipality

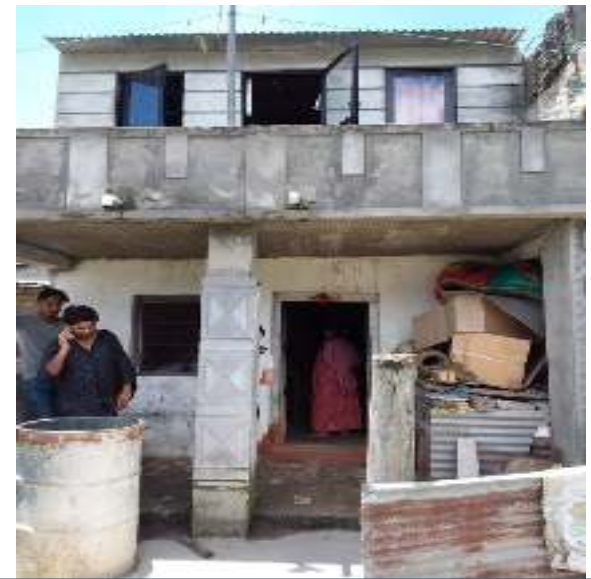
House constructed before earthquake, apply for the tranche, Pressurized the engineers and also have a approved drawing form the Municipality in the recent days. Tarakeshwor Municipality

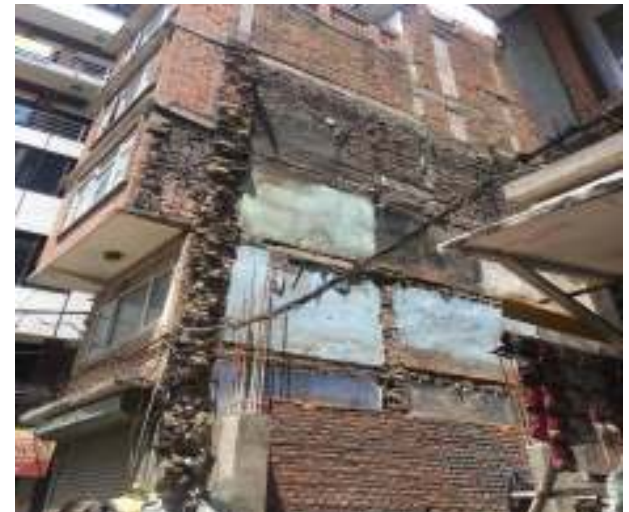
Vulnerable Adjoining Structure Causes the problem in reconstruction, Kathmandu MPC -22

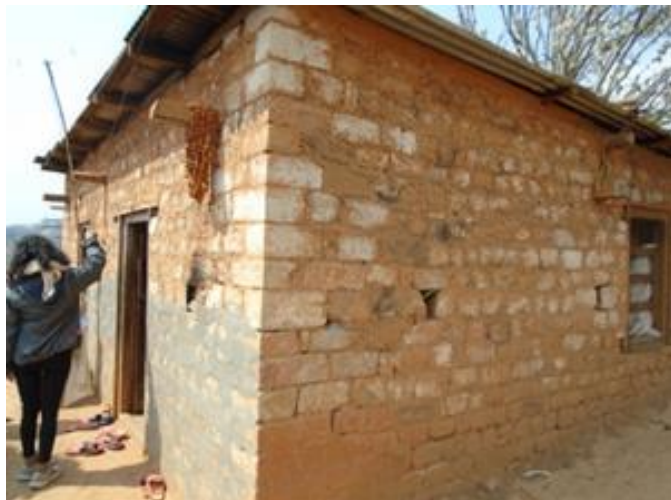
**House constructed with no horizontal Bands, but not corrected as per the engineers suggestion, Chhaimale, Daksinkali Municipality**

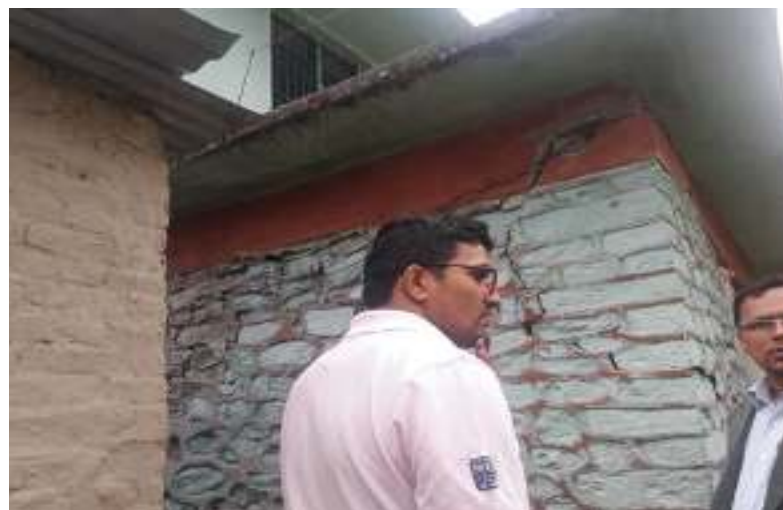
**Beneficiaries do not want to dismantle the destroyed building as they have no land for the dumping of Debris.**

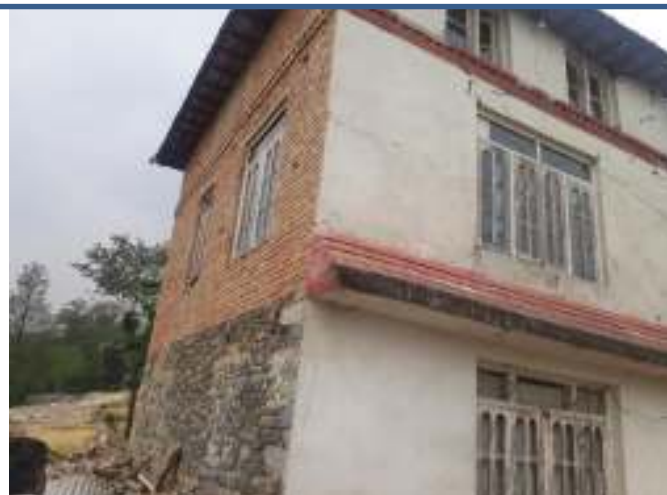
**Beneficiaries wants to retrofit the building but the building gets severely damaged, Bageshwori Changunarayan**

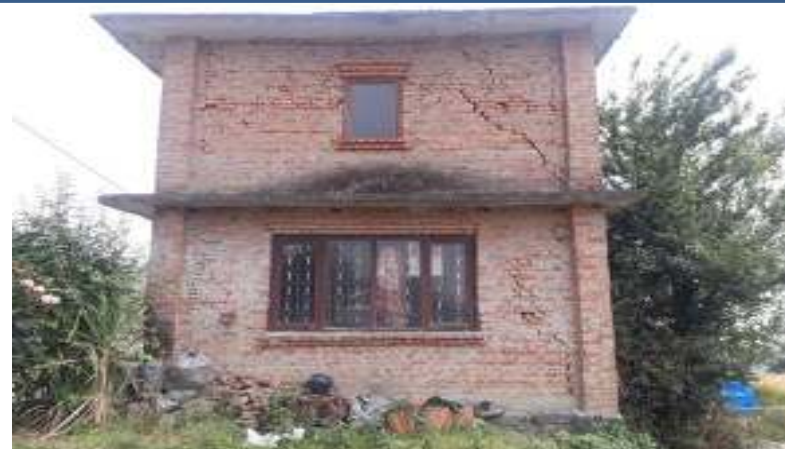
**Beneficiaries do not want to dismantle the house, after they dismantle the house then municipality covers the land as the house is in ROW of the road. Changunaryan, Bageshwori**

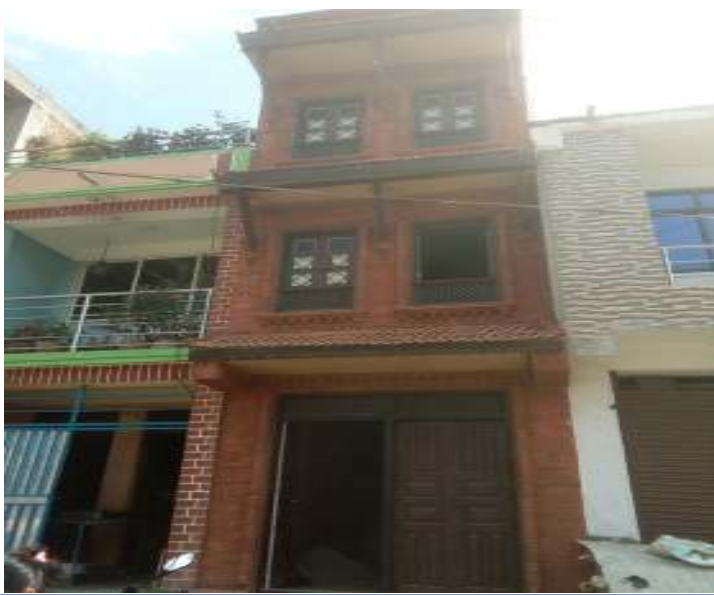
**Brick Masonry Structure(Load Bearing wall) having three storey in Chittapole of Suryabinayak Municipality**

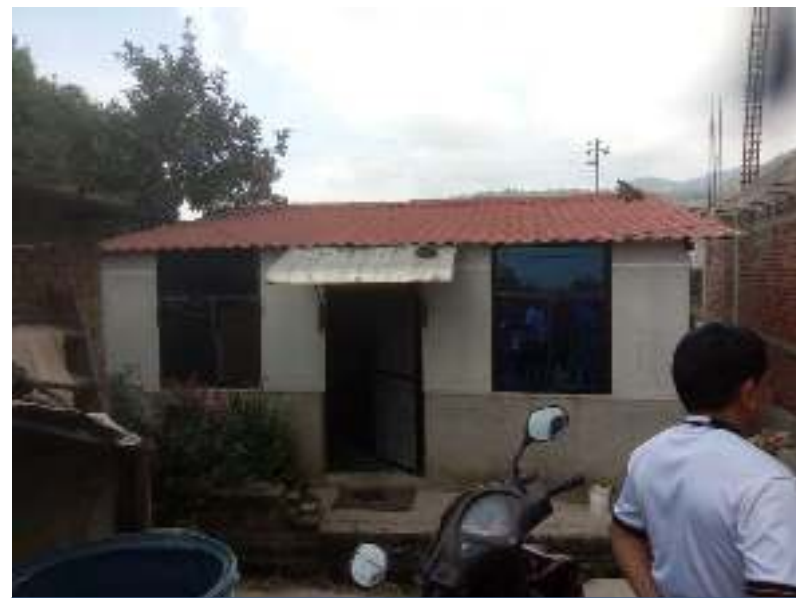
**House constructed with Steel Post as a Vertical Member 4.5 inch wall upto Sill level and then Cement Board as a wall and no analysis report.**

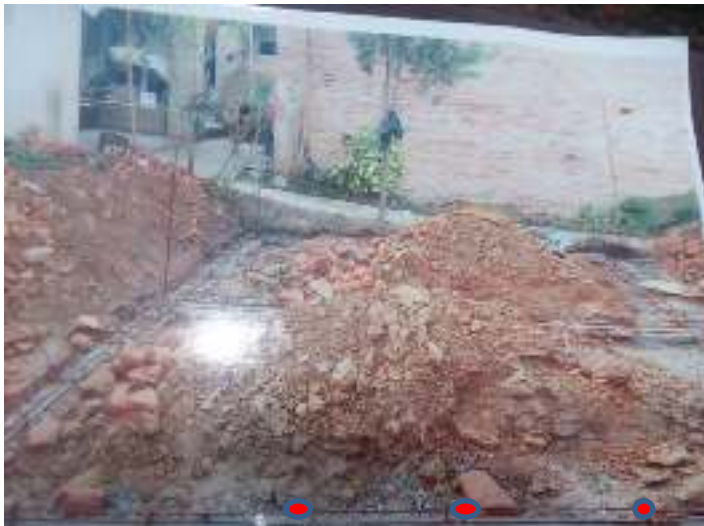
**Spacing of Stirrups in the Beam at Plinth Level. But the approved drawing form the municipality is as per the minimum requirement, Kageshwori Manahara Municipality, Gothatar.**

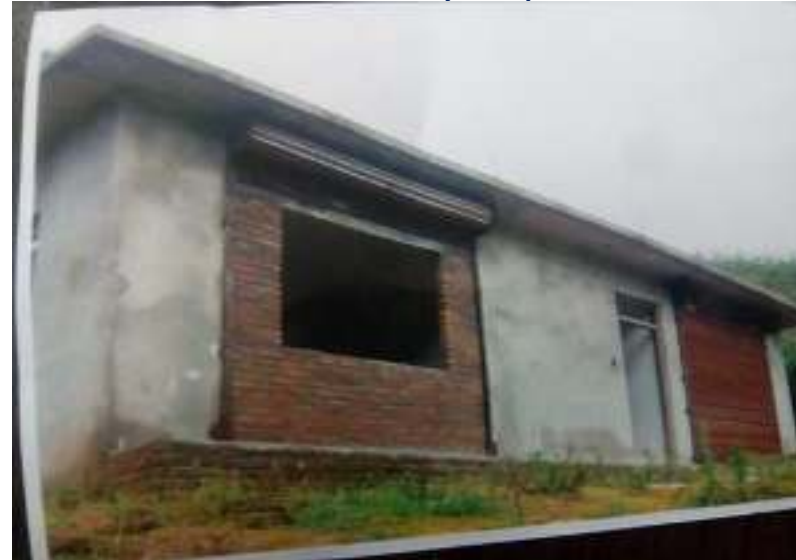
**Brick Masonry Structure with Rolling Shutter in Kakrabari of Suryabinayak Municipality**

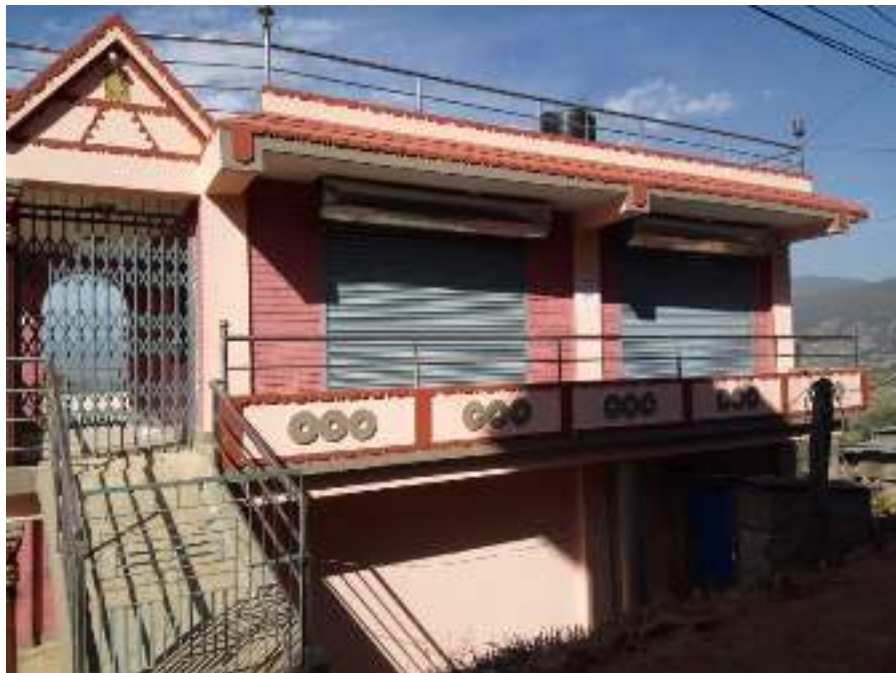
Commercial Building or Residential building? , 9\*12 size column, exceed 1000 Sq. ft. area, No Structural analysis, Suryabinayak Municipality, Bhaktapur

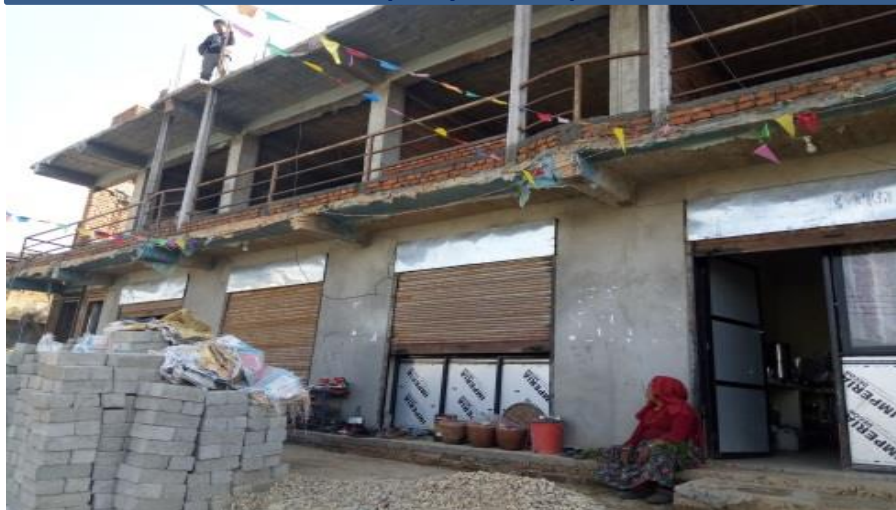
Commercial Building or Residential building? 3 no. of Beneficiaries for the same building. Submitted analysis report after 6 months.

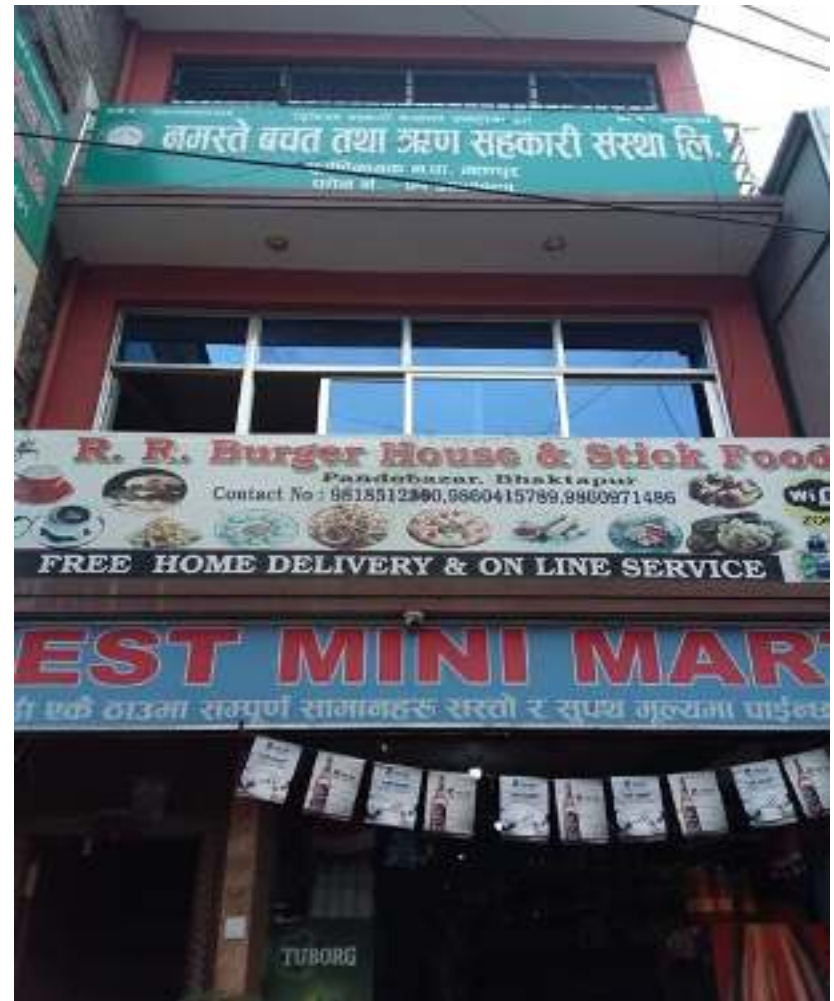
Drawing approved in the Name of Mini Mart but claimed as a residential Building. Suryabinayak Municipality

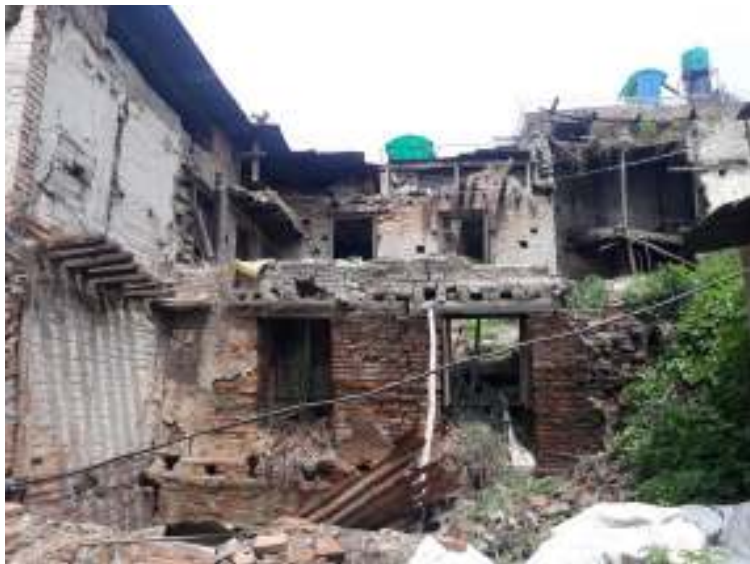
**Debris of Destructed structure are still in the Site,  
Bhaktapur Municipality**

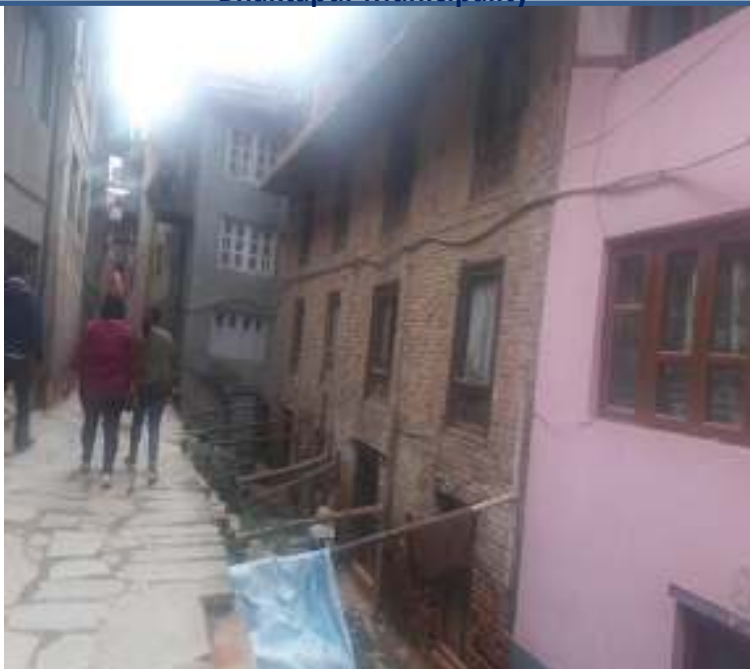
**Vulnerable structure in core settlement area near  
Bagbhairav of Kritipur Municipality (4 No. of Beneficiaries)**

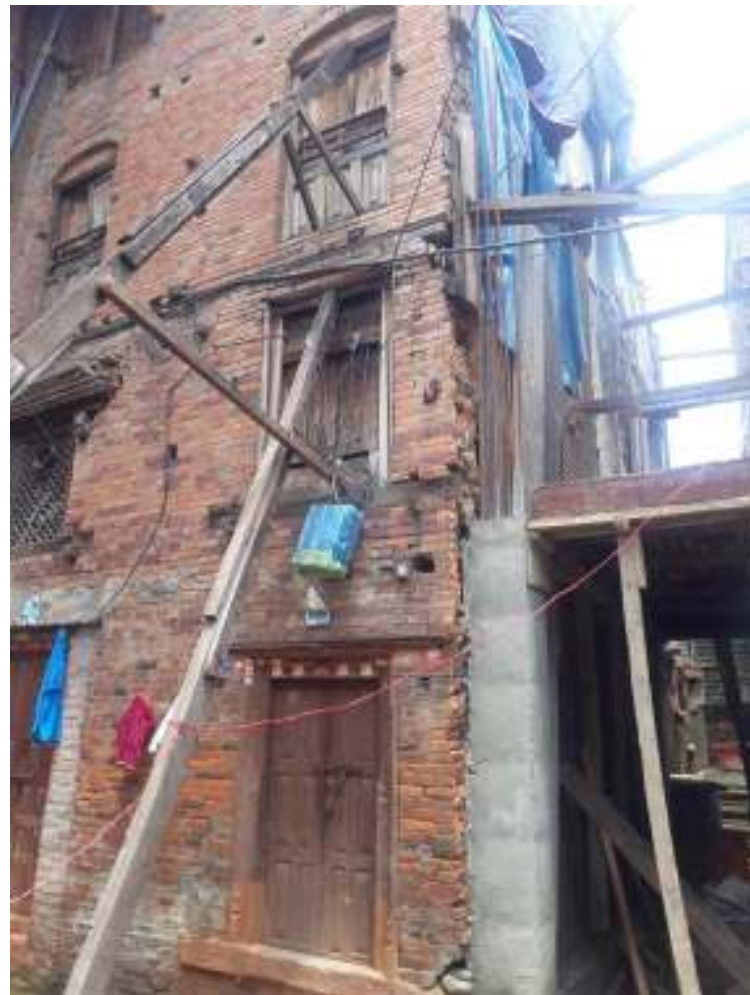
**The reconstruction of the house gets affected  
because of the adjoining structure in Kathmandu  
Metropolitan city -22**

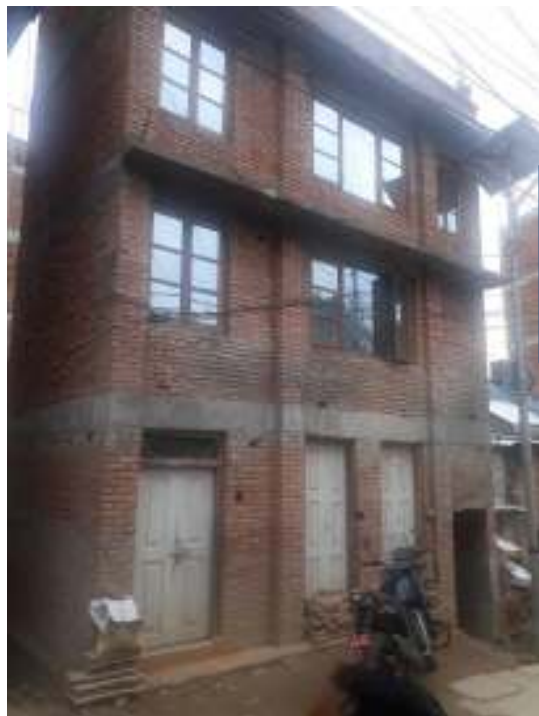
**Masonry  
Structure(BMC), 3  
storey having 9''  
wall in Kritipur  
Municipality**

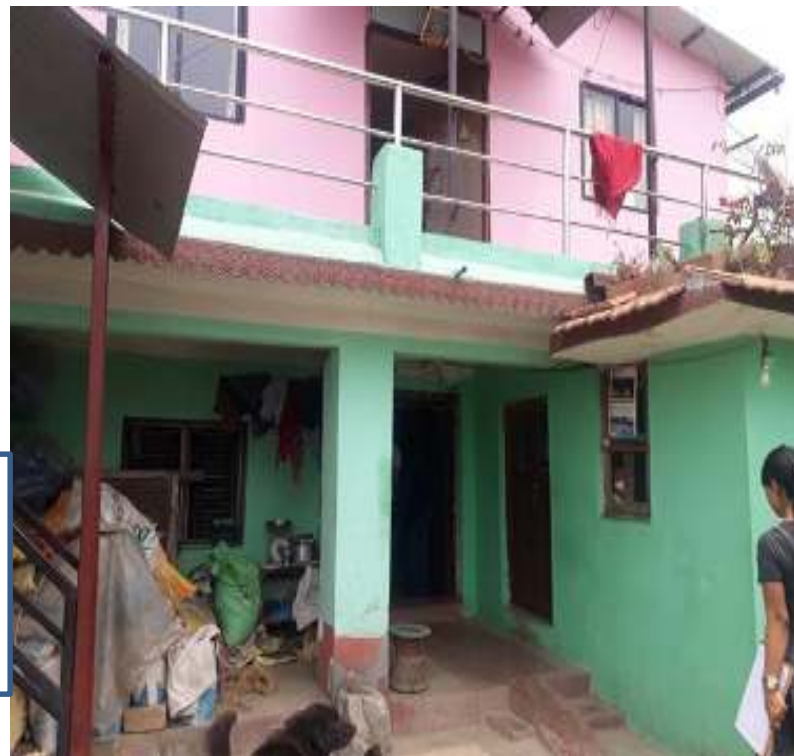
**Existing ground  
floor and newly  
construct first  
floor in  
Changunarayan  
Municipality**

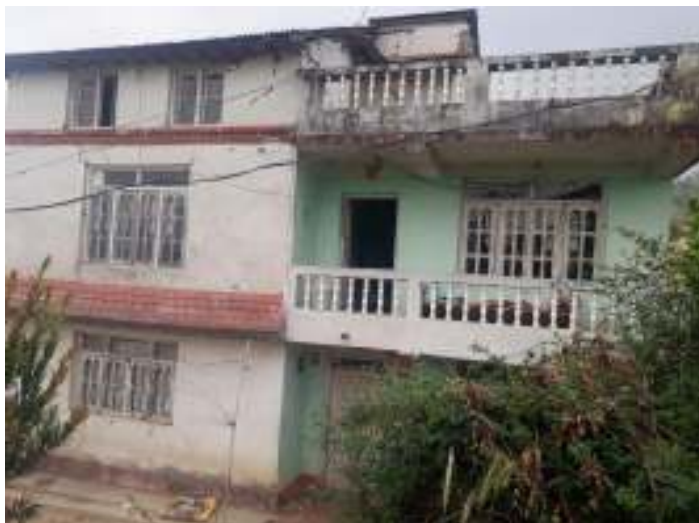
**Beneficiaries do not want to dismantle the house as  
they have no other place for living during construction  
(Changunarayan, Bageshori, Bhaktapur)**

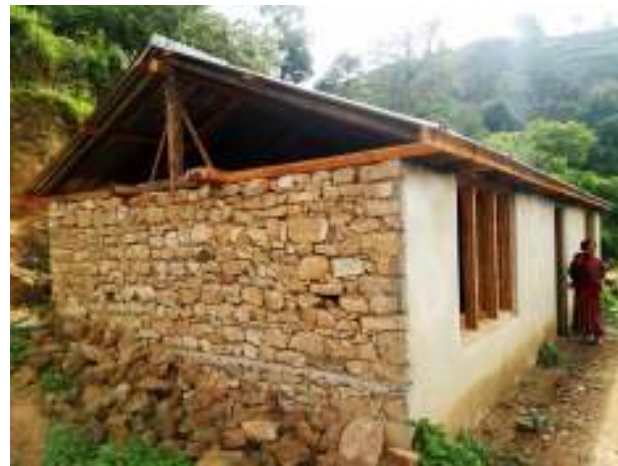
**Private housing construction in Daksinkali Municipality-1**

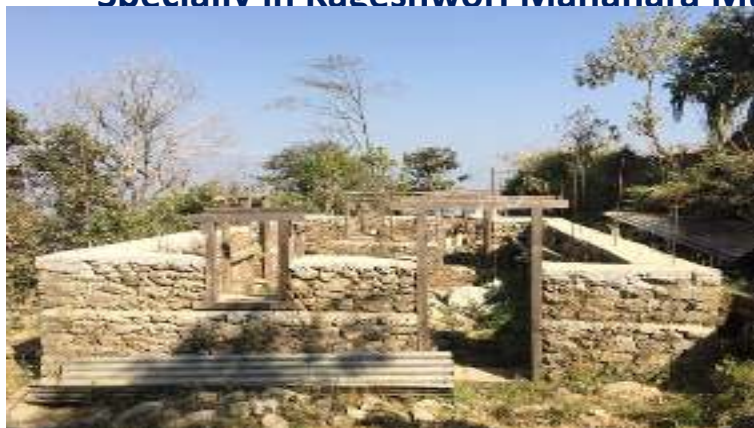
Housing reconstruction supported by LWF in Shankharapur Municipality-1. Left the works without completion

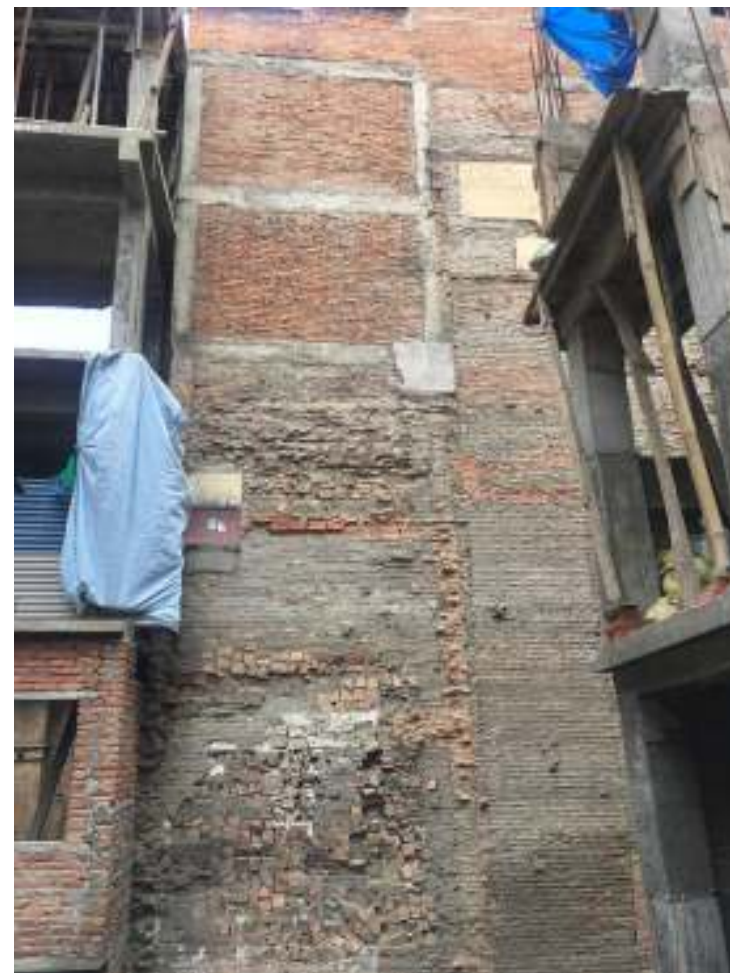
Vulnerable adjoining structure causes the problem in the reconstruction Kathmandu MPC-22
