# District Report

## Kavrepalanchok

12 – 18 January 2018

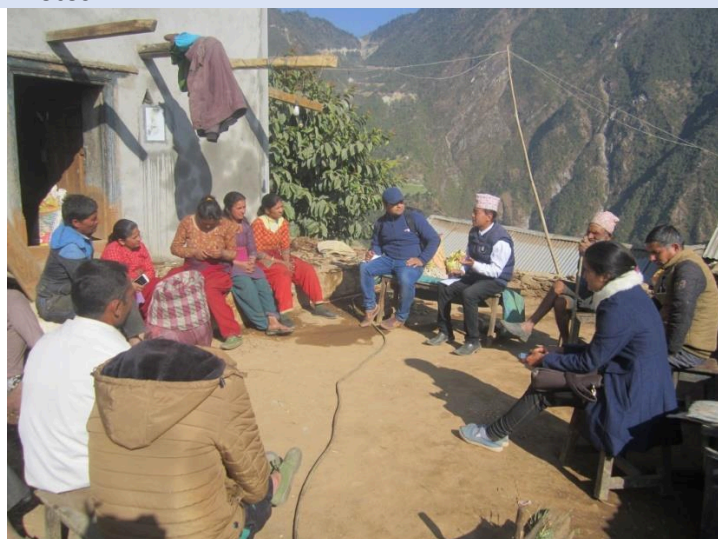
An interaction with masons and house owners involved in retrofitting at Chyamrangbesi.

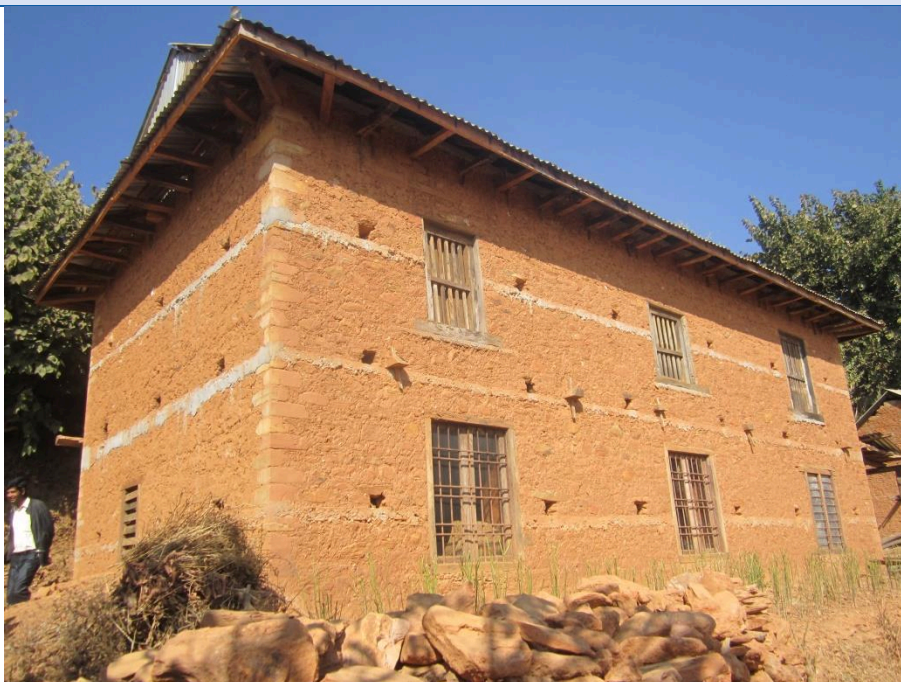
Some complaints were filed by beneficiaries regarding non-compliance certifications by DLPIU engineers. During the visit, some of the houses were visited for the details. Pictures and some information were collected to be studied back at office. The four houses visited were two and a half storey Stone in Mud constructions with RCC bands. Plinth bands and lintel bands too were missing in all of the houses.

A two storey with attic house constructed in Stone in Mud with RCC bands at Bhumlutar. The beneficiary, Nirmala Kharel has received Second Tranche.

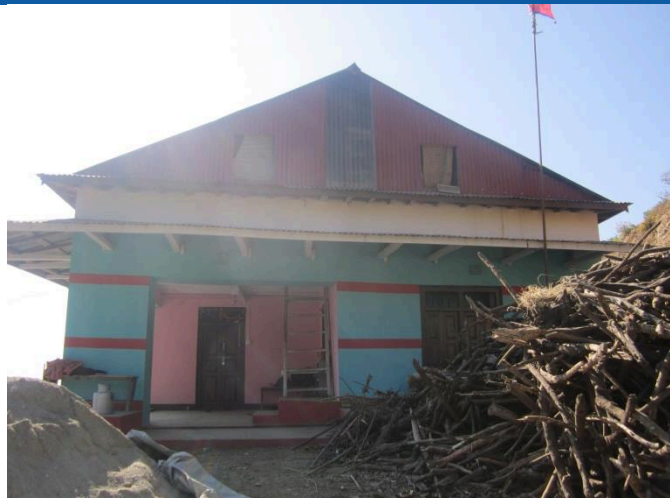
**House Owner:** Dwanda Prasad Dahal  
**Location:** Chyamrangbesi VDC (Now Bethanchok Rural Municipality)

**Building Typology:** Stone in Mud with RCC Bands

This house has received Second Tranche and applied for the third. The house owner shares that major cost for reconstruction was for demolition and site clearance.

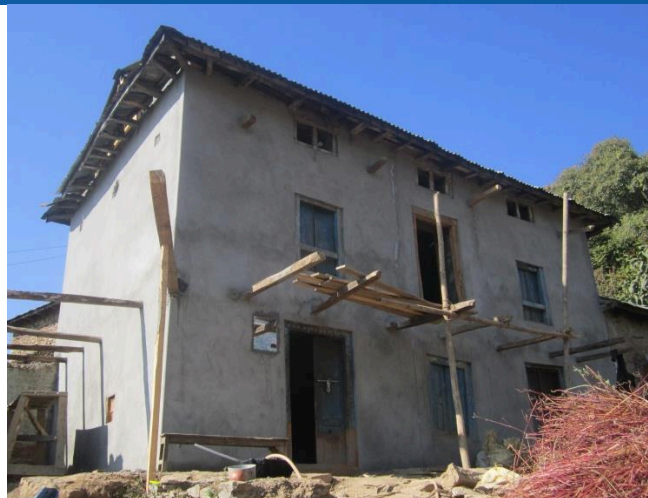
**House Owner:** Deepak Ghimire  
**Location:** Chyamrangbesi VDC (Now Bethanchok Rural Municipality)

**Building Typology:** Stone in Mud, RCC Retrofit

This house has received First Tranche and now for the further tranche, needs to switch to Retrofit Beneficiary. This house was retrofitted during 52 days Retrofitting Vocational Training by HELVETAS.

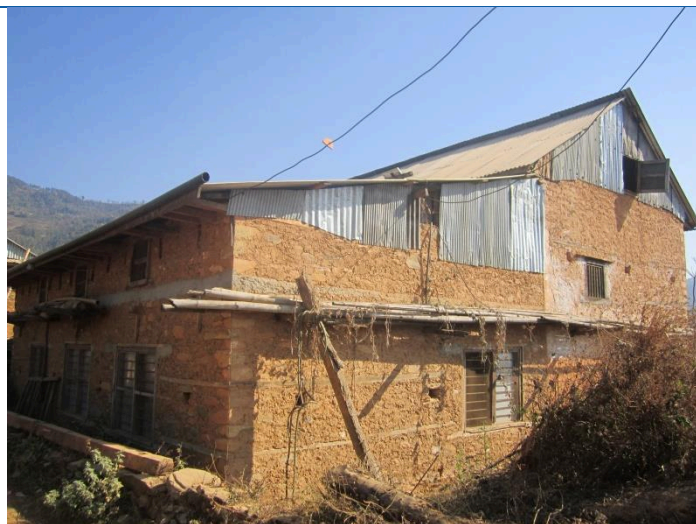
**House Owner:** Ram Sharan Kharel  
**Location:** Bhumlutar VDC (Now Bhumlu Rural Municipality)

**Building Typology:** Stone in Mud with Wooden Bands

This house has received First Tranche. The house has been constructed attached to the pre earthquake house. The leaning side has been supported only with timber supports and no masonry construction.

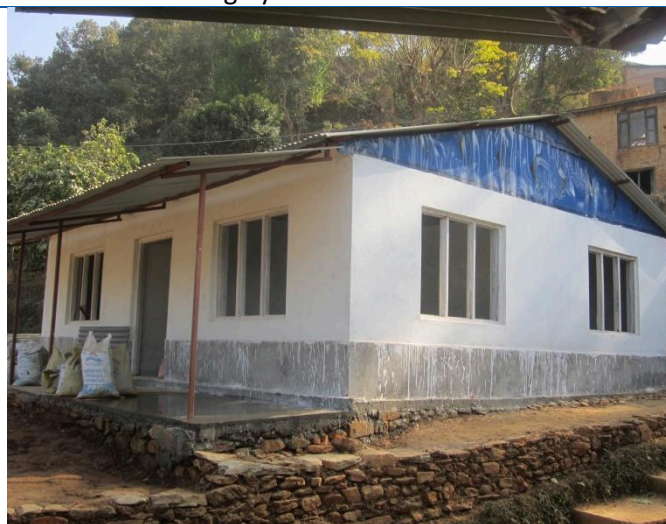
**House Owner:** Narayan Basnet  
**Location:** Bhumlutar VDC (Now Bhumlu Rural Municipality)

**Building Typology:** Brick in Cement with RCC Bands

This house has received Second Tranche and has been inspected for the Third.
