## District Report

### Okhaldhunga

21 December 2018 – 3 January 2019

## Field Visit /Joint Field Monitoring Visit Reports

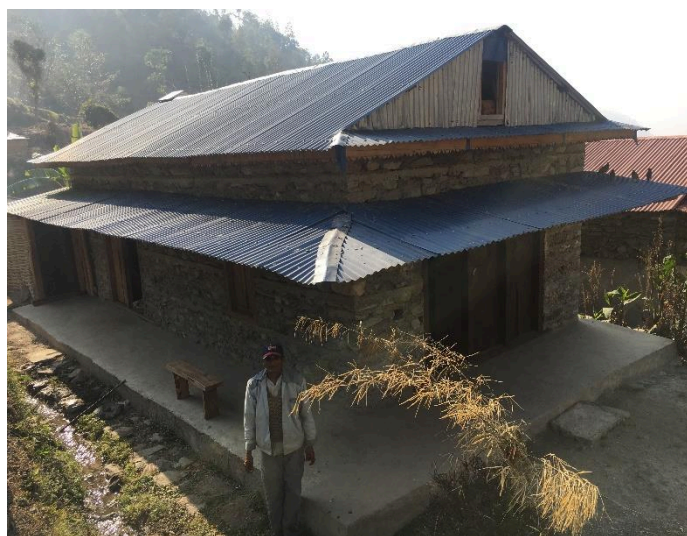
**Manju maya Giri of Champadevi Rural Municipality ward no 4** is the house owner. she has received all private house reconstruction grant. The SMM one plus attic structure is provided with RCC bands. Considering the livelihood approach she has changed the front door opening up to 9 feet considering the opening percentage as per MRs

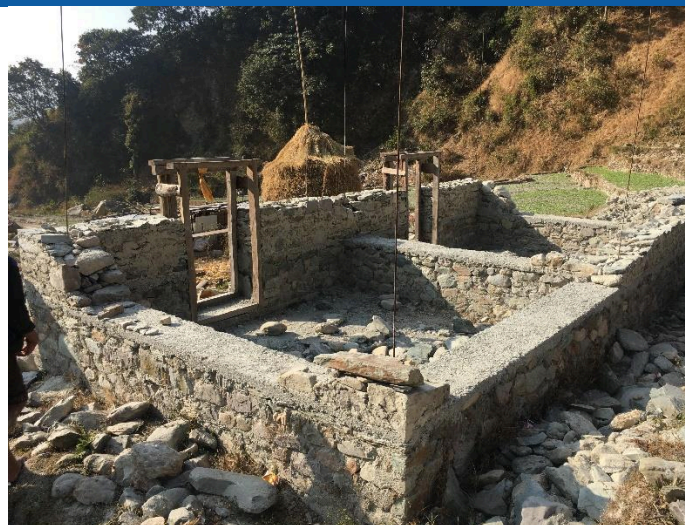
**Bachari maya Tamang of Champadevi Rural Municipality ward no 4** is the house owner. she has received only second tranche of the private house reconstruction grant. Due to the low economical status she couldnot able to reconstruct this house upward and halted the construction from last one year

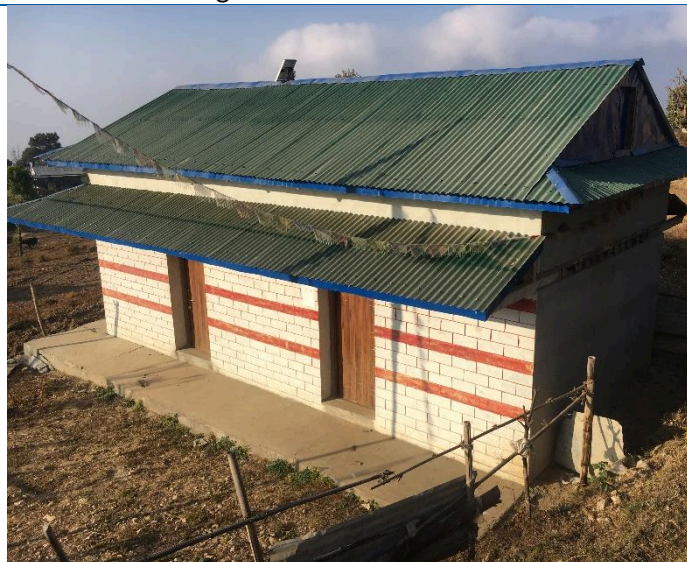
**Shova Tamang of Champadevi Rural Municipality ward no 4** is the house owner. she has received all private house reconstruction grant. The SMM one plus attic structure is provided with RCC bands and flexiabe roof.

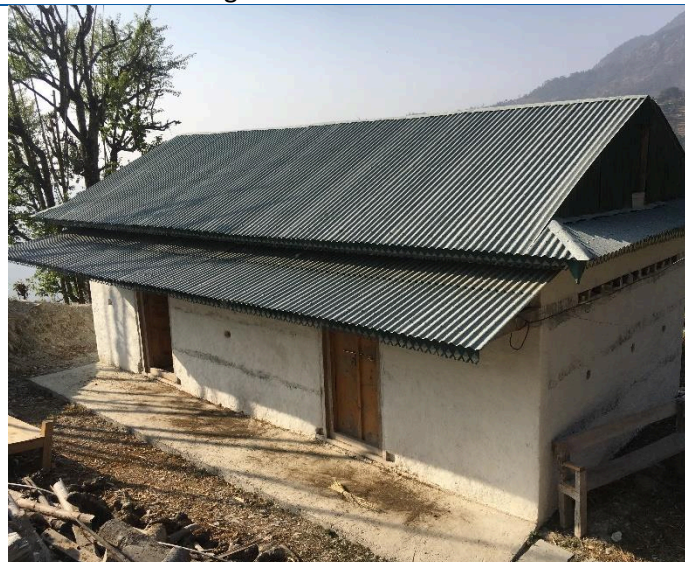
**Sarita Karki of Champadevi Rural Municipality ward no 5** is the house owner. she has received all private house reconstruction grant. The SMM one plus attic structure is provided with RCC bands.

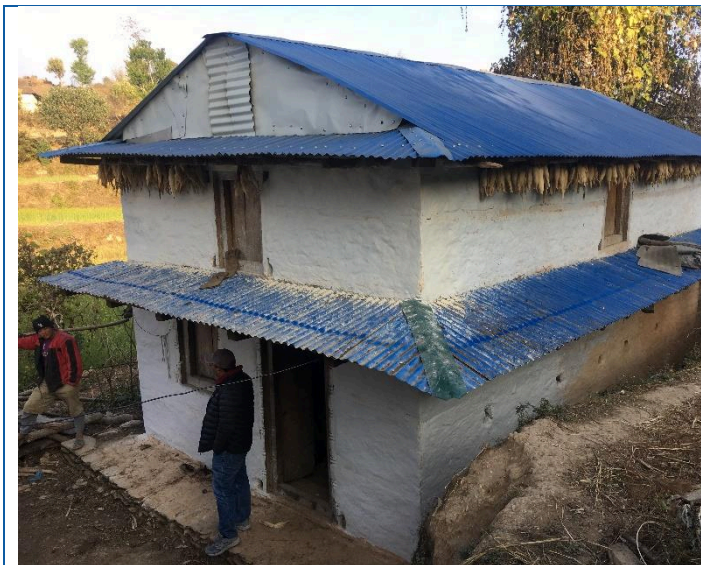
**chini Maya Tamang of Champadevi Rural Municipality ward no 5** is the house owner. Due to noncompliance on roof band she has received only second tranche of private house reconstruction grant and rejected for third tranche with recommendation of roof band correction .The SMM one plus attic structure is provided with wooden bands and flexiable roof. Due

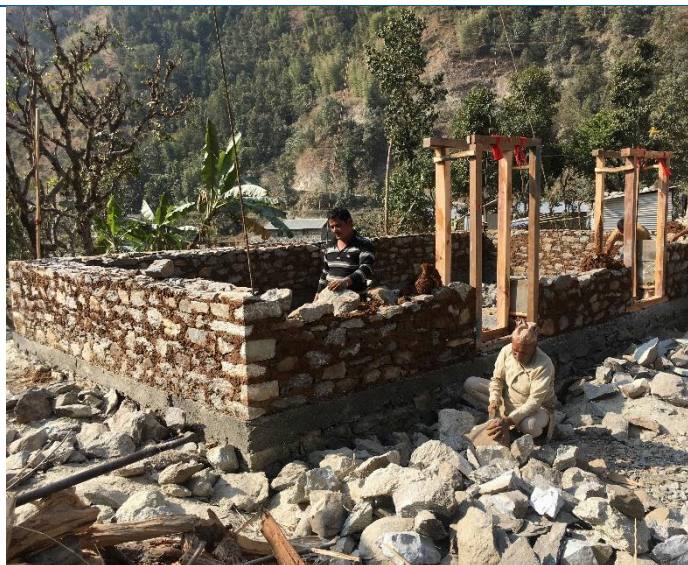
**Raju bhujel of Champadevi Rural Municipality ward no 4** is the house owner. He has not received any tranche of the private house reconstruction grant because of his totally damaged house was missed during survey by technical person.he has submitted the grievence letter and waiting for the re survey and wise to listed as total damage beneficiaries.
