# District Report

## Kathmandu Valley

25 May-7 June 2018

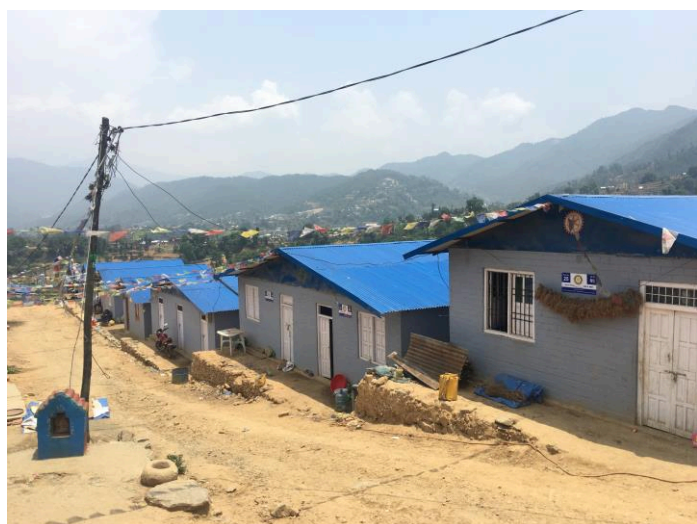
49 houses constructed by Rotary club of Manjushree, Jawalakhel in Burunchuli, Ward no 9, Godawari Municipality, Lalitpur. The houses were officially handed over to the beneficiaries in February 2018 (Falgun 2074). The houses are constructed using interlocking bricks.

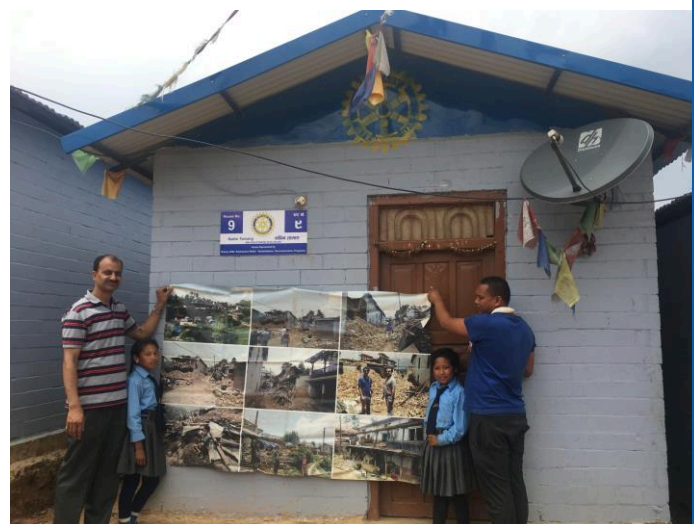
Burunchui, Ward no 9, Godawari Municipality, scenario showing the damage of the area due to 2105 earthquake and the newly constructed house of Nabin Tamang. The house has been by the Rotary club of Manjushree, Jawalakhel.

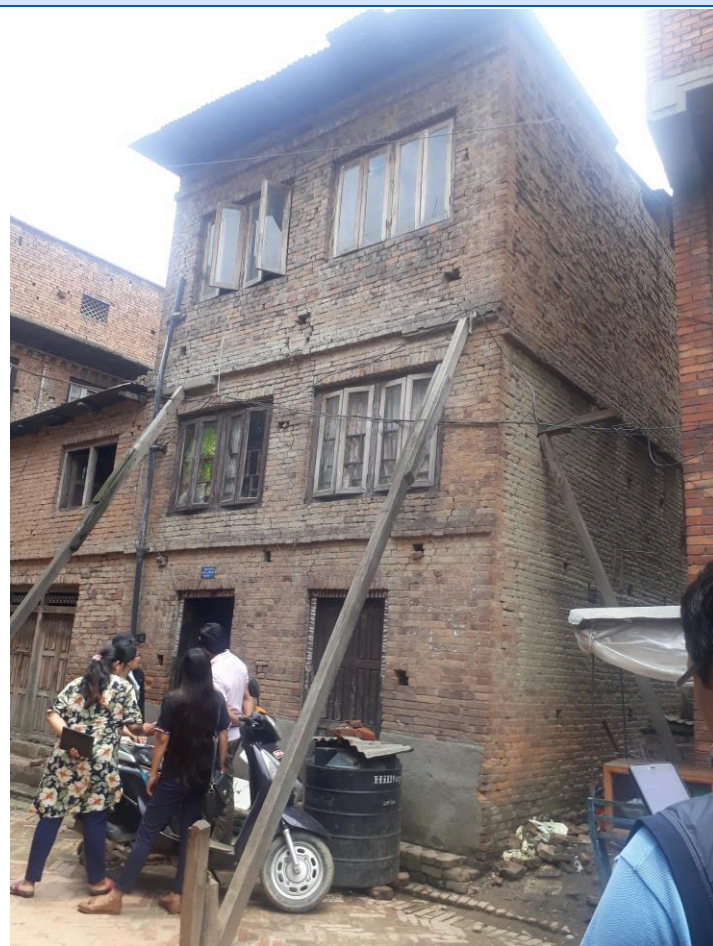
Hari Prasad gyamaru, Kamalbinayak, 10 Bhaktapur Municipality. Brick masonry mud mortar. His mother is listed as beneficiary eligible for full housing grant as fully damaged structure. The 3 sons are claiming to be eligible for housing grant as fully damaged structure separately though they had not separate house before earthquake but were living separate

| Challenges / Issues Identified | Action Required | Responsible | Timeframe |
|---|---|---|---|
| Multiple beneficiaries claim for tranche who were living in a single structure but separate kitchen. | Local authorities need to verify those beneficiaries if they are real victims. | Beneficiaries, local bodies | |

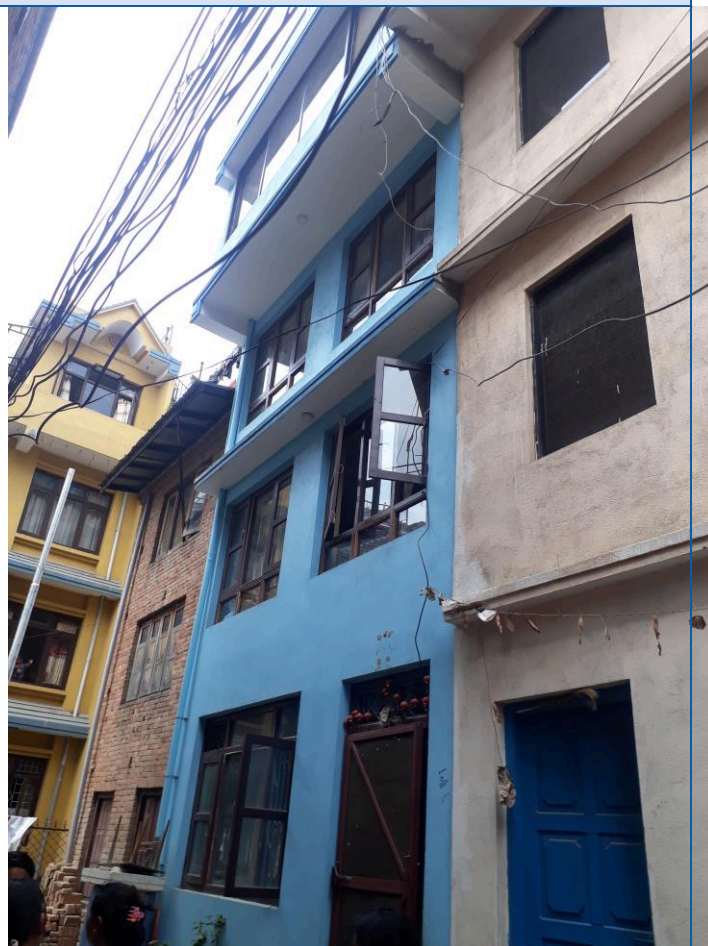
Sumati Salchu, ward no. 1, Bhaktapur Municipality. Constructed beyond as per Building permit. 3.5 stories on drawing but constructed 4.5 stories and 9"X12" column. No received II and III tranches (Blue colored building)

| Challenges / Issues Identified | Action Required | Responsible | Timeframe |
|---|---|---|---|
| Beneficiaries added more storeys than building permit/drawing in load bearing structure | Local authorities should discourage and should act strongly not only take fine. | Beneficiaries, Local authorities | |

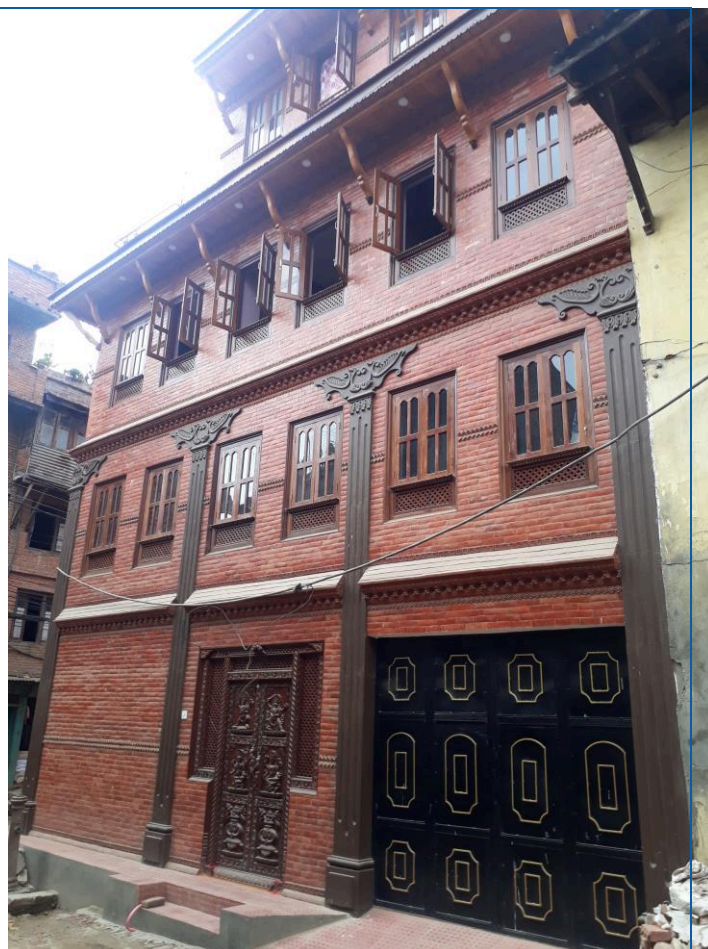
Tekhacho ward no. 3, Bhaktapur Municipality. RCC structure, 3.5 storey, traditional architect. All Tranches received

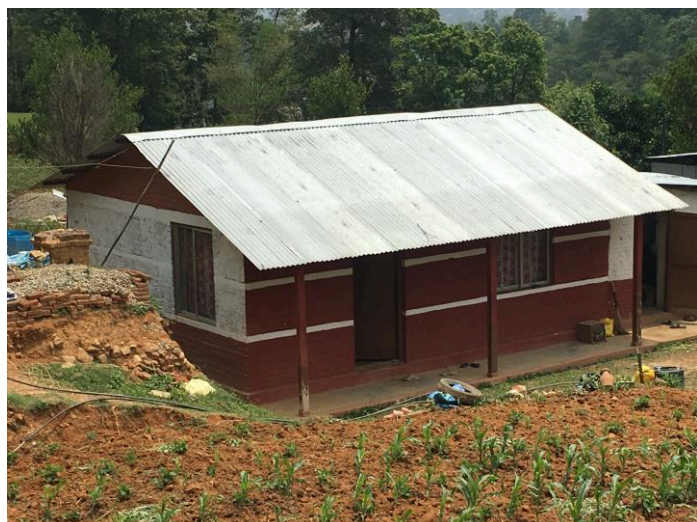
Beneficiary Name: Bhiswanath Rawat, Ward no 10, Goretar, Godawari Municipality. Load bearing structure using cement bricks. The house was constructed by Shangri-La Orphanage Home.. Beneficiary has also received 1<sup>st</sup> tranche from the government side.

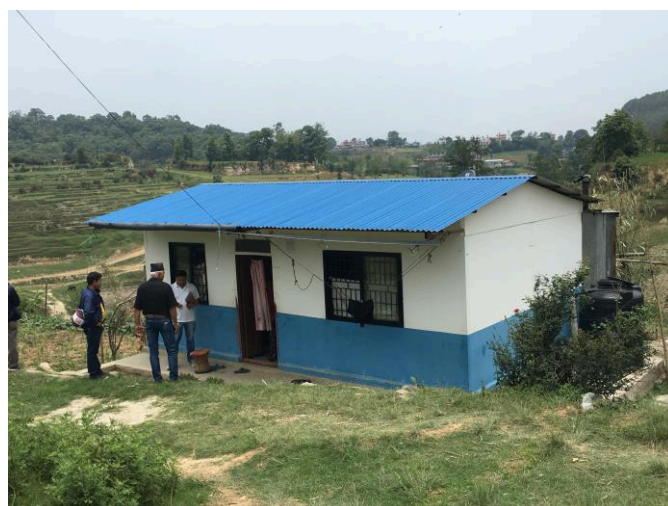
Beneficiary Name: Manju Rai, Ward no 10, Goretar, Godawari Municipality. 2 room single storey prefab house. The house was constructed by Shangri-La Orphanage Home. Beneficiary has also received 1<sup>st</sup> tranche from the government side.

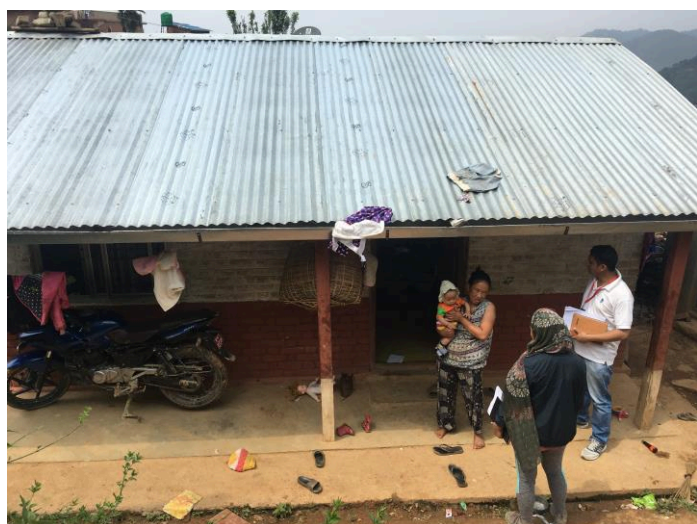
Beneficiary Name: Manisha Tamang, Salyan, Ward no 10, Godawari Municipality. Load bearing structure using cement bricks. The house was constructed by Shangri-La Orphanage Home. Beneficiary has also received 1<sup>st</sup> tranche from the government side and has requested for the remaining tranche showing the same house The tranche release of the house was stopped from the site and the beneficiary was notified that they are not eligible for the government grant.

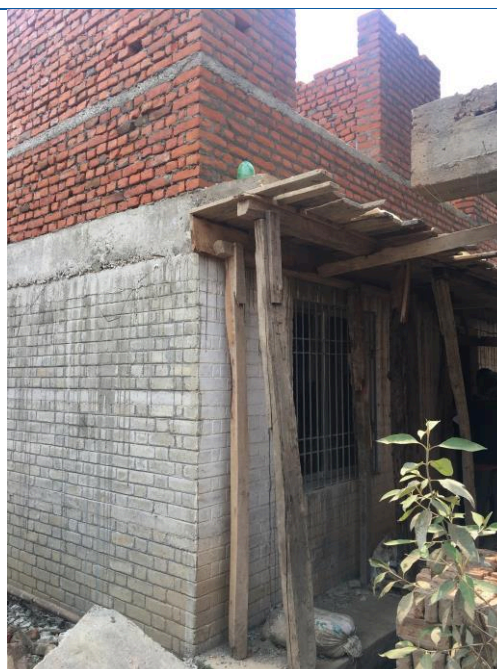
Beneficiary Name: Ramesh Sunwar, Jharuwarashi, Ward no 13, Godawari Municipality. Load bearing structure using cement bricks. The house was constructed by Shangri-La Orphanage Home. Beneficiary has added a storey to the house after the handover process from the PO. Bricks have been used in the upper structure but there are not reinforcement used which has made the house more vulnerable to earthquake.

| After receiving the complete tranche additional storey to the house without proper reinforcement, bands has been observed which makes the structure more vulnerable. | Government should come up with a modality to solve such issues. Beneficiaries should be made aware of the consequence of such construction practice | NRA DLPIU, Building, DLPIU engineers | As soon as possible |

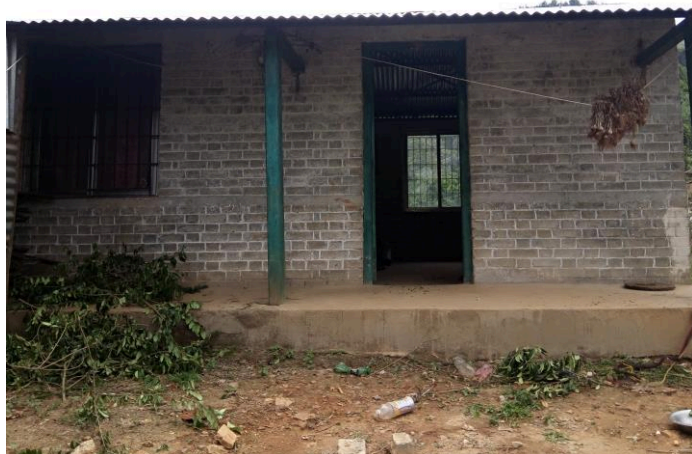
Beneficiary Name: Bhimsen Silwal, Ward no 5, Majhuwa Tole, Godawari Municipality. 2 room single storey house with wall system structure. The house was properly tied corner stitch. Beneficiary has followed up with municipality for taking building permit. Beneficiary has received 1<sup>st</sup> tranche only.

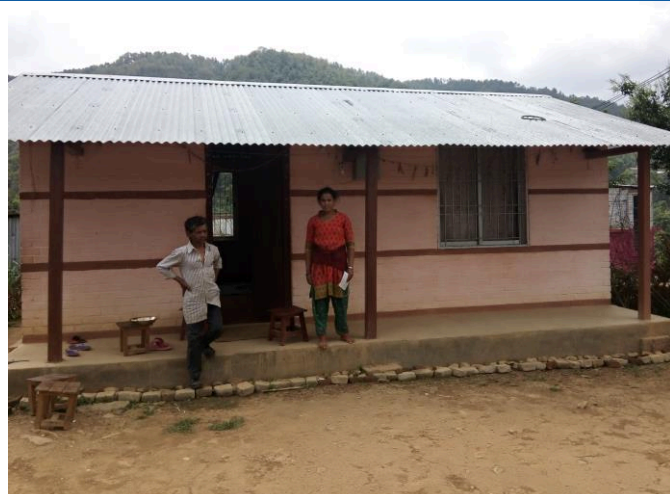
Beneficiary Name: Shyam Bahadur Damai, Majhuwa Tole, Ward no. 5, Godawari Municipality. Single storey wall system house with 2 room. The house were found to be compliance. Beneficiary has followed up with municipality for taking building permit. Beneficiary has received 1<sup>st</sup> tranche only.

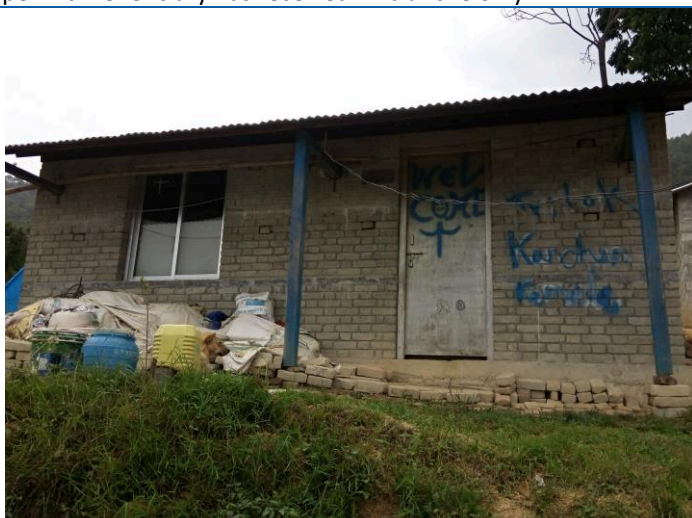
Beneficiary Name: Kamala Pariyar, Faidol, Lele, Ward no. 5, Godawari Municipality. 1 storey, 2 room with wall system structure house were found to be compliance according to technical observation. Beneficiary has received 1<sup>st</sup> tranche and file has been forwarded for 2<sup>nd</sup> tranche.

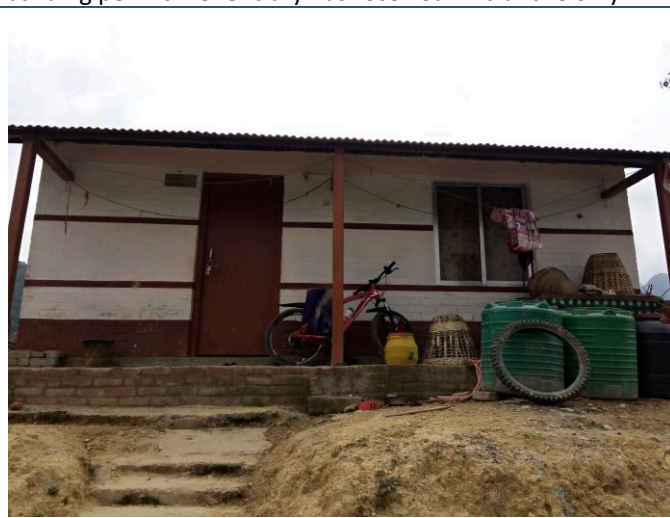
Beneficiary Name: Roshan Nagarkoti, Faidol, Lele, Ward no. 5, Godawari Municipality. 1 storey, 2 room with wall system structure house were found to be compliance according to technical observation. Beneficiary has received 1<sup>st</sup> tranche and file has been forwarded for 2<sup>nd</sup> tranche.
