## Fortnightly District Report

### Kavrepalanchok

18 – 31 January 2019

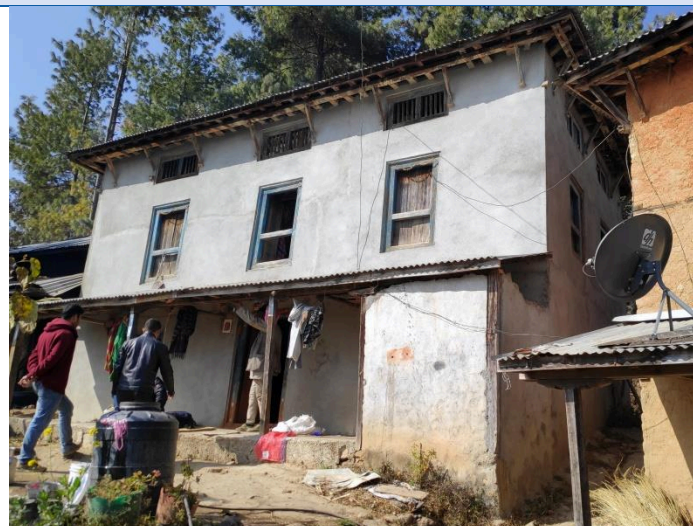
Shekhar Prasad Timilsina retrofitted his house in Asadh with technical support from Build Change. His son approached the technical team after observing the demo retrofitted house in the ward. He has received first tranche and applied for the second tranche of housing reconstruction grant.  
Photograph By: Reshma Shrestha

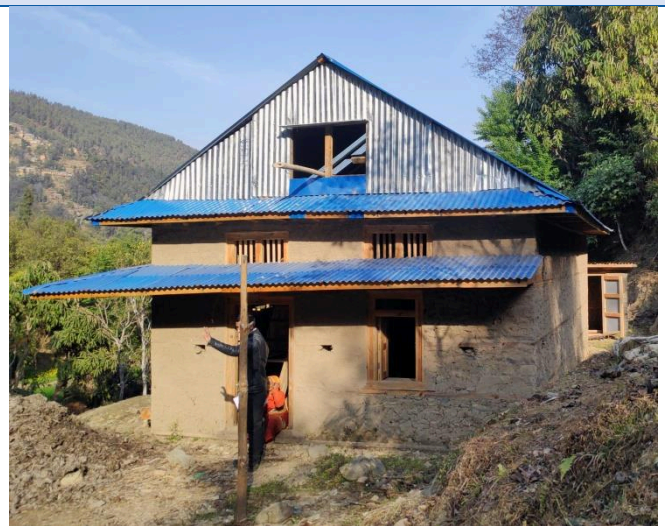
Kunti Timalisina, a single woman, reconstructed her house with the support from her married daughter with a total cost of NPRs 7 lakhs. She has received all three tranches of housing reconstruction grant.  
Photograph By: Reshma Shrestha

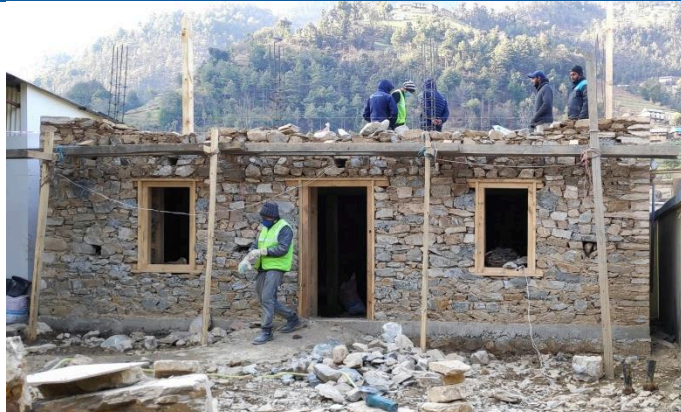
| Date | Location | Participants from HRRP and stakeholders |
|---|---|---|
| <div><div><p>A Retrofitting Demo House being constructed at the premises of Bethanchok Gaupalika office by UNOPS/Build Change. 10 masons are being trained during the construction. Photograph By: Reshma Shrestha</p></div><div><p>Hema Laxmi Lama, a single woman of Bethanchok-5 has reconstructed her house using skilled masons. She has received the second tranche of housing reconstruction grant. Photograph By: Reshma Shrestha</p></div></div> | | |

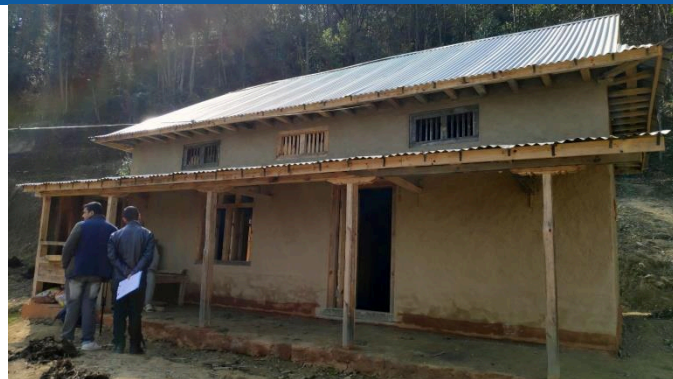
**Address:** Kavrepalanchok, Bethanchok-3

**Building Typology:** Stone in Mud

**Description:** Keshav Prasad Timalisina constructed his house using skilled masons and continuous technical assistance from NRA engineers. He has received all three tranches of housing reconstruction grant.

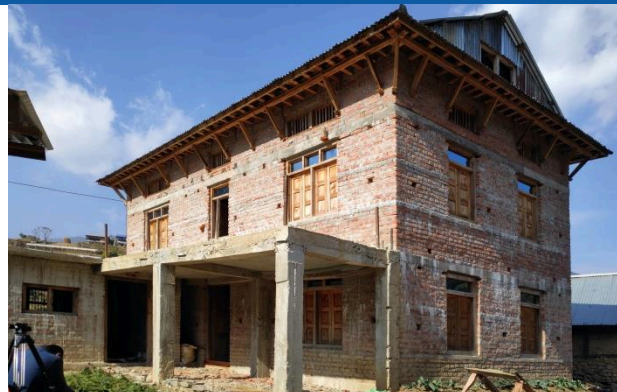
**Address:** Kavrepalanchok, Bethanchok-3

**Building Typology:** Brick in Cement

**Description:** Saraswati Timalisina constructed her house similar to her pre earthquake house but she had to switch from stone in mud to brick in cement for similar space. She later added the front porch with a small gap to the main building as suggested by the engineers. The total cost was NPRs 20 lakhs and she has already received all three tranches of housing reconstruction grant.

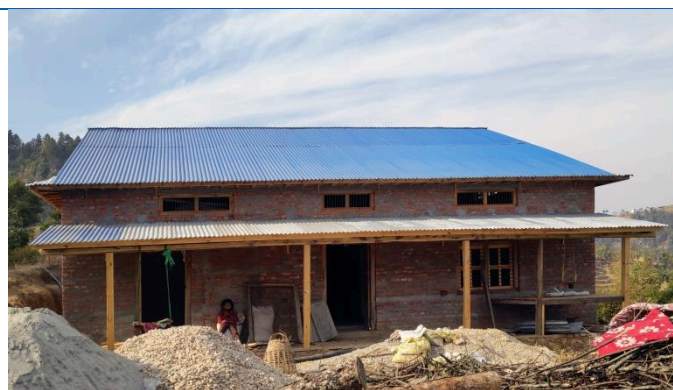
**Address:** Kavrepalanchok, Bethanchok-3

**Building Typology:** Brick in Cement

**Description:** Ram Kumari Sapkota has received all three tranches of housing reconstruction grant.

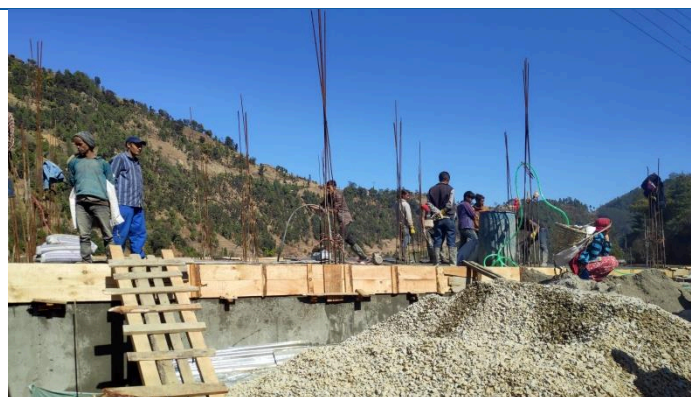
**Address:** Kavrepalanchok, Bethanchok-3

**Building Typology:** RCC

**Description:** Udhav Prasad Mainali recently returned from abroad to construct his house. He immediately had his designs made and approved from the palika to meet the deadline. He has received first tranche of housing reconstruction grant.

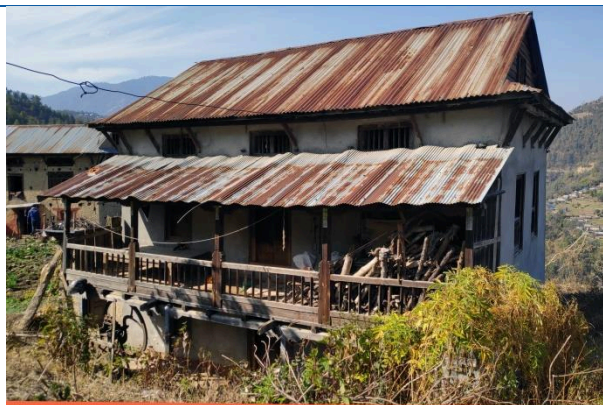
**Address:** Kavrepalanchok, Bethanchok-3

**Building Typology:** Stone in Mud

**Description:** This demo retrofit house of Januki Maya Dahal was retrofitted with technical and material support from Build Change.

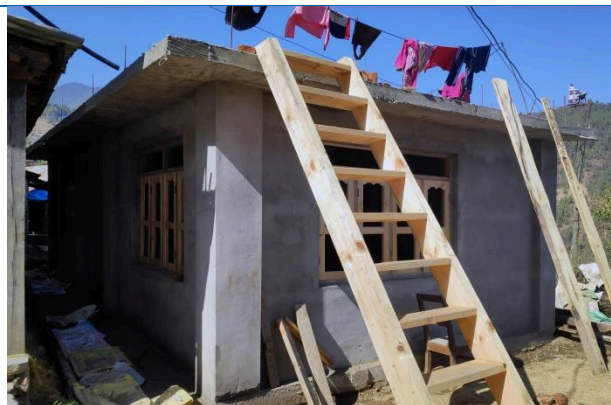
**Address:** Kavrepalanchok, Bethanchok-3

**Building Typology:** Brick in Cement

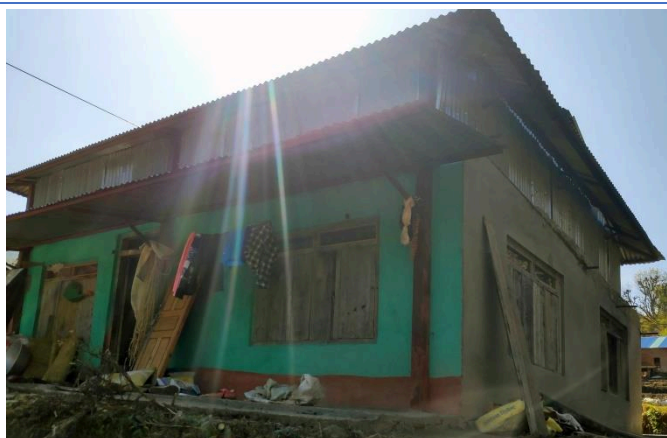
**Address:** Kavrepalanchok, Bethanchok-3

**Building Typology:** Stone in Mud

**Description:** Moti Lal Tamang constructed one storey load bearing structure with a light weight attic. The interior partition walls are constructed using wood and ply boards. Construction of load bearing partition wall was suggested as the correction measure. This house has received second tranche of housing reconstruction grant.

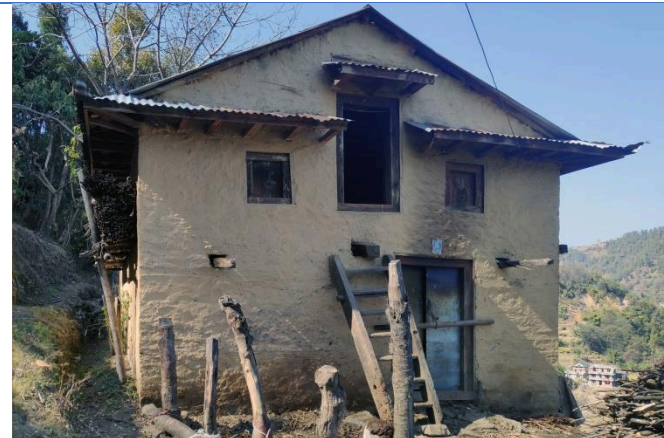
**Address:** Kavrepalanchok, Bethanchok-3

**Building Typology:** Stone in Mud

**Description:** Shiva Prasad Timalisina has received the second tranche of housing reconstruction grant but the house was non-compliant for the third tranche. Lintel, sill and roof bands are missing and the gable walls are constructed using stone. Addition of bands and stiffening the attic as per the correction guideline were suggested as correction measures.

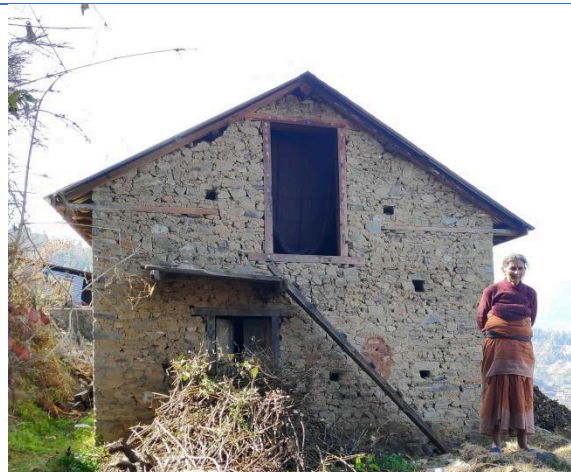
**Address:** Kavrepalanchok, Bethanchok-3

**Building Typology:** Stone in Mud

**Description:** Om Kumari Paudel immediately constructed her house after the earthquake to shelter herself and her differently abled son. The house misses all bands. Addition of bands and stiffening the attic as per the correction guideline were suggested as correction measures. She has received first tranche of housing reconstruction grant.

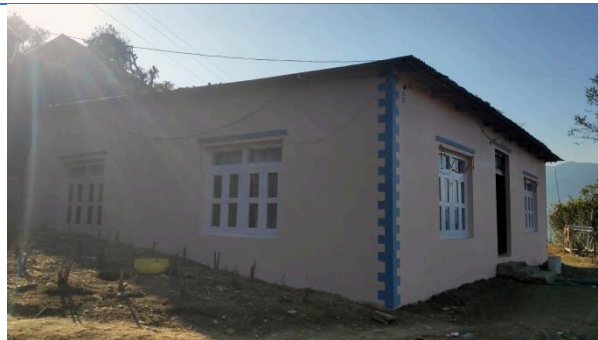
**Address:** Kavrepalanchok, Bethanchok-5

**Building Typology:** Stone in Cement

**Description:** This house of Akal Bahadur Tamang has no sill, lintel, roof and vertical bands.
