## District Report

### Makwanpur

15 February - 14 March 2019

##### Visit 1

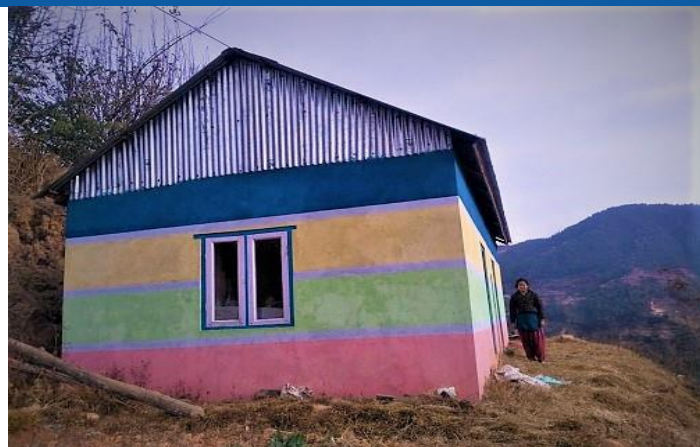
*Figure 3: Indrasarowar Rural Municipality-05, House owner; Janak Bahadur Muktan; Load bearing stone in mud mortar with flexible roof. All seismic resistant components have been provided and he received all tranches of government housing grant. Two rooms with one story. total construction cost is around 8lakh.*

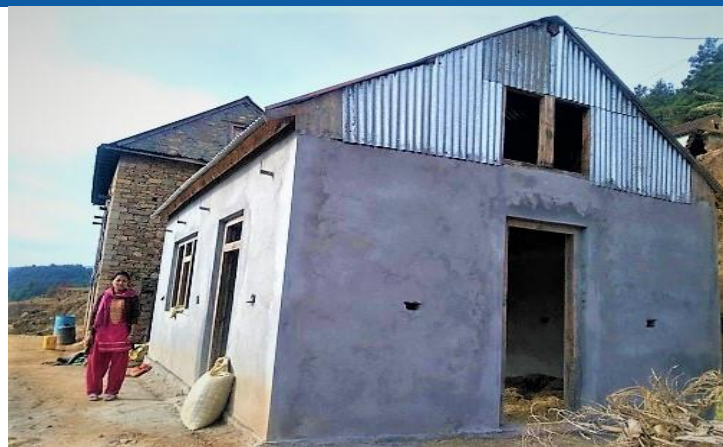
*Figure 4: House owner; Sanu Kanxi Muktan, Indrasarowar Rural Municipality-05. Load bearing stone in mud mortar with RCC band. Provided all horizontal and vertical reinforcements. She received all tranches of government grant. One room house and the construction cost is around 2lakh.*

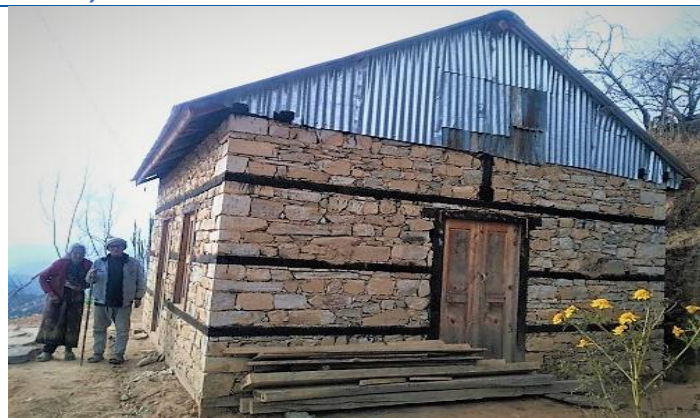
*Figure 5: House owner; Aayate sing Muktan, 88years old and wife 86 years old, only two members for this house and sufficient for their need. Indrasarowar Rural Municipality-05. Stone in mud mortar with timber band and used flexible roof, light gable wall with CGI sheet. One room building with wooden vertical post provided, the total construction cost is around 2.5lakh. He received all tranches of government housing reconstruction grants.*

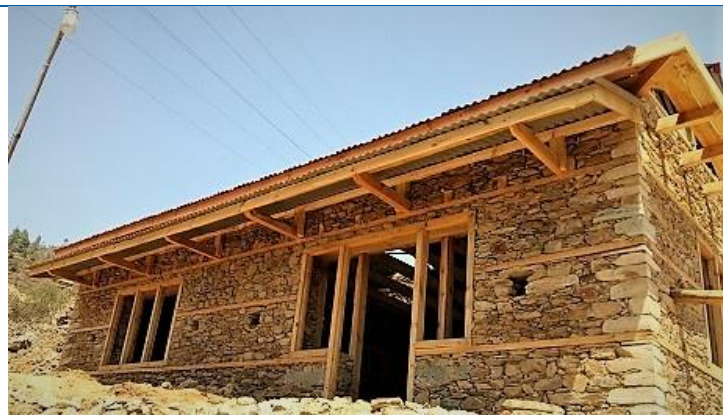
*Figure 6: House owner; Shyam Sundar karki, Indrasowar Rural Municipality-04, load bearing stone in mud mortar with timber band. All bands provided, also he used through stone in certain portion of wall also truss connected with wall. Two room with one story. He received all tranches of government housing reconstruction grant.*

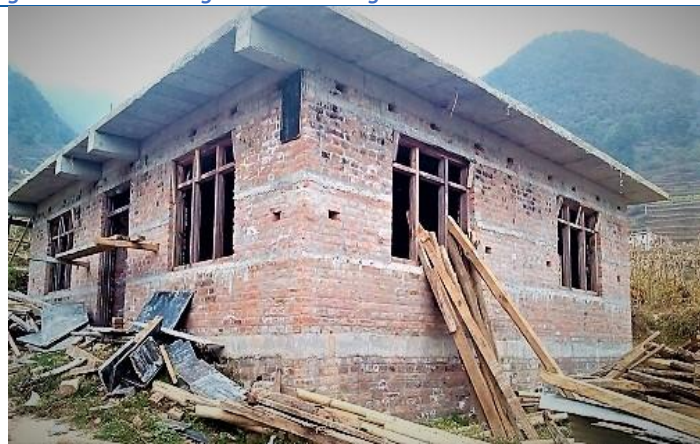
*Figure 7: House owner; Harka Bahadur Lopchan, Indrasowar Rural Municipality-04. Load bearing structure, brick materials used. All Horizontal bands and vertical reinforcement provided. 14" wall thickness. Four room with one story.*

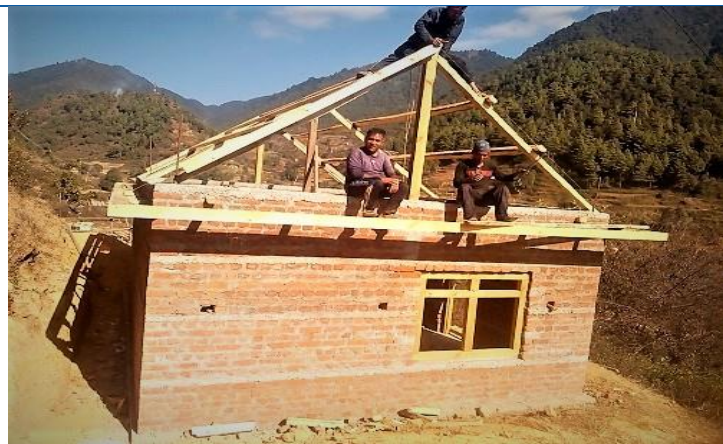
*Figure 8: House owner; Raj Kumar Thokar, Indrasarowar Rural Municipality-04. Load bearing brick in cement mortar with RCC band, all vertical reinforcements provided. skilled manpower is working for truss. We suggested, be care and safety measures during working. Two rooms with flexible roof.*
