# Gorkha North Field Report

**CRS Shelter and Settlements Team**

Loren Lockwood / Jonathan Buckland / Tsering Lama - 160728

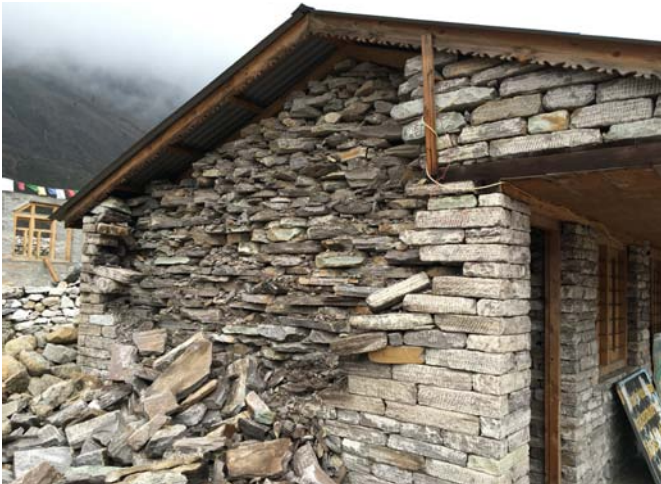
Collapsed gable end wall due to lack of through stones

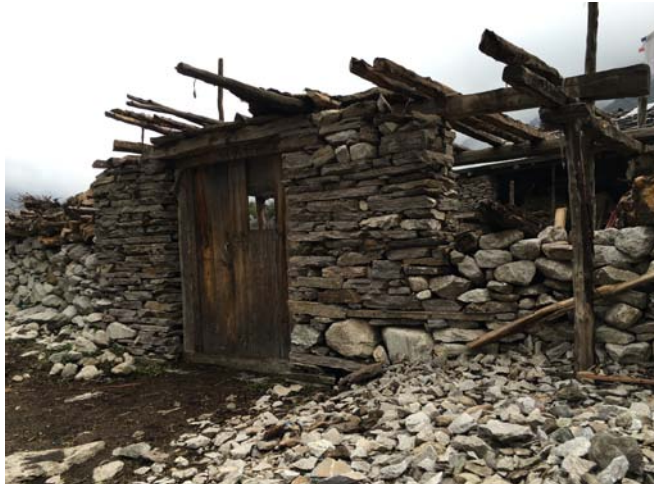
Portion of wall with large, long and well stones survived

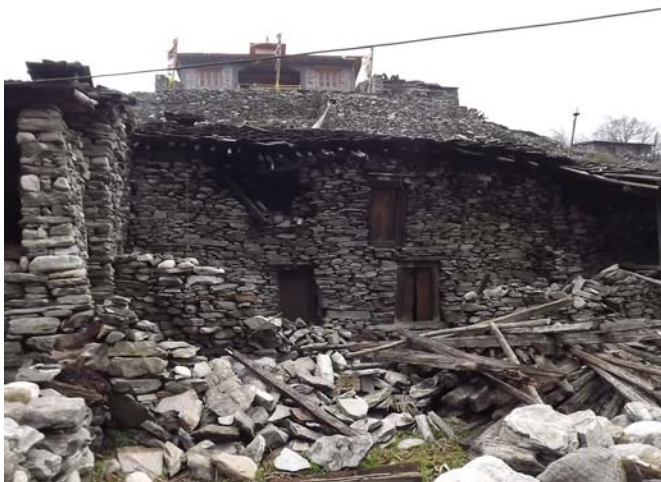
Top of wall collapsed around a window opening, lintels are often under sized to take stone wall above

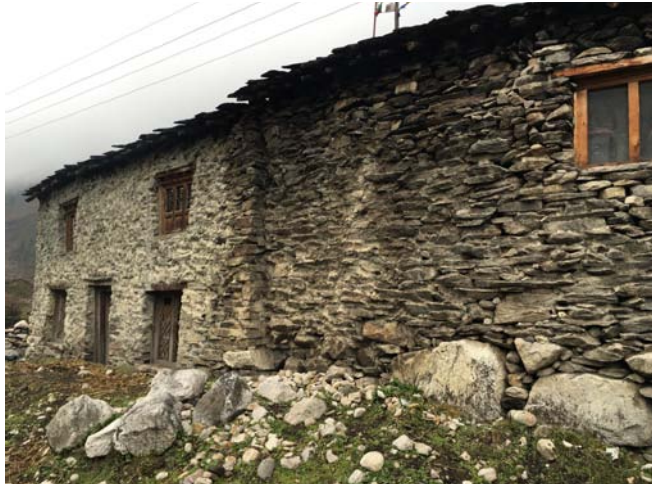
Complete stone house without a verandah that survived the EQ. Extensive use of clay mortar

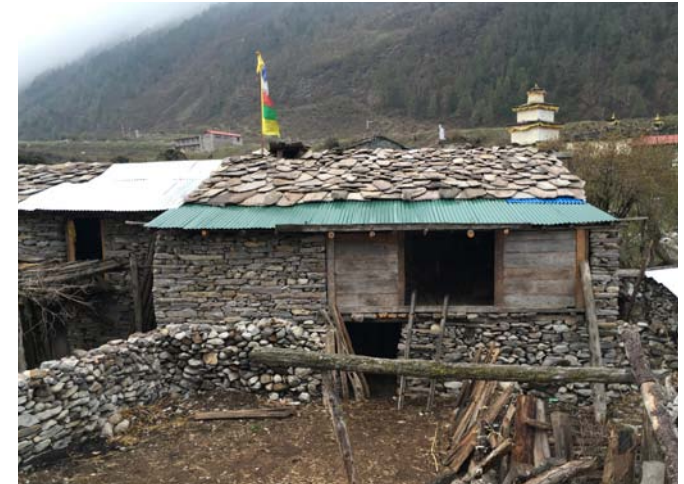
Good shape and size of stonework but wall bowing on the left. Traditional stone tile roof with CGI over the Verandah

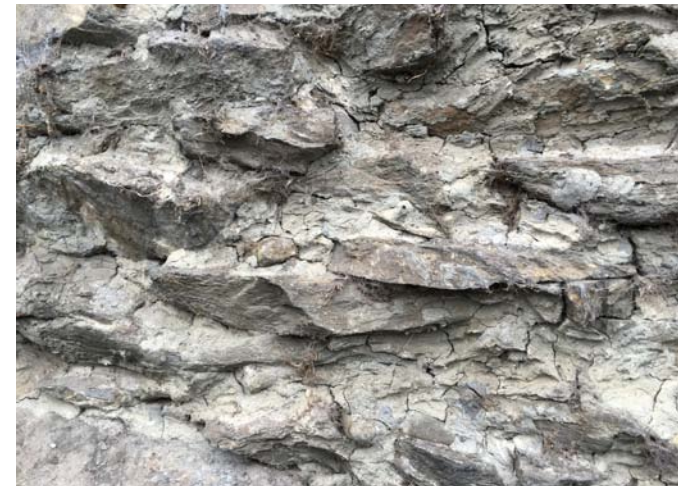
Clay applied to gaps between stone work

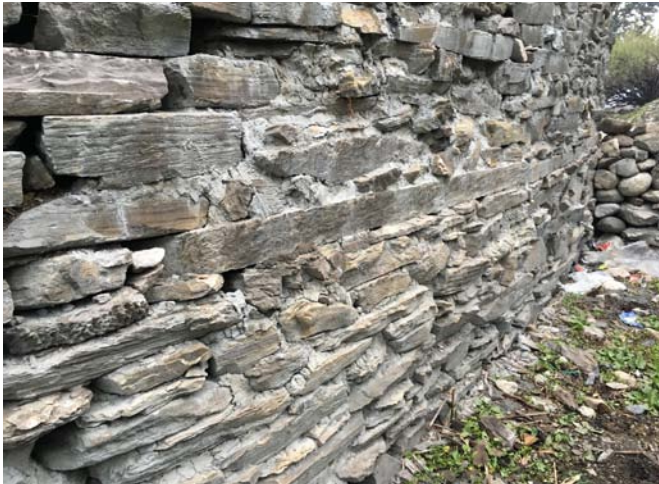
Stone banding, piece laid approx. 1m above GL and is 100x deep x 2.5m long

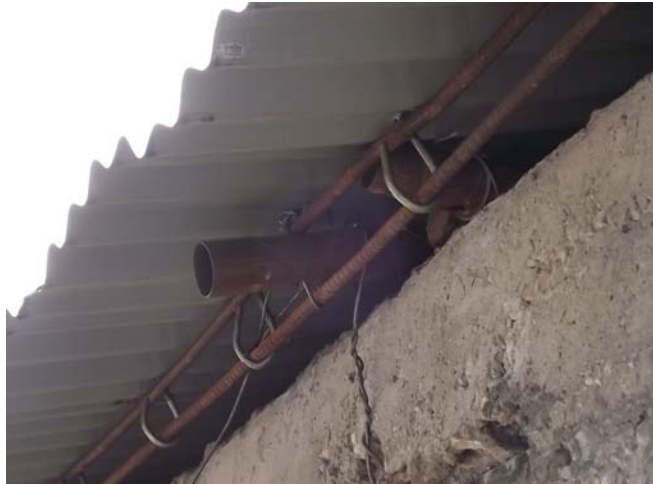
Use of steel pole and hooks on a concrete block hotel, wire wall ties used to secure the rafters

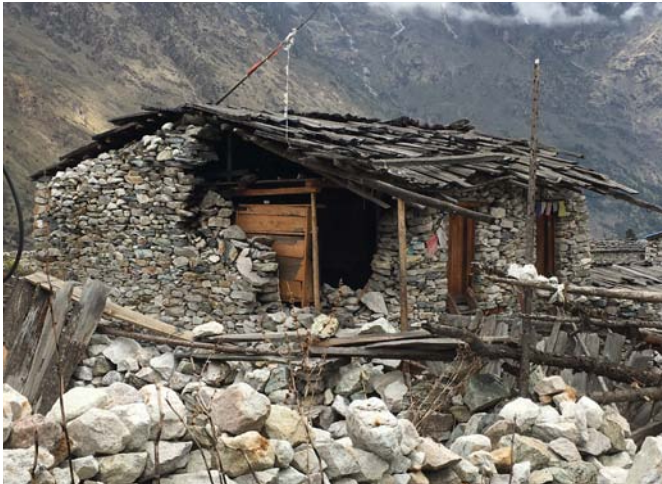
Corner wall collapse with internal timber joinery still standing

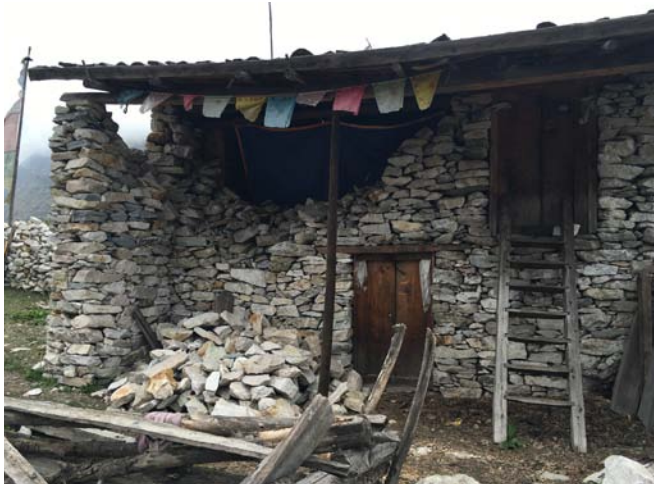
Verandah and front wall collapse, roof eave beam supporting the roof on a few stones on the flank wall

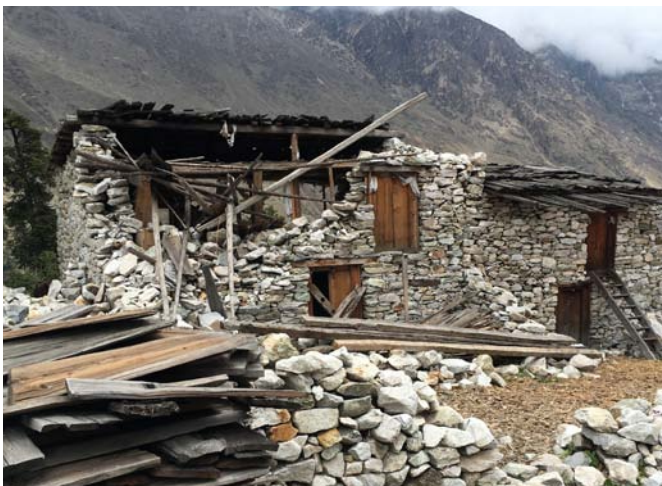
Corner wall collapse on a Khim with no original verandah

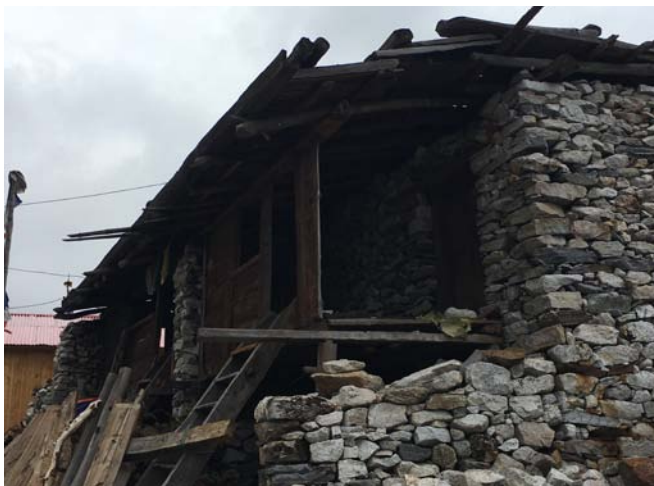
Verandah flank wall collapse

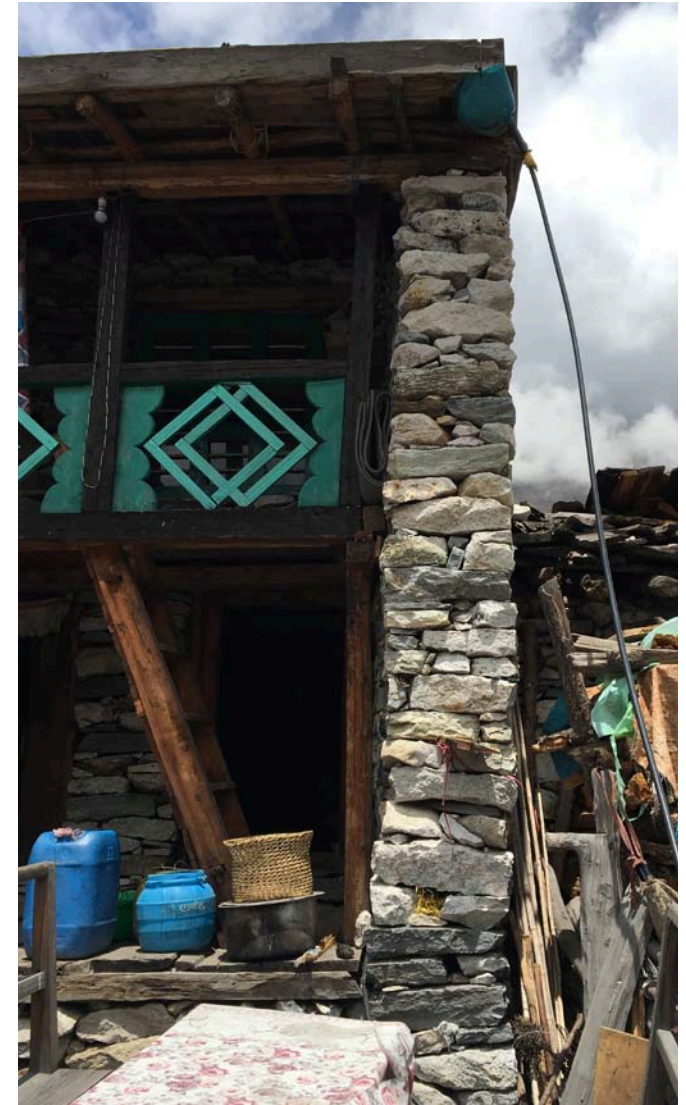
Stone work to a two storey home verandah wall, bowing outward and tapering in width toward the top

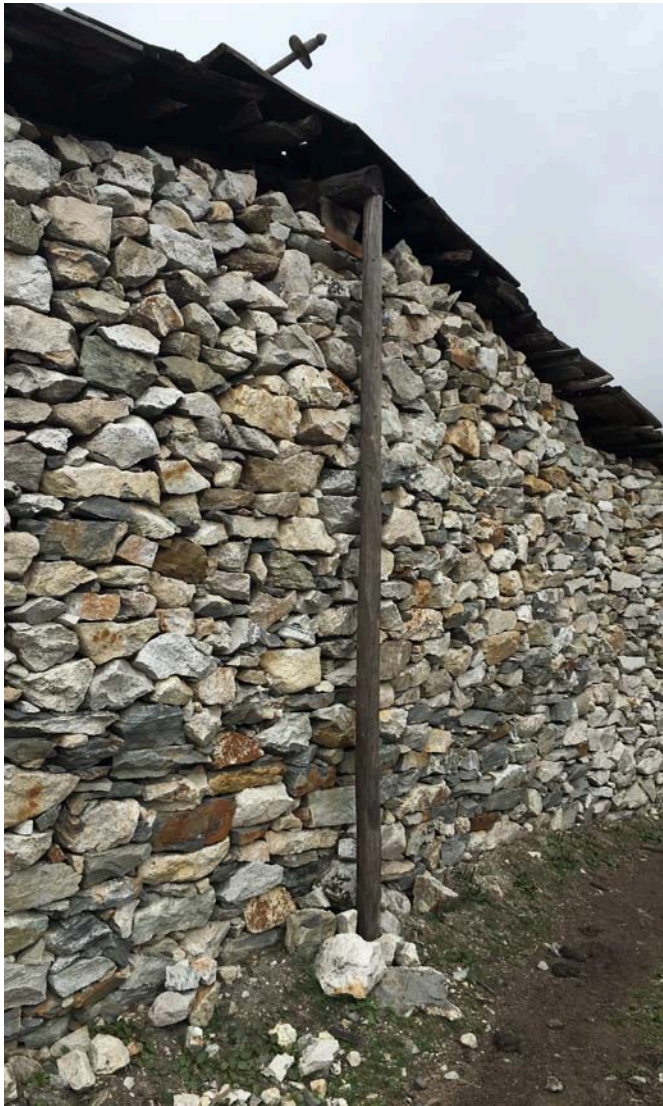
Timber post added to support the ridge beam

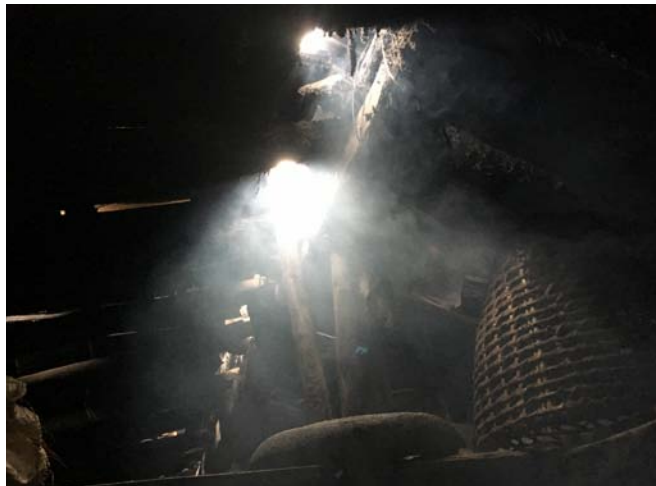
Voids in the roof tiles/ shingles act as chimney's and provide an inadequate escape route for the smoke

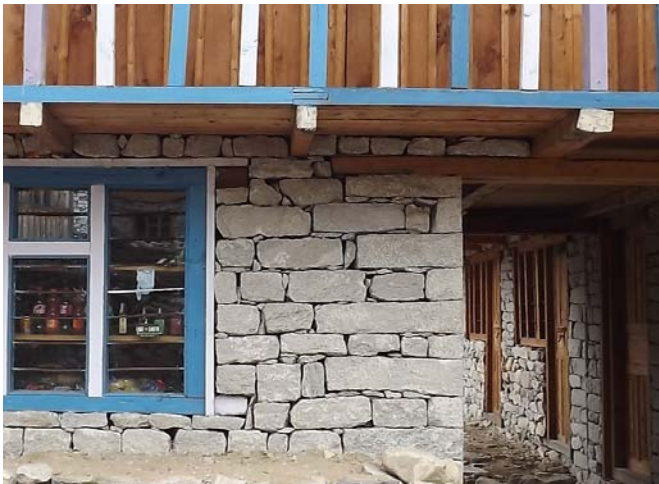
Good stonework again found on the hotel buildings, good coursing and stone shape and size

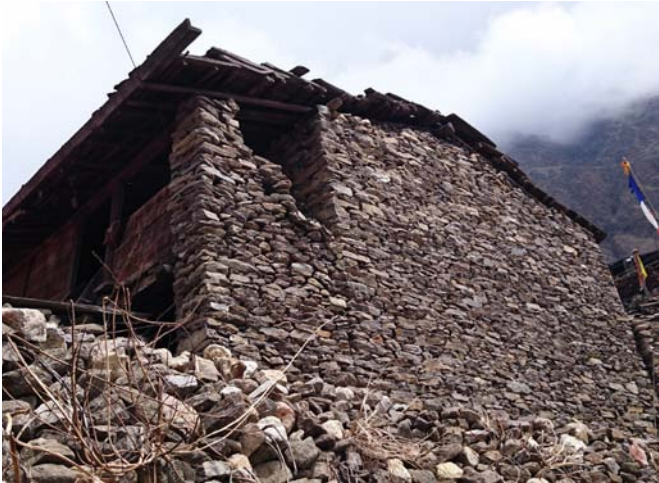
Verandah flank wall collapse, these elements are never keyed in to the main building walls

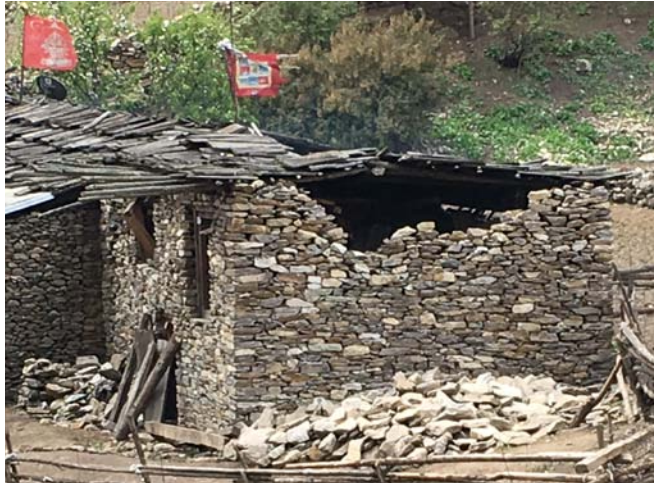
Gable end stone wall and roof collapse

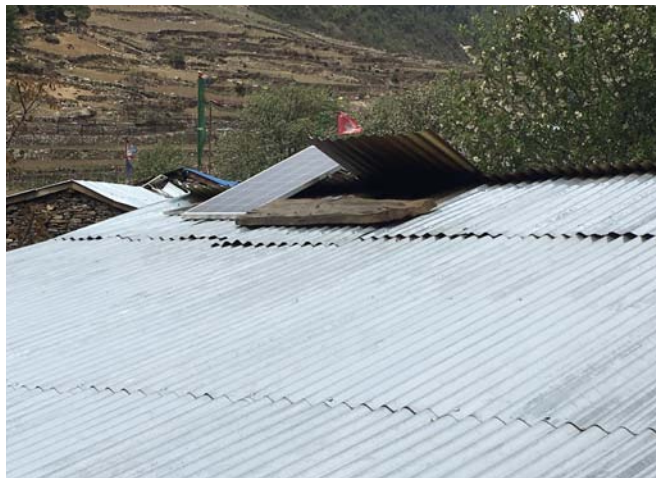
Open chimney and solar panel arrangement on a new CGI roof

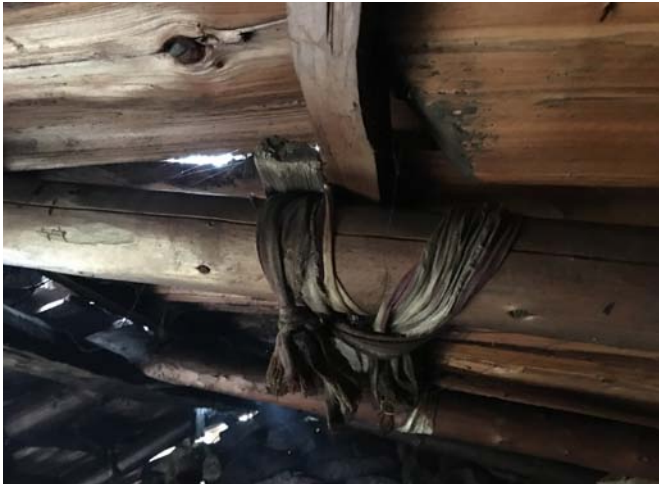
Fabric used to lash rafters and battens together

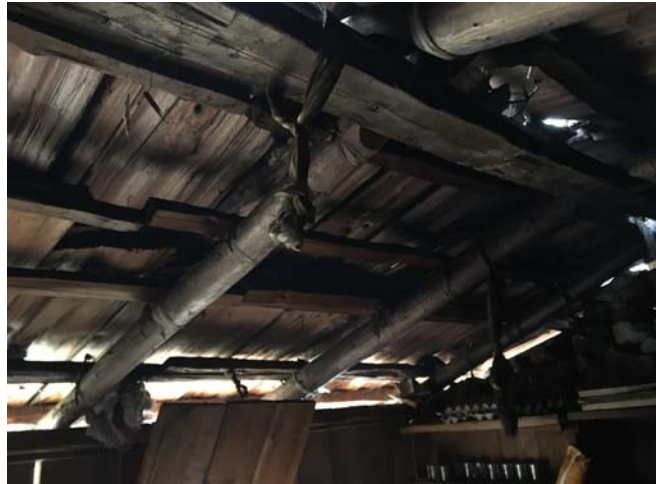
View of the ridge beam and rafters supporting a traditional timber shingle roof, voids in the building fabric can be clearly seen

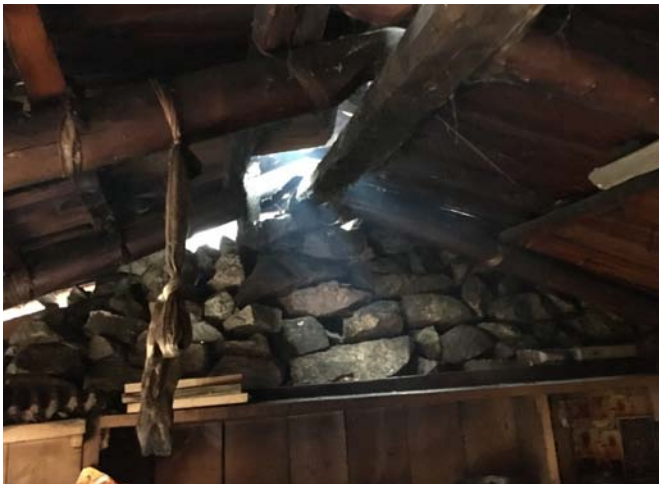
Chimney void within the roof located adjacent to the gable

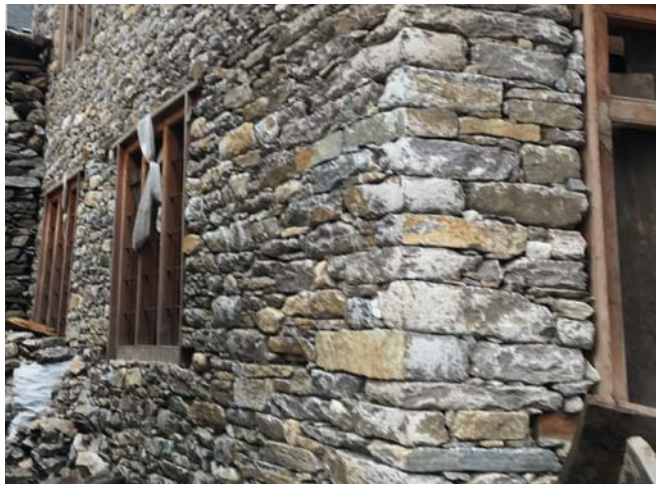
Good example of well shaped and sized corner stones used on a hotel building

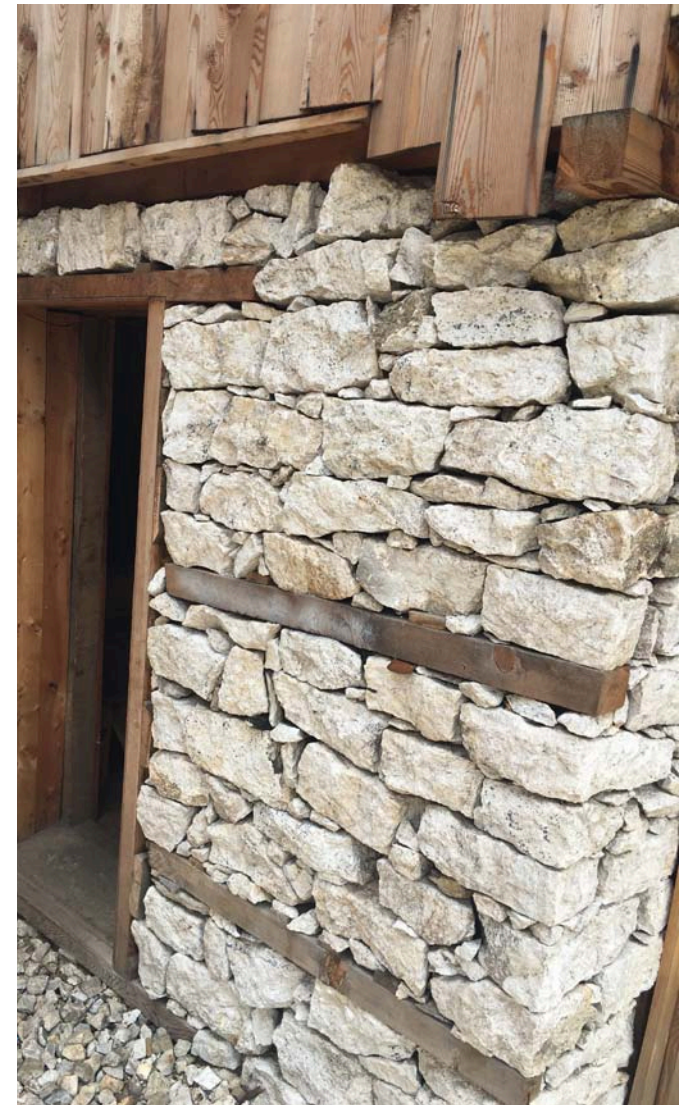
A single piece of timber banding used on a hotel wall

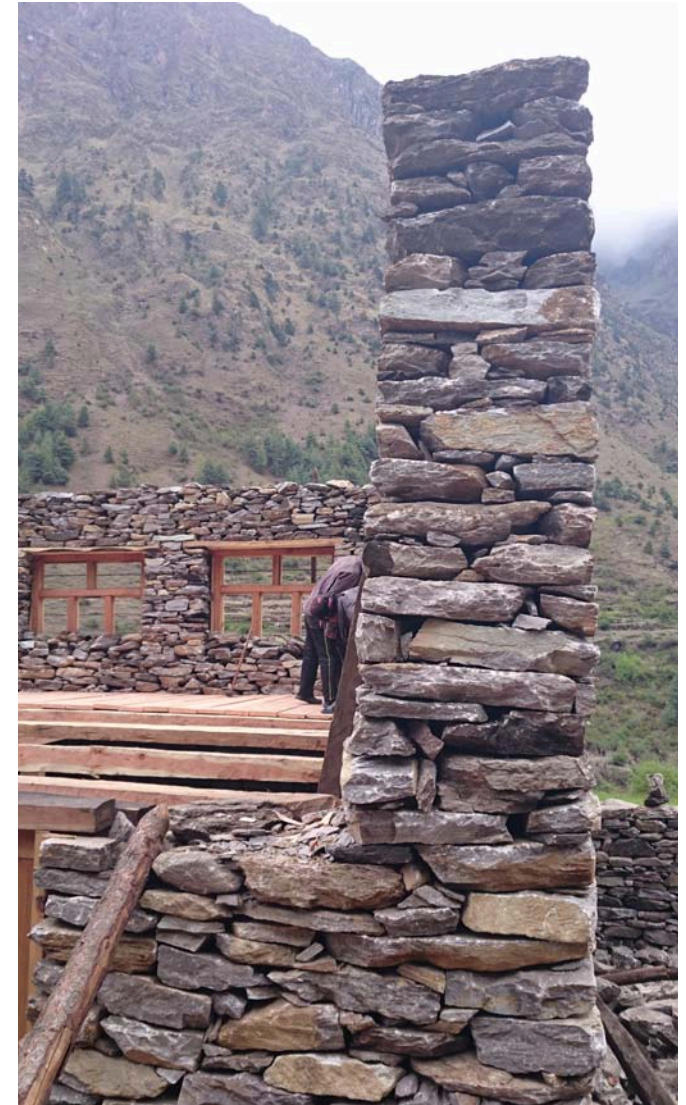
Flank wall to the house tapers well, but has not been built using a plumb bomb

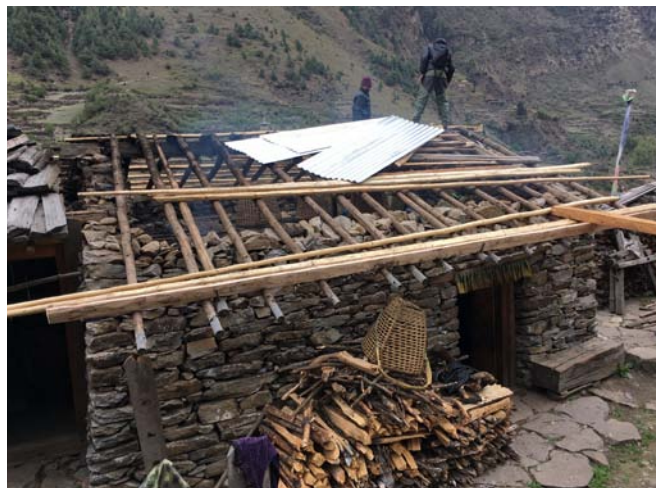
A team of locals are laying a new CGI roof natural in colour, the amount of reflection and glare can be seen

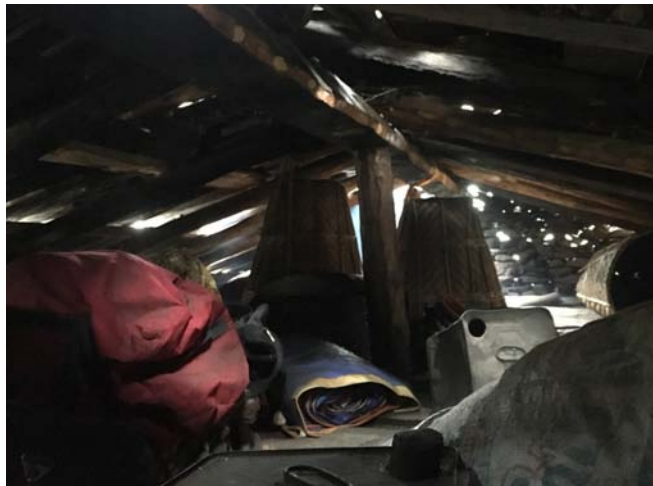
View of the attic space used for storage. The gable end wall have large gaps between the stone work letting light through

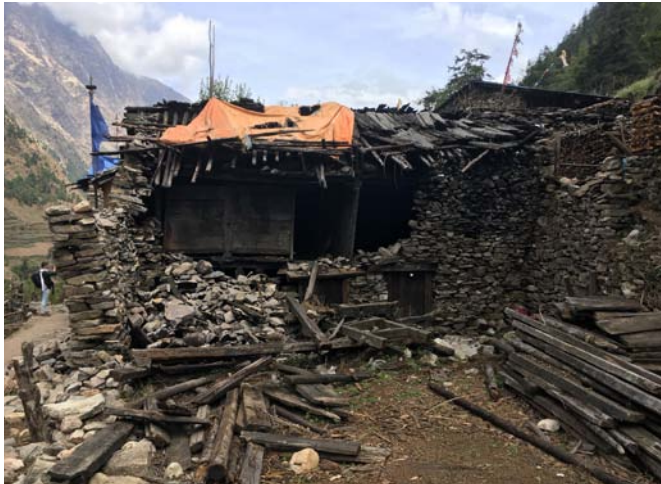
Verandah flank wall collapse, temporary tarpaulin used for rain protection

| | ISSUE | RECOMMENDATION | |
|---|---|---|---|
| 8 | Stone walls at first floor to verandahs collapsing | <i>Replace stonework with timber</i> | |

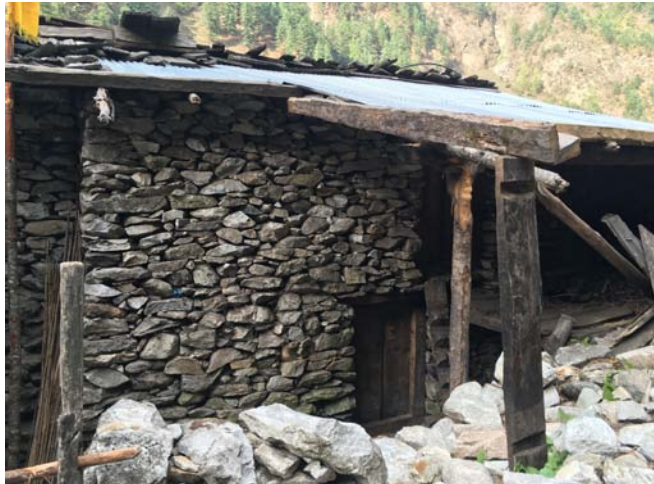
Series of carved timber gutters connected to channel water away from the building

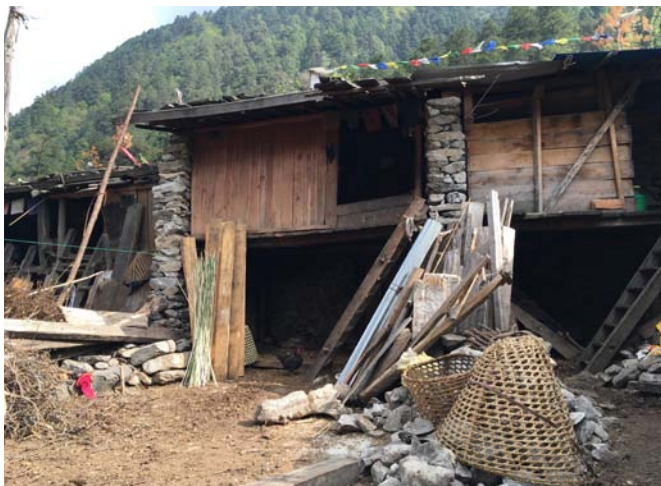
Small terraced house with Verandah

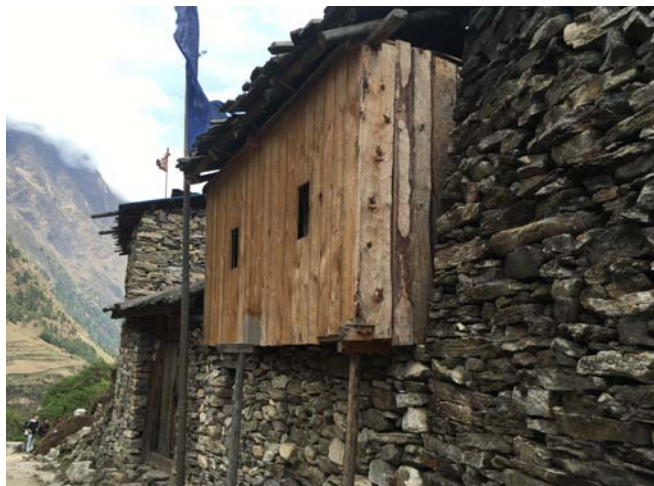
Protruding timber first floor element

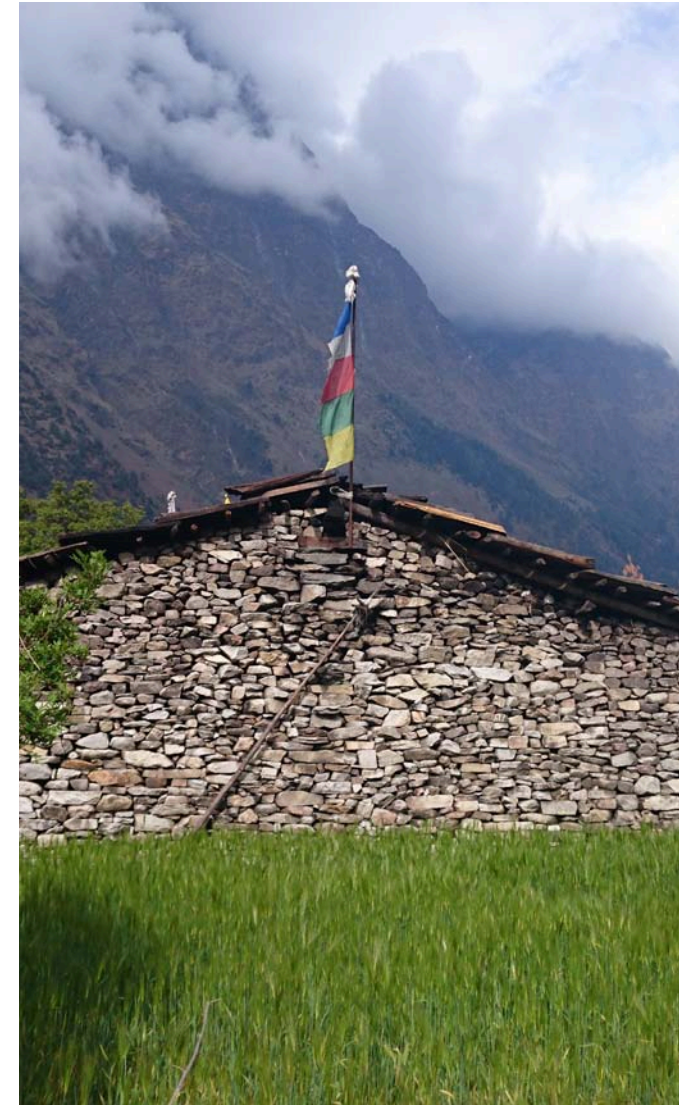
Large pad stones located beneath ridge beam

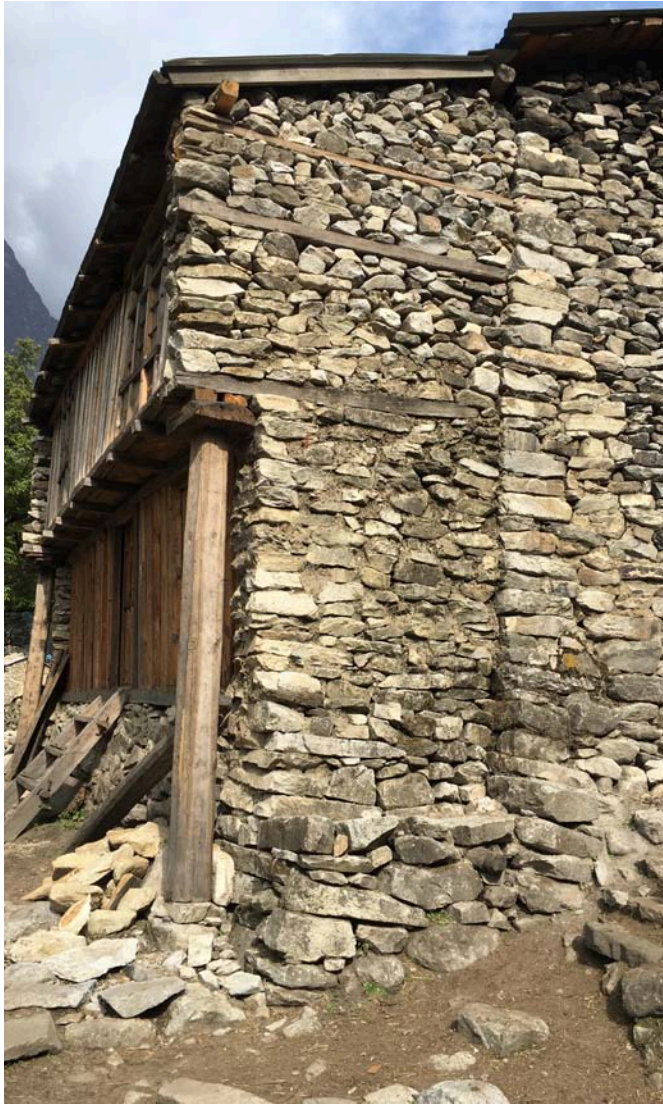
Timber bands set within the verandah flank wall, clay mortar used at the lower levels

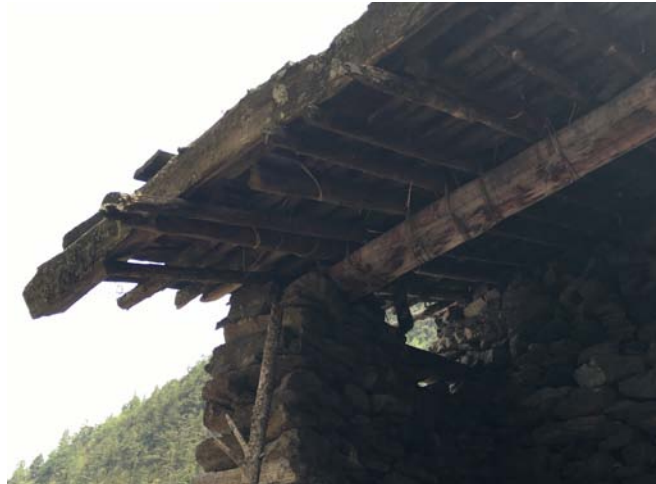
Roof structure supported by a remaining section of the verandah flank wall

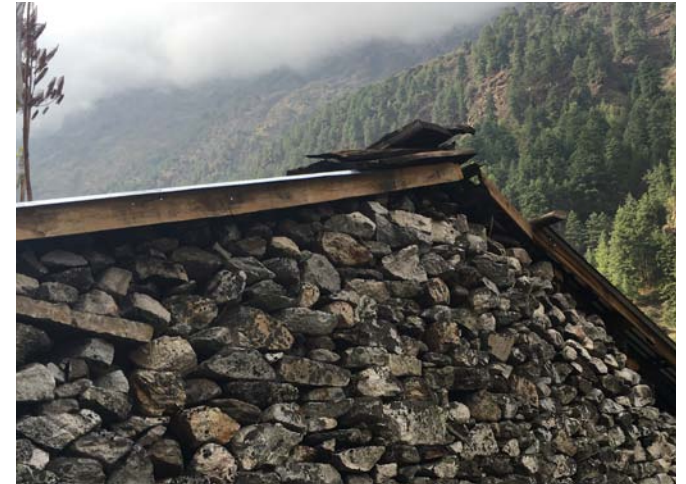
Example of poor stonework, round in shape and curving

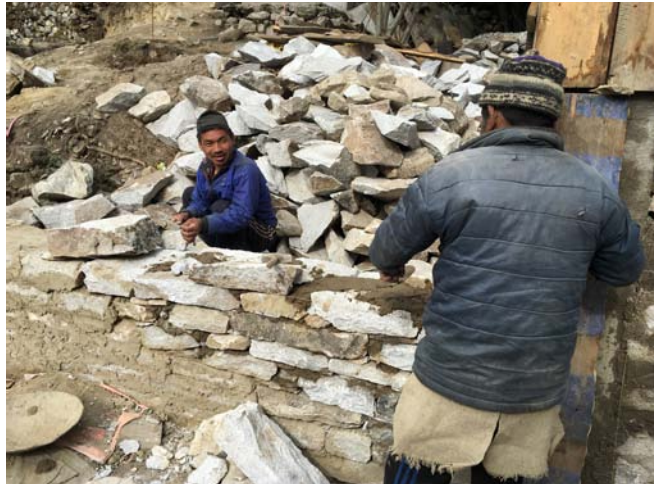
Cement mortar used to lay new temple walls

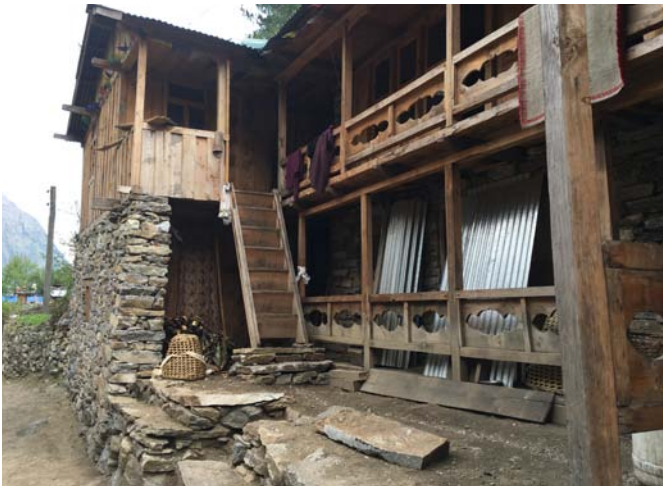
Hotel with timber first floor element

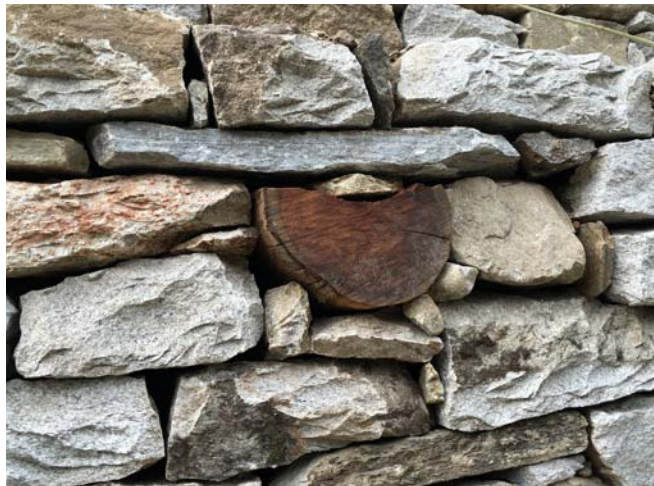
Timber retaining wall pins found on newly constructed walls

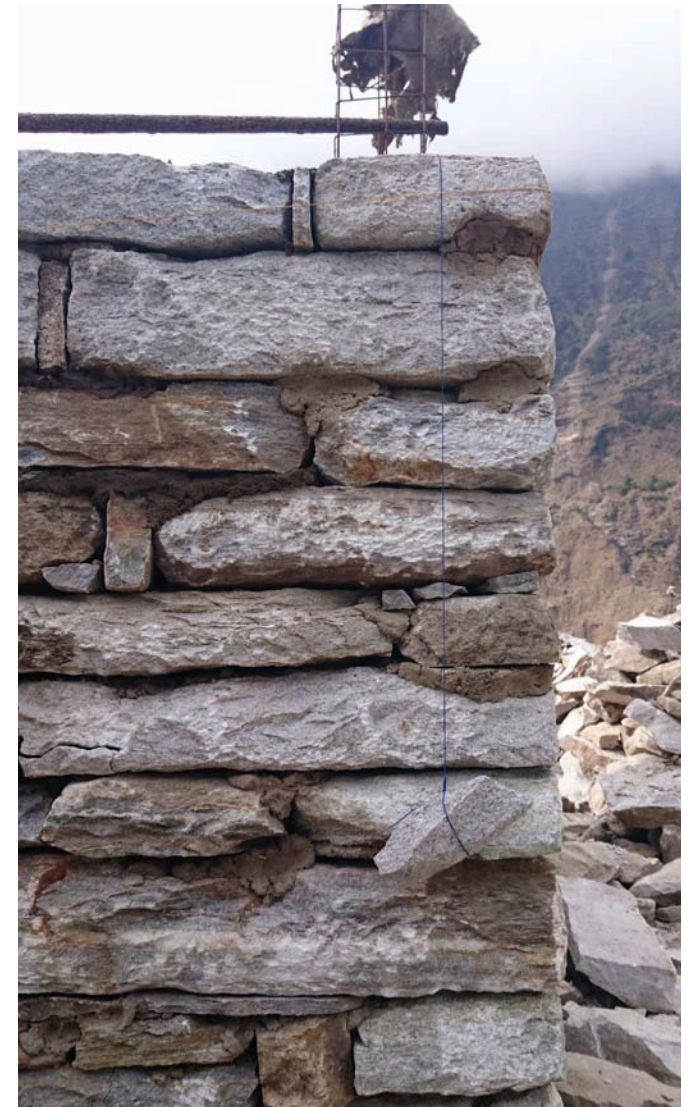
Plumb bob used to set out stonework on the temple

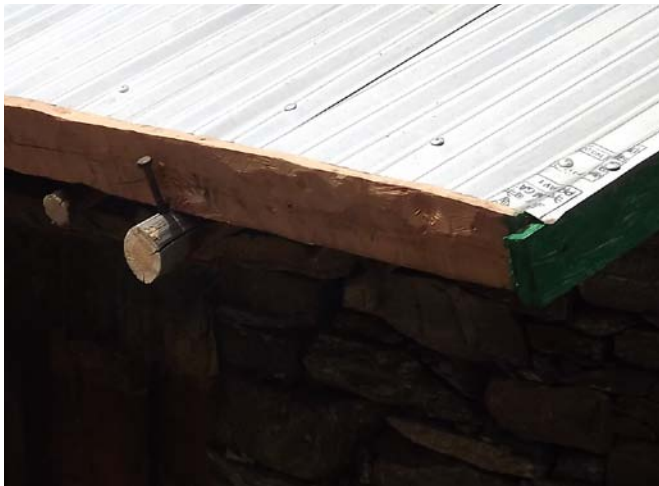
Carved timber gutter with steel peg support

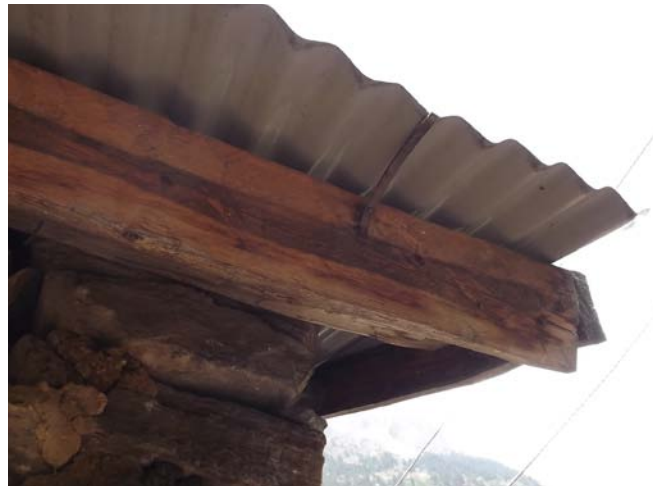
CGI strap/clip, see detail opposite

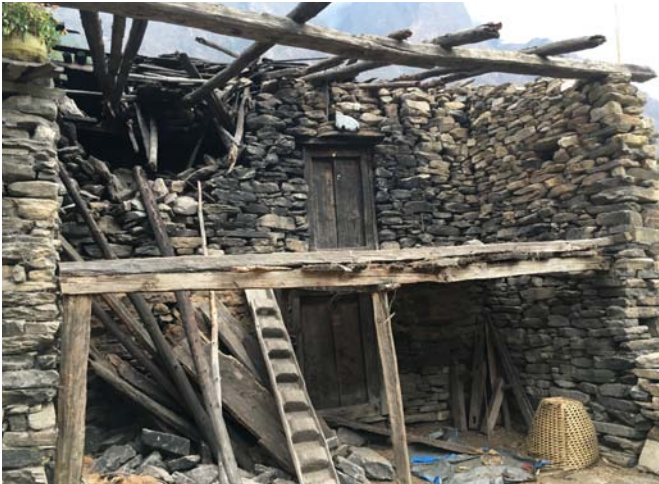
Collapsed roof structure

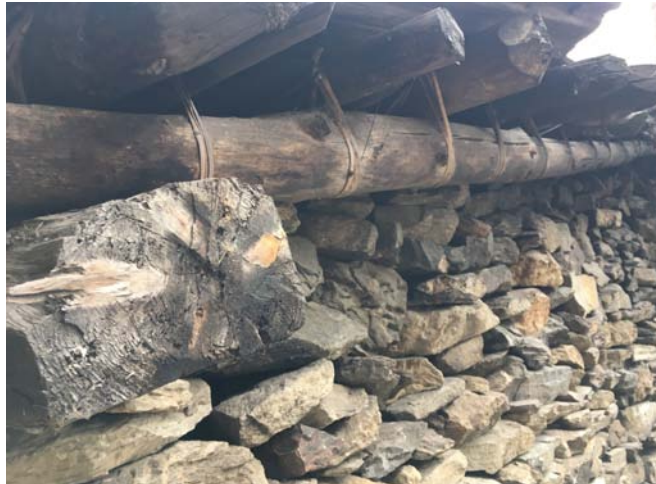
Poor stonework, no sign of stones being shaped, bamboo migalo lashing between rafter and purlin

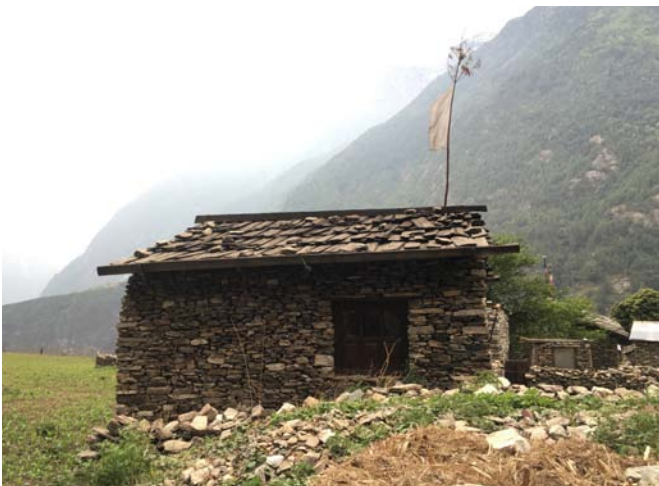
Wall to the left is bulging, carved timber can be seen used for a capping piece over the ridge

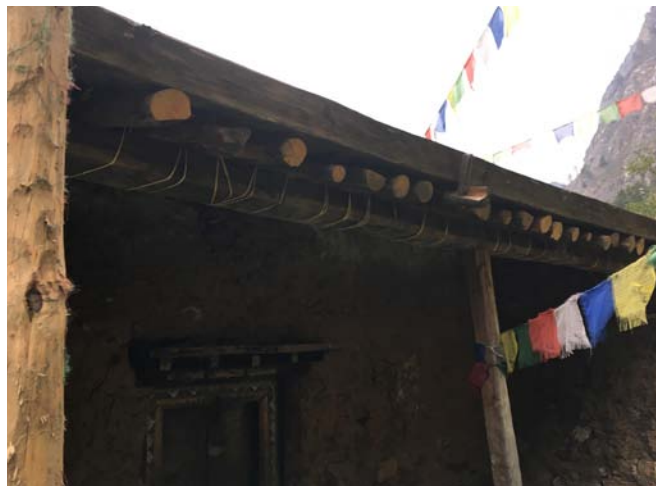
Double the quantity of rafters required to take the load of a stone tile roof

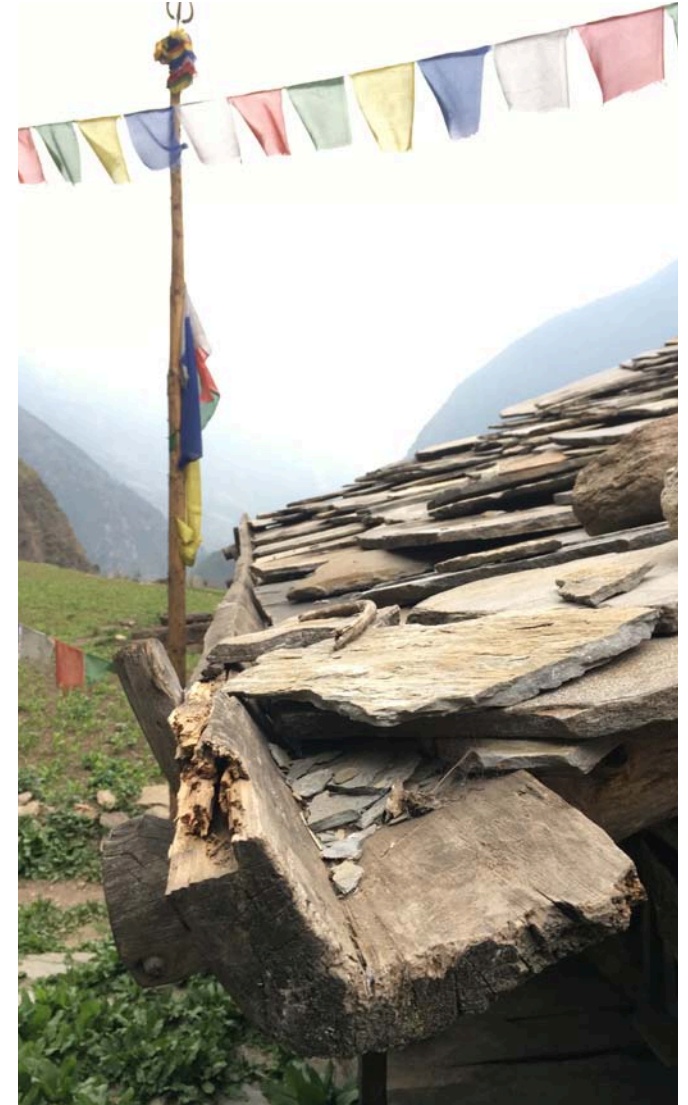
Carved timber gutter

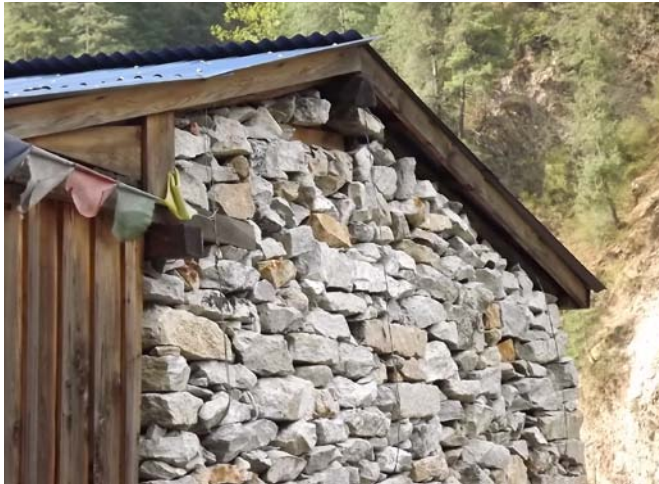
Good shaping of stone at the lower part of the wall and then very poor at the weakest point within the gable zone

| | ISSUE | RECOMMENDATION | |
|---|---|---|---|
| 2 | Gable stonework is unsupported and is a common point of collapse | <i>Use lightweight gables - Timber truss structure should replace the stonework above the top plate</i> | |

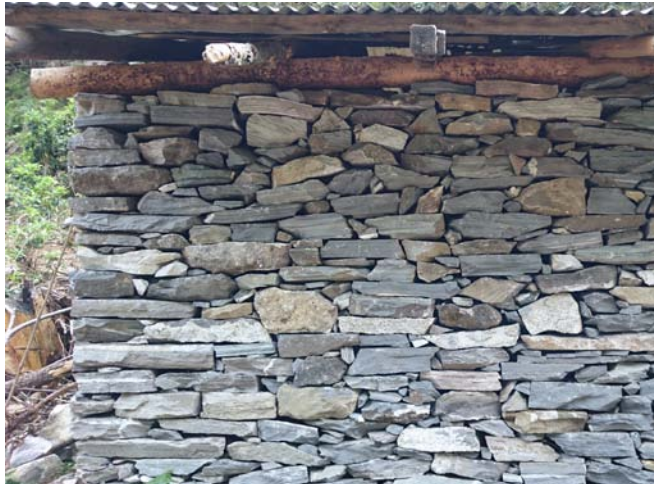
Good shaping and corner long corner stones toward to lower part of the wall

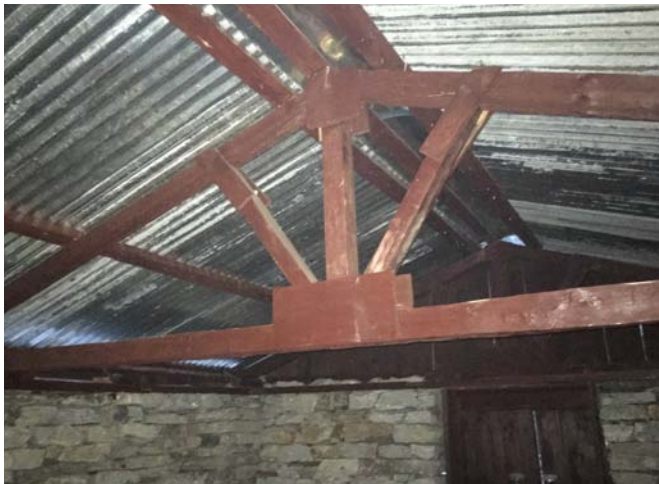
PIN (People in Need Czech R) NGO model house

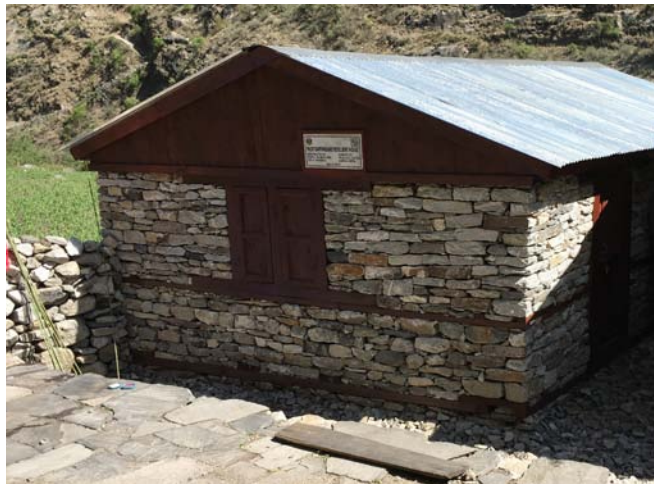
A creosote paint has been used on all timber elements to help protect from UV, moisture and insects.

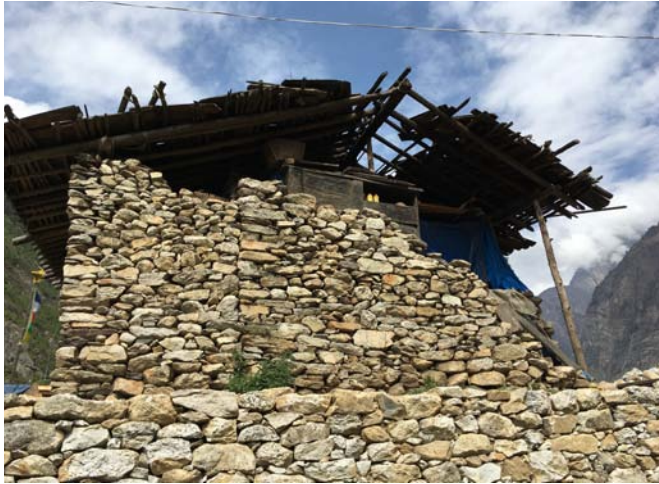
Collapsed corner wall and verandah flank wall, roof temporarily propped with a timber post

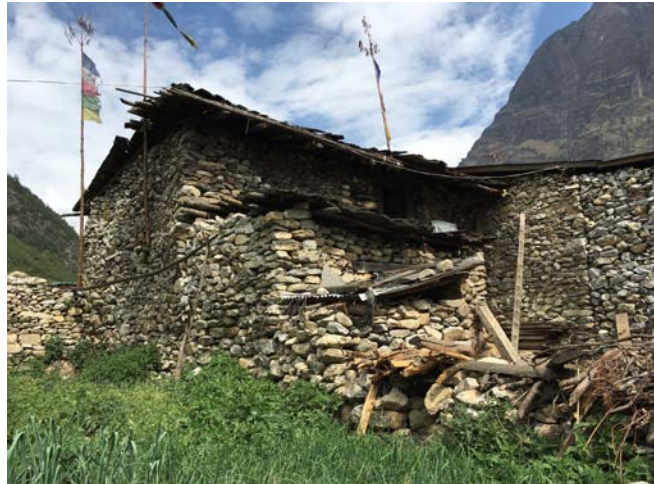
Party wall between two properties can be seen on the right with no keystones used

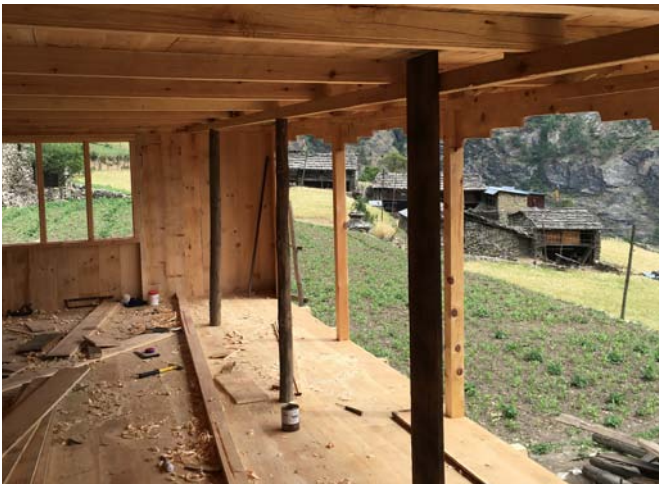
New timber extension to a hotel with no bracing

| | ISSUE | RECOMMENDATION | |
|---|---|---|---|
| 3 | No bracing has been observed to help improve the structures rigidity | <i>Use bracing - Timber structures require bracing in two directions and should follow the rule of thumb illustrated in diagram on p 54</i> | |

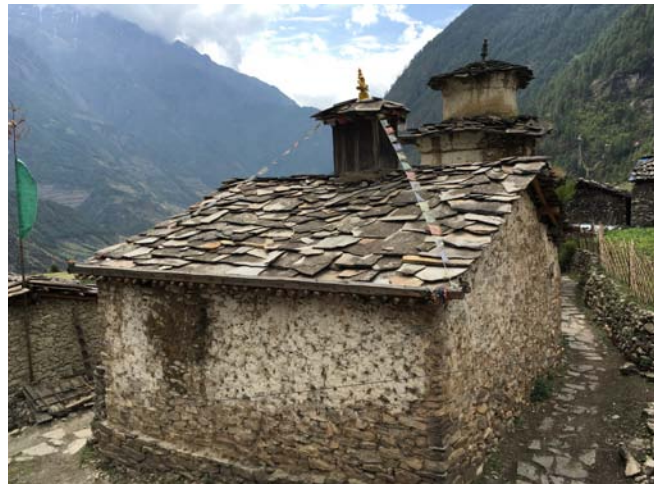
Temple with stone tiled roof, mud render and adequate quantity of rafters

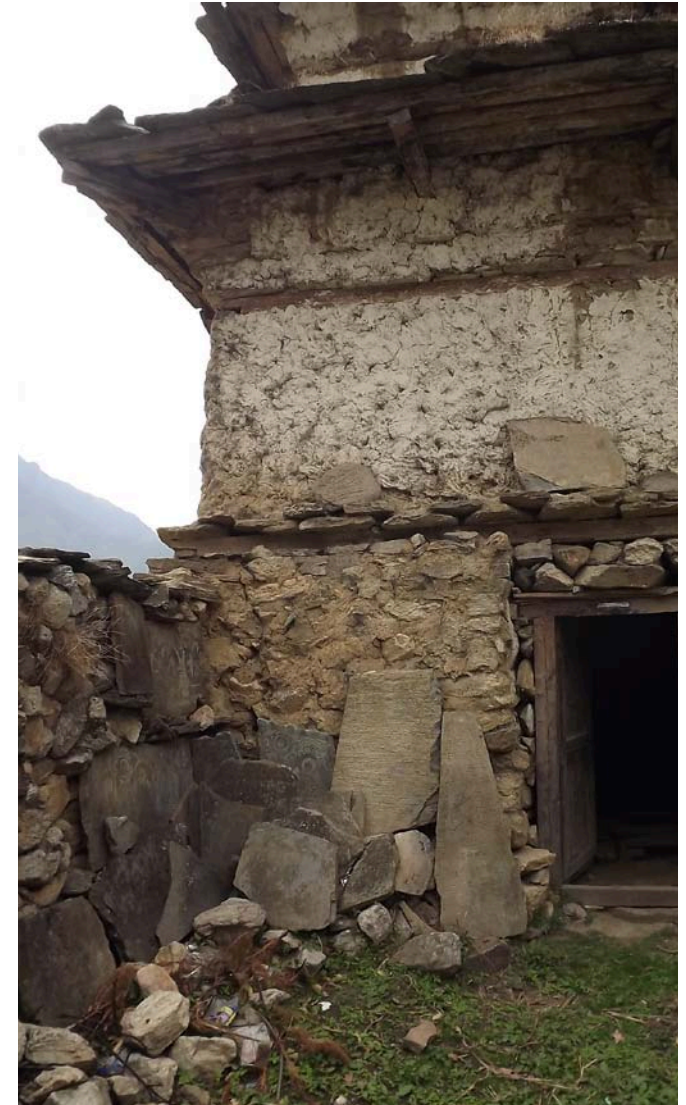
Timber banding found on the Stupa, an example of the traditional use of this detail

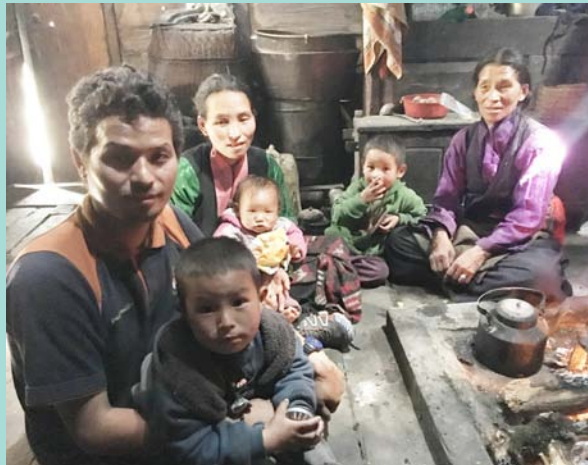
Family of six visited in Bihi, their Khim had a unique layout with the cooking hearth located centrally in the plan
