# Gorkha North Field Report

**CRS Shelter and Settlements Team**

Loren Lockwood / Jonathan Buckland / Tsering Lama - 160728

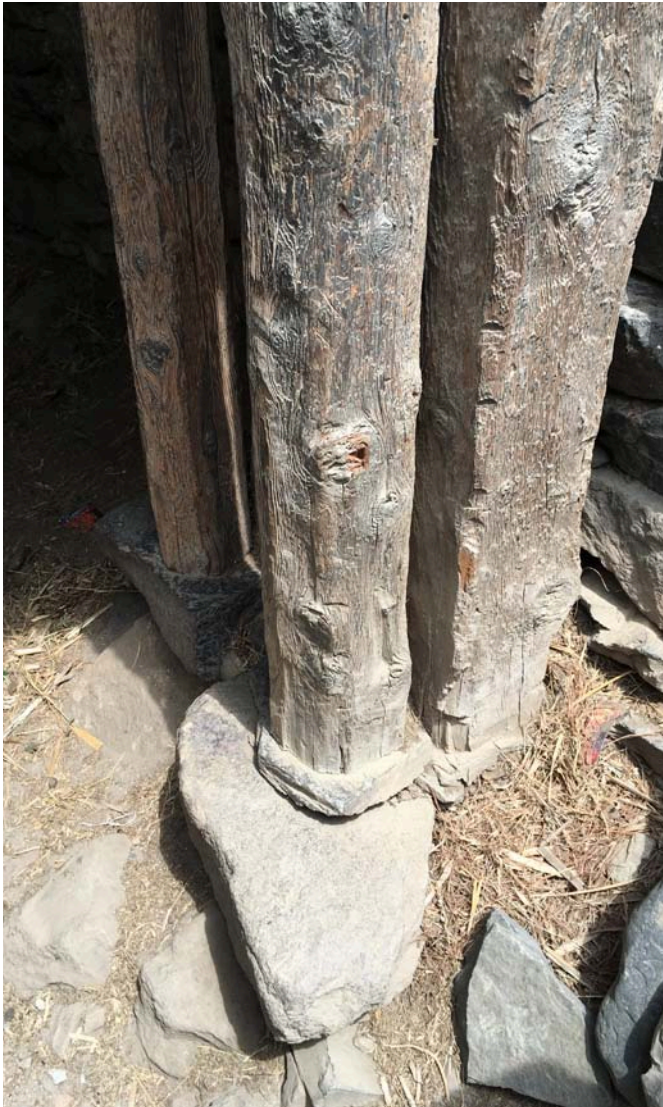
Timber post footing with no secure fixing

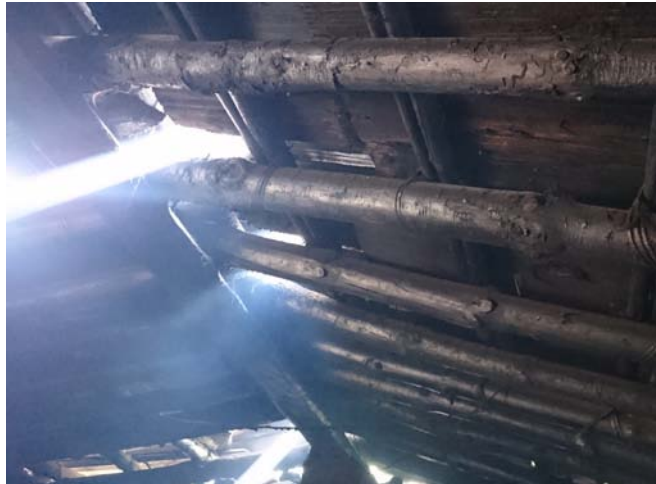
Chimney void within roof

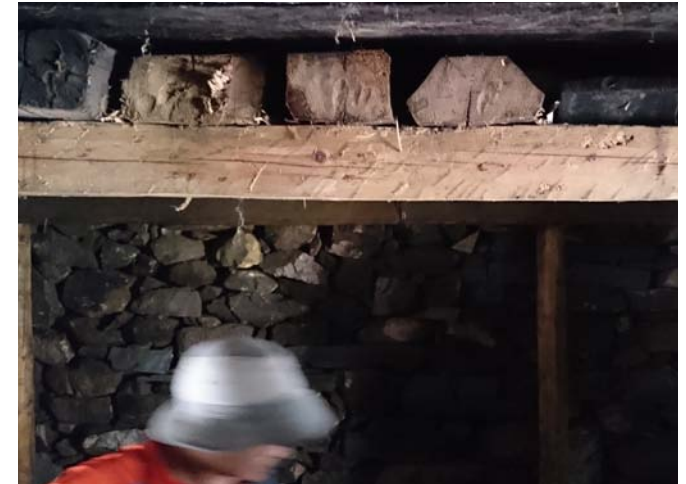
Hearth cooking area lower than first floor level and is supported by large timber floor beams

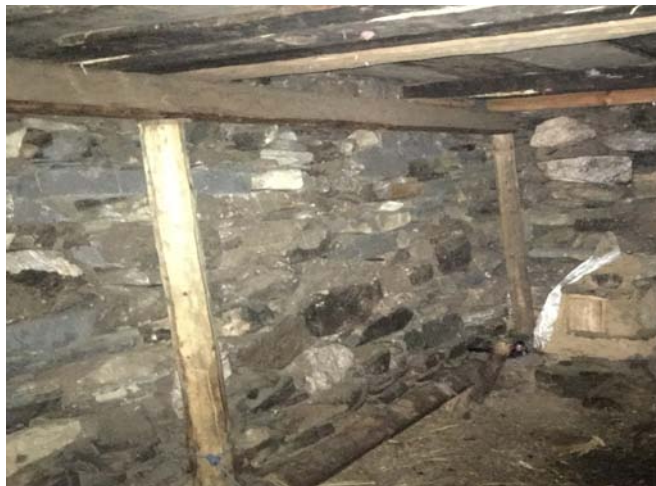
Arrangement of timber posts and beams within livestock ground floor area

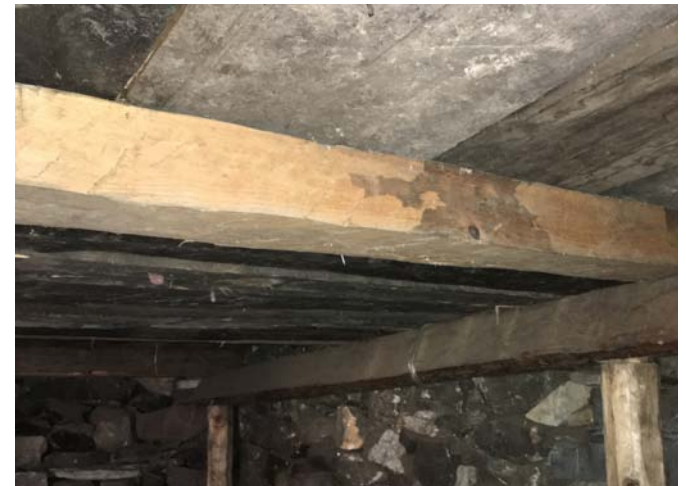
No fixings between timber elements

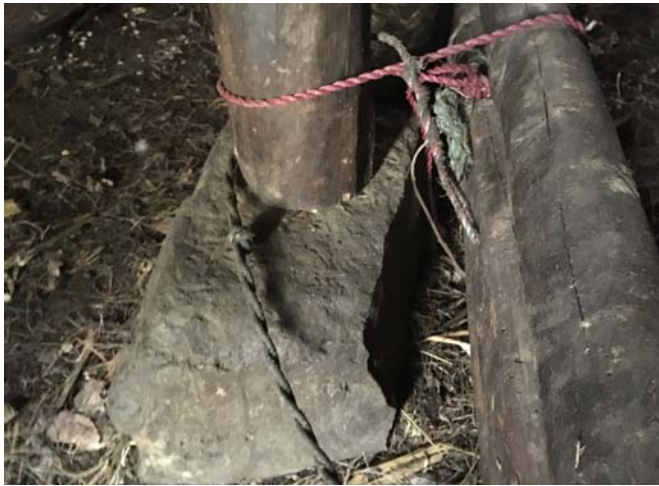
String used to tie post

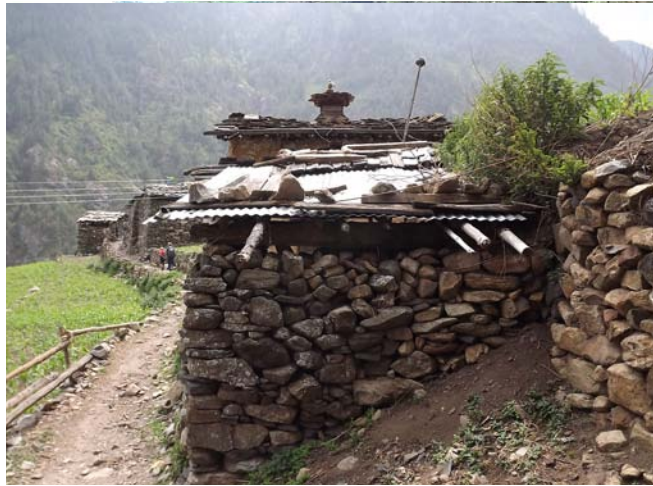
Stone used to weigh down CGI roofing

| | ISSUE | RECOMMENDATION | |
|---|---|---|---|
| 12 | In high winds the roof structure and roof covering are often lifted and damaged by up draught | <i>Rafter wall ties should be used to secure the roof structure to the stonewalls and these can be retrofitted by threading wire through existing dry-stone walls</i> | |

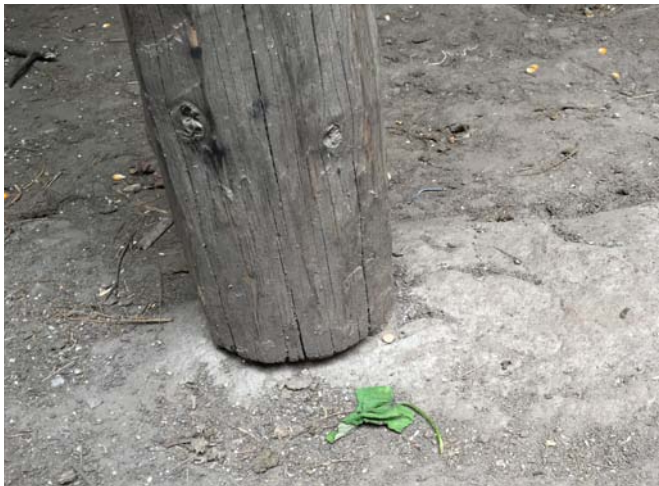
No fixings between verandah post and ground

| | ISSUE | RECOMMENDATION | |
|---|---|---|---|
| 17 | Poor stability for floor posts as no ground anchor connection | Timber posts should be suitably fixed to a stone base pad. Timber posts in a horizontal line should be founded on a timber no smaller than the post size, this detail was not observed. No fixings observed between posts and beams | |

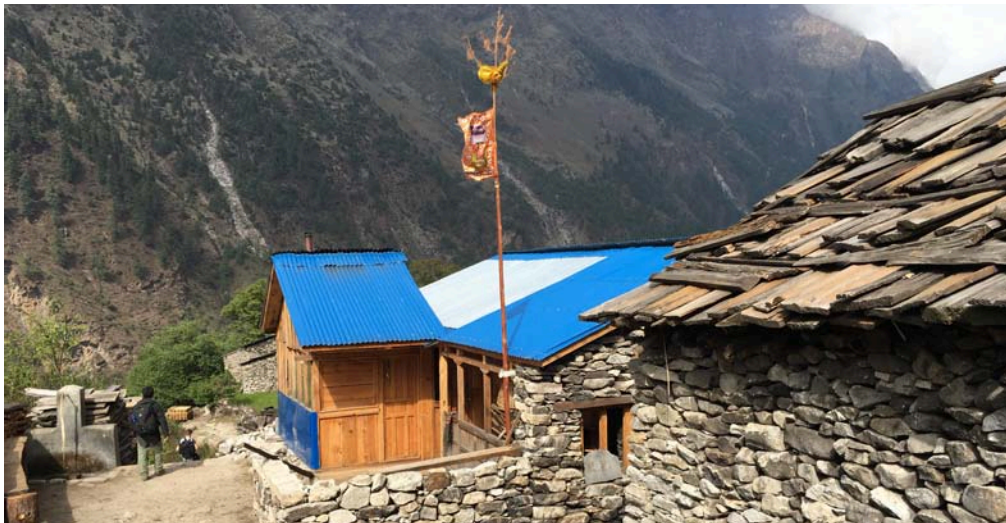
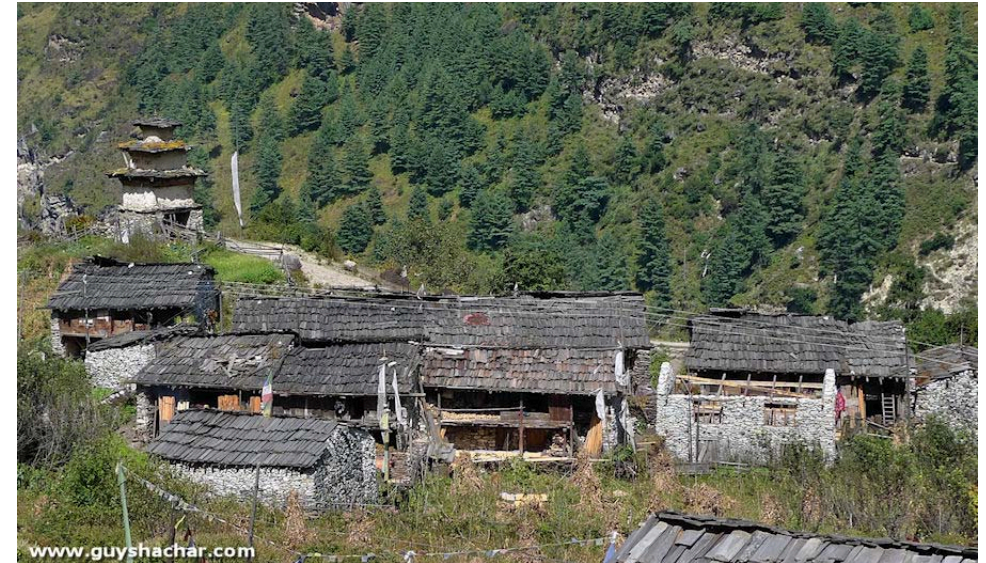
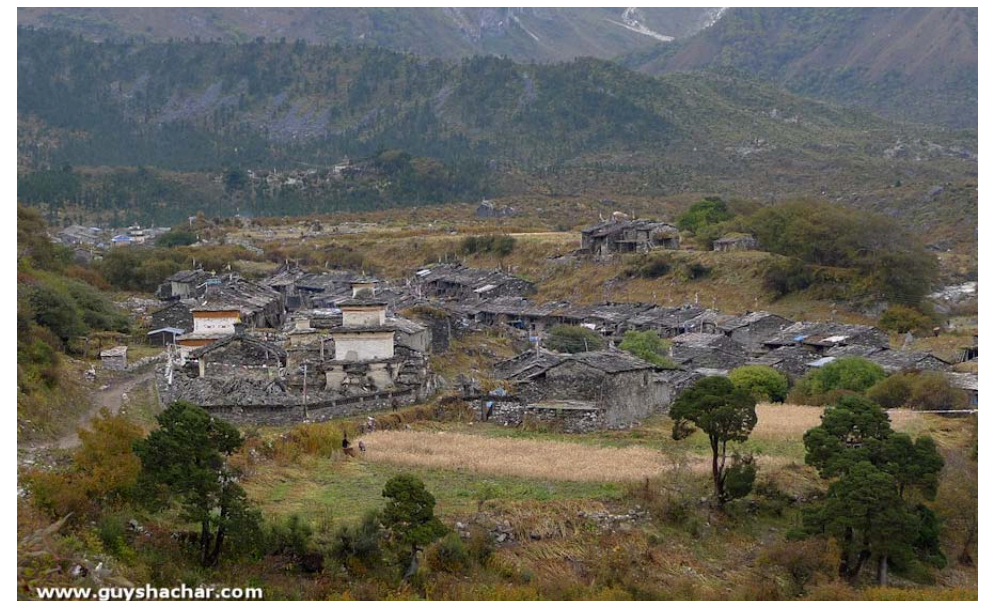
The photos opposite were taken in 2011 and illustrate how the villages blend into the landscape. In stark contrast, the photo below was taken in 2016 and shows how the use of CGI drastically changes this relationship between building and landscape.
