## District Report

### Kathmandu Valley

23 Nov – 6 Dec 2018

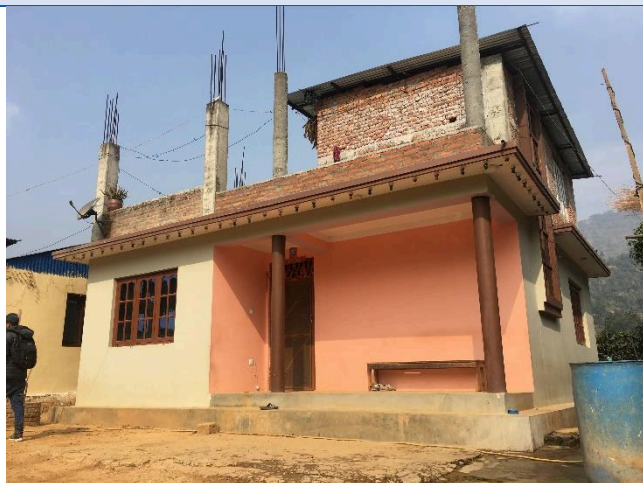
Beneficiary Name: Mangal Tamang, ward no 8, Pakhure, Nagarjun Municipality. Two storey RC structure. The beneficiary has received all tranche and has been living in the newly constructed house.

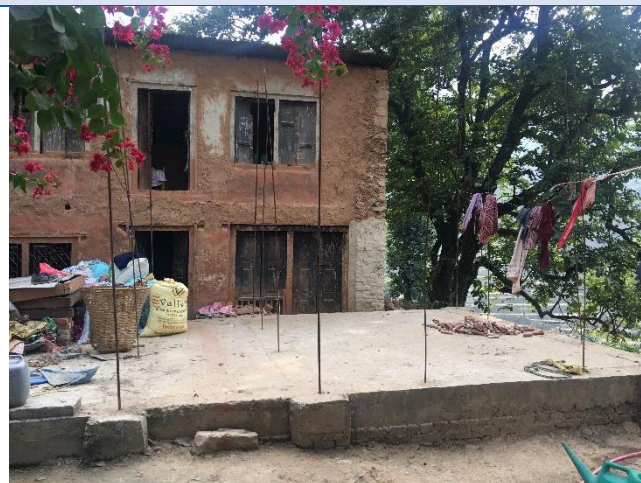
Beneficiary Name: Bhagwati Tamang, ward no 8, Pakhure, Nagarjun Municipality. The beneficiary has received 2<sup>nd</sup> tranche but due to financial condition has not been able to

| | | continue the reconstruction. Ms. Tamang is Interested in getting the soft loan if possible. |

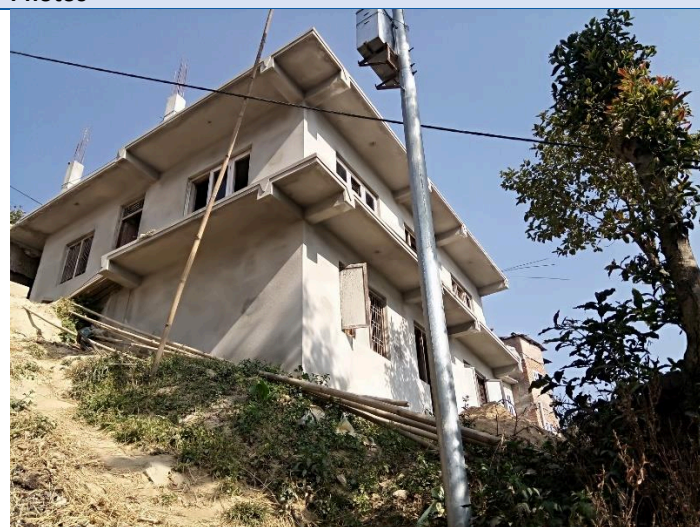
Beneficiary name: Rajkumar Bastola, Bastola Gaun, Ward no. 6, Nagarkot, 2 storey and RCC frame structure. The house lies in extremely landslide prone area and is left with .5 storey to reconstruct. The DPC level of house is done in different parts of plot due to very slope area. The owner has approved building drawing and applied for 2<sup>nd</sup> and 3<sup>rd</sup> together.

| Challenges / Issues Identified | Action Required | Responsible | Timeframe |
|---|---|---|---|
| Beneficiaries have reconstructed houses in landslide prone areas without taking sufficient precautions. | Beneficiaries need to take care of proper precautions such as construction of retention wall and water drainage system (water inlet and outlet) along with the wall of the houses. Further, placement of sand sacks should be done on premises part in order to check the soil erosion. | Beneficiaries, Ward Office, Municipality office DLPIU Engineers | As soon as possible |

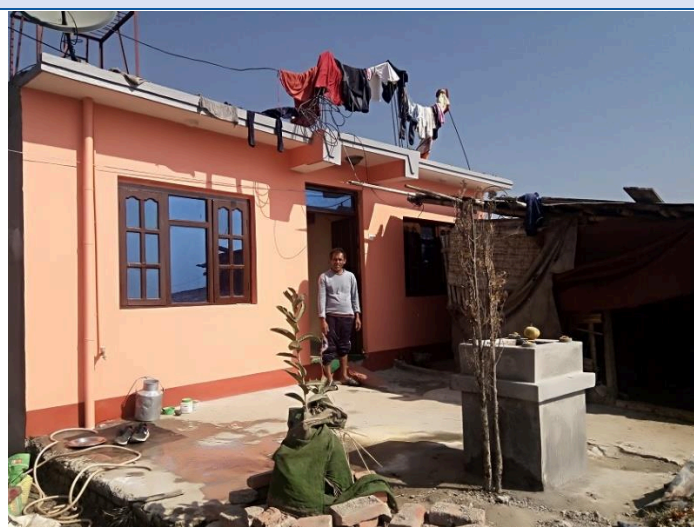
Beneficiary Name: Meghnath Ghimire, Ward no. 3, Jhaukhel, RCC BMC with single storey. House has 14-inch wall outside and 9-inch wall inside. The owner has approved building drawing and applied for 2<sup>nd</sup> and 3<sup>rd</sup> together. During the time of applying tranche, the house was found to have cracks on interiors parts.

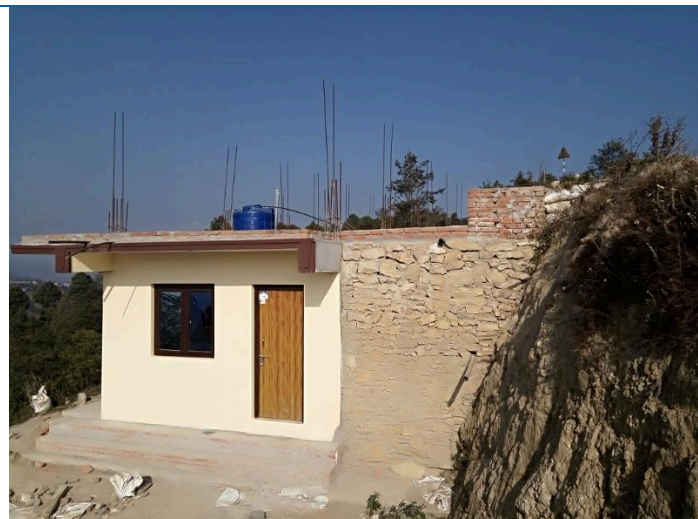
Beneficiary name: Kanchi Maya Tamang, located at Ward no. 6, Bakhri Gaun, Nagarkot is RCC pillar system with rigid roof, 1 storey and single bay. The owner has approved building drawing and applied for 2<sup>nd</sup> and 3<sup>rd</sup> together. The house is located very close to road and in landslide prone area.

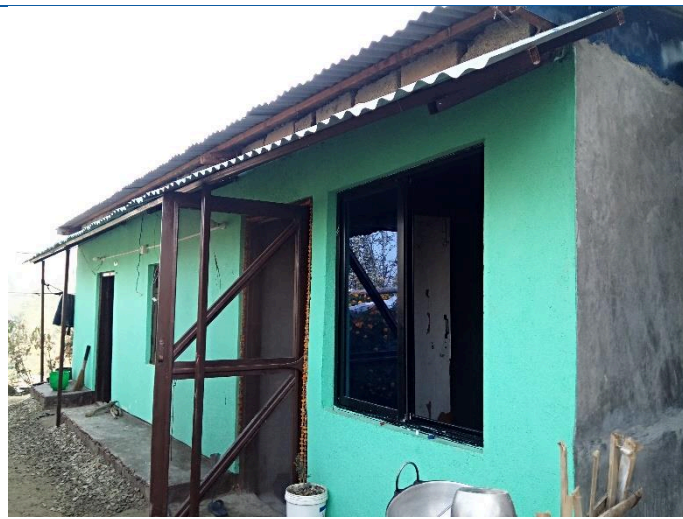
Beneficiary name: Niran Nepali, Ward no. 6, Pipalbot, Nagarkot area is reconstructed with hollow concrete blocks, single storey and wall system with flexible roof. The beneficiary revealed that tie beam and bands has been properly kept. The owner has approved building drawing and applied for 2<sup>nd</sup> and 3<sup>rd</sup> together.

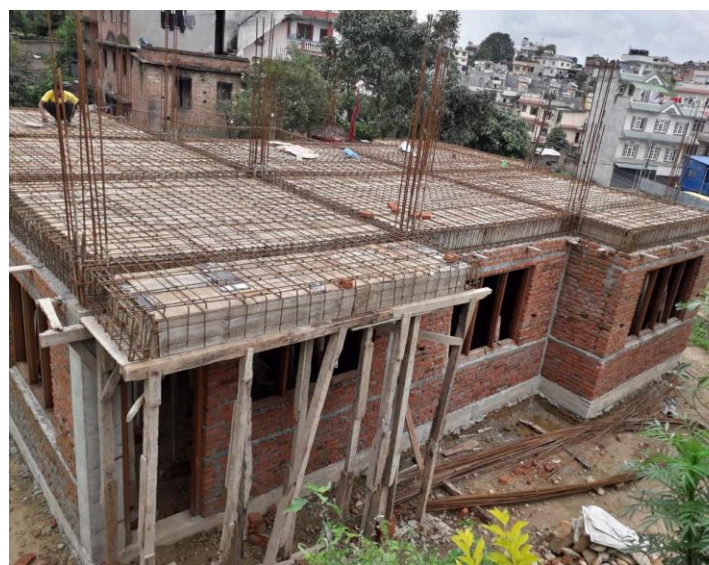
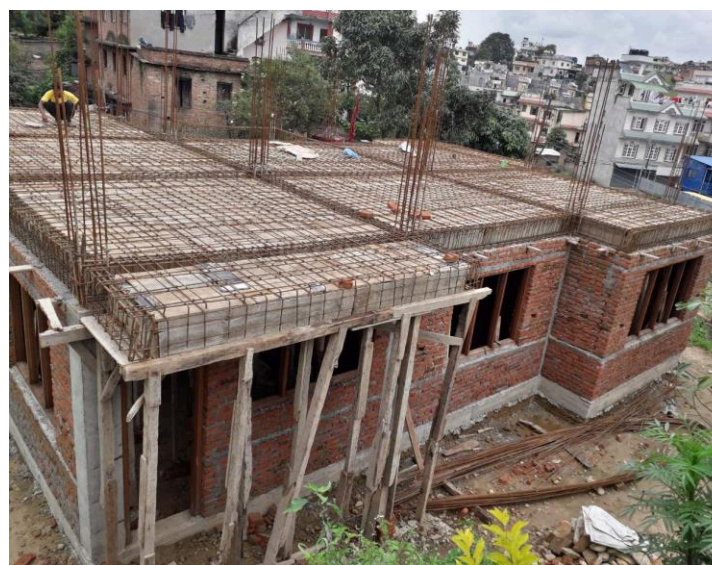
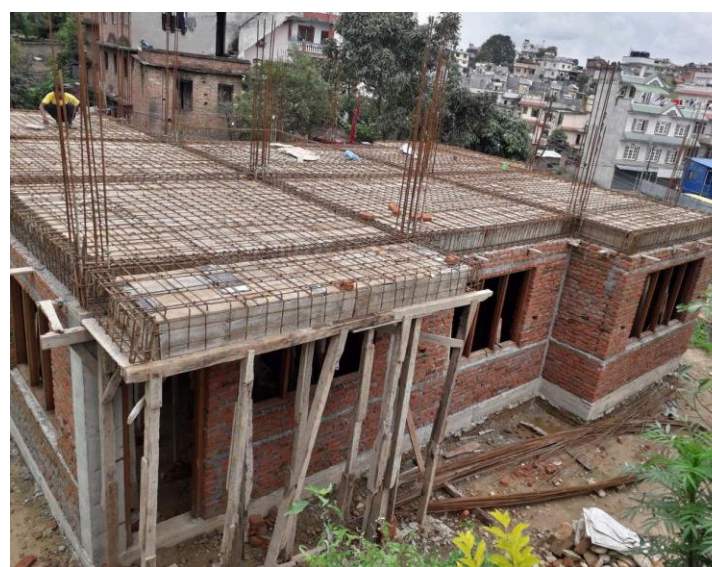
Beneficiary Name: Ms. Pramila Budathoki, Ward no 14, Lalitpur Metropolitan city, Lalitpur district. Two storey RC structure. The beneficiary has requested for the 2nd and 3rd tranche. Dated: 180830

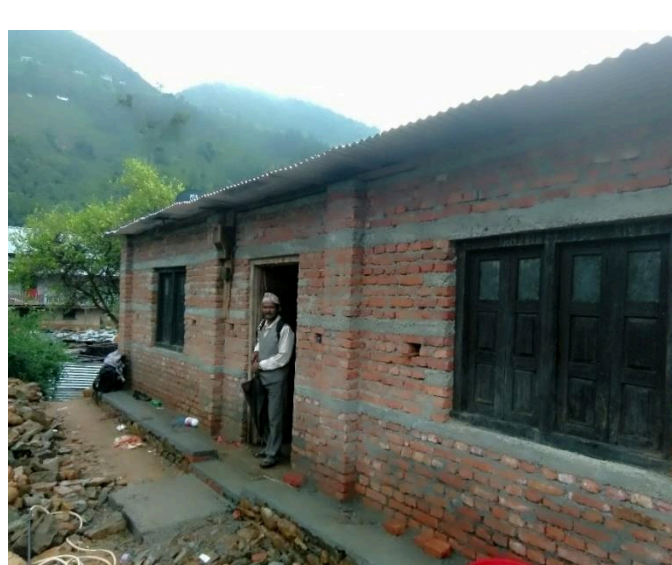
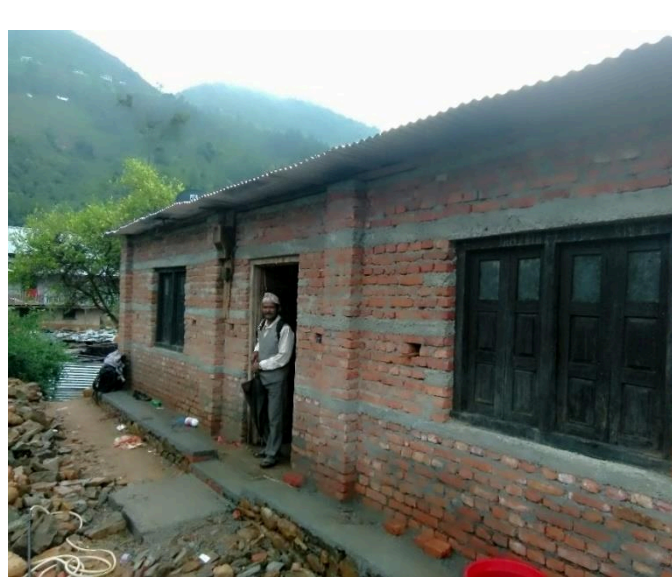
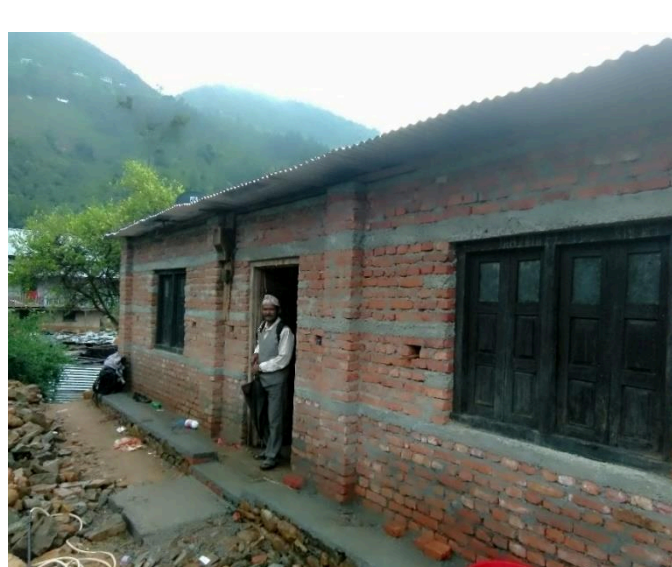
Beneficiary Name: Mr. Balram Sunwar, Bhardeu, Ward no. 5, Konjyosom Rural Municipality, Lalitpur district. One storey structure with CGI roof. The beneficiary has requested for the 2nd and 3rd tranche. Dated: 180603

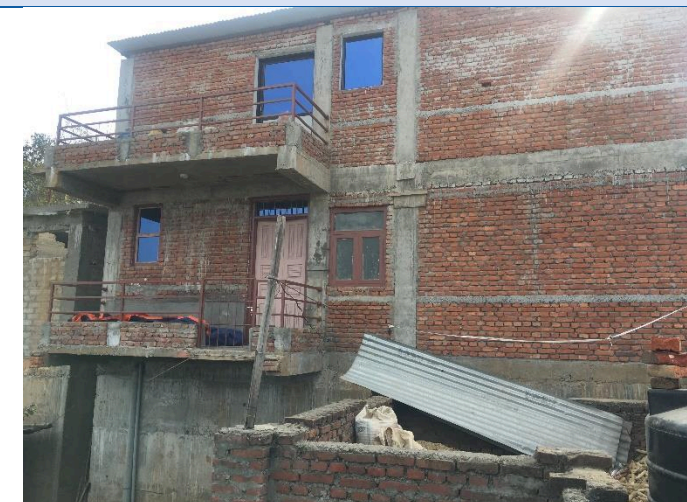
| Challenges / Issues Identified | Action Required | Responsible | Timeframe |
|---|---|---|---|
| Most of the houses designed by the Municipal engineer are mixed typology- i.e BMC structure with RCC pillar at only back section. Such houses are non-compliance and | DLPIU Building engineers/ DLPIU Kathmandu should coordinate with the municipal engineers and demoralize such houses design. | NRA building, DLPIU engineers, Municipal Engineers | As soon as possible |

Beneficiary Name: Tek Bahadur Ale Magar, ward no 10, Puwar Gaun Suryabinayak Municipality. Two storey BMC structure at front and 4 12"X12" pillar at rear side. The beneficiary requested for the 2<sup>nd</sup> and 3<sup>rd</sup> tranche but as the structure is non-compliance the file has been on hold. To resolve the issue, the municipal engineer who designed the structure has been requested to meet

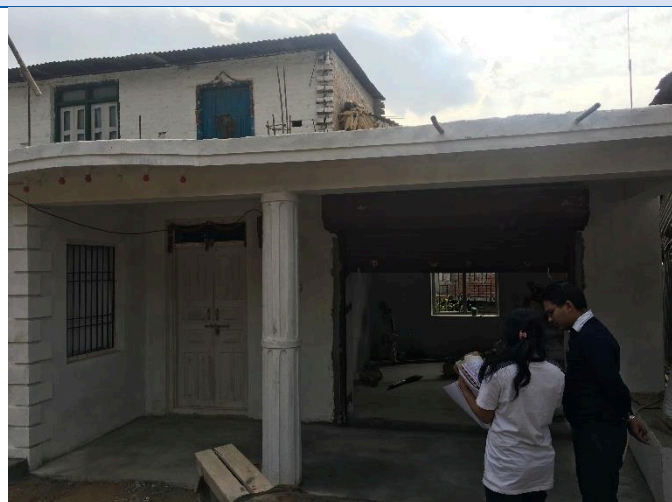
Beneficiary Name: Ajay Khadka, ward no 10, Khadka Gaun, Suryabinayak Municipality. 1 storey BMC structure with 14" wall and a rolling shutter. The beneficiary has requested for the 2<sup>nd</sup> and 3<sup>rd</sup> tranche. Due to the rolling shutter, the house was considered as non-compliance but after the monitoring visit the structure was found to be safe and eligible for the remaining tranche
