## Fortnightly District Report

### Dhading

18 - 31 January 2019

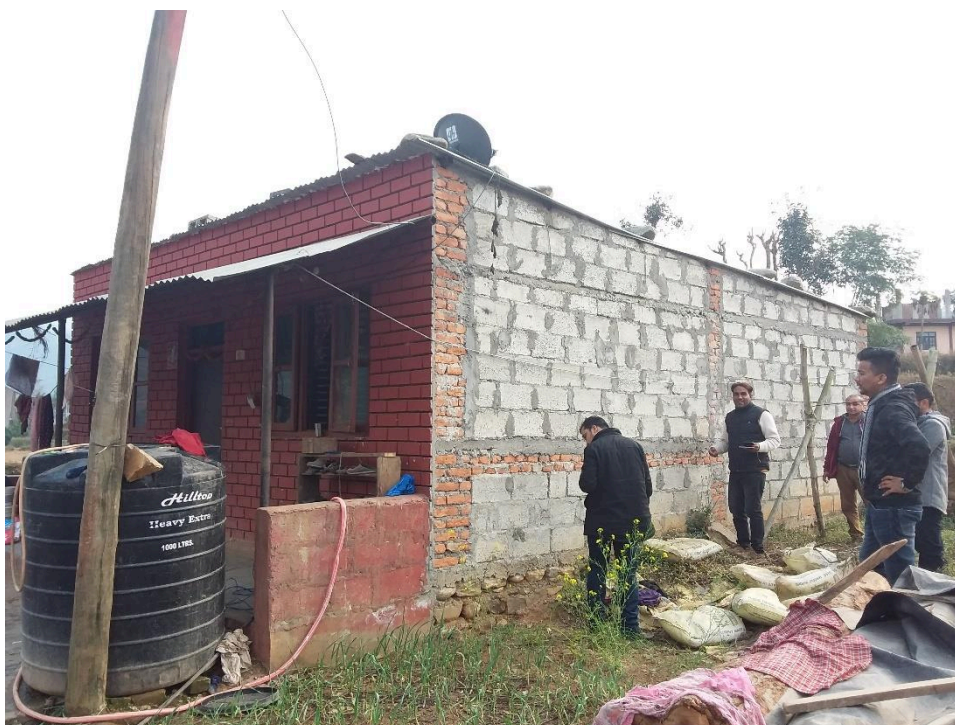
Photo: - Jointly Observing Load Bearing Masonry Structure

It is a one storey load bearing masonry structure with CGI sheet as roofing. In ground floor beneficiary uses block and brick as masonry along with horizontal sill bands. Some of the portion of masonry are done by brick while most of the part are block masonry. The Beneficiary has received second tranche.

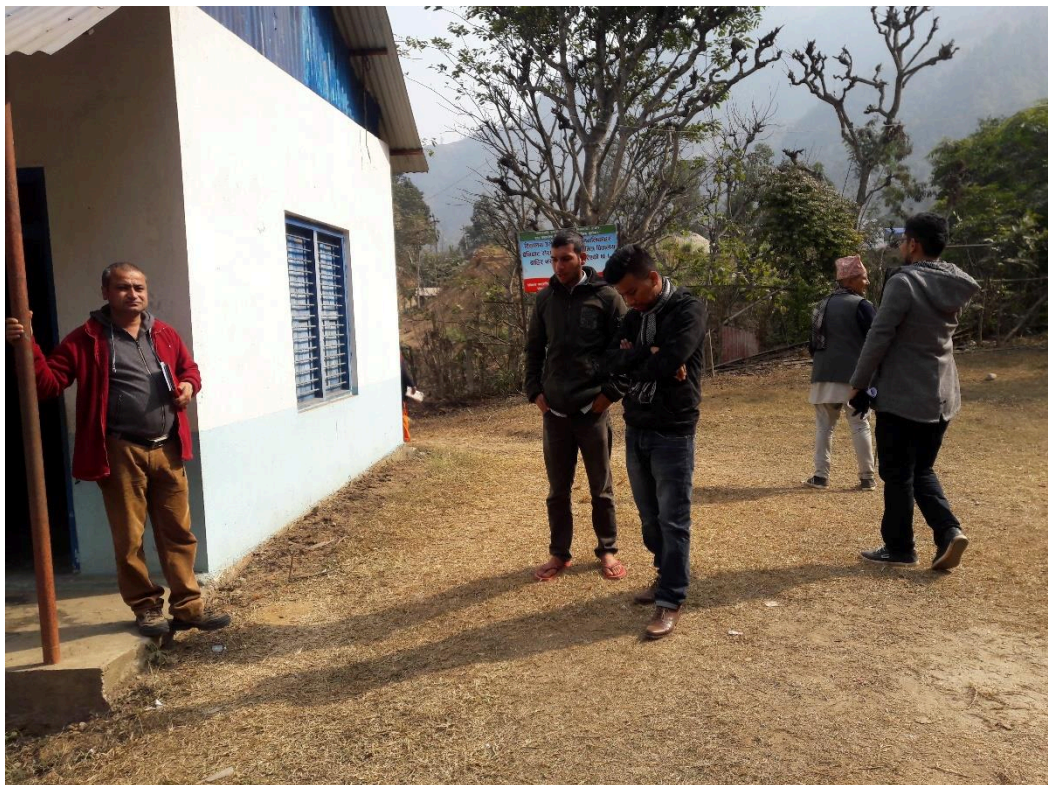
- 3) We had Informal meeting with Technical group of Benighat Rorang Rural Municipality i.e. Engineer, Sub-Engineer & Assistant Sub Engineer on 22<sup>nd</sup> Jan 2019 regarding Non-Compliance Issues of the ward.

As per close discussion with them, some of the Non-compliance's issues in RCC Structure and Load Bearing

Structure are as follows: -

**1) Non-Complaint Issues in RCC Structure**

- Plan and Elevation Irregularities
- Less Reinforcement in Column Beam i.e. Less than 8 nos.
- Room area greater than 13.5 Sqm.
- One bay Building.
- Column size less than (12 x 12) inch.
- Insufficient foundation size.
- Aspect Ratio.
- Missing Grid Column.
- Insufficient Lap.
- Insufficient Anchorage bonding.
- Haphazard lapping in beam and column

**2) Non-Complaint Issues in Load Bearing Structure**

- Structural span more than 4.5 mts.
- Missing band i.e. horizontal band, Vertical band, sill band, Lintel band, Plinth band, roof band etc.
- Insufficient foundation size.
- Lack of through stone.
- Inappropriate Position and Size of Opening

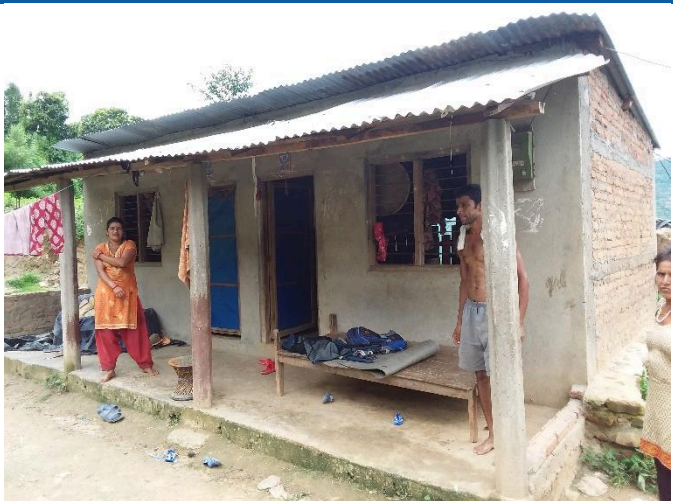
Name: - Rajan Paudel

It is one storey special moment resisting frame structure (RCC) with material used M20 Grade of concrete in pillar, beam, band and 9" infilled wall with brick in cement mortar (1:4). Its floor area is less than 1000 sqft whose Column size is (9" x 12") with 6-12mmØ. The beneficiary has received 2nd tranche of government grants.

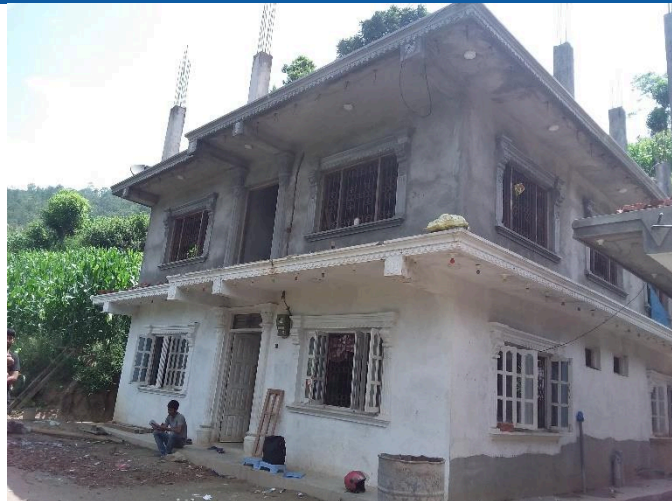
Name: - Timba Prasad Nepal

It is two storey special moment resisting frame structure (RCC) with material used M20 Grade of concrete in pillar, beam, band and 9" infilled wall with brick in cement mortar (1:4). Its floor area is more than 1000 sqft whose beam size is (9" x 13") with 4-16mm Ø and Column size (12" x 12") with 4-16mm, 4-12mmØ. The beneficiary has received All Tranche of government grants.

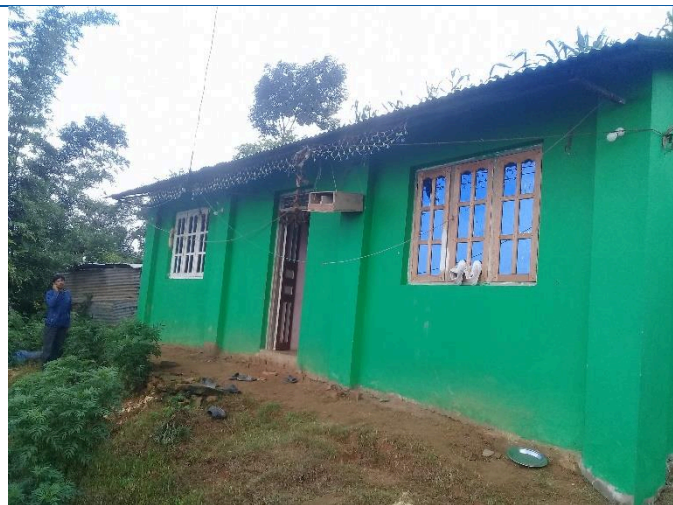
Name: - Aatma Ram Tamang

It is one storey load bearing structure with material used burned brick with cement mortar. Its floor area is less than 1000 sqft. He has use vertical pipes in place of vertical rod deu to which engineer has send this file to DSE for analysis. The beneficiary has received 1<sup>st</sup> tranche of government grants.

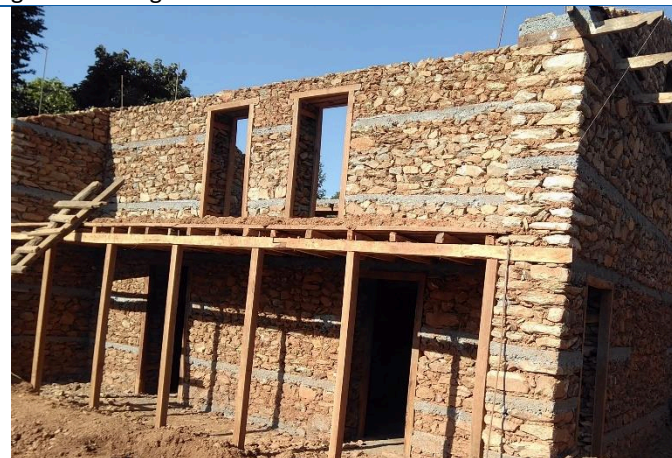
Name: - ChandraKant Duwadi

It is a one storey plus attic stone mound mortar load bearing structure. Its floor area is less than 1000 sqft. The height of building is more than mention in the MRT. The beneficiary has received 2nd tranche of government grants.

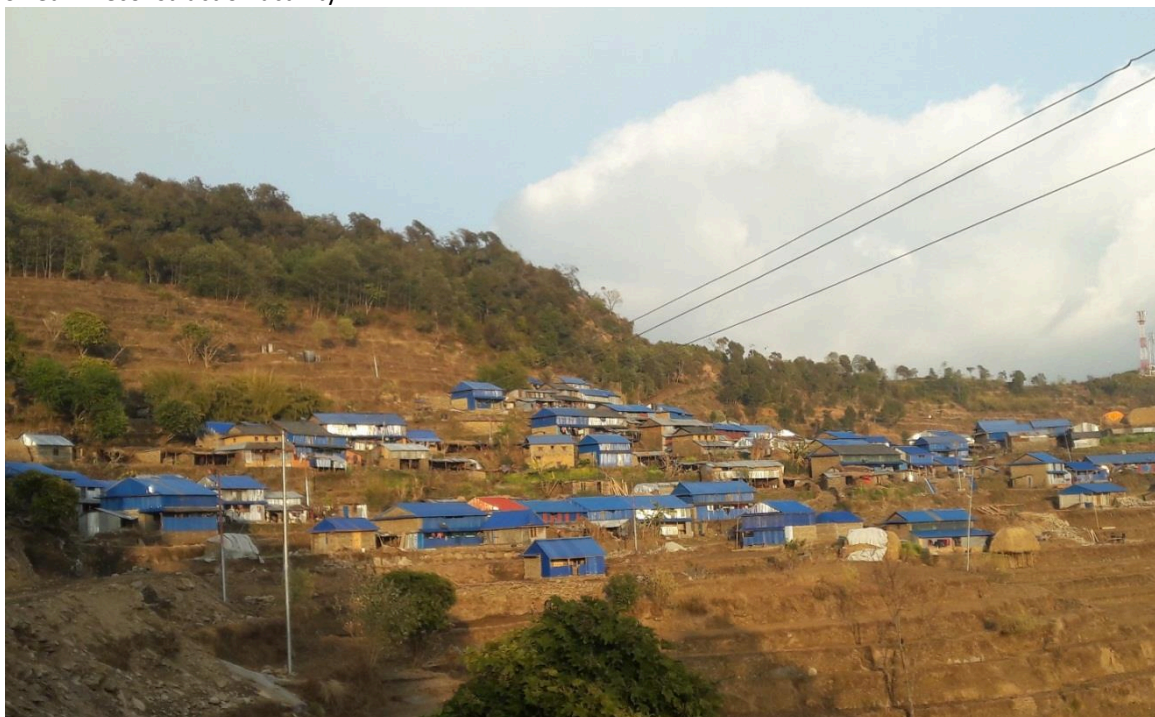
**Photo: - Uniformly constructed structure at Aalu Pokhara, Gangajamuna Rural Municipality, Dhading.**

Most of the houses in these VDC were damaged in earthquake 2072, After Reconstruction Grant from Nepal Government VDC constructed similar type of structure to make it uniform using locally available materials i.e. Stone, Wood, CGI Sheet etc. Most of the structure built in these areas are Earthquake resistant.

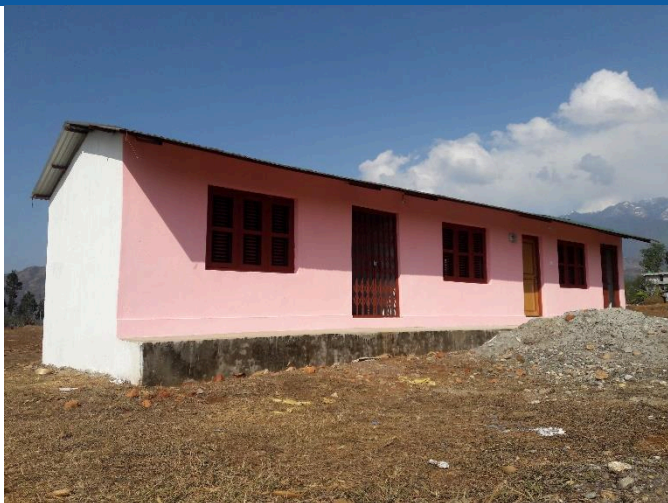
Name: - Bharat Sharma  
Location: - Salyantar, Tripurasundari Rural Municipality  
It is one storey load bearing structure with material used burned brick with cement mortar, its floor area is less than 1000 sqft. The beneficiary has received 2nd tranche of government grants.

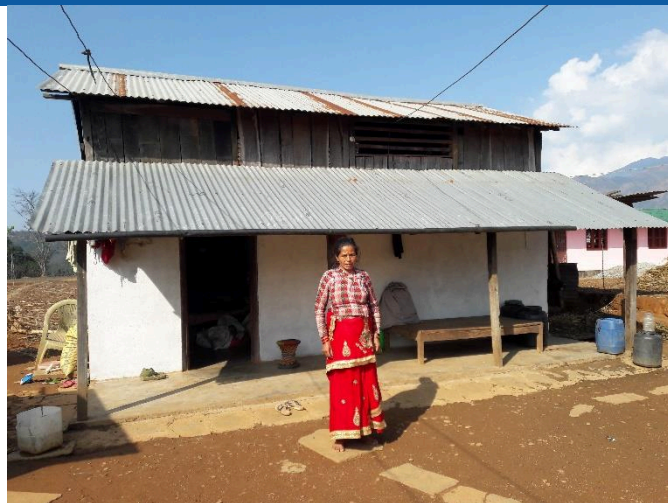
Name: - Laxman Shrestha  
Location: - Salyantar, Tripurasundari Rural Municipality  
It is two storey Hybridstructure with material used burned brick with cement mortar in ground floor and CGI sheet in second floor, its floor area is less than 1000 sqft. The beneficiary has received all tranche of government grants.

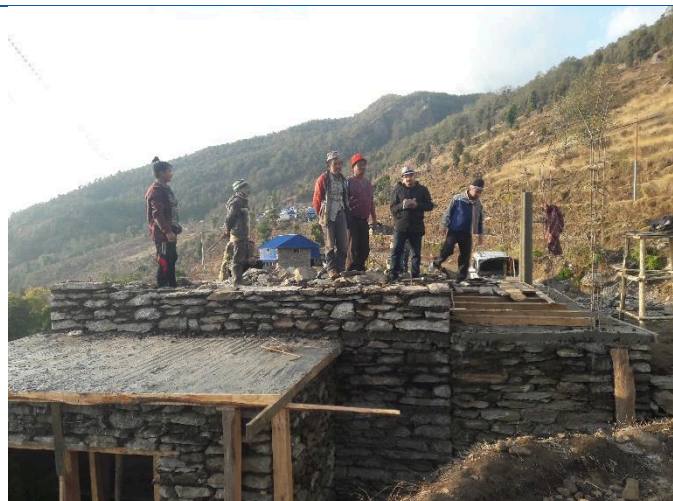
Name: - Bir Bahadur Gurung  
Location: - Sadhan ward no- 05, Gangajamuna Rural Municipality, Dhading  
It is one storey plus Attic load bearing structure with material used Stone with cement mortar. The beneficiary has received 2<sup>nd</sup> tranche of government grants.

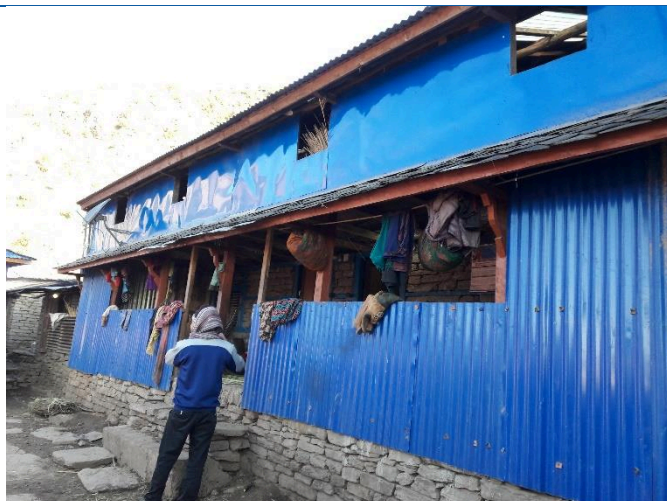
Name: - Dai Bahadur Tamang  
Location: - Latap Ree Vdc, Gangajamuna Rural Municipality, Dhading  
It is a Two storey Hybrid structure with material used burned brick with cement mortar in ground floor and CGI sheet in second floor. The beneficiary has received all tranches of government grants.
