TRANSITIONAL PROJECT IMPLEMENTATION SUPPORT  
FOR  
EMERGENCY RECONSTRUCTION PROJECTS  
IN NEPAL

# **TRAINING STRATEGY and HOUSE SURVEY in Target VDCs**

**JICA Technical Assistance Team**  
**December 2016**

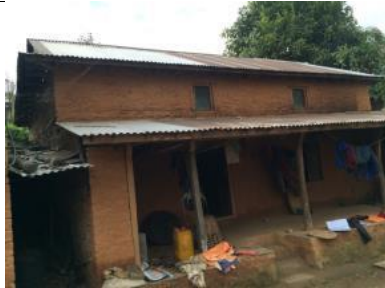
| <ul style="list-style-type: none"> <li>• No bands are used.</li> <li>• Two storey house with heavy gable wall</li> </ul> | | | |

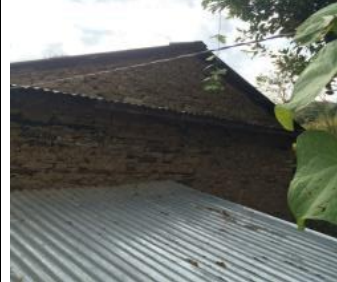
| No Bands | | Heavy material in gable | |

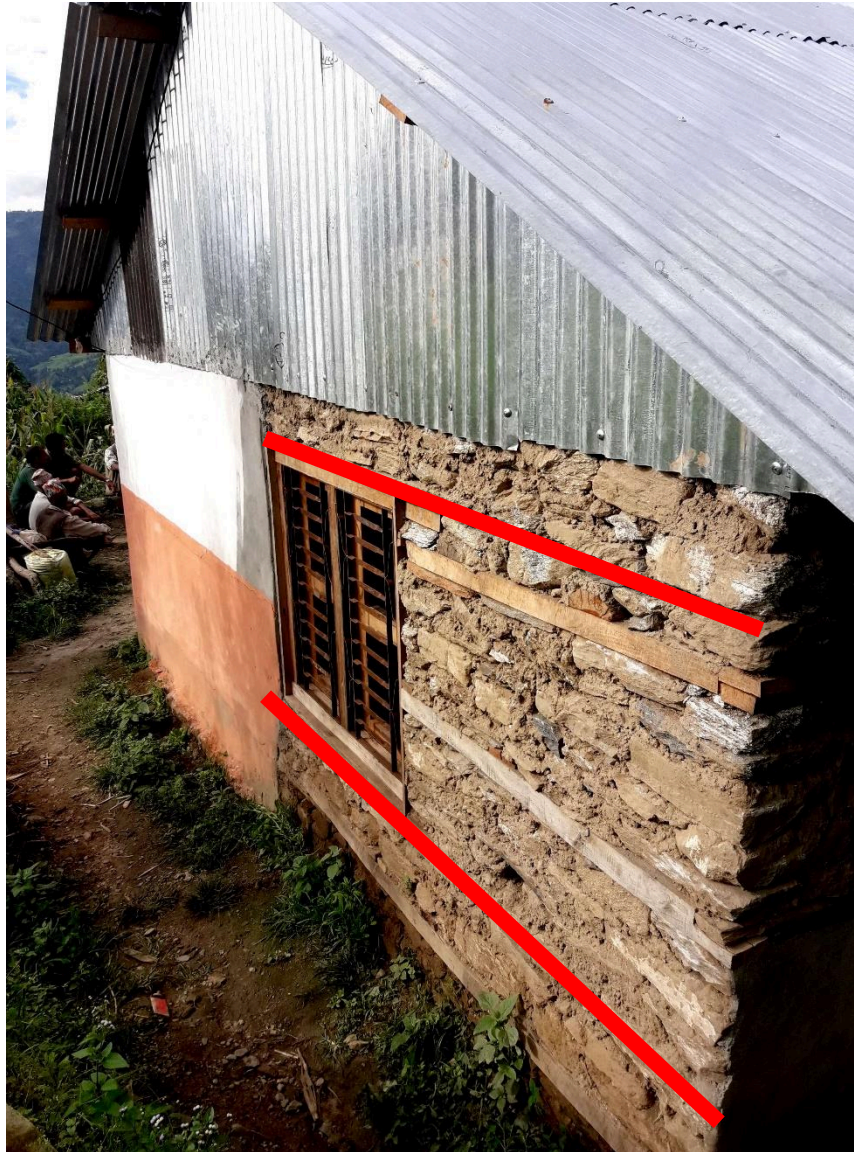
# ● Compliant and Non-compliant Houses in field

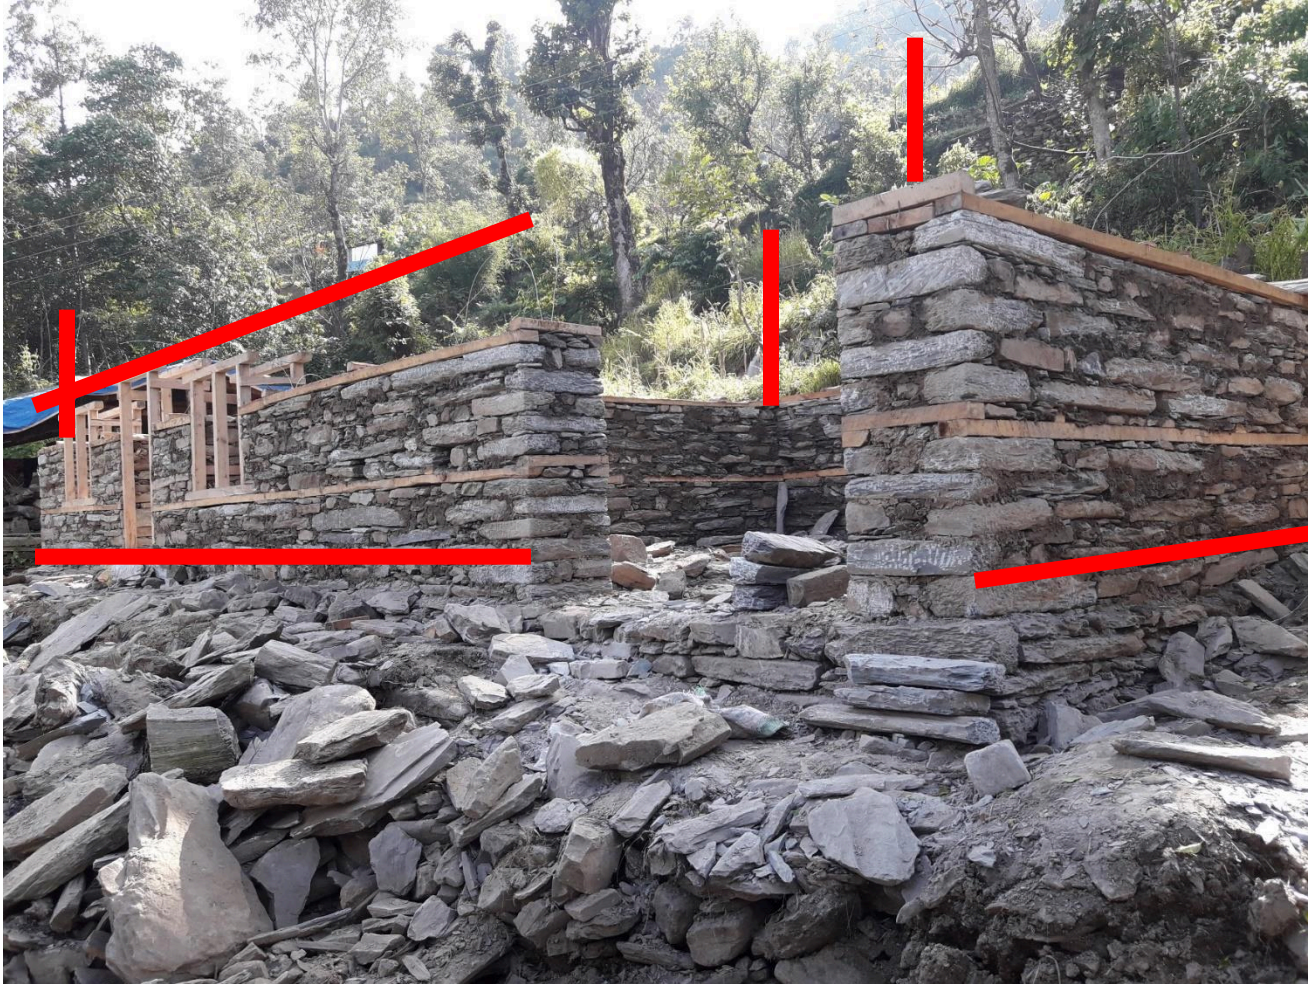
# ● Compliant and Non-compliant Houses in field

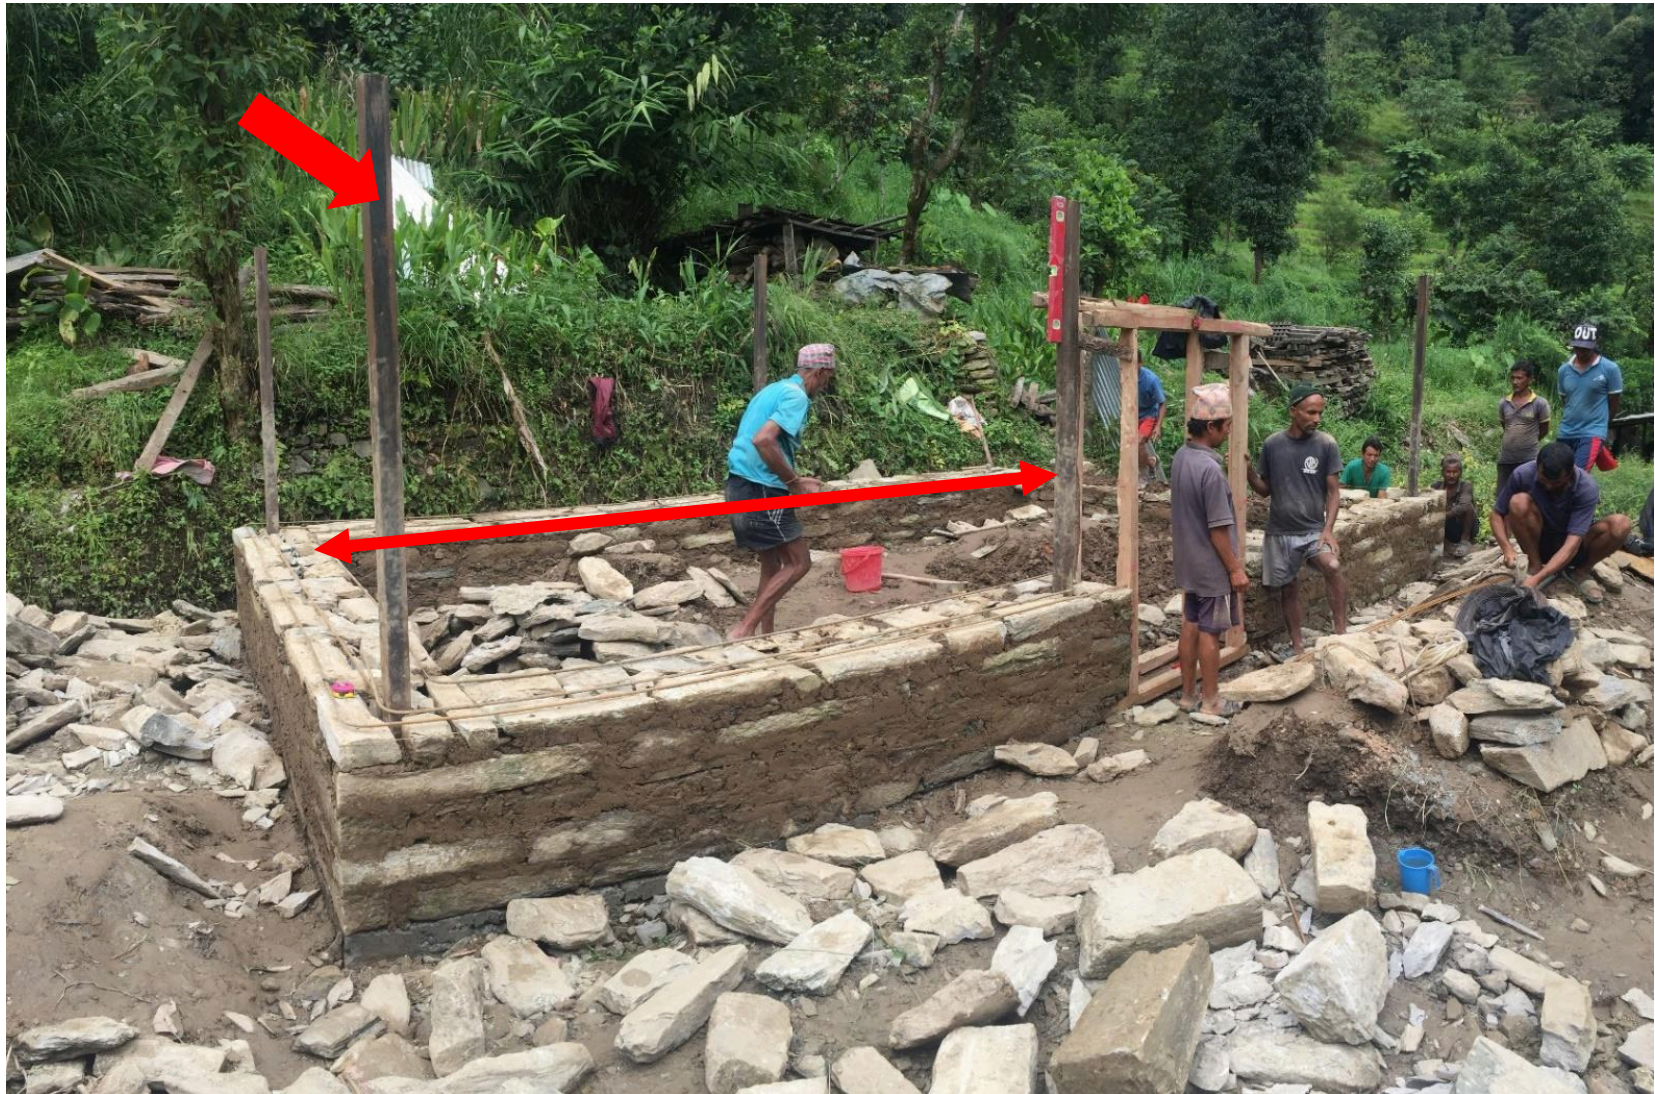
# ● Compliant and Non-compliant Houses in field

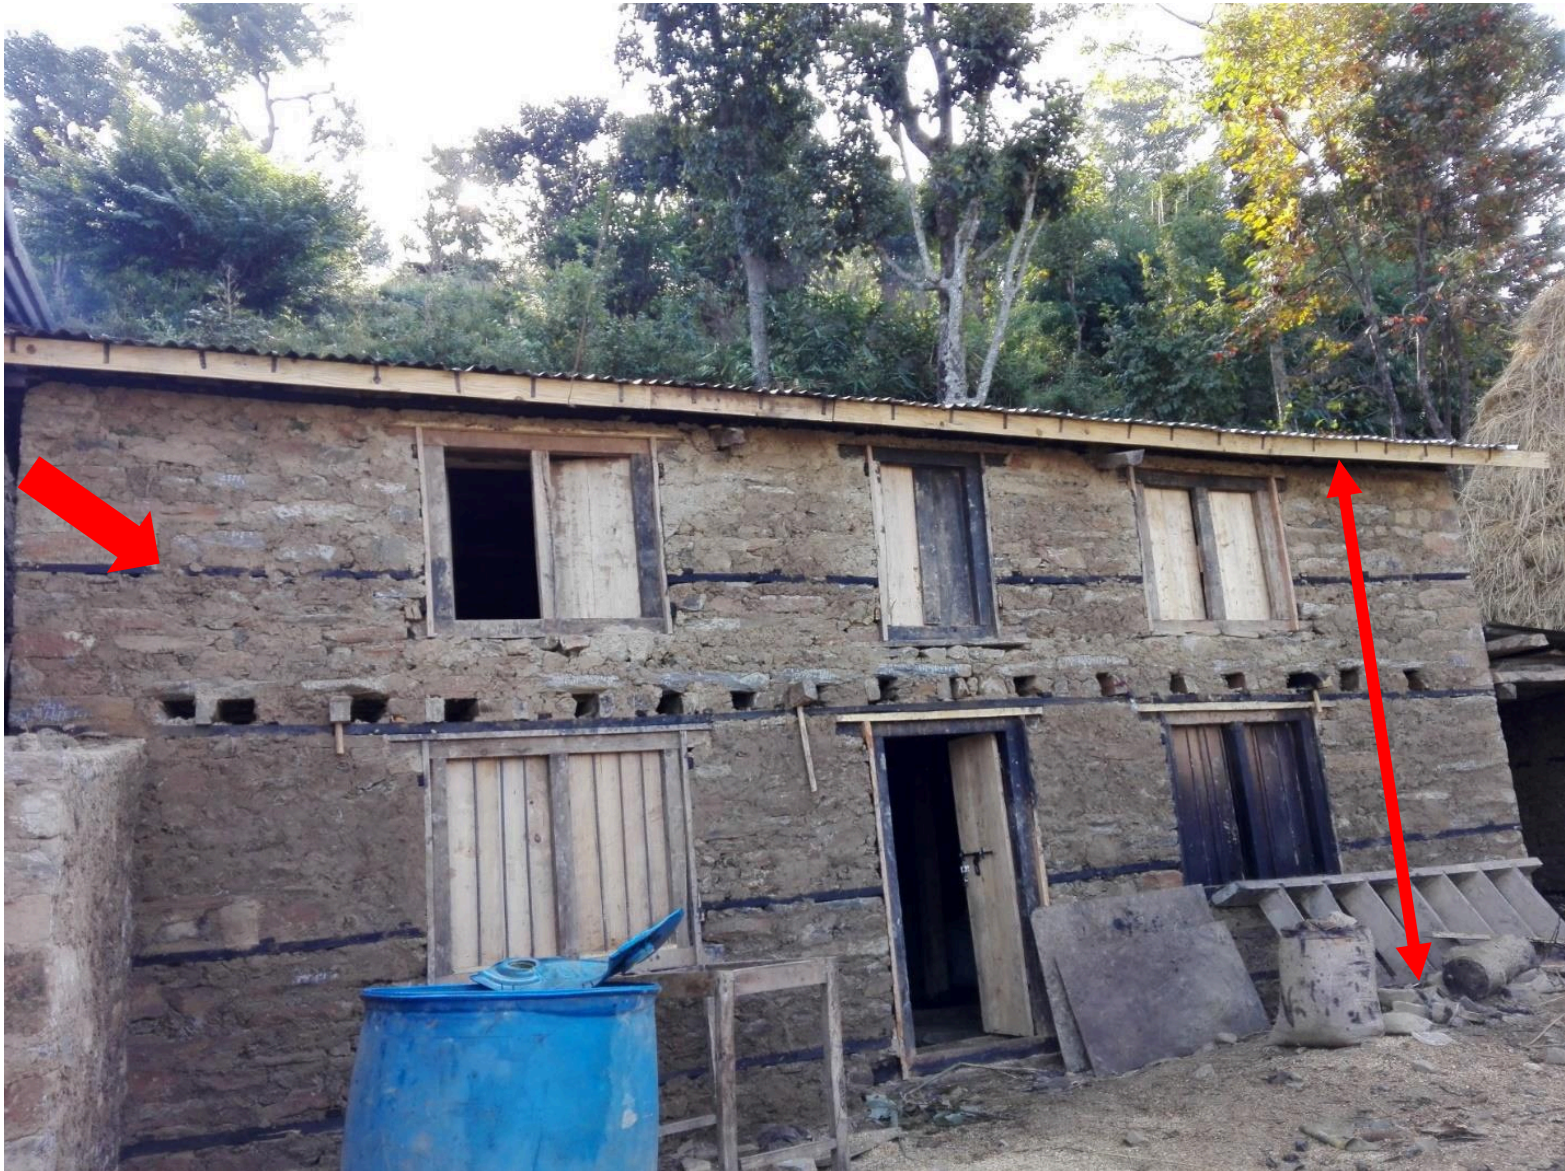
## ● Compliant and Non-compliant Houses in field

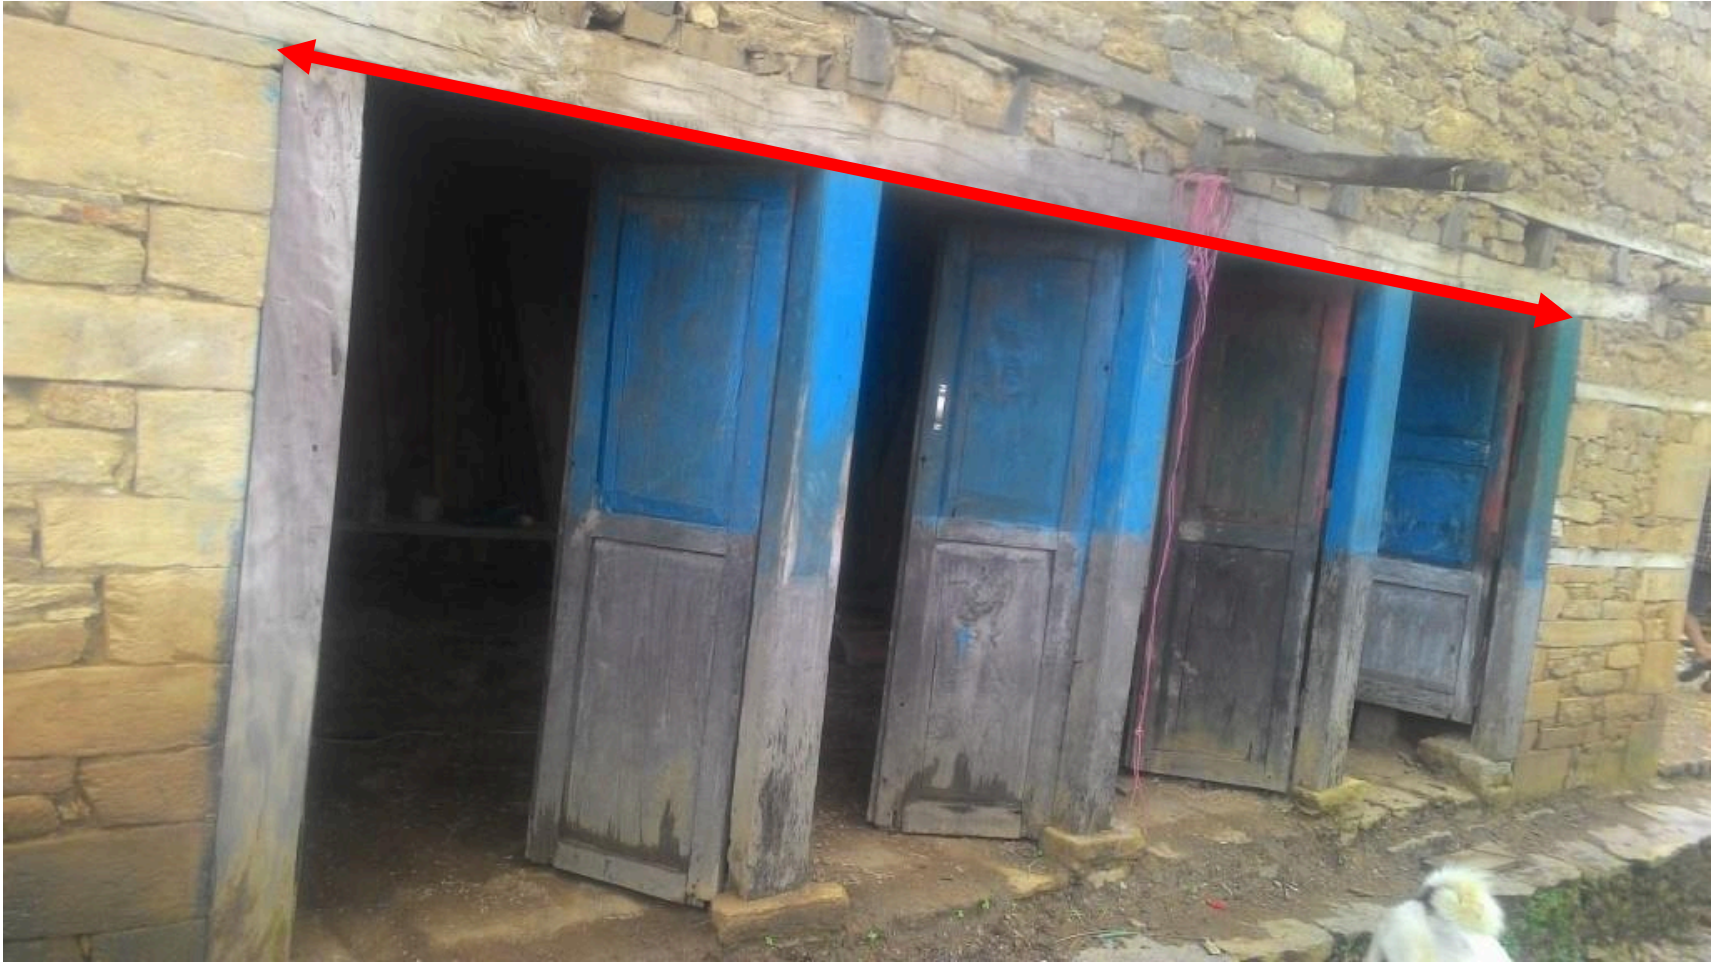
# ● Compliant and Non-compliant Houses in field

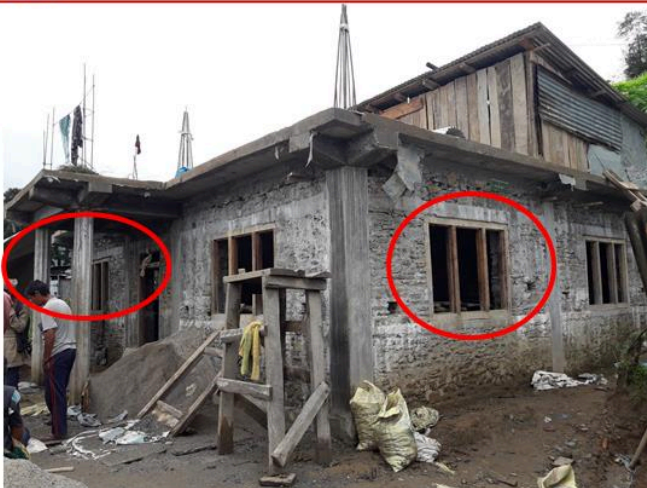
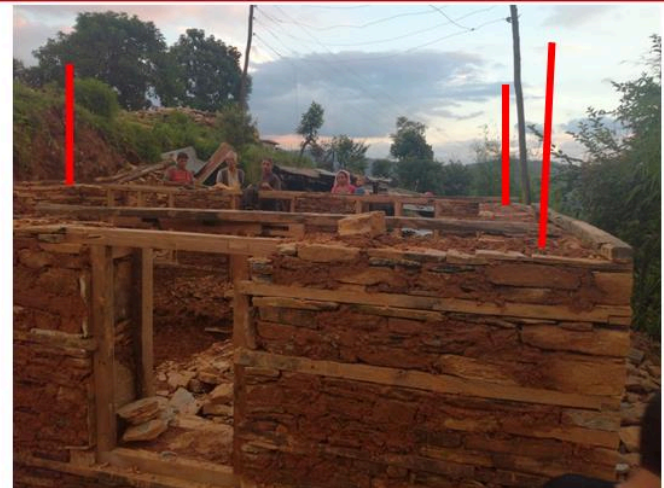
## Compliant and Non Compliant Houses
