# **Gorkha Northern VDCs Study & Mud Mortar Additive Research update**

Presented by : CRS

## **CRS: Gorkha Recovery and Resilience Program (Oct 2016 - Sep 2019)**

This presentation is based on the field visit & study conducted by CRS to provide input to its Shelter Nepal Program by observing and assessing the remote situation in the North.

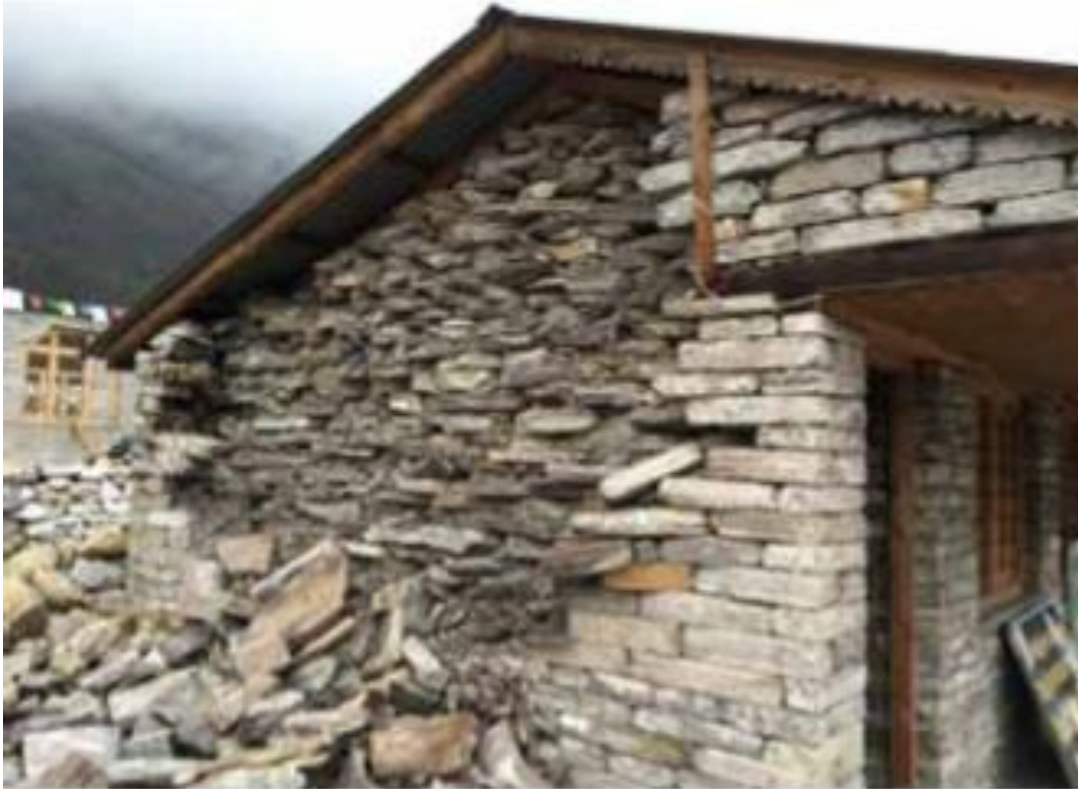
Callapsed gable end wall due to lack of through stones

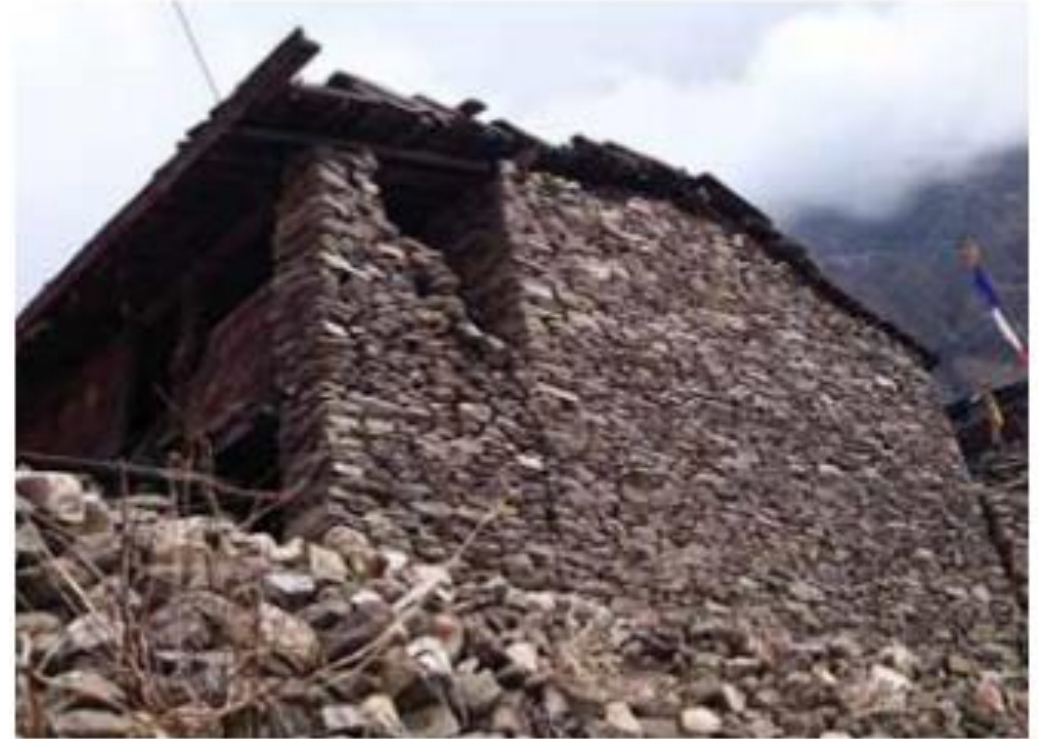
Verandah flank wall collapse, these elements are never keyed in to the main building walls

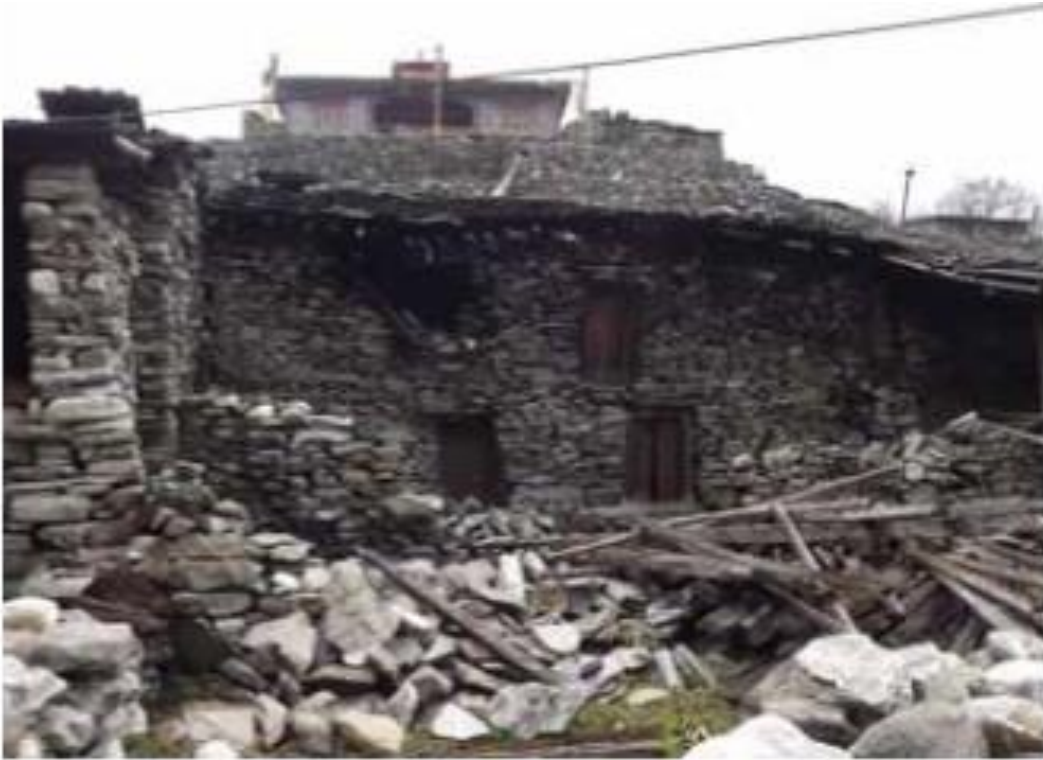
Top of wall collapsed around a window opening, lintels are often undersized to take stone wall above

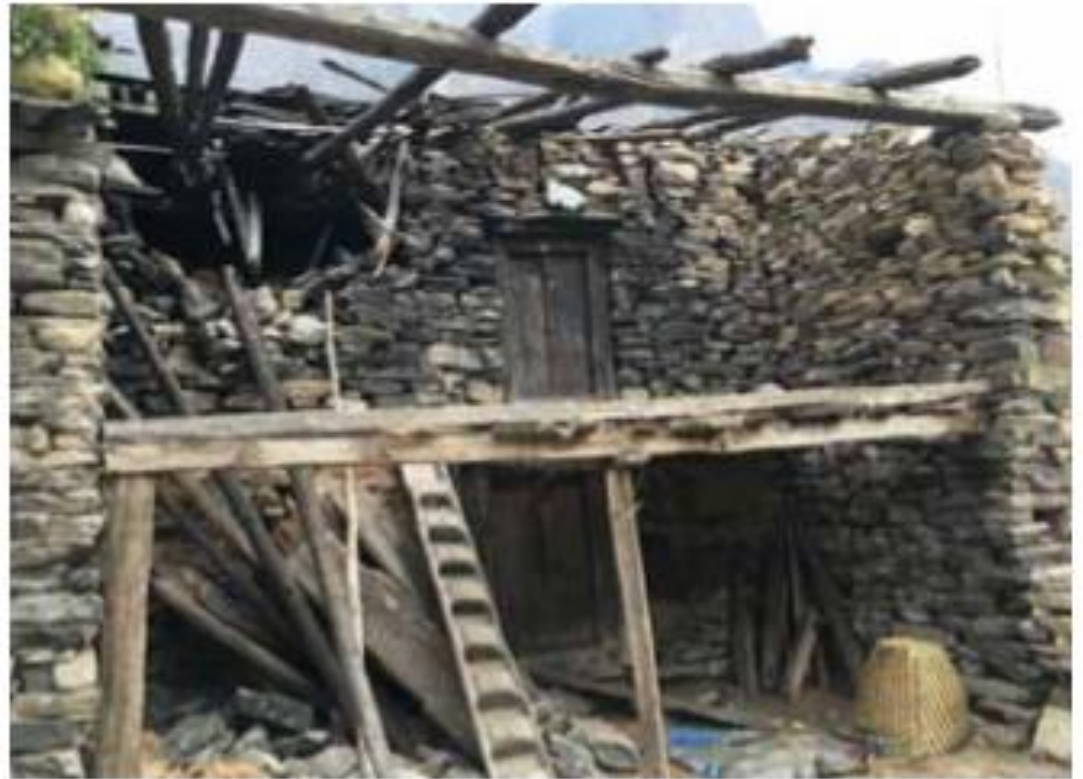
Collapsed roof structure

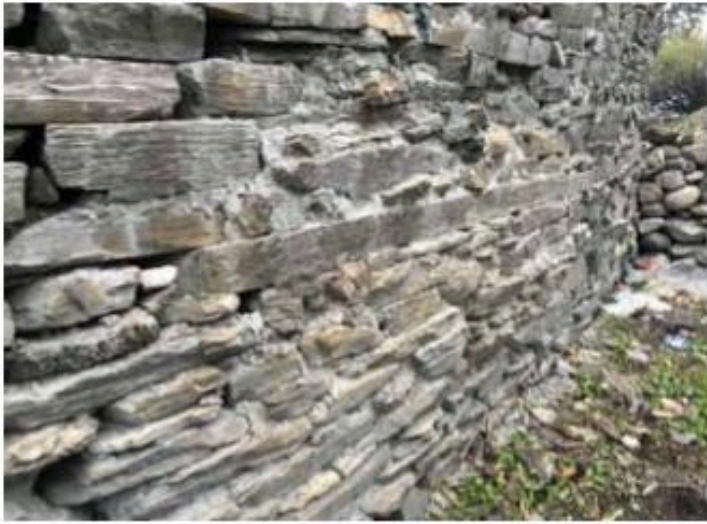
Stone banding, peice laid approx 1m above GL and is 100x deep x 2.5m long

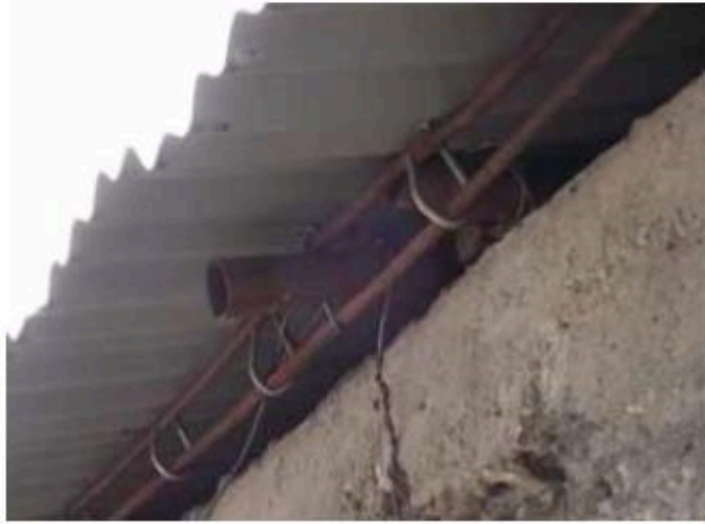
Use of steel pole and hooks on a concrete block hotel, wire wall ties used to secure the rafters

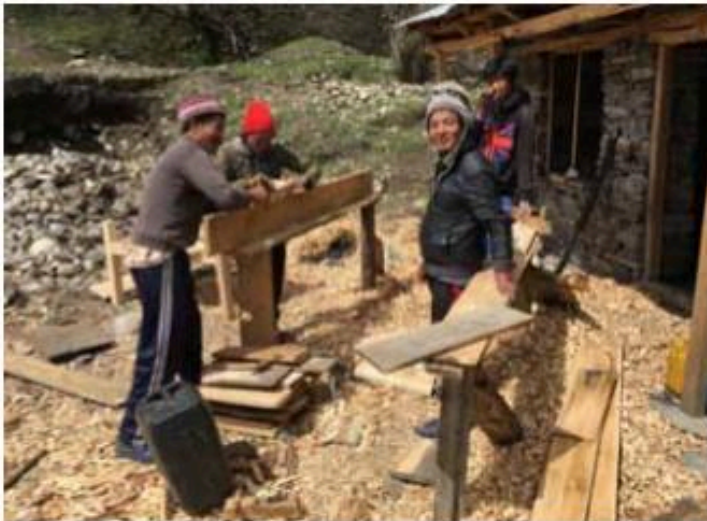
Carpenters working with hand tools

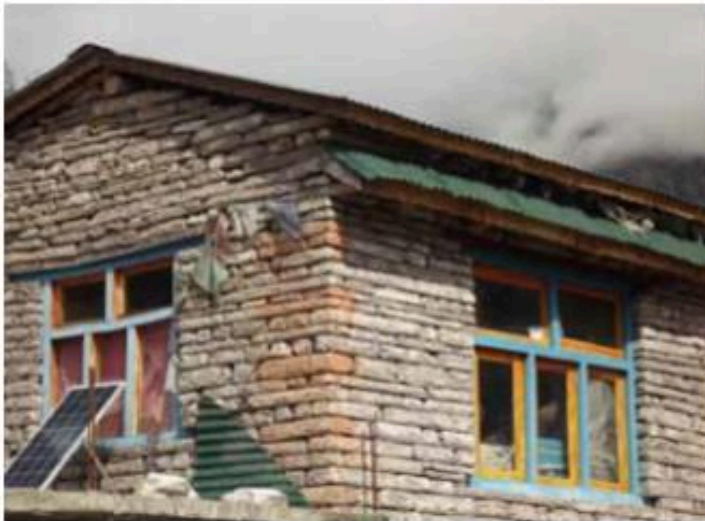
Best examples of stonework were observed on the hotel buildings

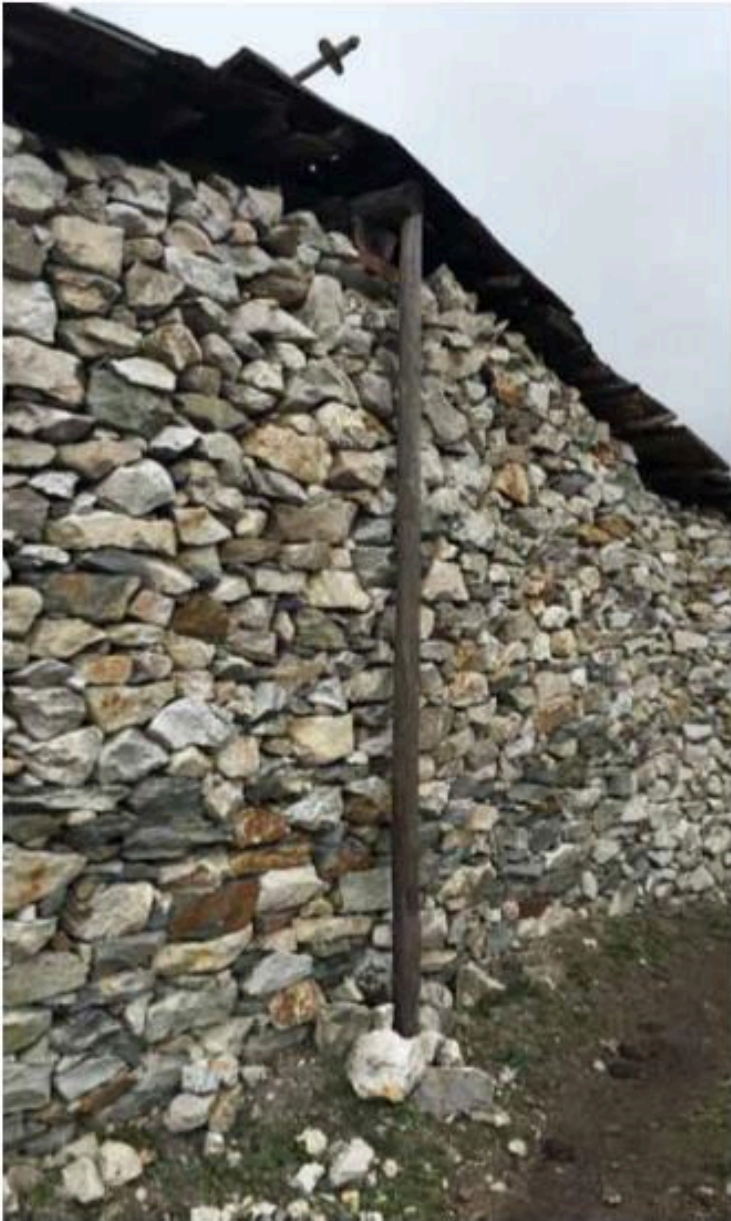
Timber post added to support the ridge beam

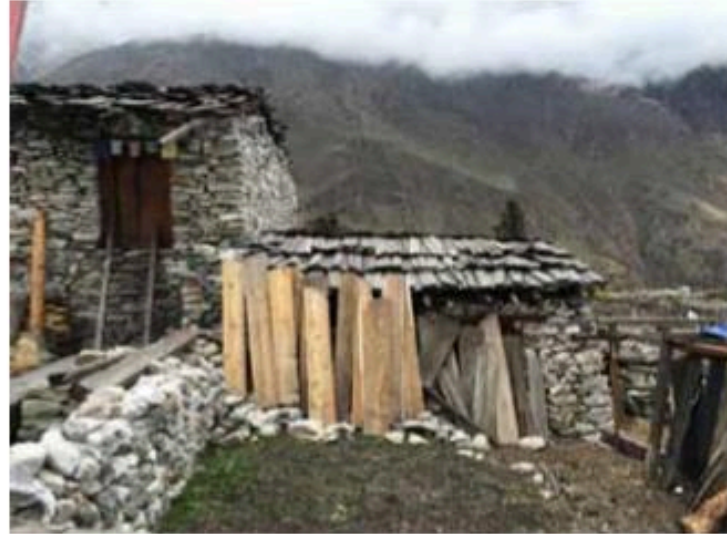
Timber roof planks as shingles

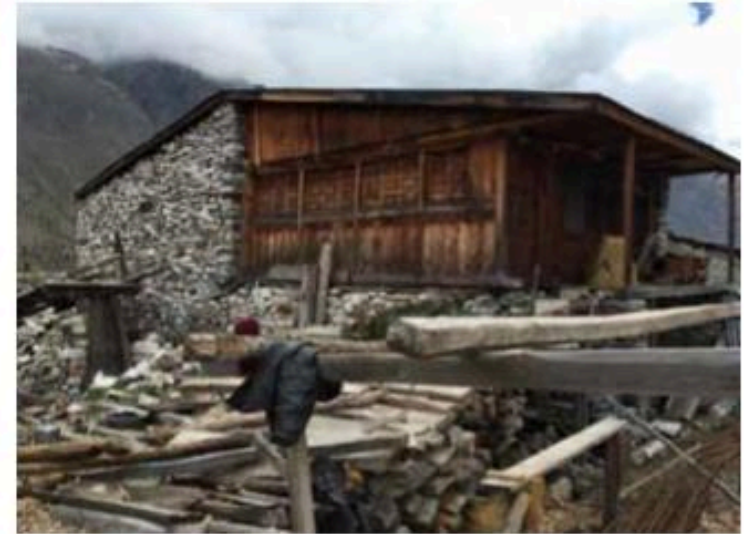
Large first floor extension in timber

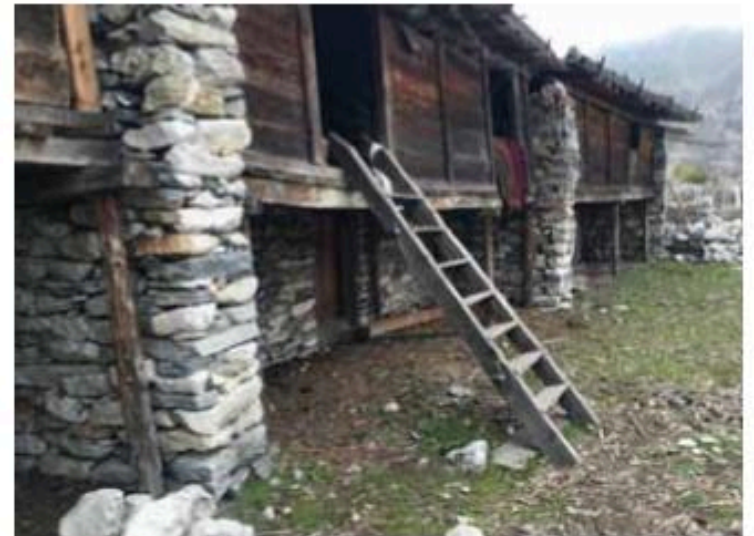
Terraces of 3/4/5 Khims are found throughout the village with shared stone party wall

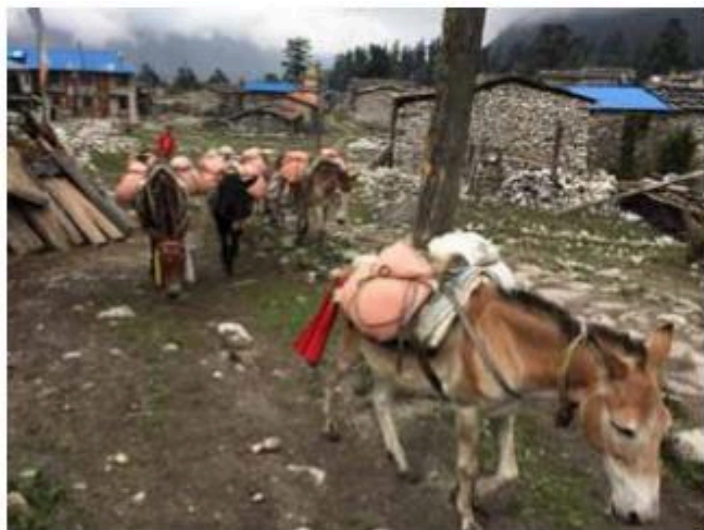
Mules transporting cement through the village to supply the hotel building projects

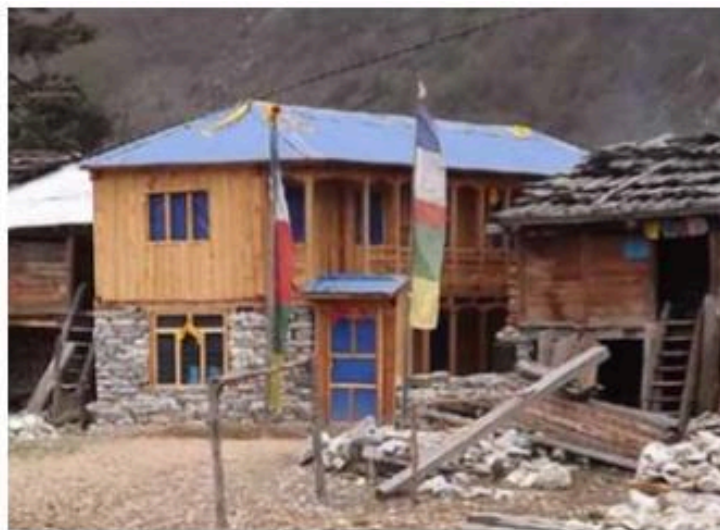
First storey timber found on an hotel structure

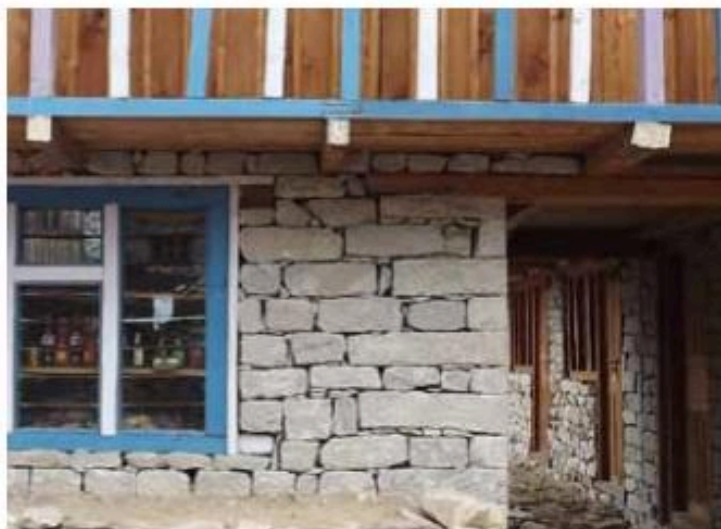
Good stonework again found on the hotel buildings, good coursing and stone shape and size

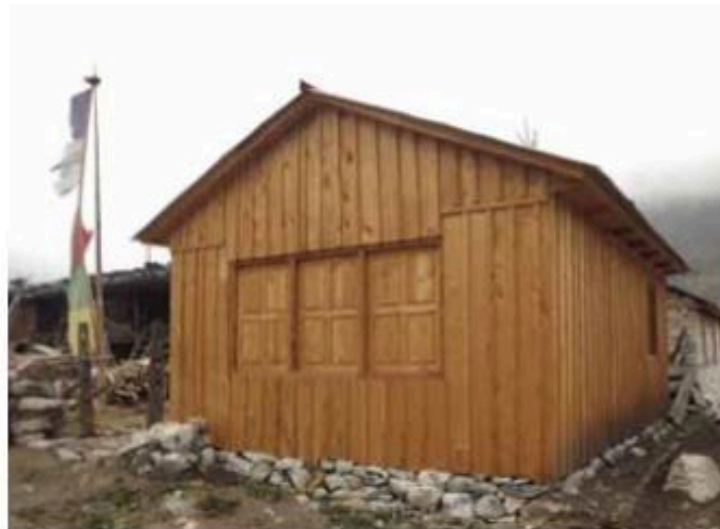
Timber single storey home

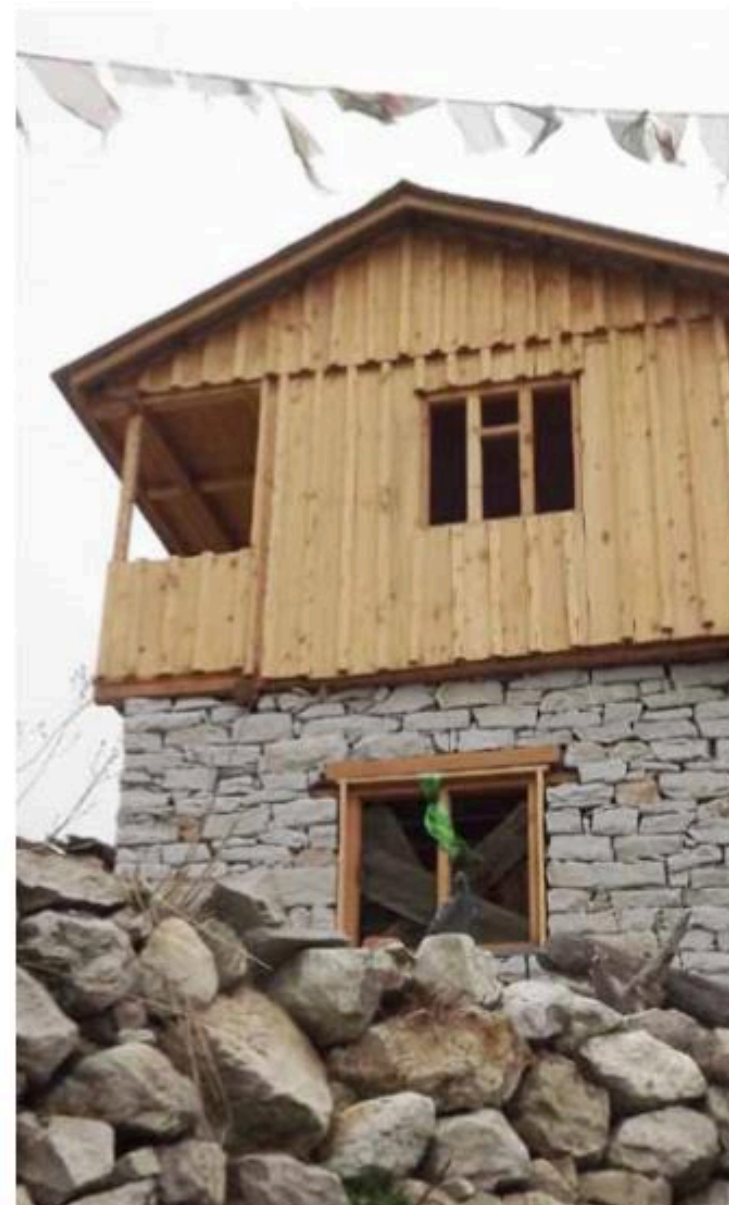
Hotel with new first floor timber floor

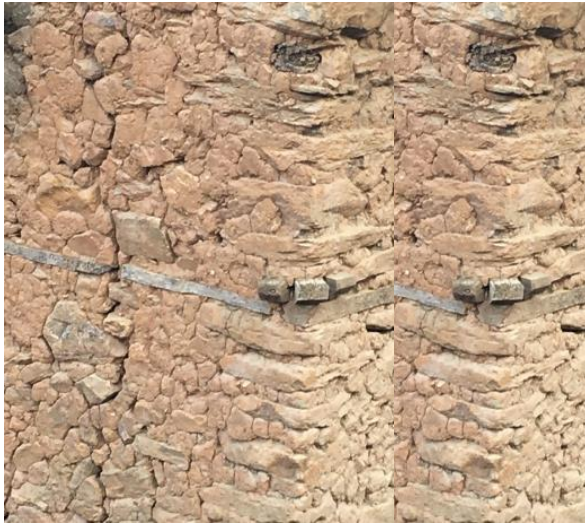
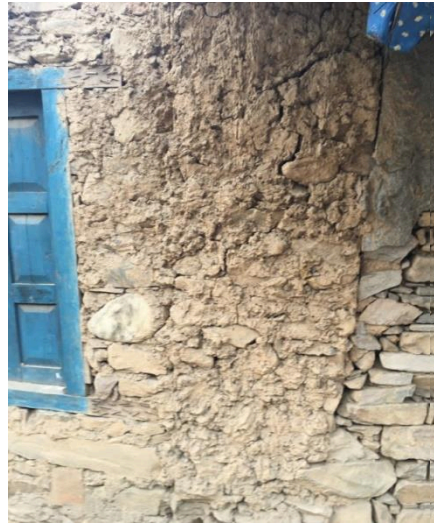
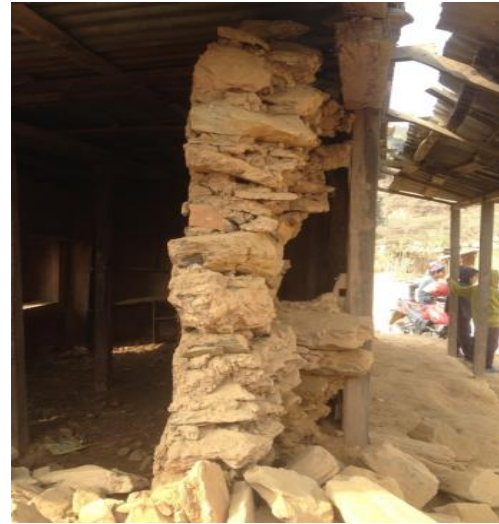
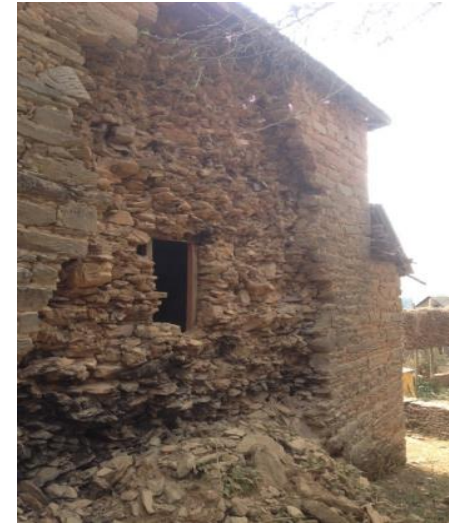
Issues with mortar are evident.

- Excessive proportion of mortar.
- Quality of soils for mortar.
- Issues of micro-cracking due to high clay content and quantity of water.
- Lack of tensile strength.

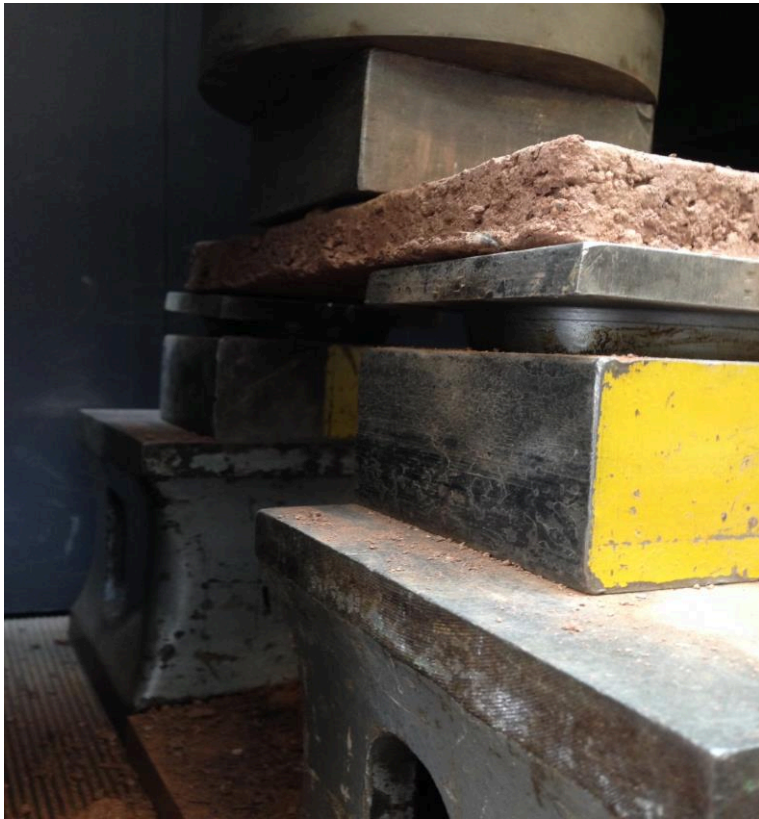
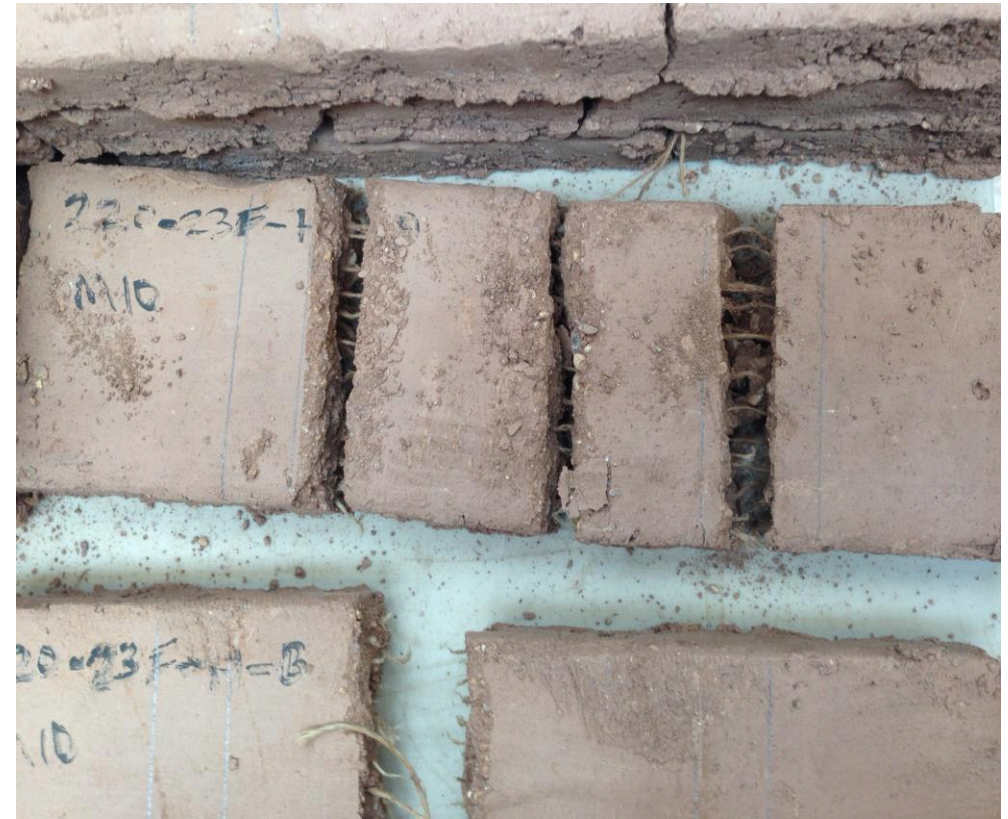
- Significant variability in the initial resistance (when the samples first cracked) and ultimate failure was observed.
- But there was no clear distinction between the three types of reinforcement and two types of mortar.

- The performance of the samples between initial cracking and ultimate failure was largely dependent on the density of the reinforcement fibres and their location rather than the type of fibre or mortar.

- Although the reinforcement did little to improve the shear resistance of the mortar, the improved post-cracking behaviour is likely to have some benefit in terms of the earthquake resilience of the masonry, by improving the structural integrity of the building and reducing the risk of total collapse during a seismic event.
